Bridge Inspection Report

A1338
US 64 WHITE
over
WHITE RIVER RELIEF

Structure Number: A1338

Facility Carried: US 64 WHITE

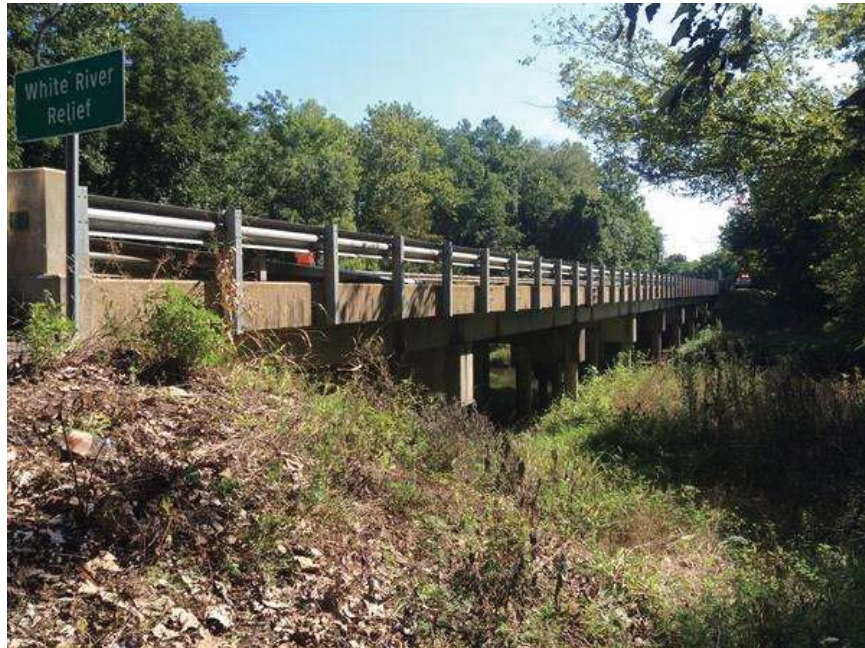
Log Mile looking East.
Construction Job 5501.

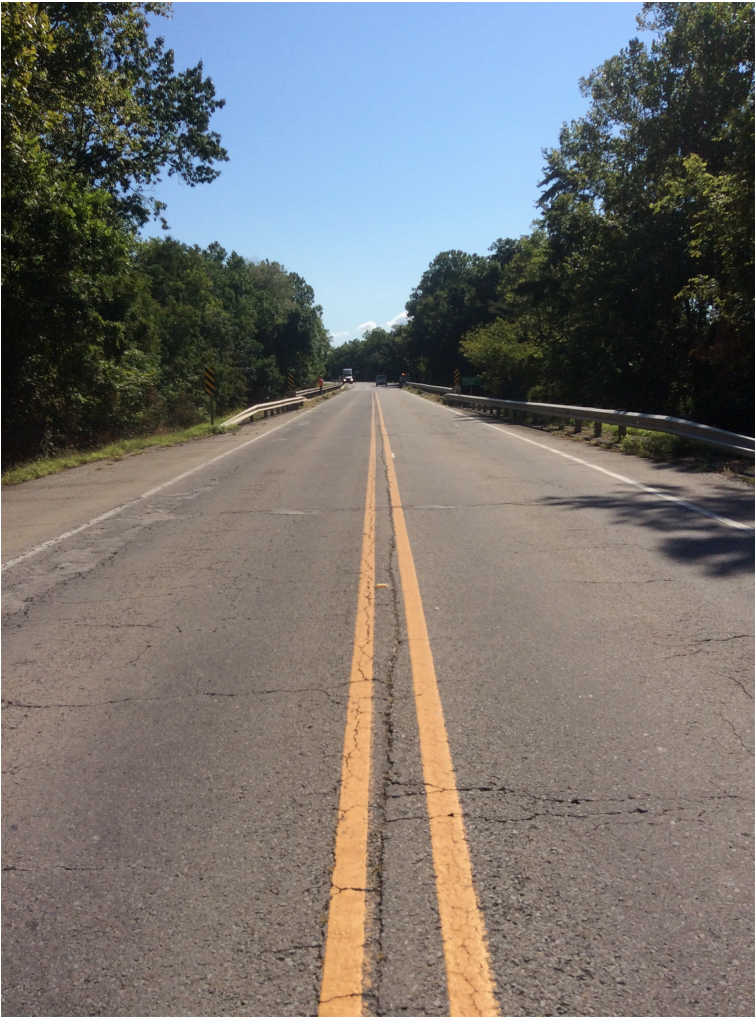
4 inches of asphalt on the bridge deck

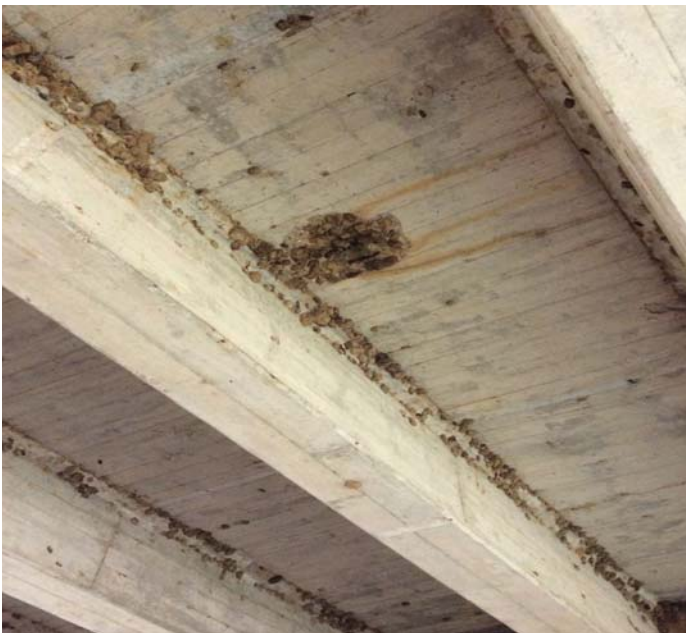
Priority: D - Routine

Spall with corroded rebar exposed to deck below/overhang at Spans 2, 3, & 6.

PHOTO 1 Description Spall with corroded rebar exposed to deck below at Spans 2 & 3.

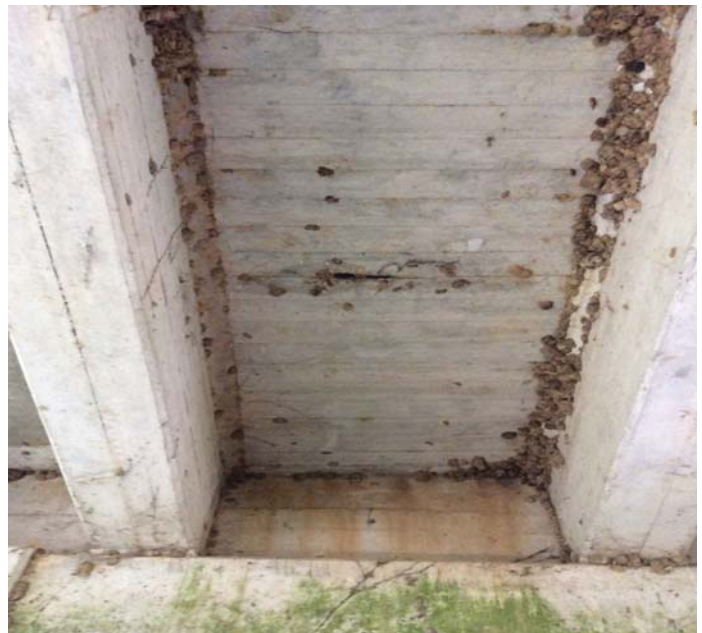
PHOTO 2 Description Span 3. Spall with corroded rebar exposed to deck below at Spans 2 & 3.

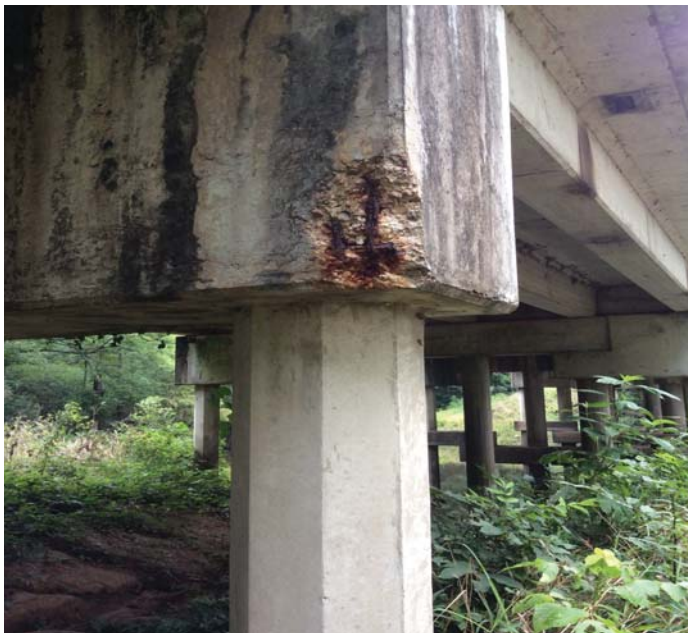
Priority: C - Important

Cracks, delaminating &/or spalls with rebar to caps at Bents 2 - 6.

PHOTO 1 Description Bent 2 Right Side.
Cracks, delaminating &/or spalls with
rebar to caps at Bents 2 - 6.

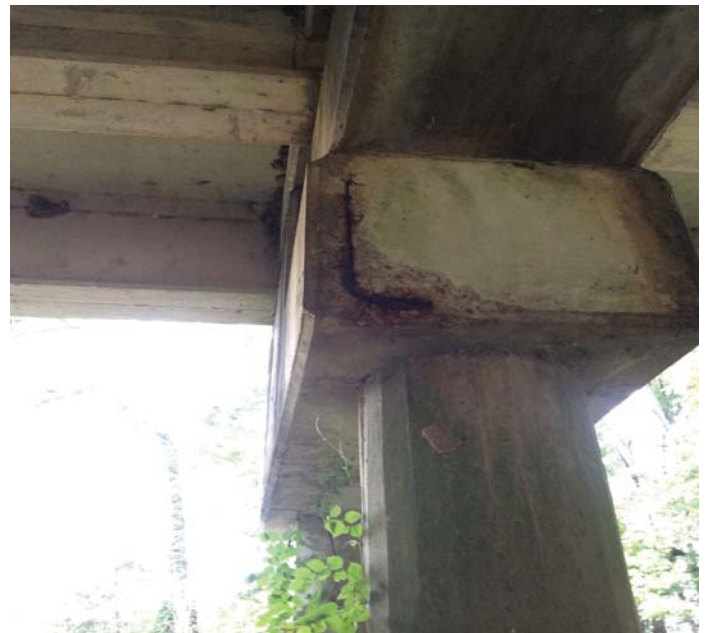
PHOTO 2 Description Bent 2 Right Side.
Cracks, delaminating &/or spalls with
rebar to caps at Bents 2 - 6.

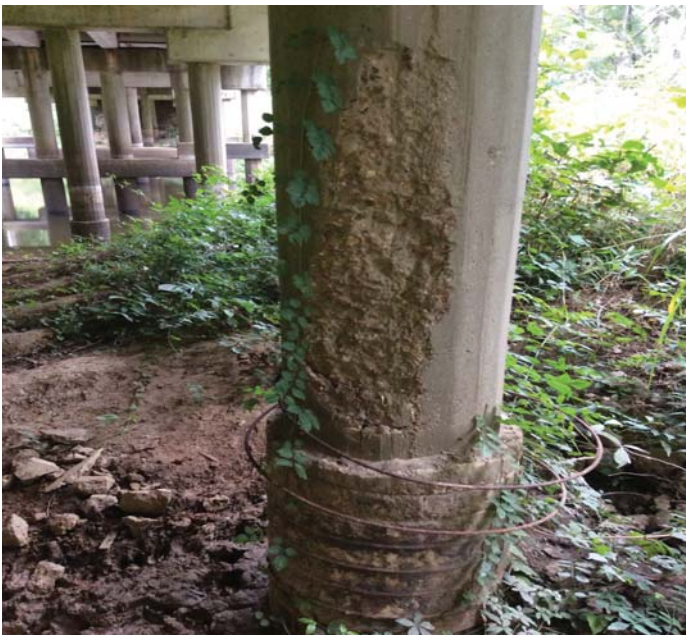
Priority: D - Routine

Large spall no rebar exposed to Pile 5 at Bent 2.

PHOTO 1 Description Large spall no rebar exposed to Pile 5 at Bent 2.

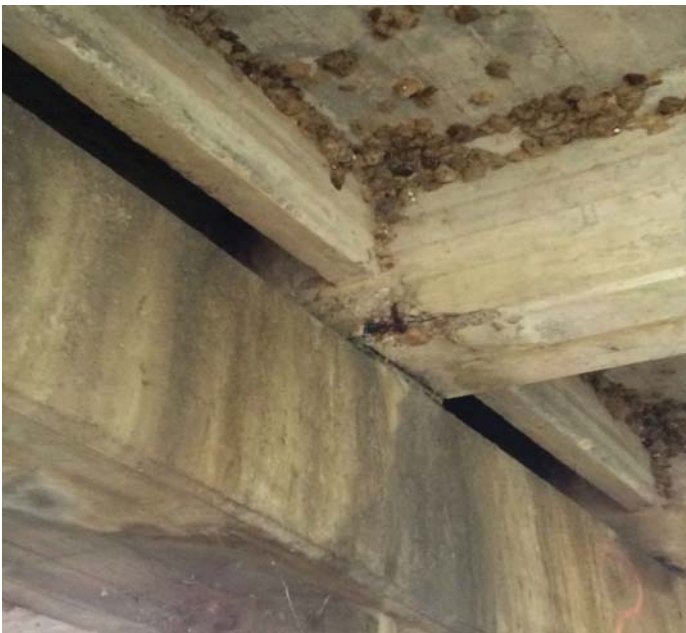
Priority: C - Important

Cracks, delaminating &/or spalls with rebar exposed to concrete girders at Spans 1 - 7.

PHOTO 1 Description Cracks, delaminating &/or spalls with rebar exposed to concrete girders at Spans 2 - 7.
