Bridge Inspection Report

**A1339
US 64
over
WHITE RIVER RELIEF**

Structure Number: A1339

Facility Carried: US 64

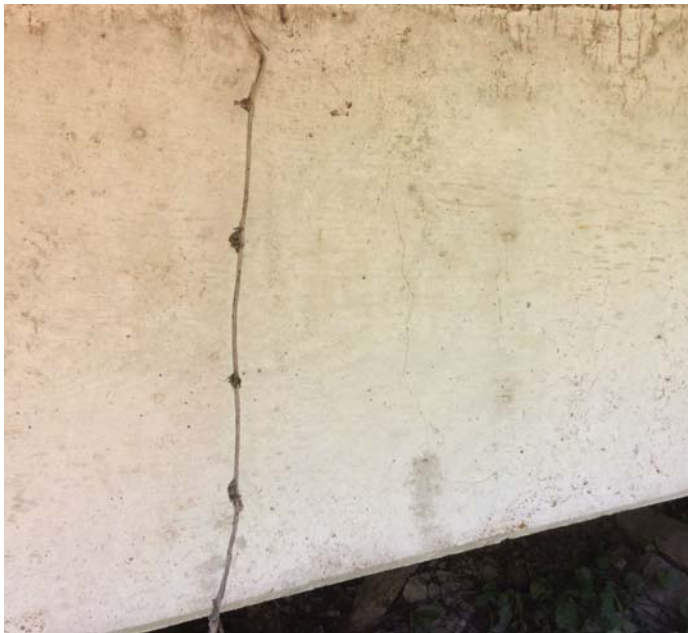
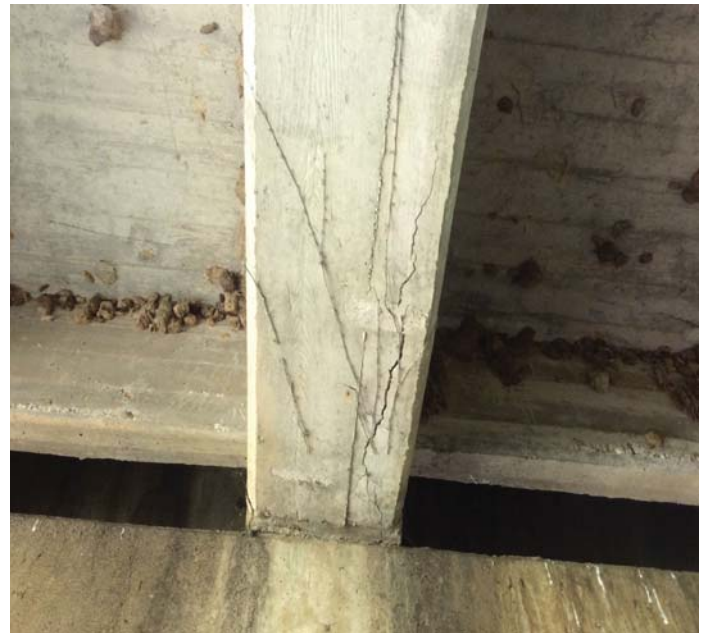
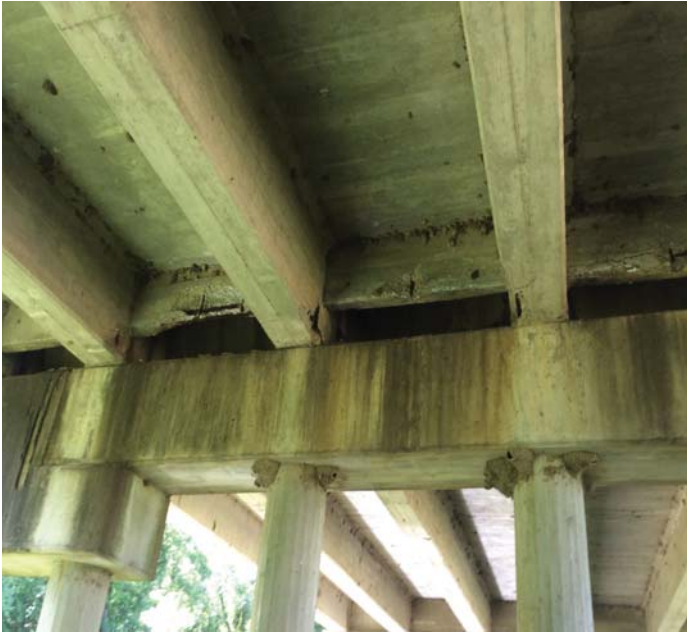
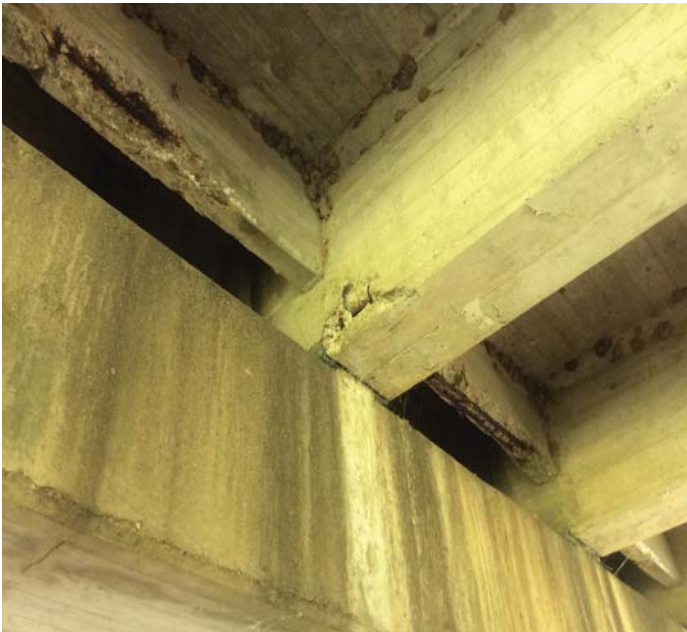
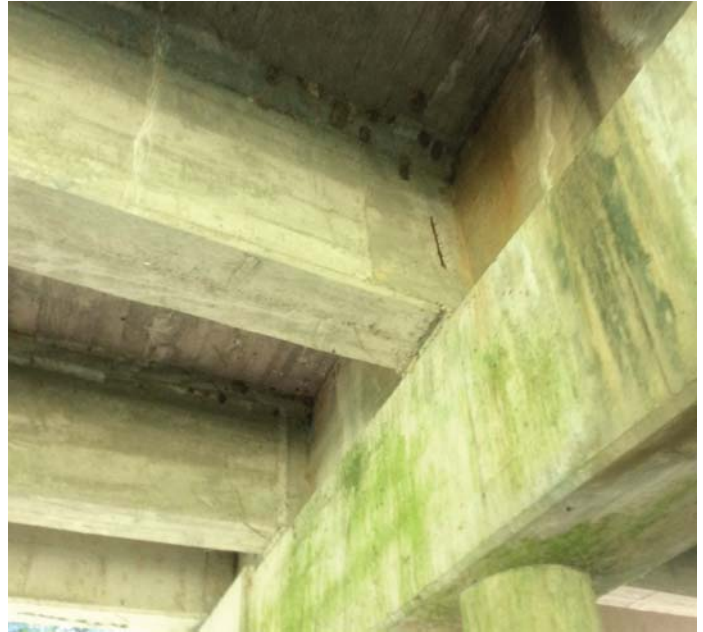
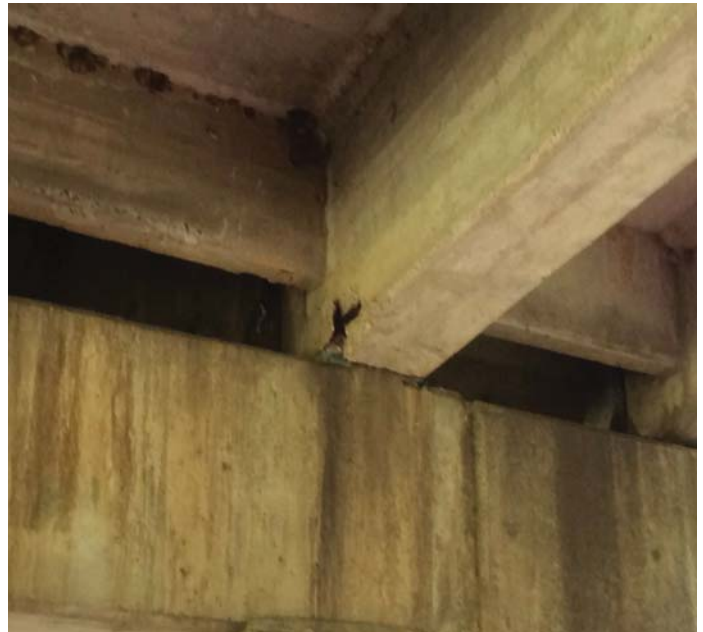
GIRDERS - BENT #2 GIRDER #4
SPAN #2 GIRDER #5 - BENT #3
SPAN #8 GIRDER #3 - BENT #7
SPAN #10 GIRDER #3,4 - BENT #9

MODERATE SPALLS AT BEARING AREA WITH EXPOSED PRIMARY REBAR

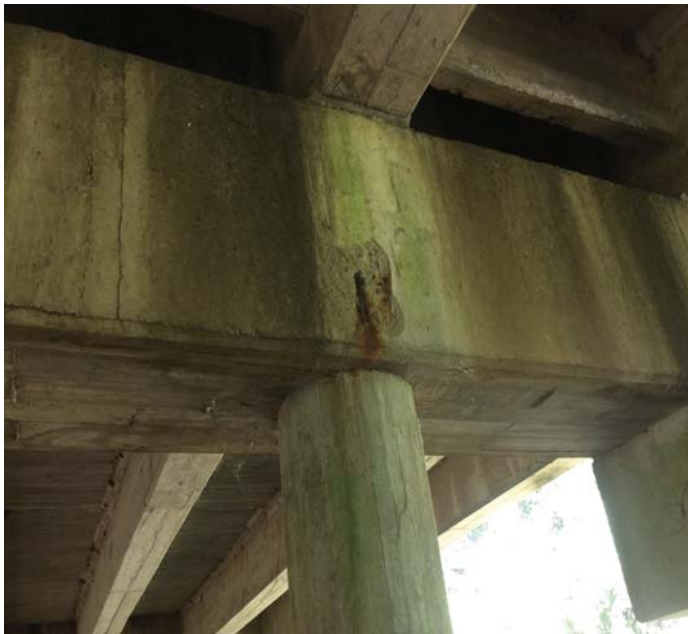
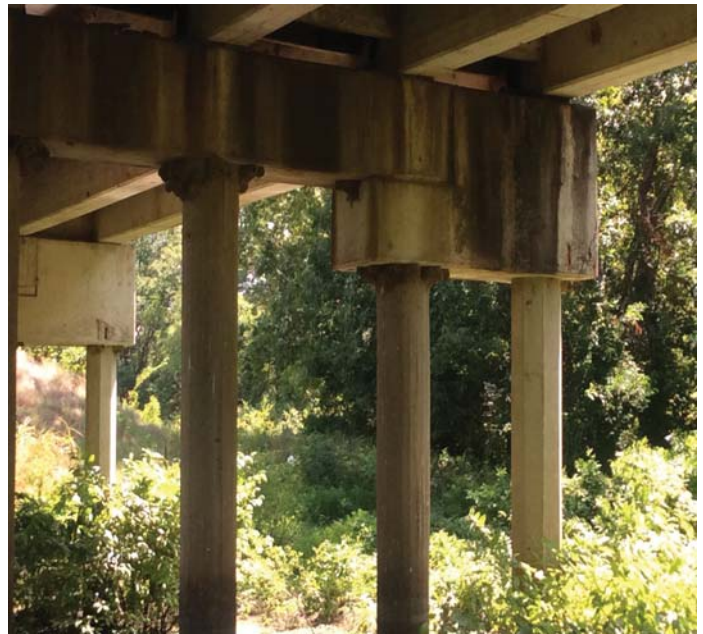
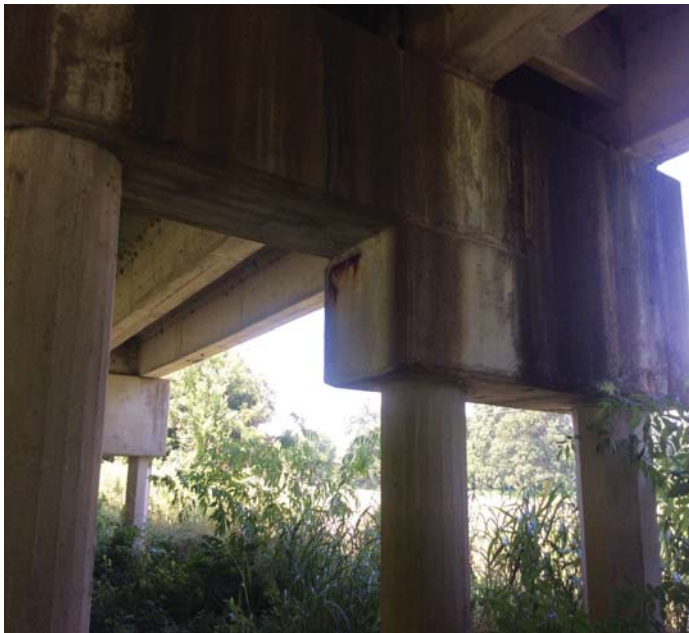
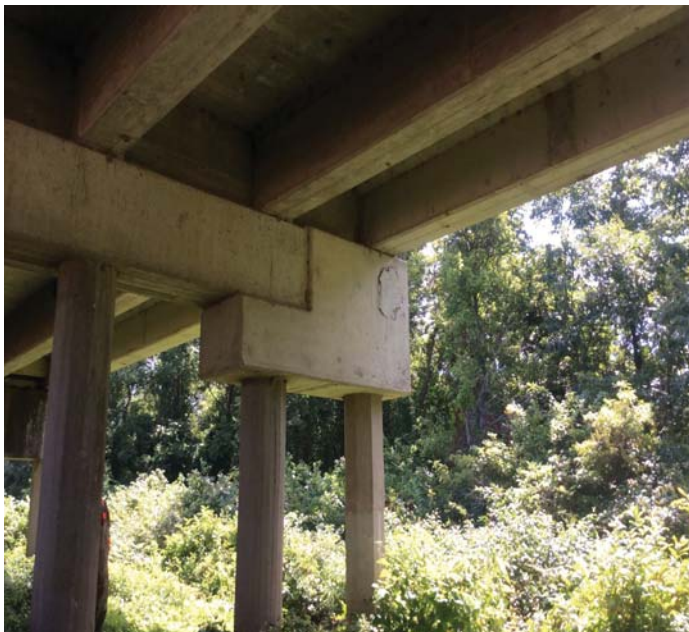
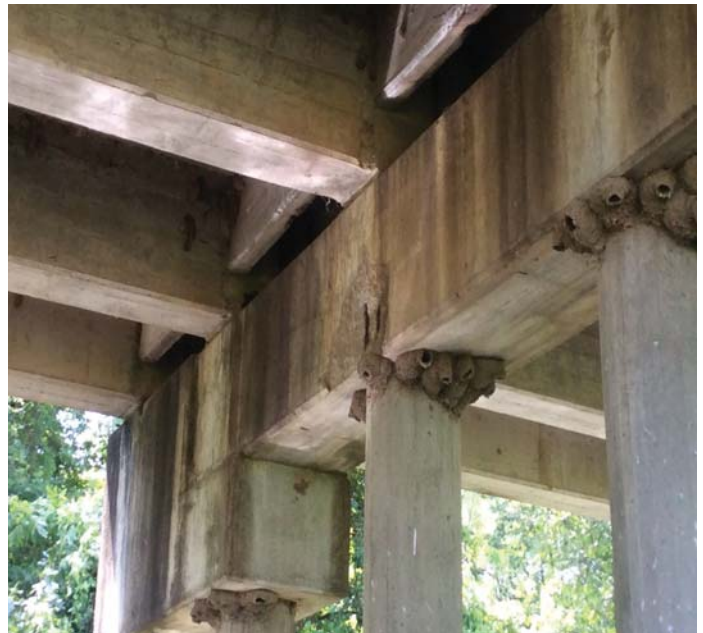
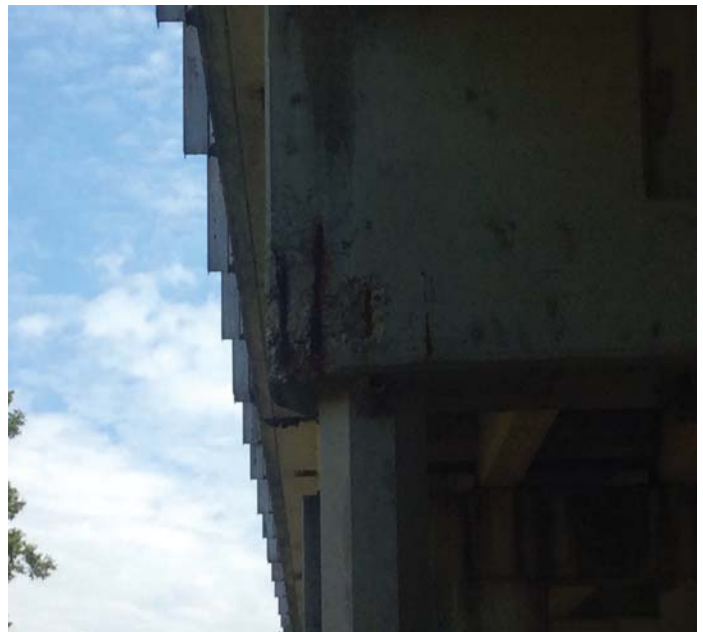
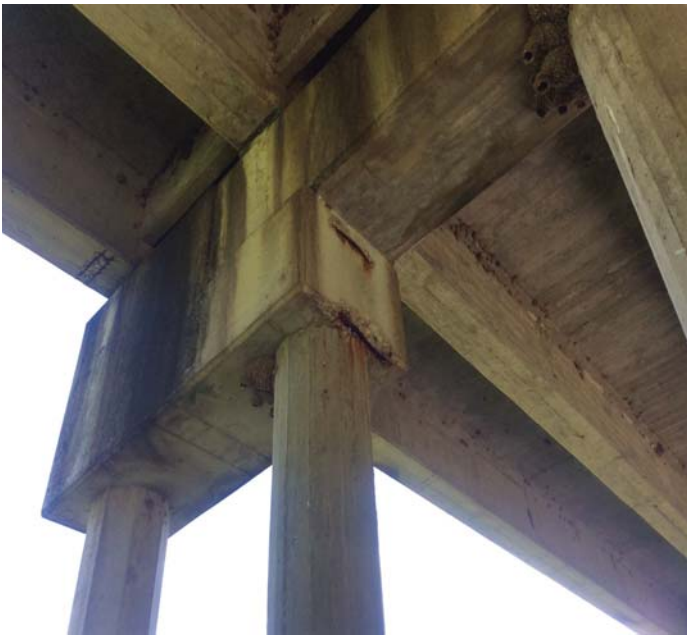
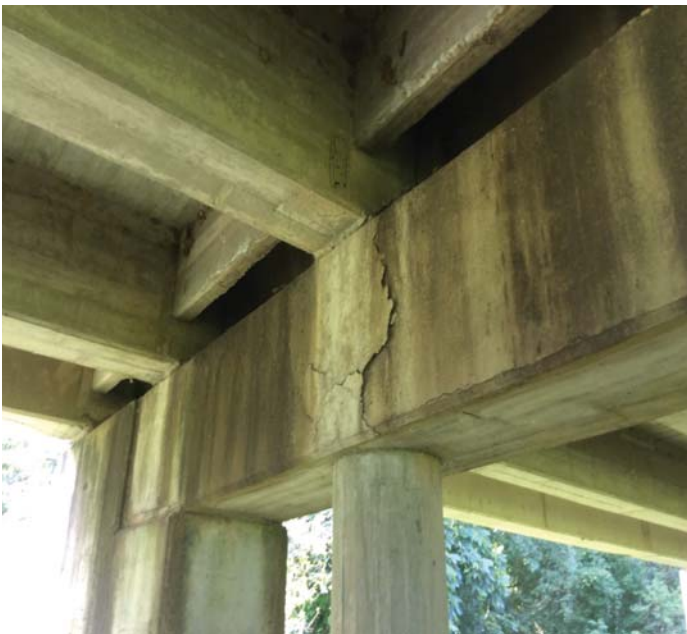
CAPS - BENTS 3, 5, 7, 9, 10, 11, 13, 14, 15

SEVERAL CAPS HAVE MINOR SPALLS WITH EXPOSED SECONDARY REBAR

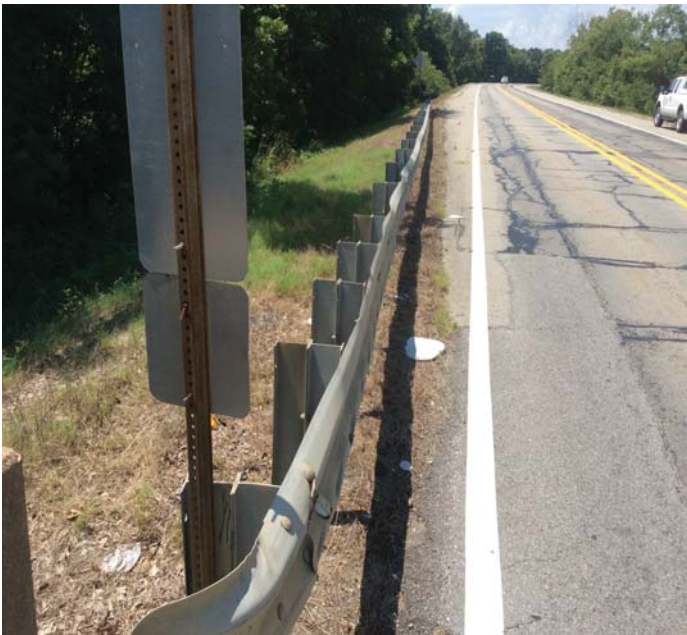
PHOTO 1 Description

APPROACH RAIL

ABUTMENT #1
RIGHT

APPROACH RAIL HAS MINOR IMPACT DAMAGE.
