# Bridge Inspection Report

A1340  
US 64  
over  
GOOSE POND

Facility Carried: US 64

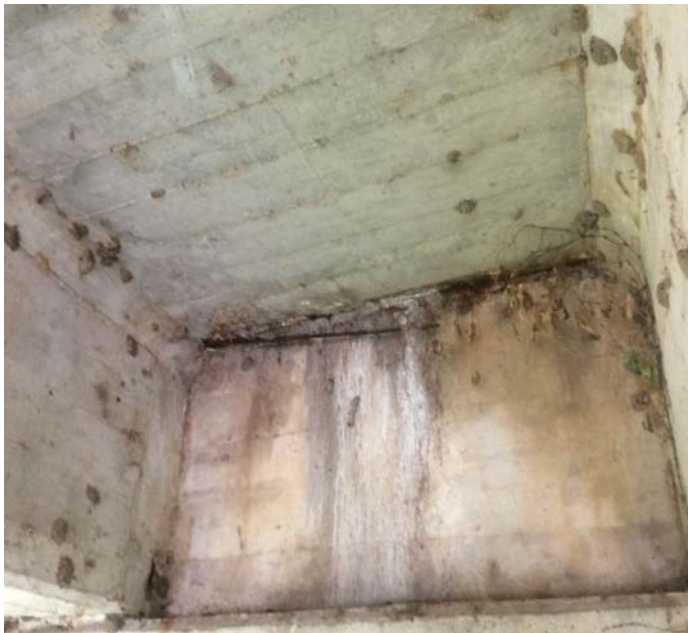
MOST SPANS HAVE CRACKS, DELAMINATIONS AND OR SPALLS

PHOTO 1      Description      Typical exposed rebar in soffit

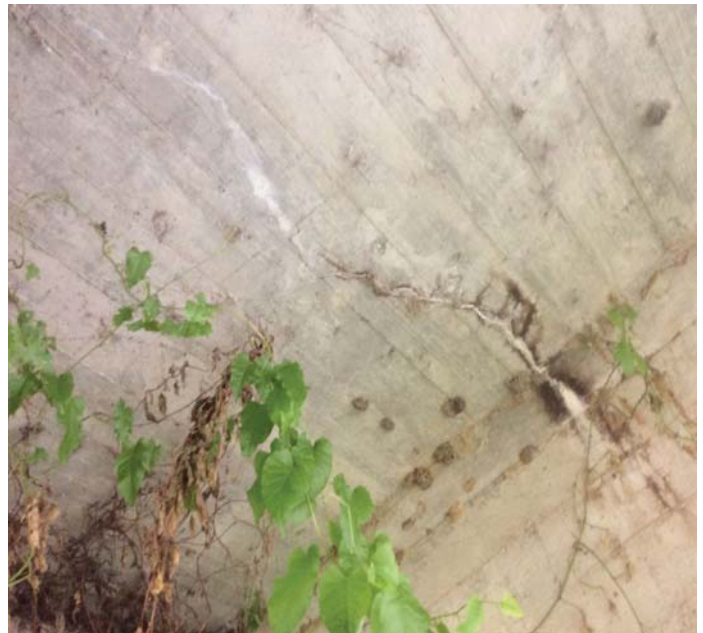
PHOTO 2      Description      Typical soffit crack with efflorescence.

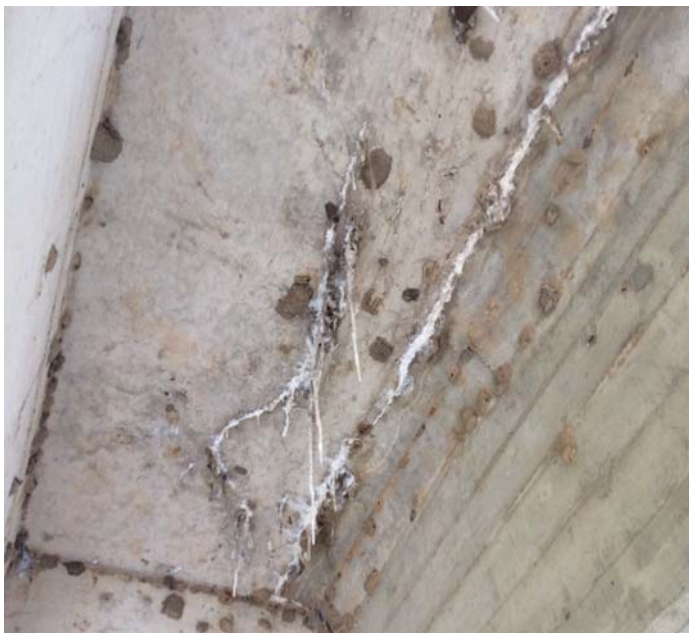
PHOTO 3      Description      Soffit span 9 between girders 5,6.

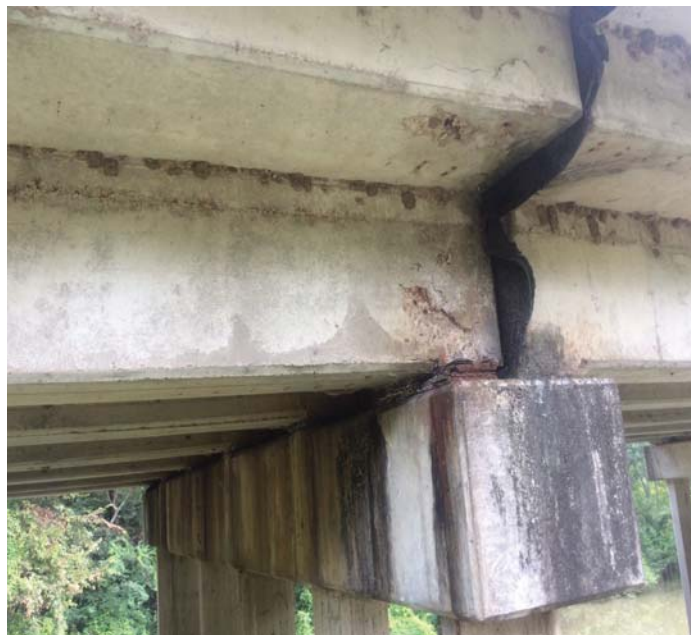
Cracking &/or spalling to ends of girders #1 & OR #6. Interior girders are typ. cracked on ends.

PHOTO 1      Description      Typical light spalling on girder ends.

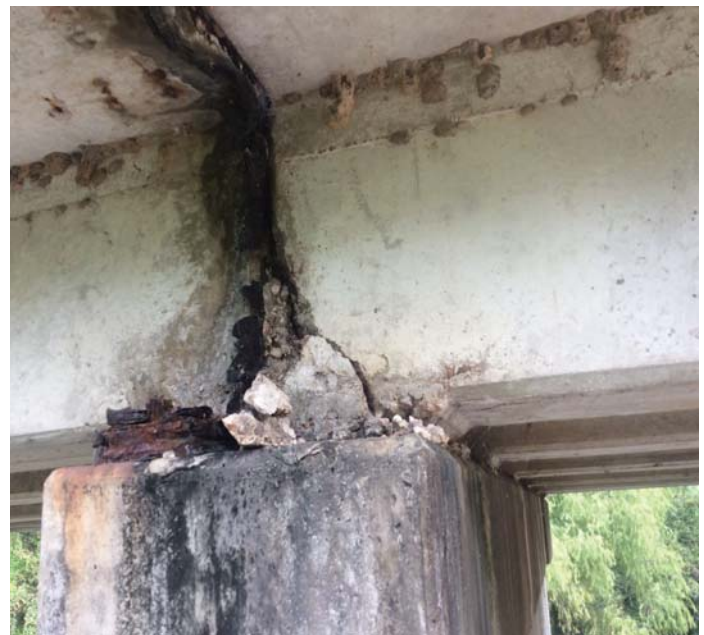
PHOTO 2      Description      Typical girder end spalled.

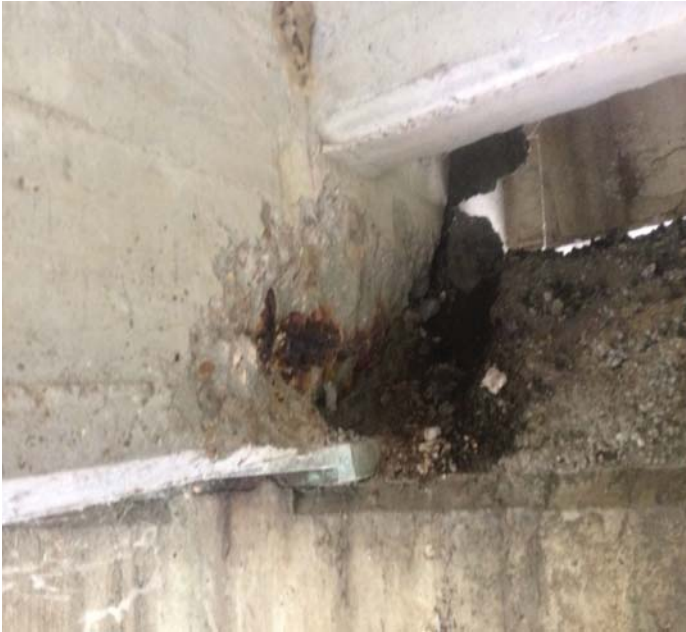
PHOTO 3 Description Span 6 girder 3 right side.

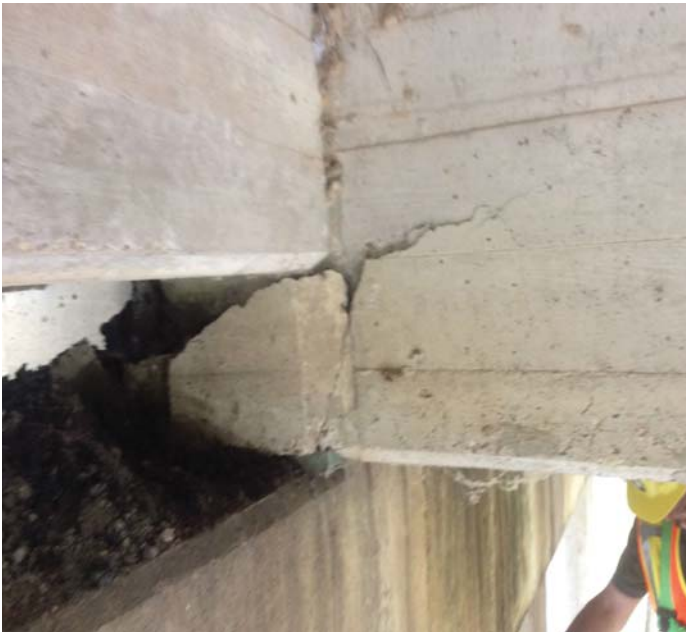
PHOTO 4 Description Span 6 girder 3 left side.

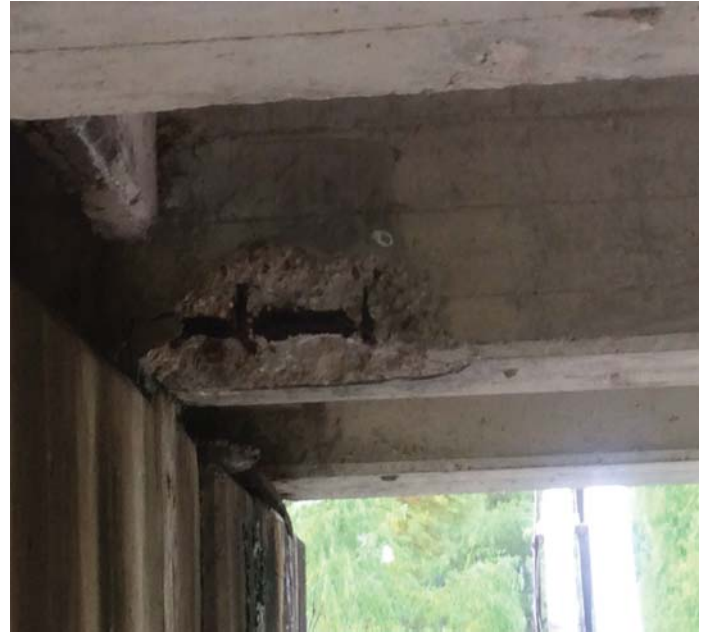
PHOTO 5 Description Span 8 girder 5 left side at bent 9

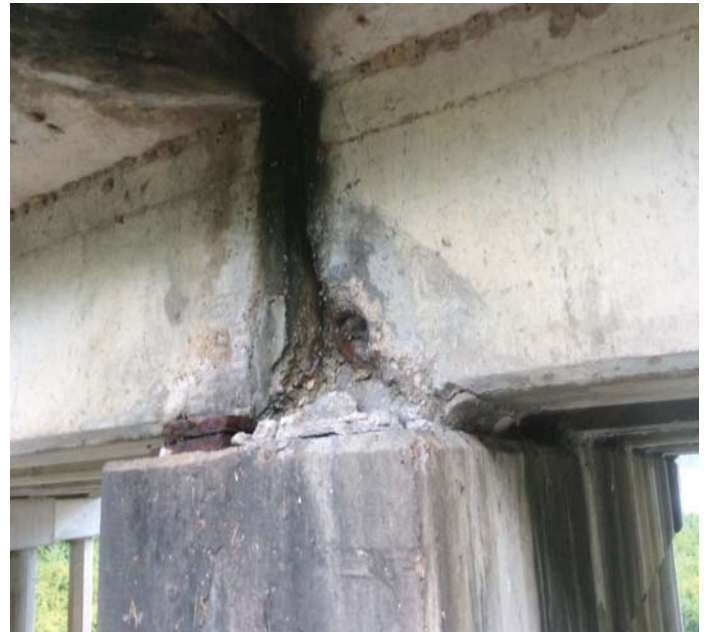
PHOTO 6 Description Span 11 girder 6 right side at bent 10.

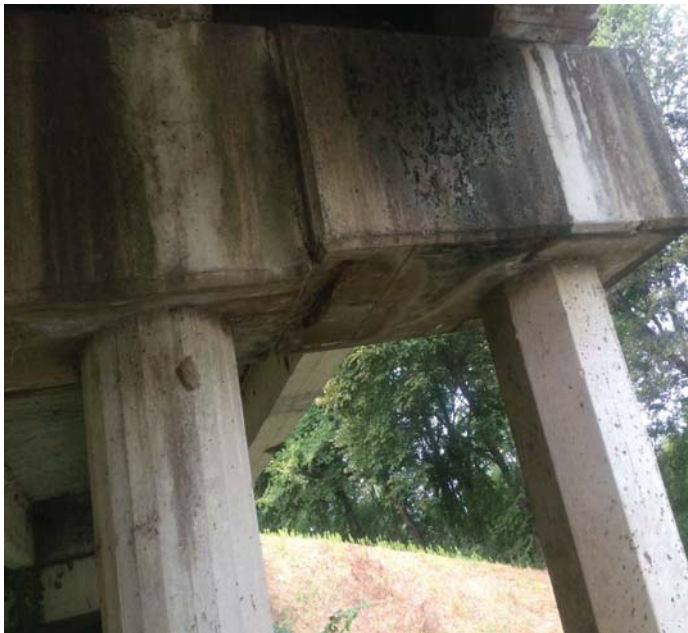
These caps have areas of cracking, delaminations and or spalls.

PHOTO 1      Description      Typical spall bottom of cap.

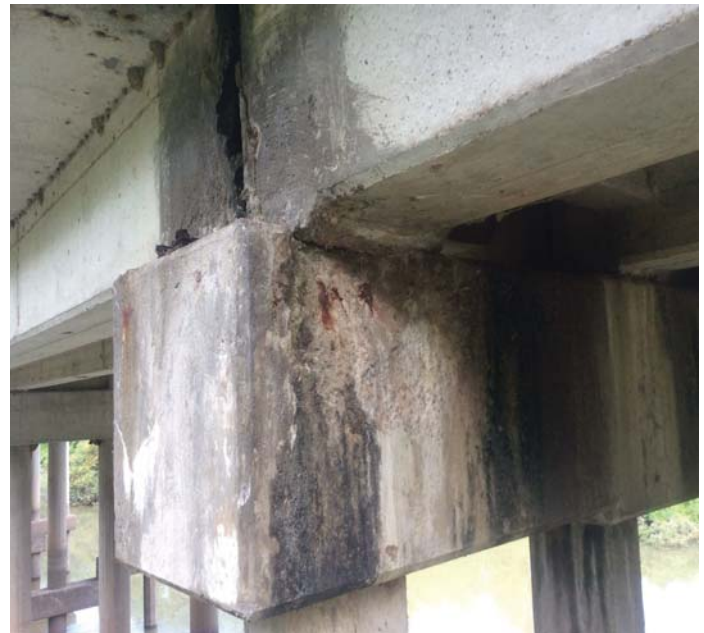
PHOTO 2      Description      Bent 13 cap ahead face right end 2' spall under bearing area 6

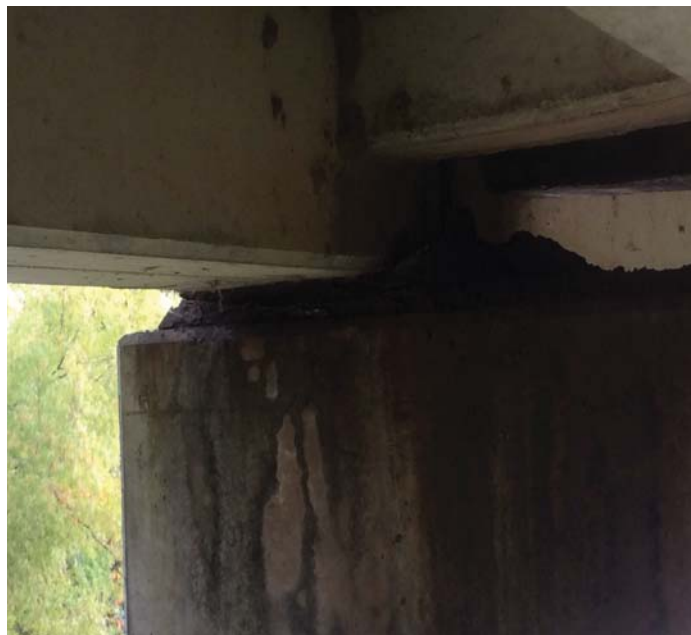
Heavy rust with section loss to bearings #1 & #6

Heavy build up of debris on caps

PHOTO 1      Description      Typical bearings on outside girders.

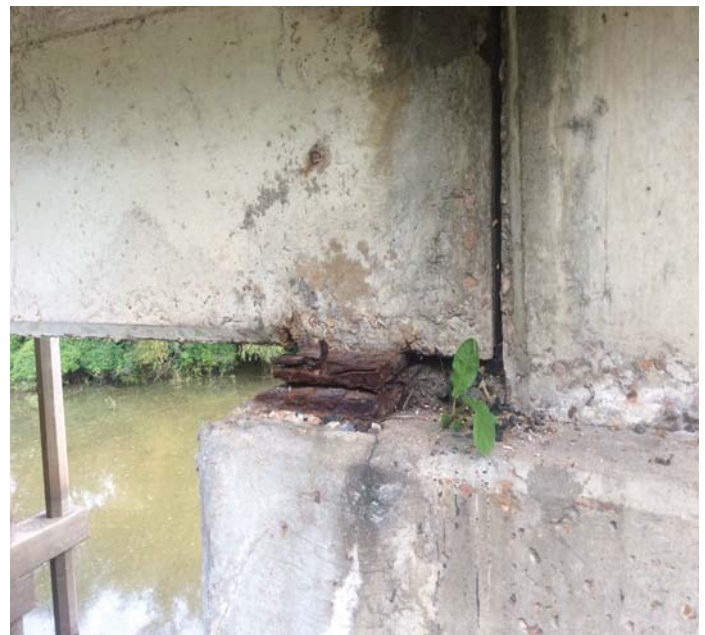
PHOTO 2      Description      Typical bearing

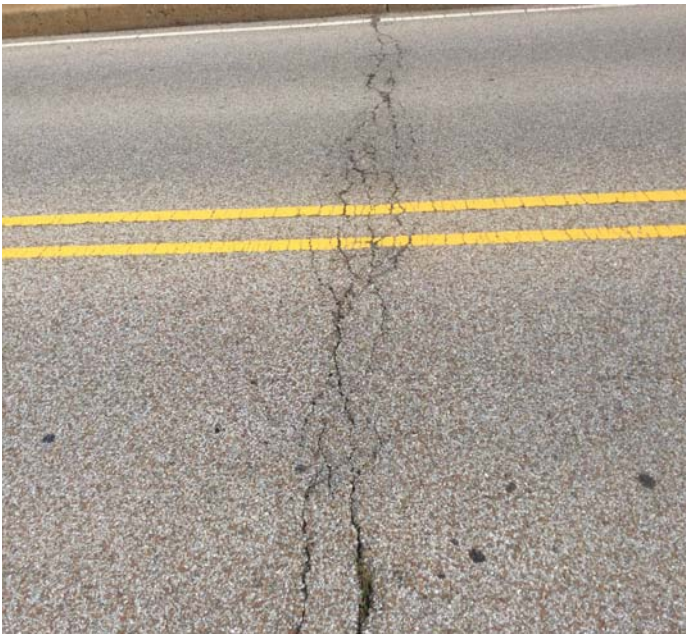
Asphalt is cracked and raveling at these locations.

PHOTO 1      Description      Typical cracks in asphalt at joints.
