Bridge Inspection Report

A1922
US64 RROP WHITE
over
Grubbs Rd. & UPRR

Structure Number: A1922

Facility Carried: US64 RROP
WHITE

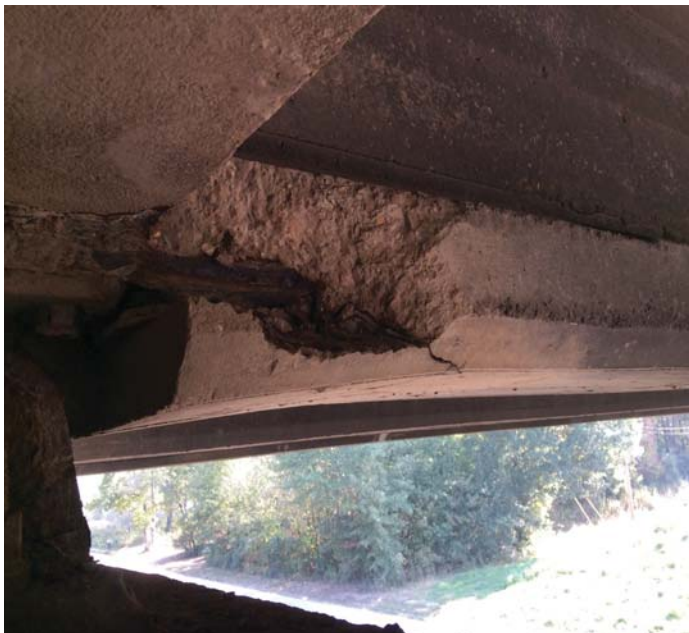
Spalls with Rebar Exposed to Girders at Spans 3, 4, & 5.

PHOTO 1 Description Typical condition of ends of all Girders
@ beginning of Span 3.

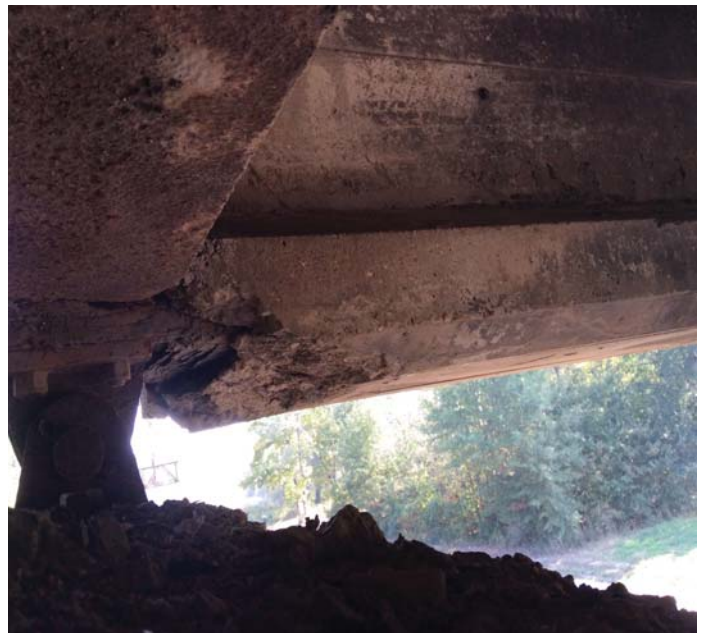
PHOTO 2 Description Typical condition of ends of all Girders
@ beginning of Span 3.

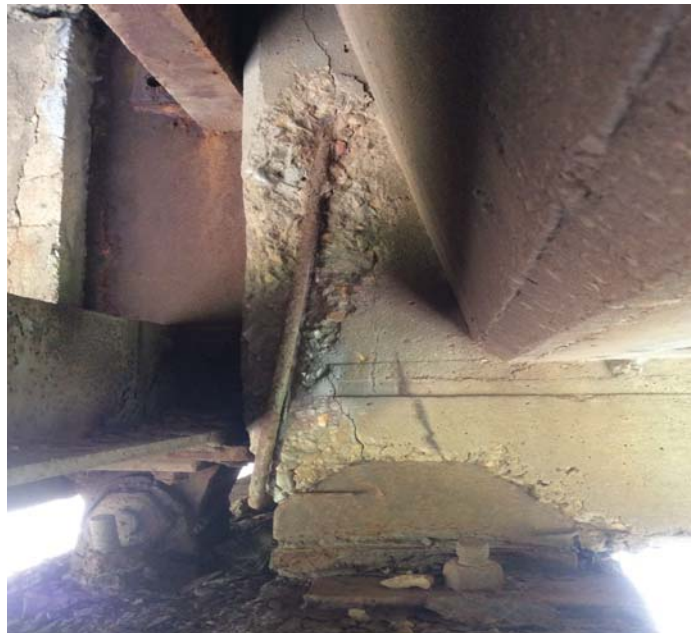
PHOTO 3 Description Spall with large area of Rebar Exposed to Girder 2 @ beginning of Span 4, Typical condition of Girders 2 & 3.

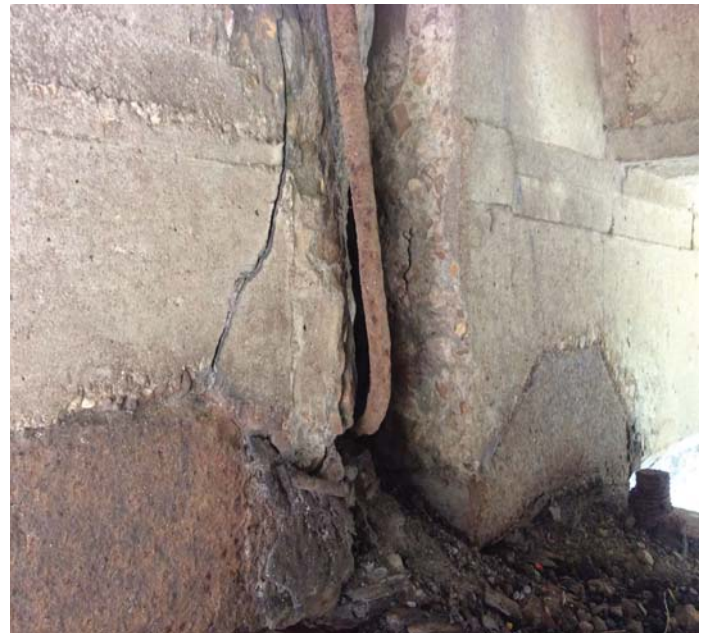
PHOTO 5 Description 100% Section Loss to Rebar @ End of Girder 3 @ Span 4.

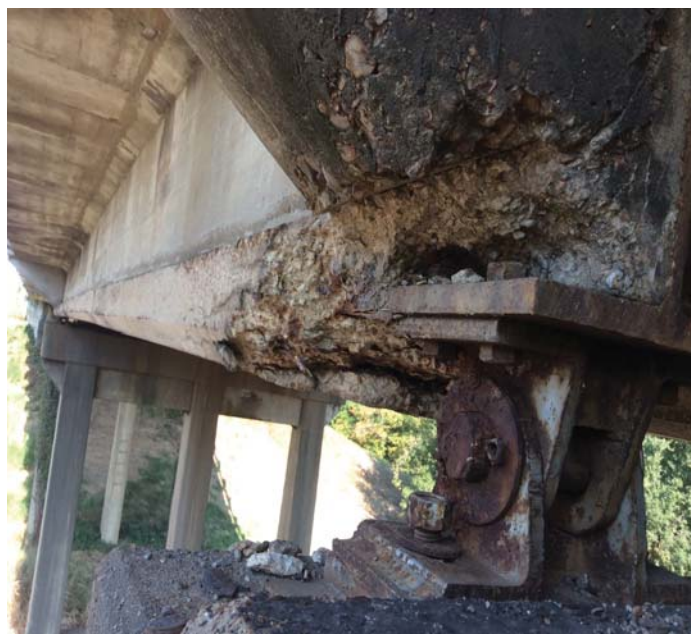
PHOTO 4 Description Typical spalls and cracking to Girder 1, 2 & 5 @ end of Span 3.

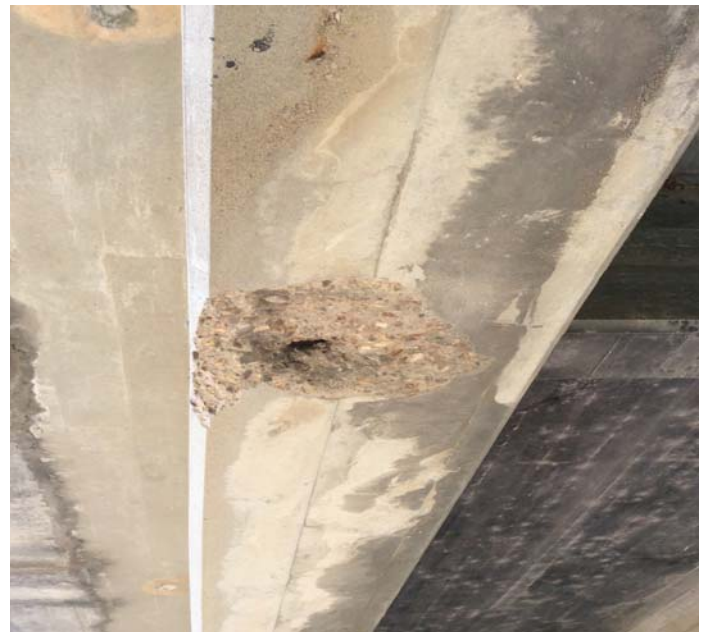
PHOTO 6 Description Girder 3 @ Span 4 has Spall with 4" Rebar Exposed.

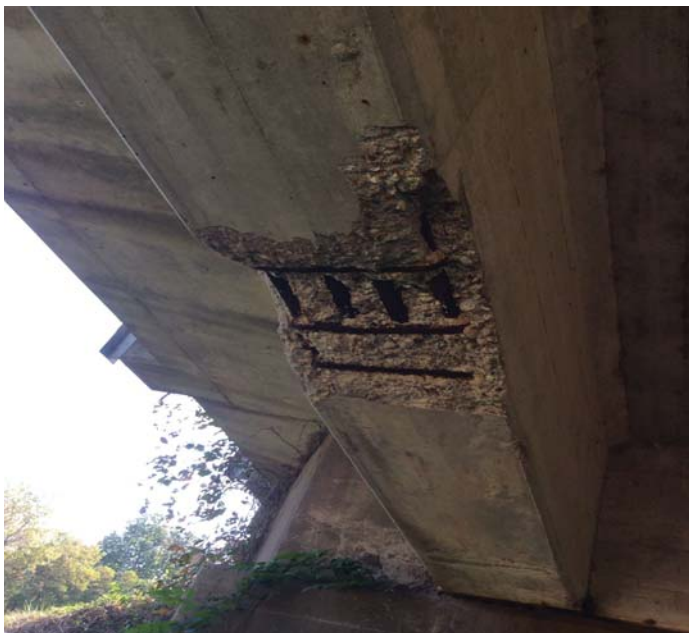
PHOTO 7 Description Girder 1 @ Span 5 has large spall with 5' rebar exposed near mid span.

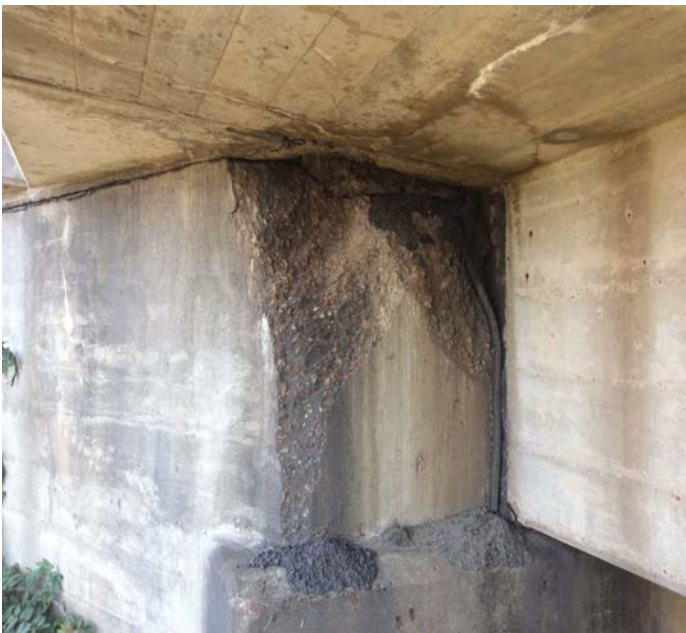
Cracking, Delaminated areas &/or Rebar Exposed to Abutment 1 & 2.

PHOTO 1 Description Spalls with Rebar Exposed to Left & Right ends of Abutment 1.
