Bridge Inspection Report

05368
US 70 - 05- 10.58
over
MUD CREEK

Structure Number: 05368

Facility Carried: US 70 - 05- 10.58

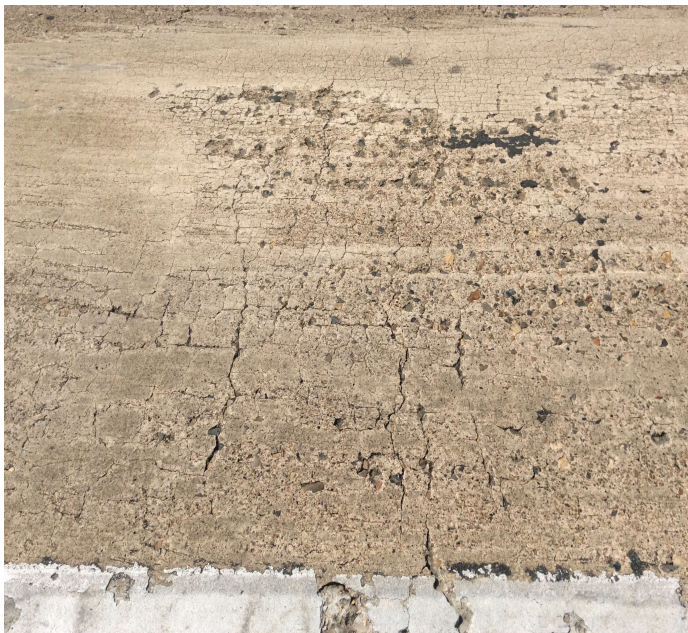
PHOTO 1 Description SPAN 1

ALL SPANS HAVE SEALABLE DECK CRACKS AND SMALL POP OUTS VARIOUS LOCATIONS.

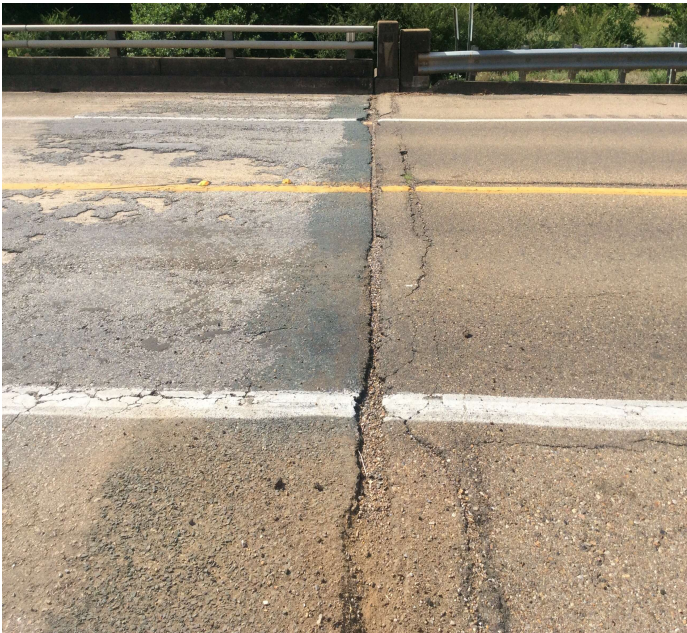
BEGINNING AND END OF BRIDGE ASPHALT IS BREAKING APART

PHOTO 1 Description BEGINNING AND END OF BRIDGE
ASPHALT IS BREAKING APART

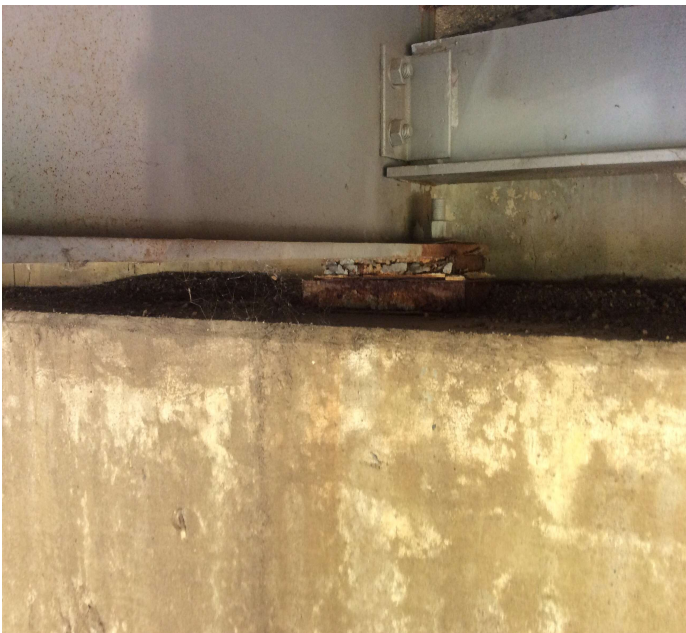
BEARINGS ARE RUSTING ENTIRE BRIDGE NEED TO BE REPAIRED

PHOTO 1 Description BEARINGS ARE RUSTING ENTIRE
BRIDGE NEEDS TO BE REPAIRED

1130 - Cracking (RC and Other)		7			7		
300 - Strip Seal Expansion Joint	1- Ben.	184	ft.	184			
311 - Movable Bearing	1- Ben.	21	each	21			
ALL BEARINGS NEED BLASTED AND PAINTED 7/03/2018.							
515 - Steel Protective Coating		73	sq. ft.	0	0	73	0
3440 - Effectiveness (Steel Protective Coatings)		73				73	
313 - Fixed Bearing	1- Ben.	21	each	21			
515 - Steel Protective Coating		73	sq. ft.	73			
321 - Reinforced Concrete Approach Slab	1- Ben.	2700	sq. ft.	2700			
Approach slab end bridge has 1/2" chip seals...Approach slab beginning of bridge asphalt estimated 1 1/2" thick							
330 - Metal Bridge Railing	1- Ben.	244	ft.	244
