# Bridge Inspection Report

**05369**  
**US 70 - 05 -12.14**  
**over**  
**CANEY CREEK**

IDENTIFICATION		INSPECTIONS	
(1) STATE CODE	056 - Arkansas	(90) INSPECTION DATE	07/03/2018
(8) STRUCTURE NUMBER	05369	(91) DESIGNATED INSPECTION FREQUENCY	24

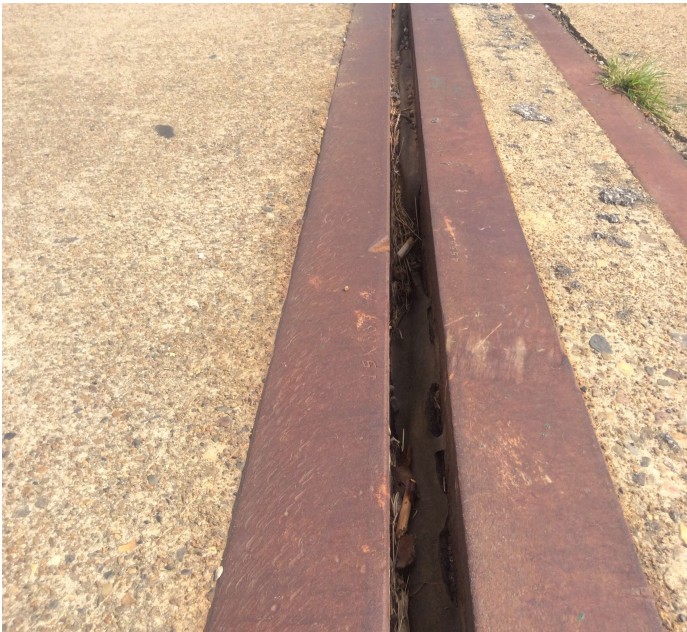
PHOTO 1 Description

JOINT SEAL LEAKING BT 4 END  
RT SIDE BRIDGE ABOUT 16 FT.

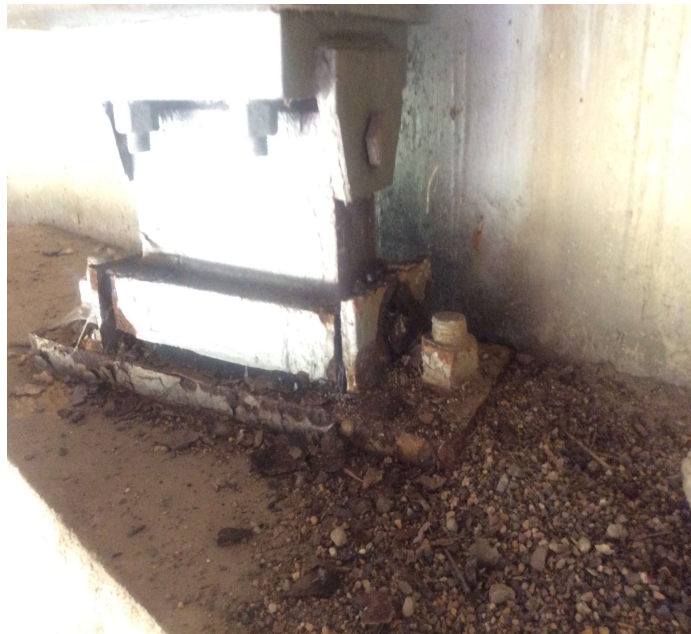
BEARING 3,4,5,6 RUST AND HEAVY SECTION LOSS TO BOTTOM PLATE AND BOTTOM OF ROCKER , BOLTS ARE RUSTED INTO AND  
1 EAR IS BROKEN ON BEARING 4, AT BENT 1 .....END BENT BEARINGS ARE RUSTED AT Bearing #4,5,6,7

PHOTO 1      Description      Bent 1 bearing rust, ears on bearing broke photo of bearing 4

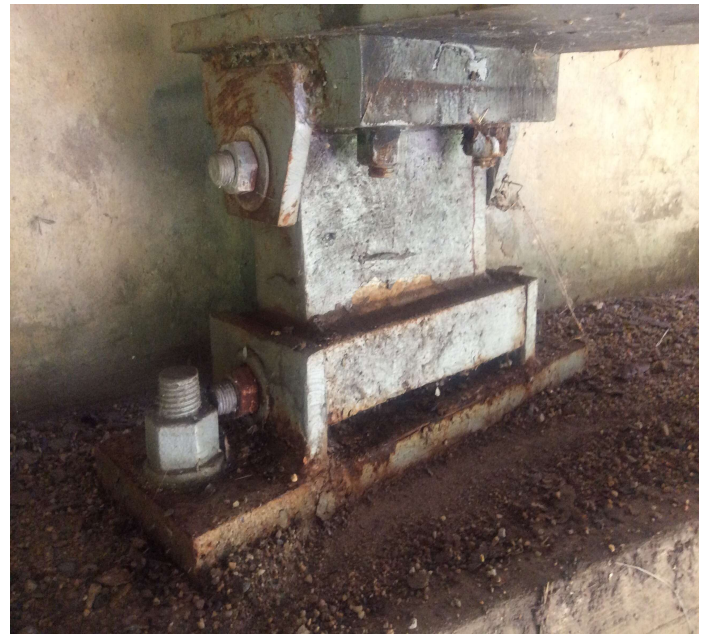
PHOTO 2      Description      End bent bearing rust Bearing #4,5,6,7

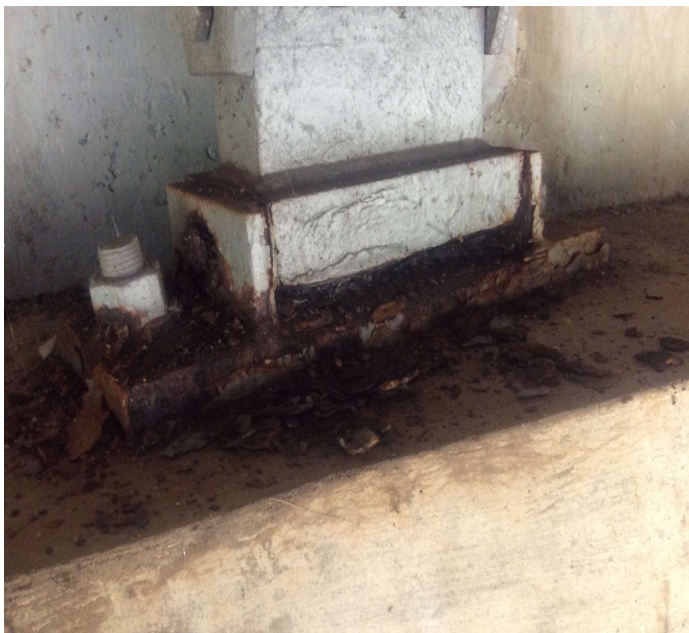
PHOTO 3 Description Bent 1 bearing #3 rust and section loss

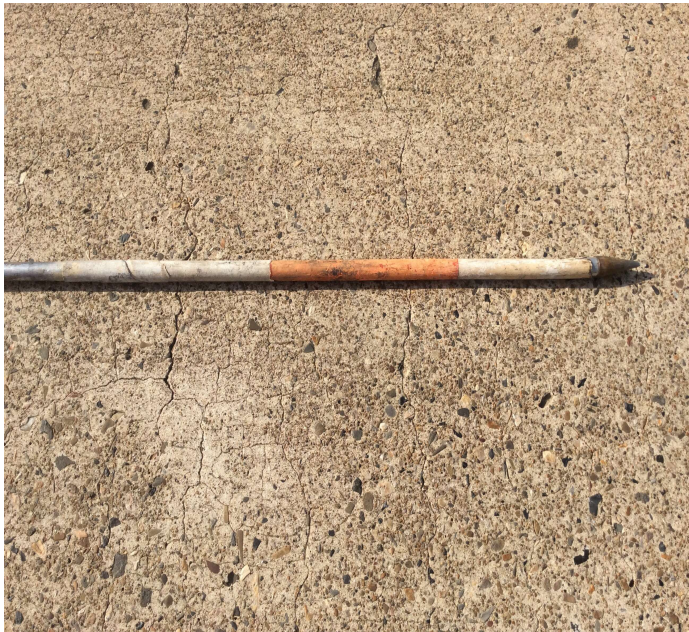
Sealable deck cracks all spans and map like cracking. 4 spalls on deck with rebar exposed less than 1 ft square 3/4 DEPTH

PHOTO 1      Description      MAP LIKE CRACKING ENTIRE  
BRIDGE VARIOUS LOCATIONS

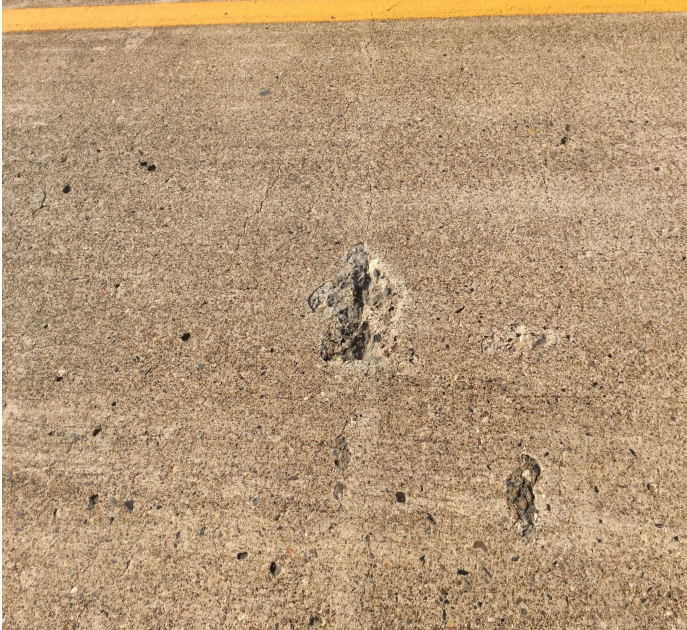
PHOTO 3      Description      DECK SPALL SPAN 2 LEFT SIDE

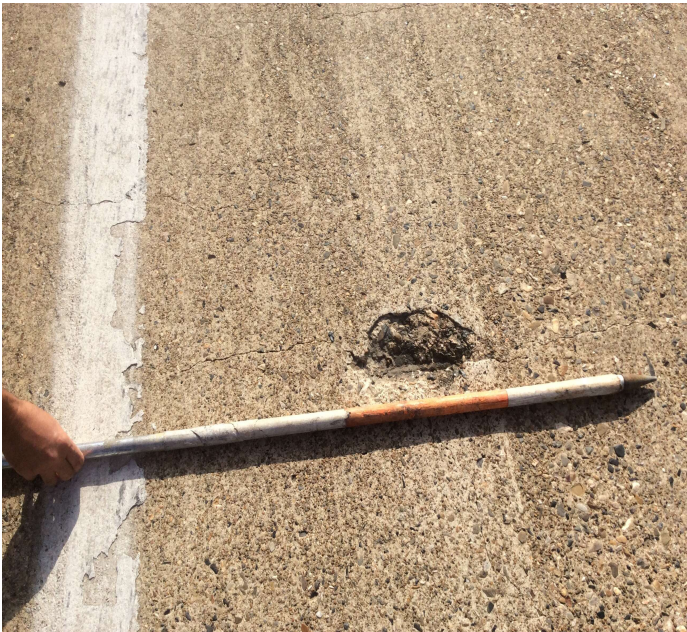
PHOTO 4      Description      Spall in deck with rebar exposed span 1..

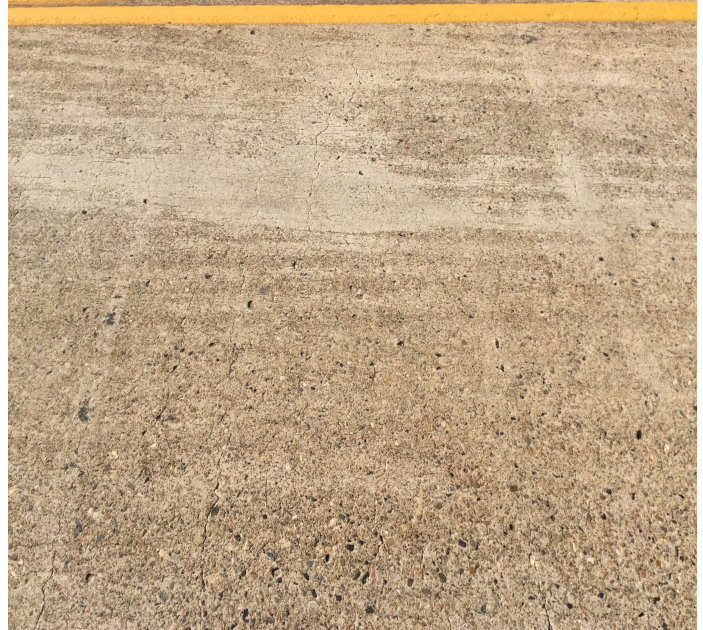
PHOTO 5      Description      Sealable deck cracks and map like cracking. Photo taken of span 2

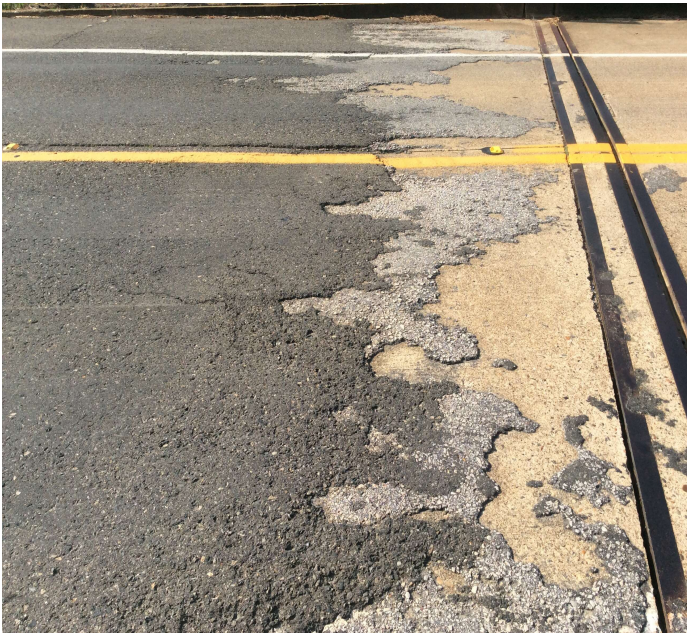
ASPHALT ON APPROACH COMING APPART END BRIDGE. Montgomery co. side.

PHOTO 1      Description      ASPHALT ON APPROACH COMING  
APPART END BRIDGE
