Bridge Inspection Report

05372
US 70-6 Log 5.72
over
Sugar Loaf Creek

Structure Number: 05372

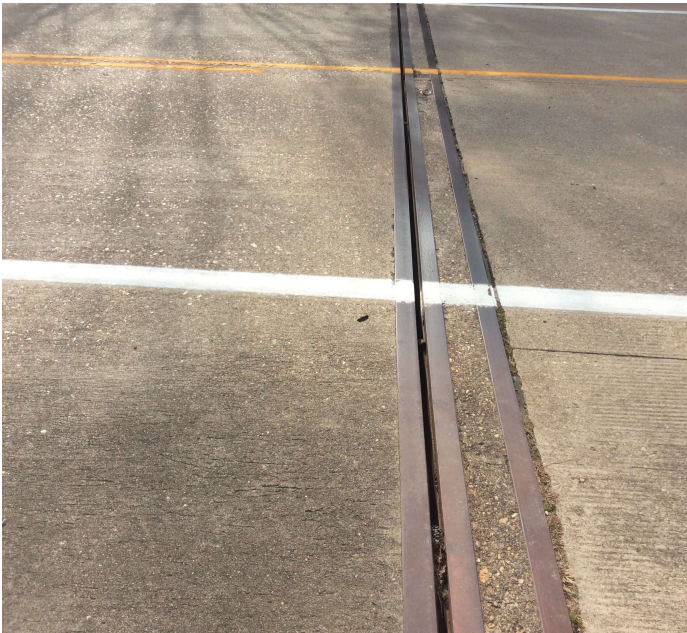
Joint seals are missing at bent 1,2 & 3

PHOTO 1 Description Bent 1 joint seal missing
