Bridge Inspection Report

A0395
US 70-8 Log 3.57
over
LOST CREEK

Structure Number: A0395

Facility Carried: US 70-8 Log 3.57

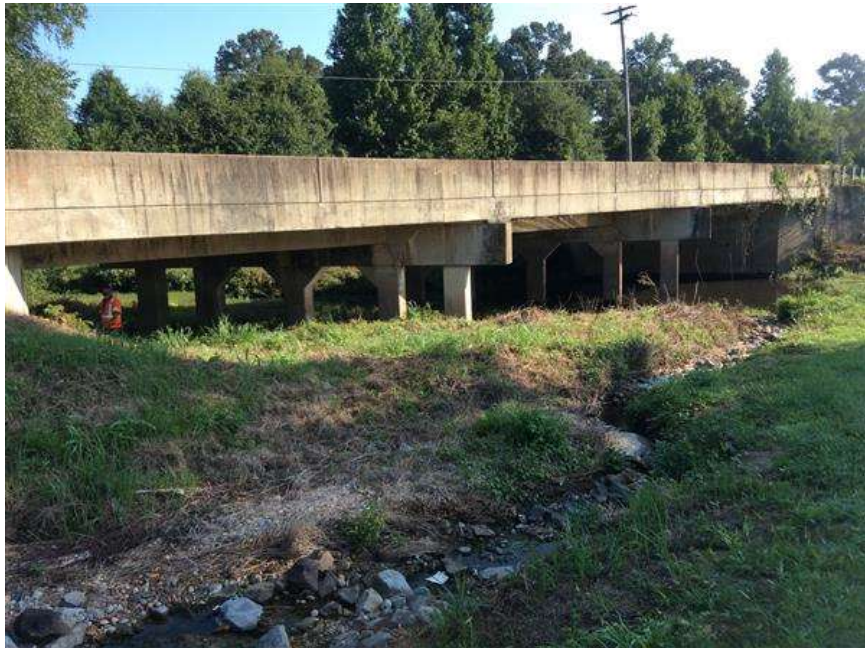
job 1450 dwg 18574 Approach going east.
