Bridge Inspection Report

A0396
US 70-8 Log 2.59
over
LOST CREEK

Structure Number: A0396

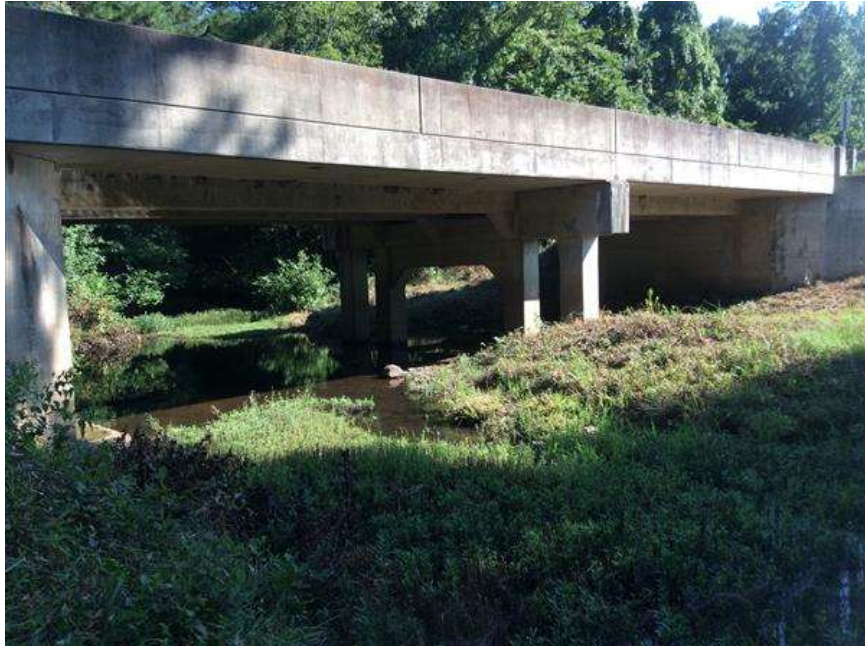
approch looking east
