# Bridge Inspection Report

**A0397**  
**US 70-8 Log 1.81**  
**over**  
**Lost Creek**

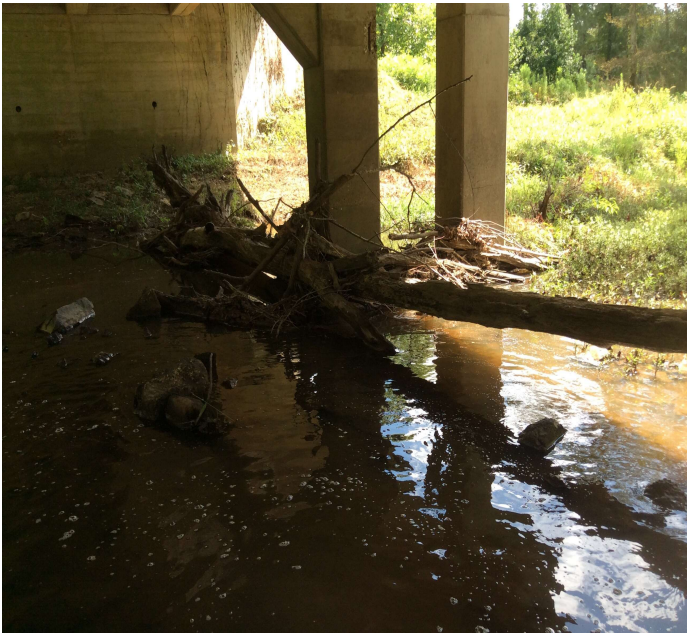
Drift built up on column 3 at Bt. 2.

PHOTO 1      Description      Drift built up on column 3 at Bt. 2.
