Bridge Inspection Report

A0484

US 70-7 Log 2.62

LITTLE MAZARN CR

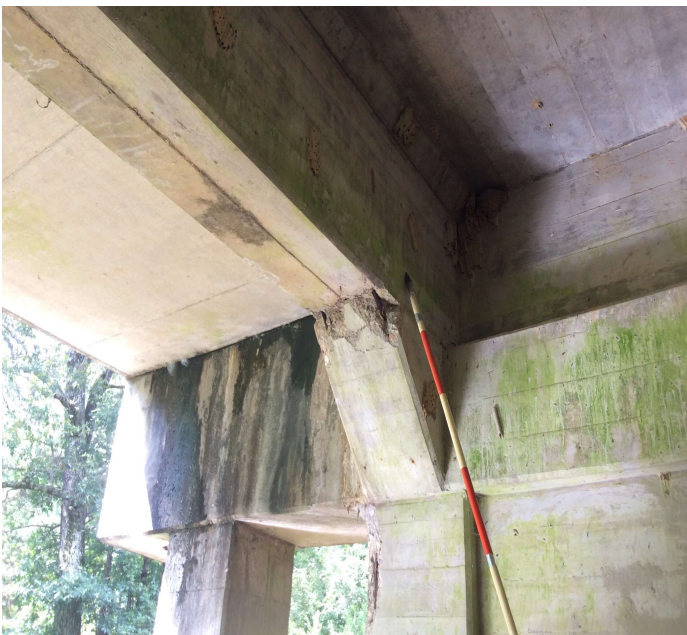
All three girders in span 2 at the haunch
Has Spalls with exposed rebar.

PHOTO 1 Description Span 2, girder 3, Bt. 2, exposed rebar
at haunch of the girder.

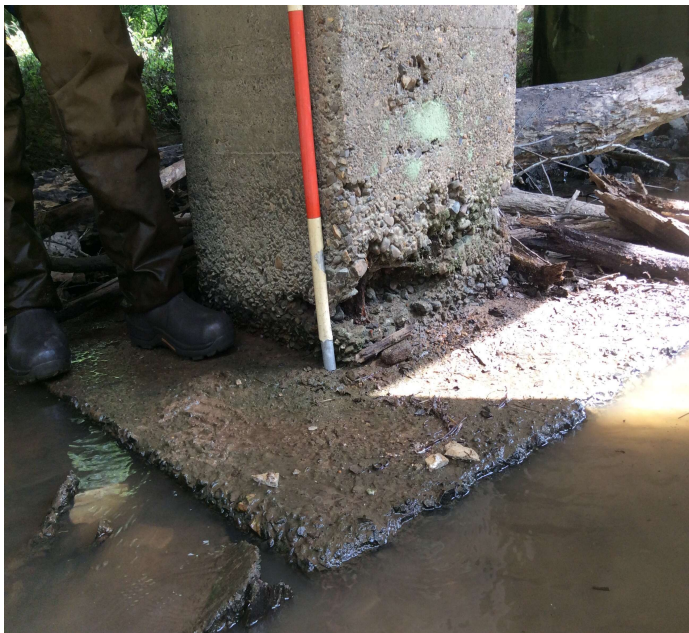
Bent 2 column 2 and 3 has spalls and severe abrasion.

PHOTO 1 Description Bt. 2, column 3, severe abrasion exposing the rebar.

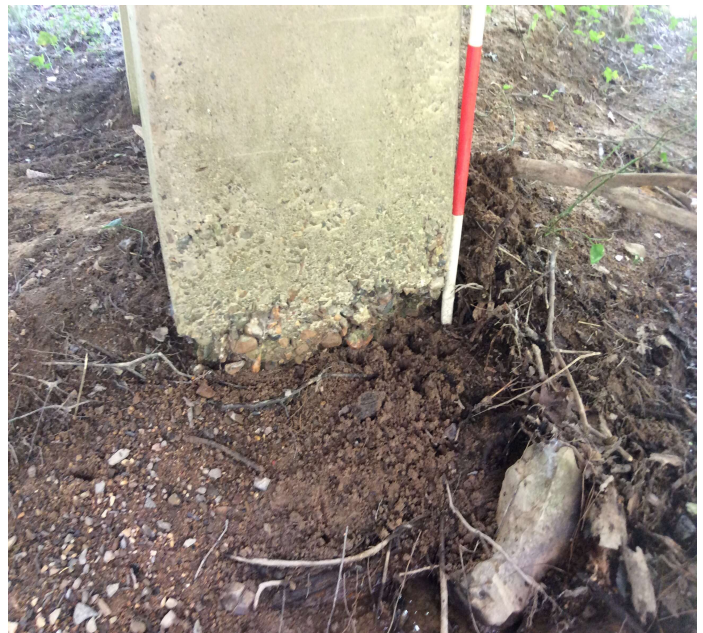
PHOTO 2 Description Bt. 2, column 2, severe abrasion.

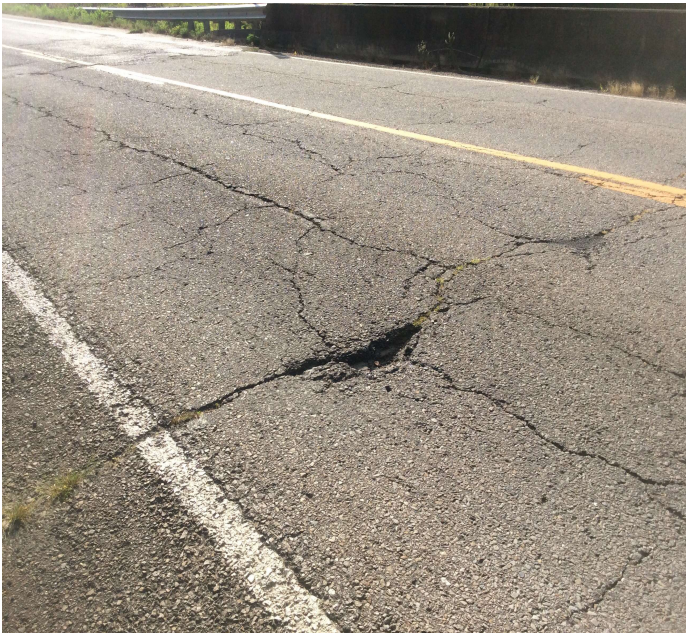
Deck Asphalt overlay has large unsealed cracks

PHOTO 1 Description Potholes

Assign to Garland County 062830 09/28/2015

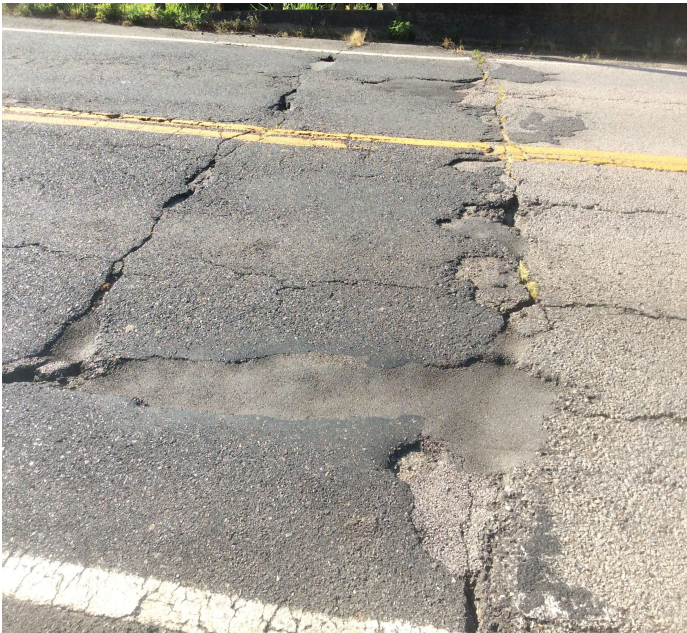
Minor settlement & potholes at both approaches of the bridge.

PHOTO 1 Description Approach roadway settlement

Assign to Garland County 062830 09/28/2015
