# Bridge Inspection Report

**A0485**

**US 70-7 Log 1.65**

**Br. Little Marzarn Cr.**

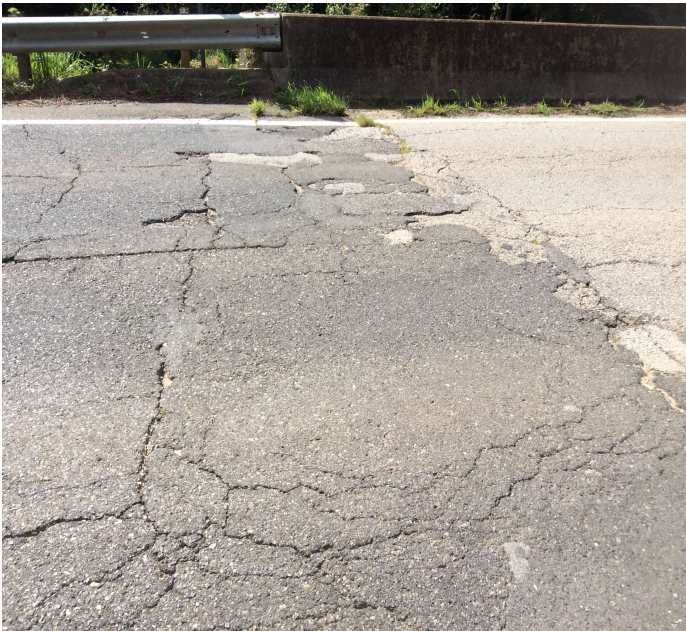
East end of bridge asphalt approach has settled.

PHOTO 1      Description      East end of bridge asphalt approach has settled.
