Bridge Inspection Report

A0707
US 70-6 Log 3.95
over
Sugar Loaf Creek

Structure Number: A0707

Facility Carried: US 70-6 Log 3.95

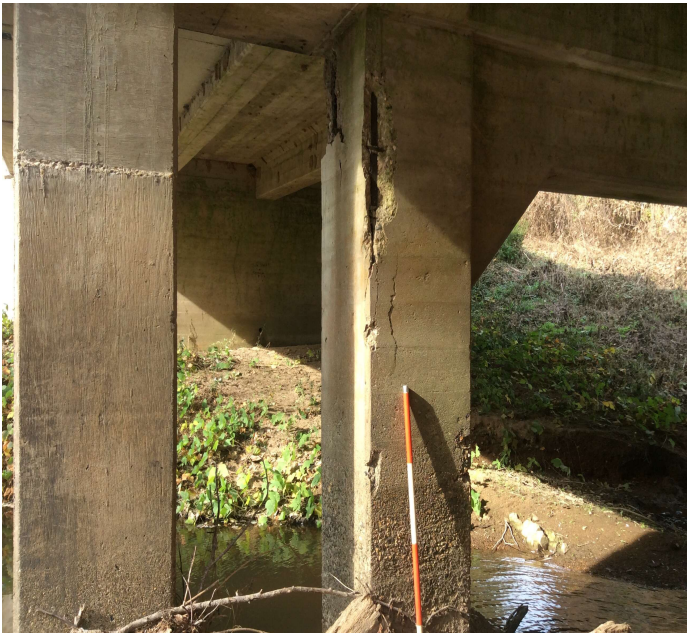
Bent 2 column 1,2 & 3 have spalls with exposed rebar.

PHOTO 1 Description Bent 2 column 3 lager spall with exposed rebar

Stage: Monitor
