Bridge Inspection Report

05539

I-555Sb/Sec1/L0.97

Little Cypress Bayou

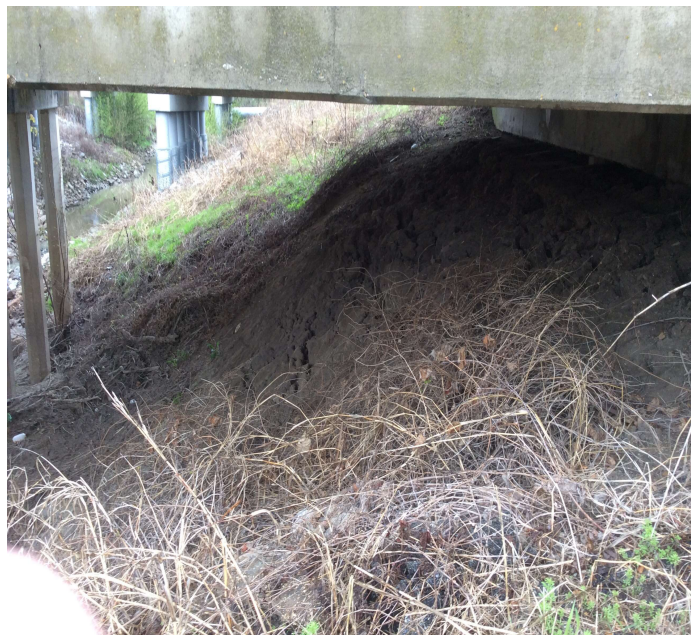
ABUTMENT #2 SLOPE UNDER SPAN #3 IS ERODED TO 1:1 SLOPE WITHIN 5' OF ABUTMENT CAP.
(PILE AND BENT NUMBERS CHANGED DUE TO LOG DIRECTION CHANGE WHEN HWY 63 WAS RENAMED I555).

PHOTO 1 Description Abutment 2 slope

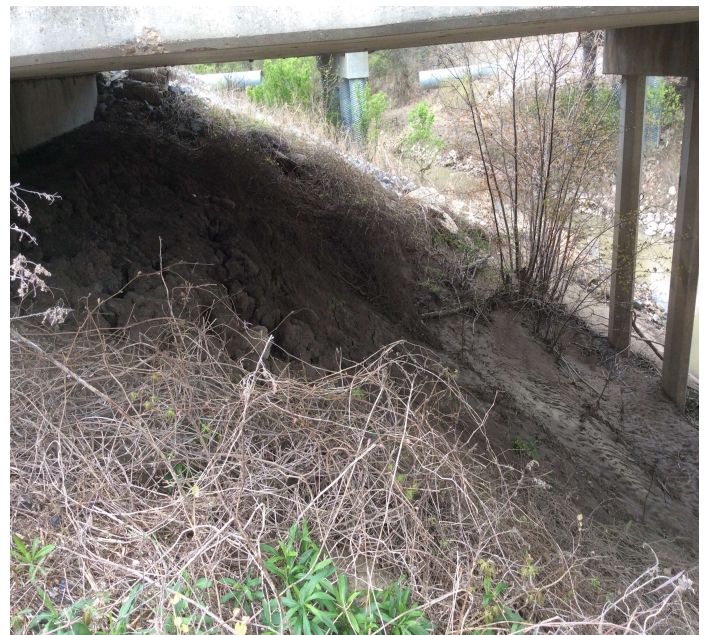
PHOTO 2 Description Abutment 2 slope.

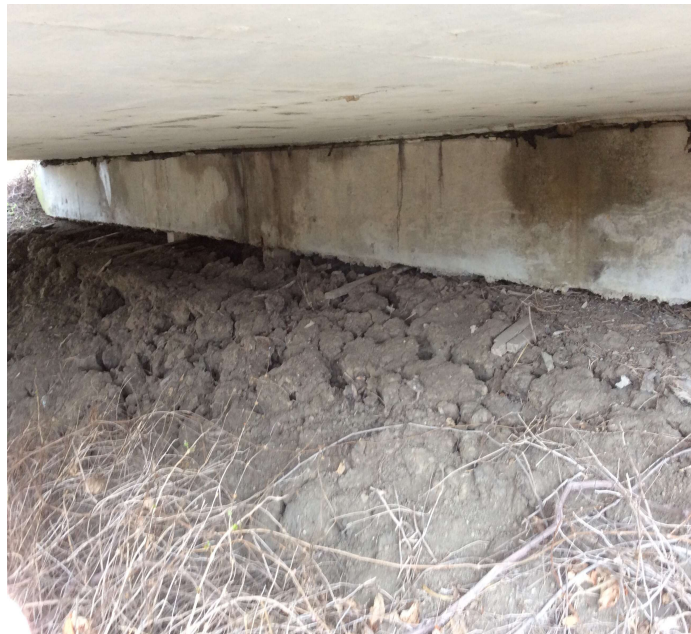
BENT #1 CAP IS UNDERMINED 2" - 1' FULL LENGTH EXPOSING PILES #3,5,6,7.

BENT #4 CAP IS UNDERMINED 1" - 4" FULL LENGTH EXPOSING PILES #6&7.

PHOTO 1 Description Abutment 2 cap undermined

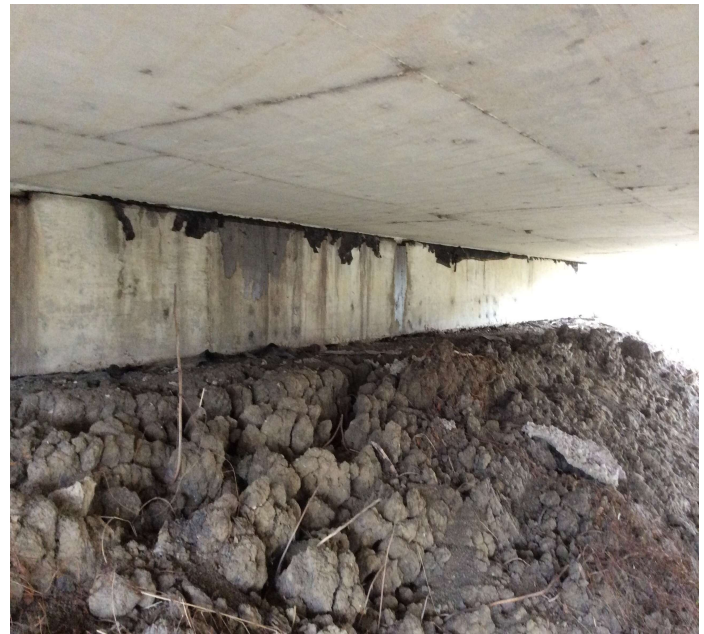
PHOTO 2 Description Abutment 1 cap undermined

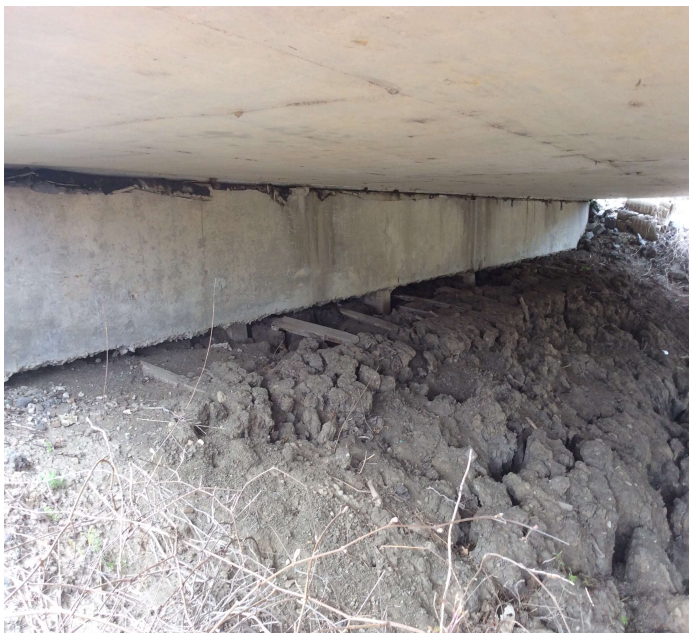
PHOTO 3 Description Abutment 2 cap undermined.

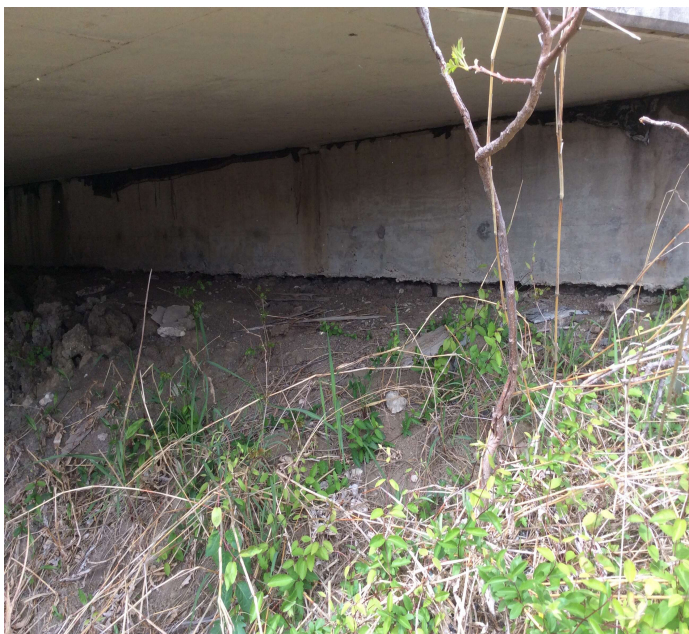
PHOTO 4 Description Abutment 1 cap undermined.

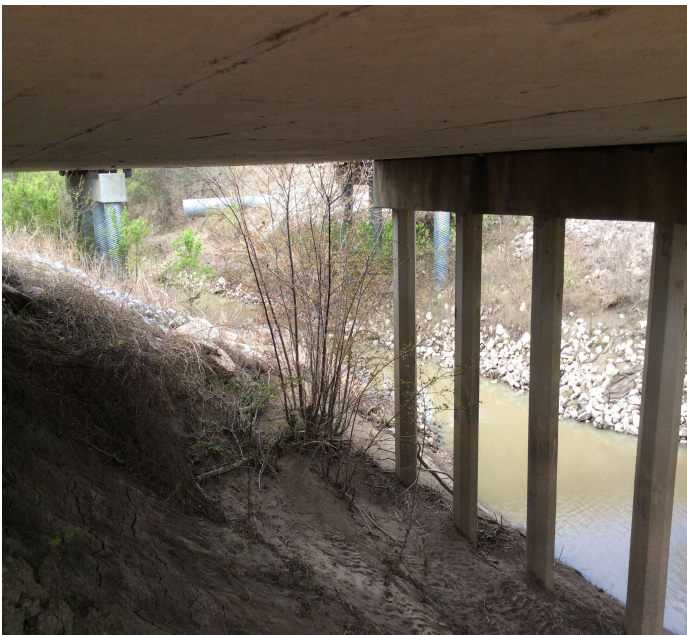
VEGETATION GROWING UNDER & BESIDE BRIDGE IN SPAN #1 & 3 RIGHT & LEFT SIDE.

PHOTO 1 Description Typical vegetation.

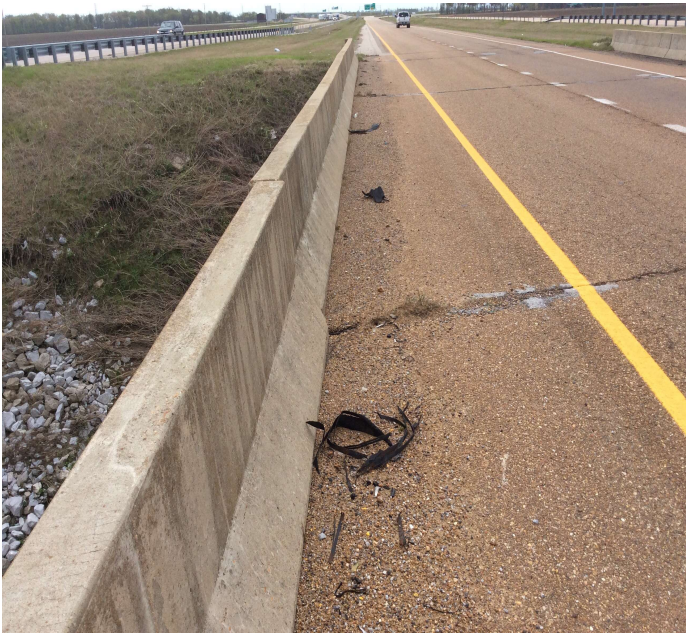
Gutters are full of dirt and debris with vegetation growing.

PHOTO 1 Description Gutters are full of dirt and debris with vegetation growing.
