# Bridge Inspection Report

**05607**

**I-555 SB-02-LM4.07**

**DEAD TIMBER LAKE**

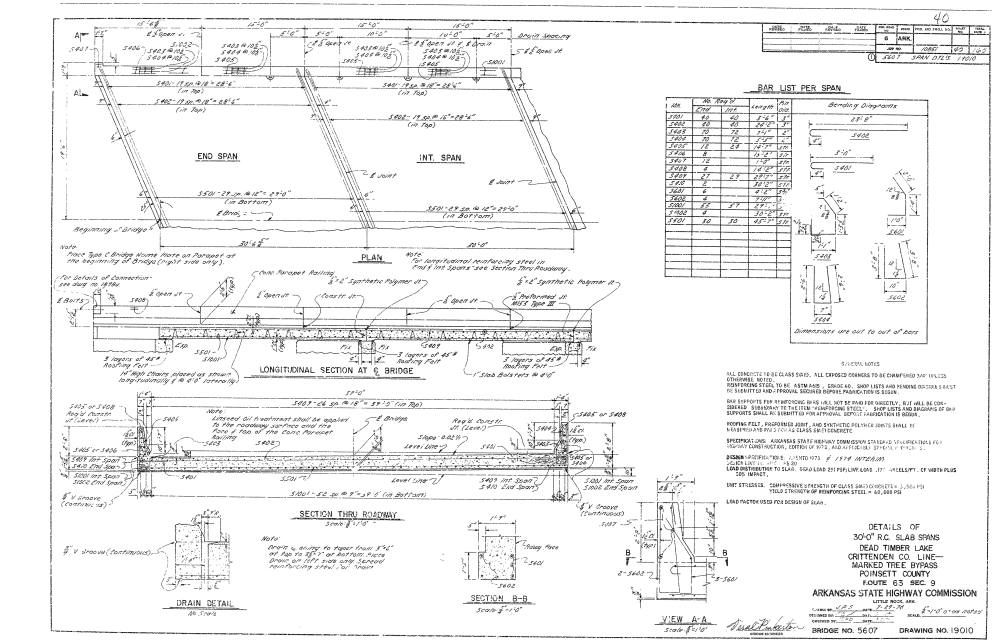
PHOTO 2

Description slab details

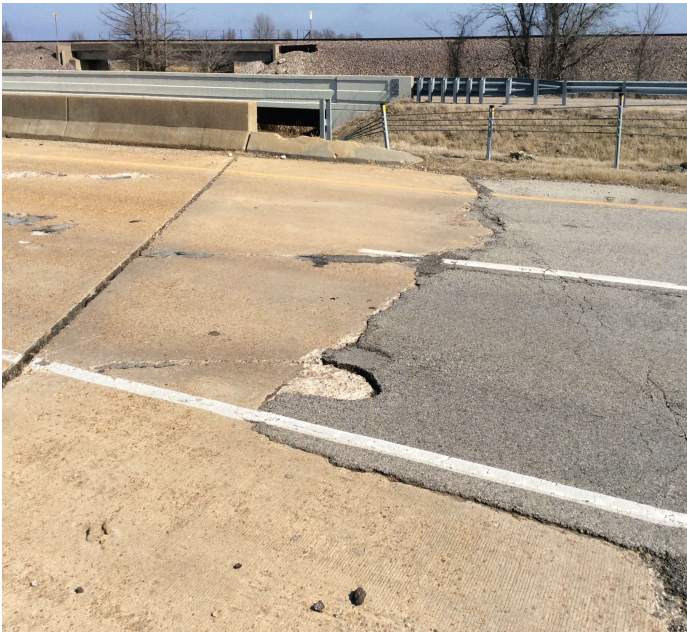
PHOTO 1 Description

Bent 1 approach slab has a few spalls and is cracked and has settled in the past in the Lt lane. Slab is partially covered with asphalt.

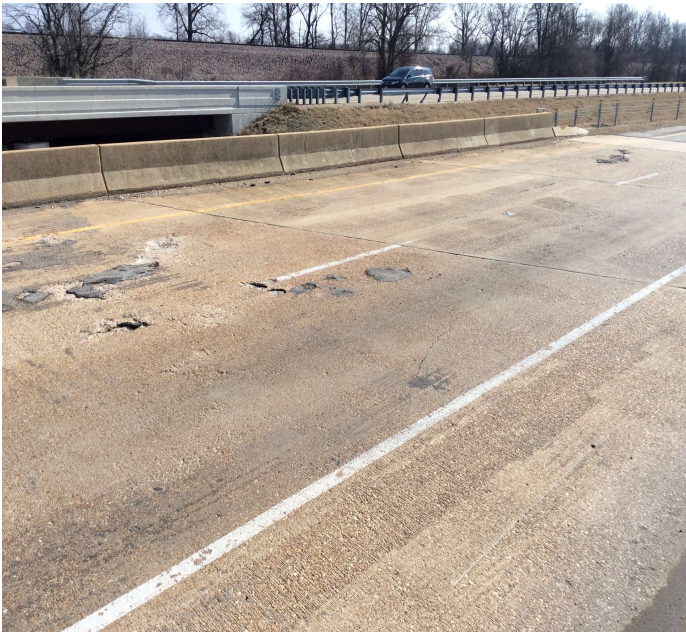
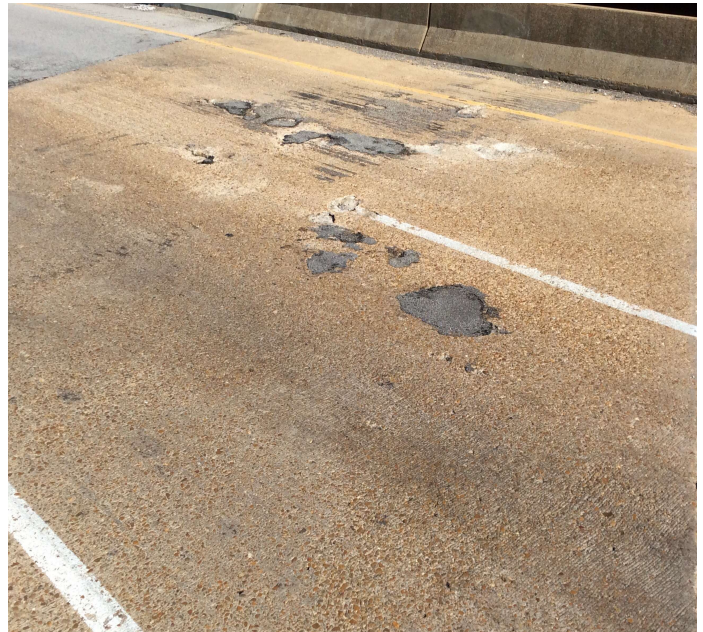
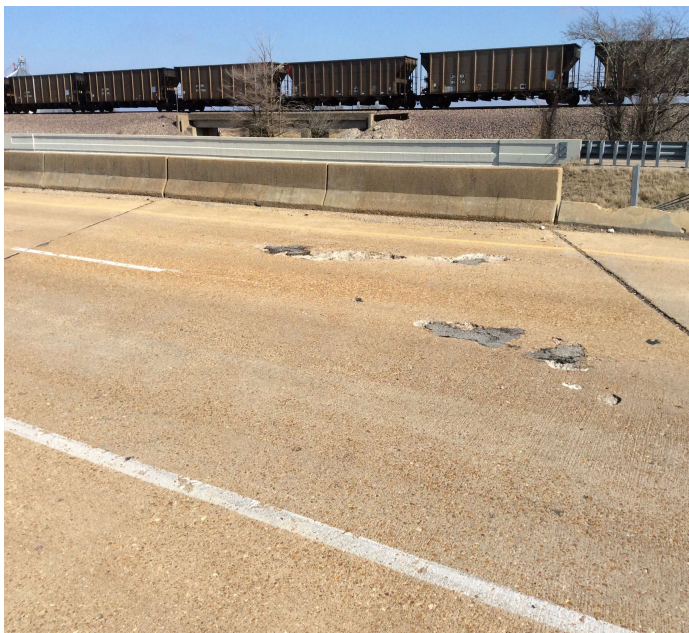
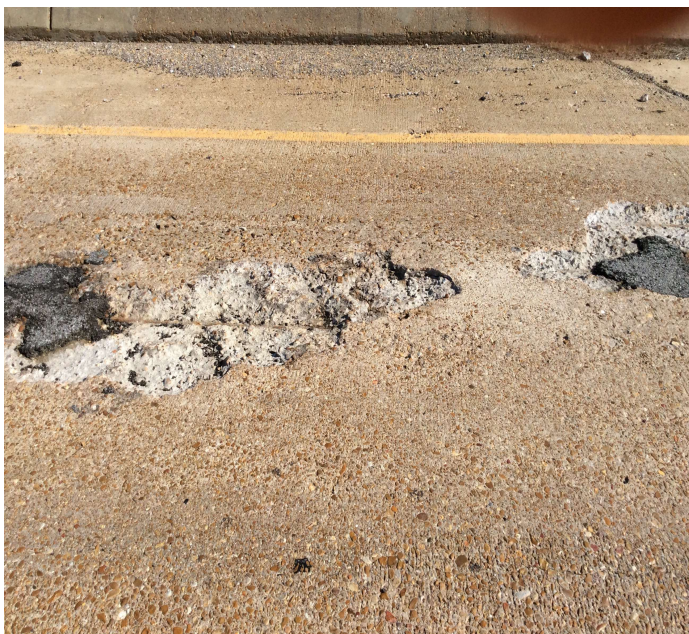
Slabs have minor abrasion throughout with areas of moderate abrasion in wheel path.  
Slabs have longitudinal unsealed cracks, and several spalled areas with some rebar exposed.
