# Bridge Inspection Report

**05608**

**I-555 SB-02-LM7.78**

**DEAD TIMBER LAKE**

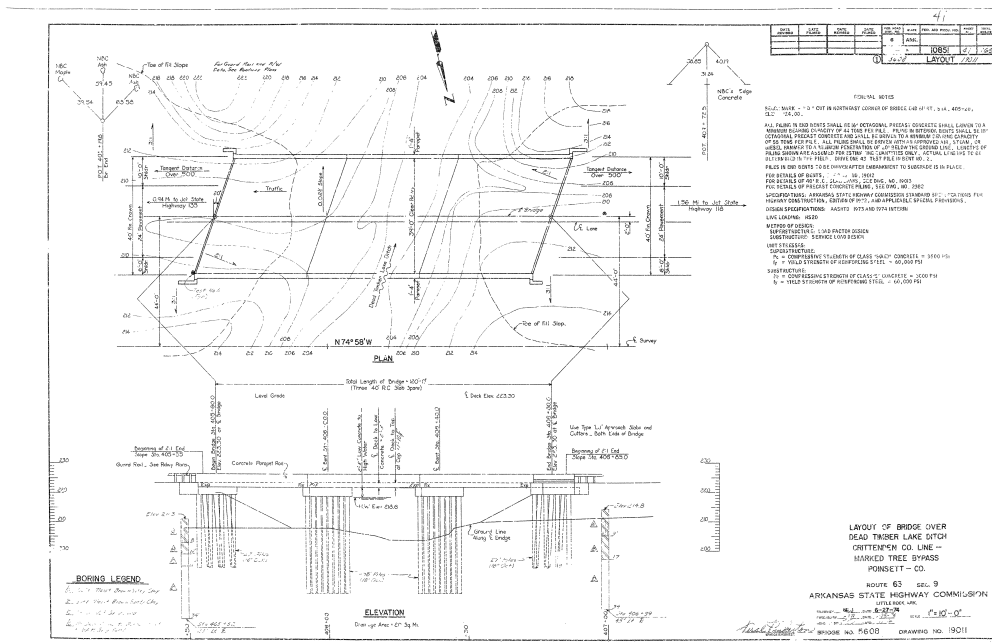
PHOTO 1

Description channel profile

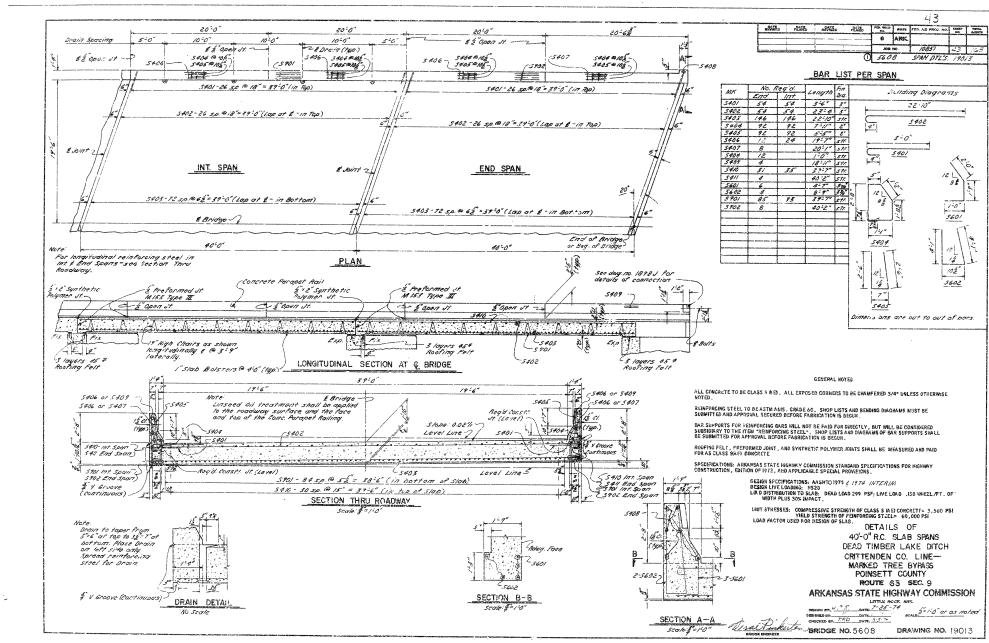
Description	slab details
-------------	--------------
