Bridge Inspection Report

05609
I-555-02NB-LM 3.19
over
TYRONZA RIVER

Structure Number: 05609

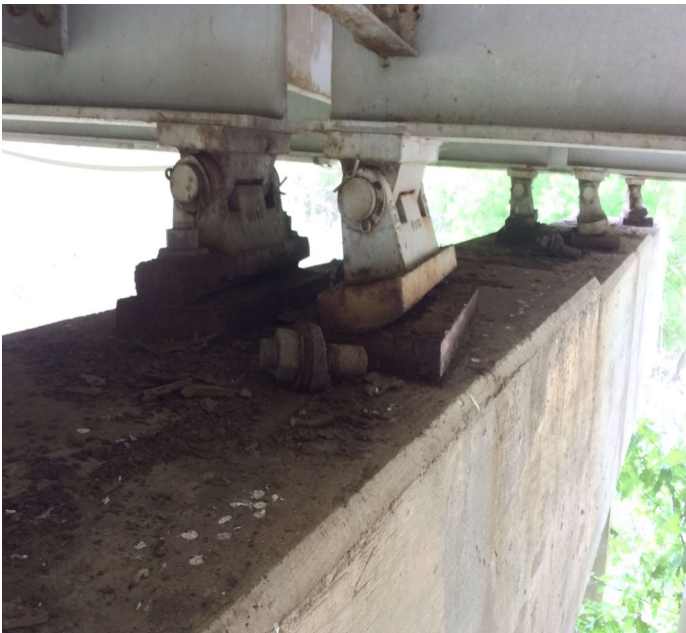
PHOTO 1 Description

Bearings are rusted with pitting and/or initial section loss.

Bents 2, 3, 4 & 5 have pack rust between rocker bearings and masonry plate.

Span 3 Bent 2 Rocker Bearings 2, 3, 5, 6 are tilted close to their limit.

Spans 1&2 Girder 2 Bent 2 has 1 anchor bolt (each) broke or sheared off.

Span 2 Girder 3 Bent 2 has 2 anchor bolts broke or sheared off.

Spans 4&5 Girder 3 Bents 2&3 has a few short anchor bolts.

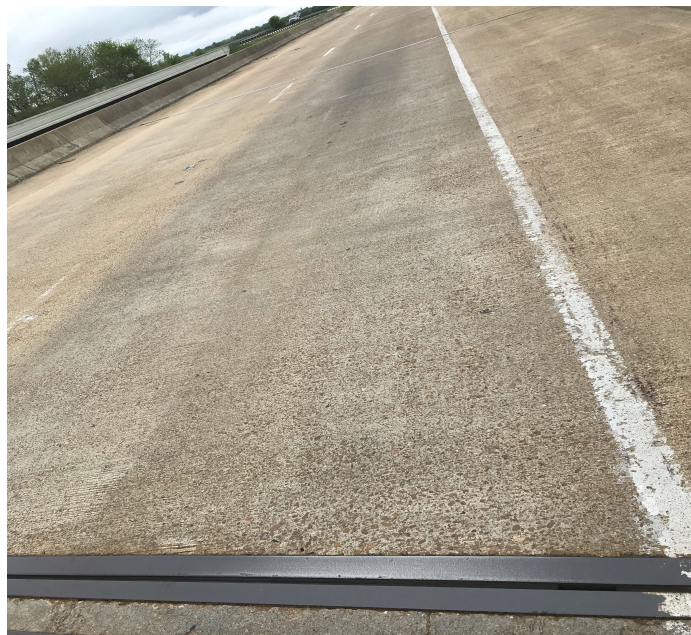
Concrete deck has minor abrasion, moderate width cracking with some spalls & potholes that have been filled with asphalt.

PHOTO 1 Description Deck

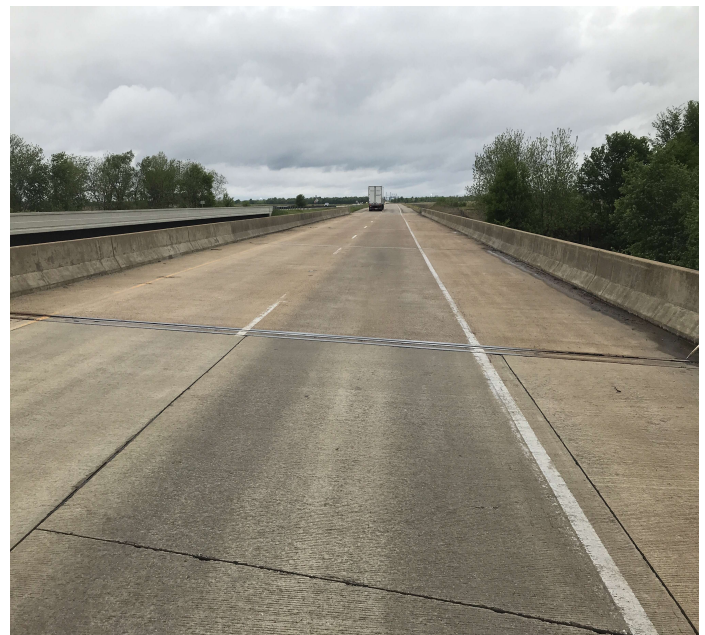
PHOTO 2 Description Roadway

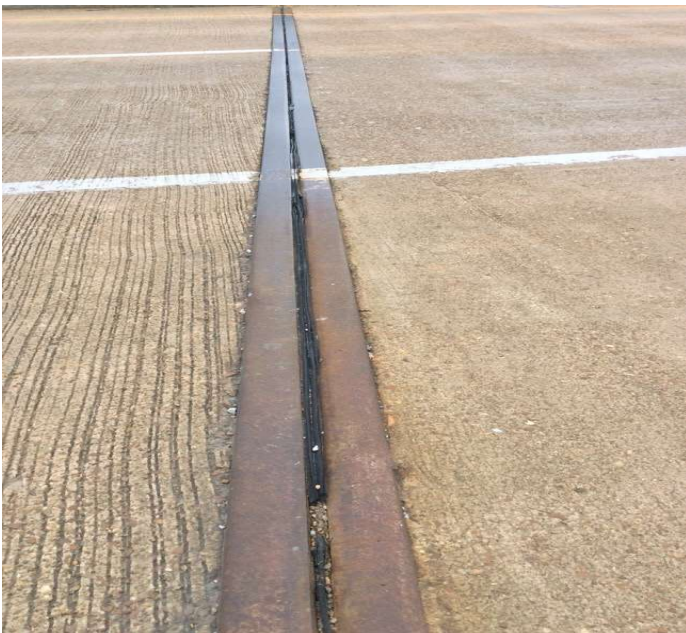
PHOTO 1 Description

All compression seals are split & torn. Some of the seals have areas that have dropped out.
