Bridge Inspection Report

05610
I-555SB-02-LM11.54
over
DITCHES NO 1-47-9

Structure Number: 05610

Facility Carried: I-555SB-02-LM11.54

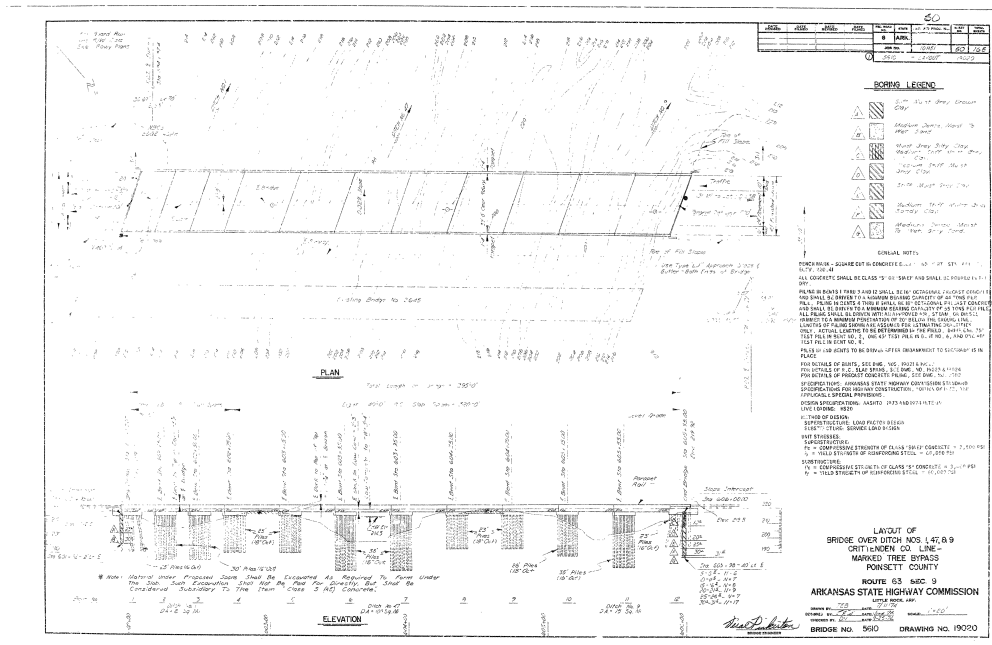
PHOTO 1

Description	layout
-------------	--------

Description	channel profile
-------------	-----------------

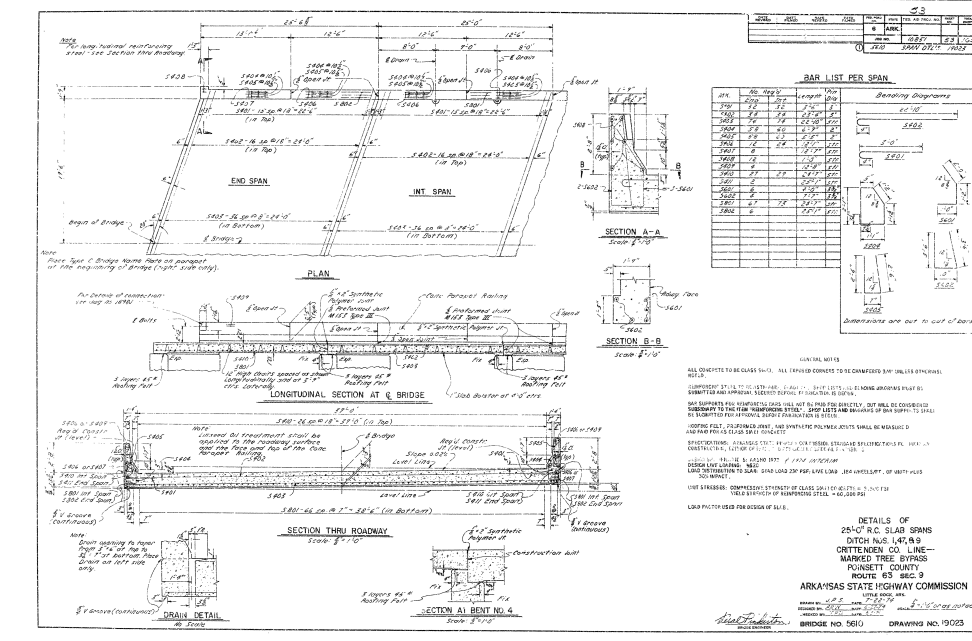
PHOTO 2

Description 25' slabs

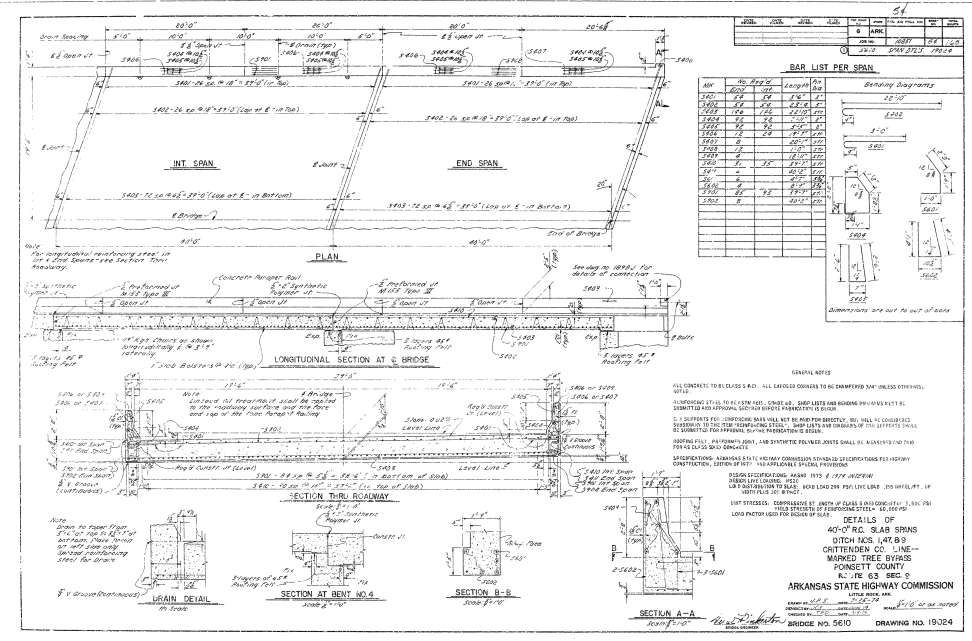
PHOTO 3

Description 40' slabs

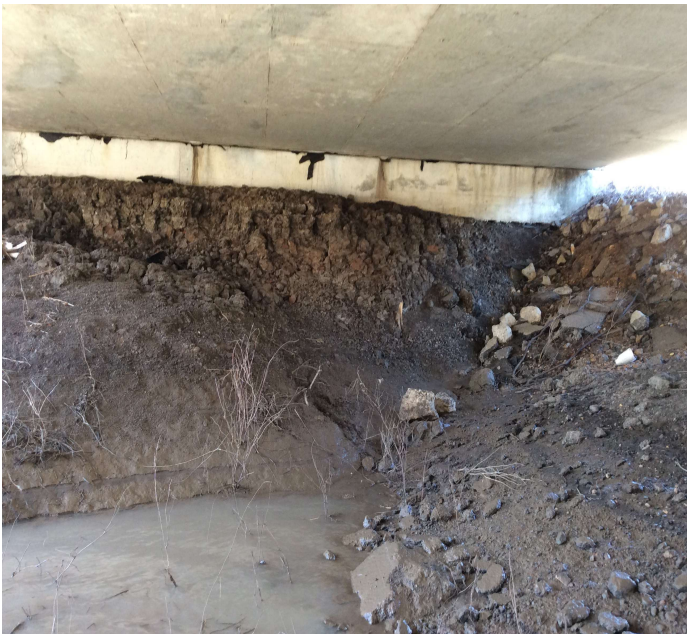
PHOTO 1 Description

Slopes have some embankment erosion under bridge at spans 4 and 11. Minor scour at bents 6 and 9. Bent 12 cap is undermined for 8' on Lt end up to 1' below and 1.5' back under. 6' on Rt end of cap is beginning to undermine.

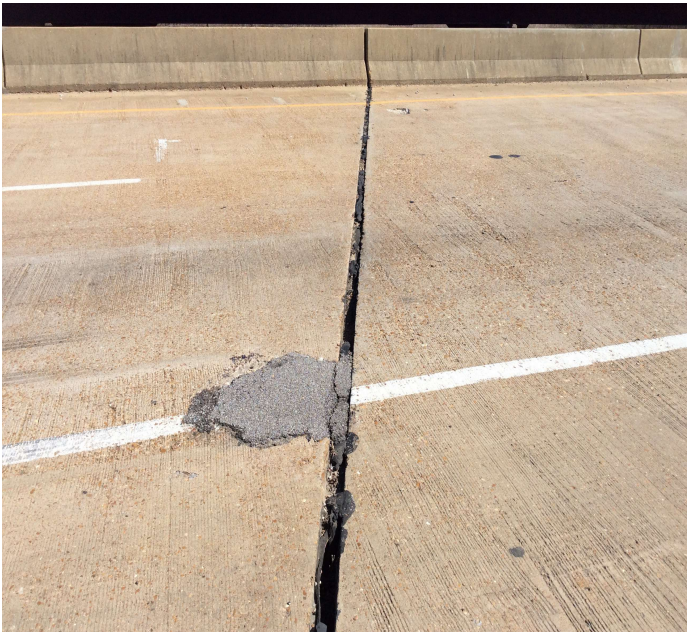
PHOTO 1 Description

Deck has areas of minor abrasion in wheelpaths.

Deck has a few unsealed longitudinal cracks and a few small spalls.

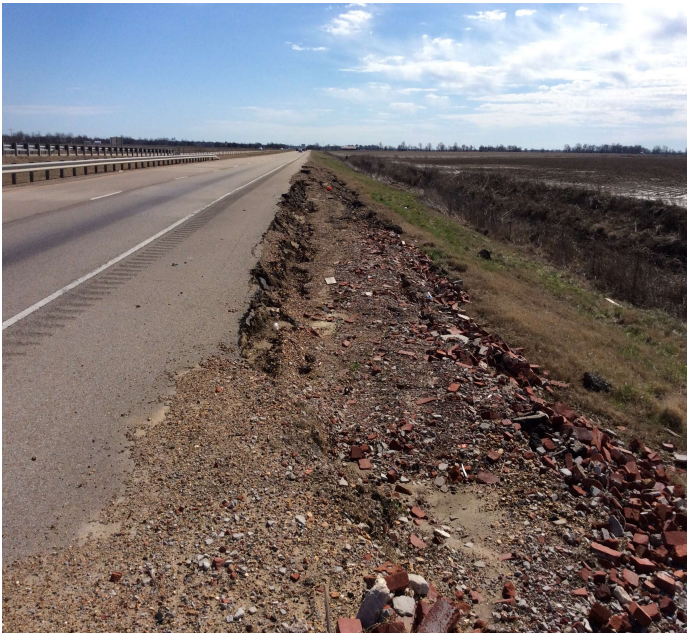
PHOTO 1 Description

Lt approach roadway at bent 1 end has embankment settlement at edge of shoulder.

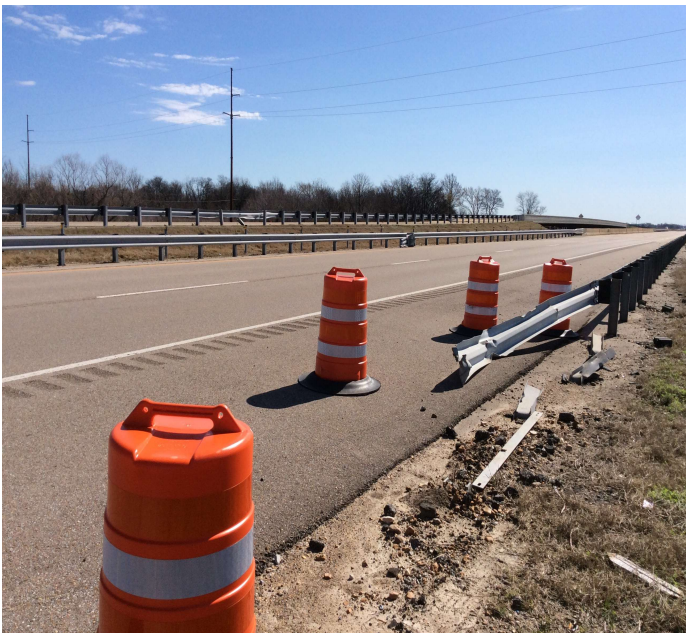
PHOTO 1 Description

Lt approach rail at bent 12 end has collision damage.
