Bridge Inspection Report

06998

I-555/Sec-1/L-0.22

I-55/Sec-11/L-23.47

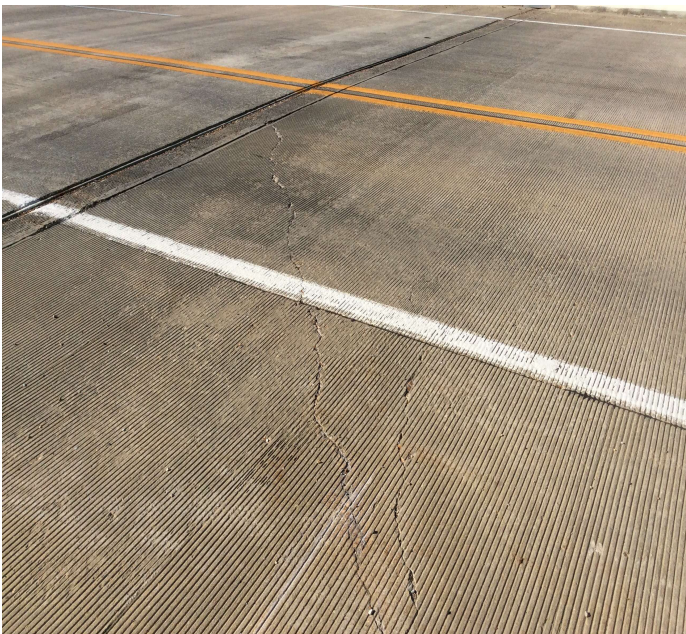
PHOTO 1 Description Approach slab cracks.

APPROACH SLABS ABUTMENTS #1 AND #2 SLABS ARE CRACKED DIAG. ON BOTH SIDES.

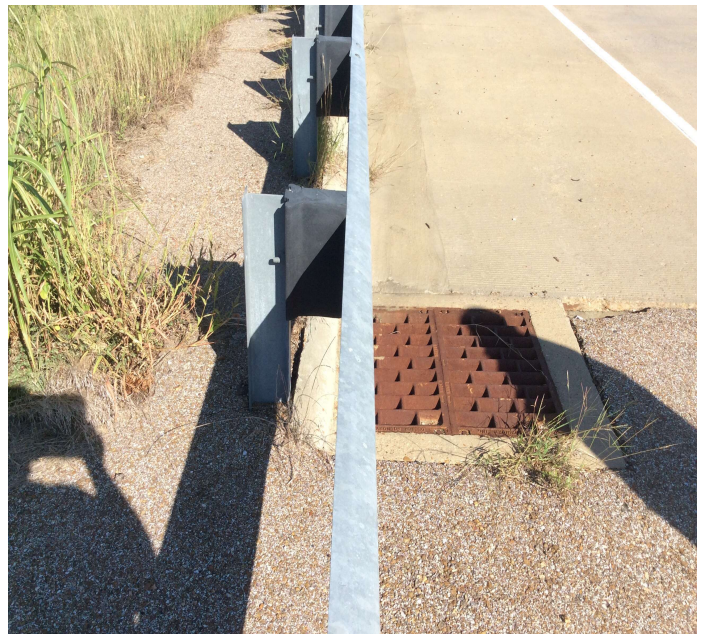
DRAINS

ABUTMENT #1

RIGHT AND LEFT SIDES

AT SHOULDERS. SMALL HOLE STARTING TO WASH OUT AT BOTH LOCATIONS.

PHOTO 2 Description Abutment 1 erosion around drain.

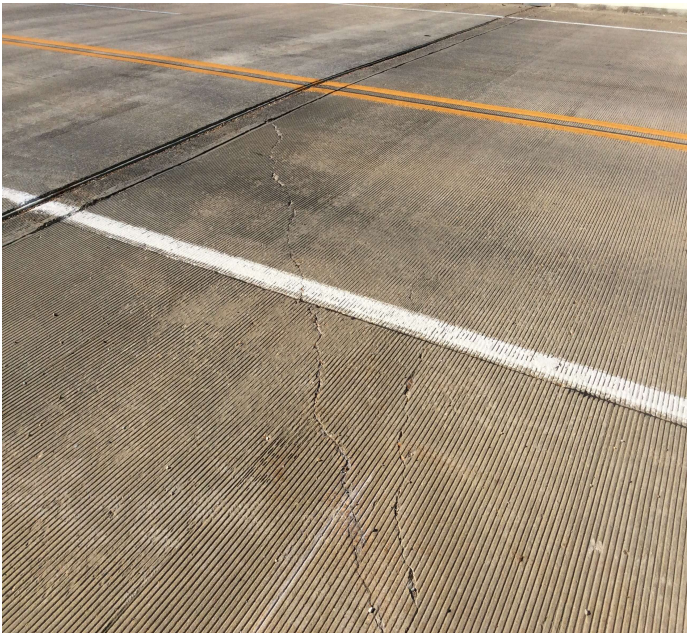
PHOTO 1 Description Approach slab cracks.

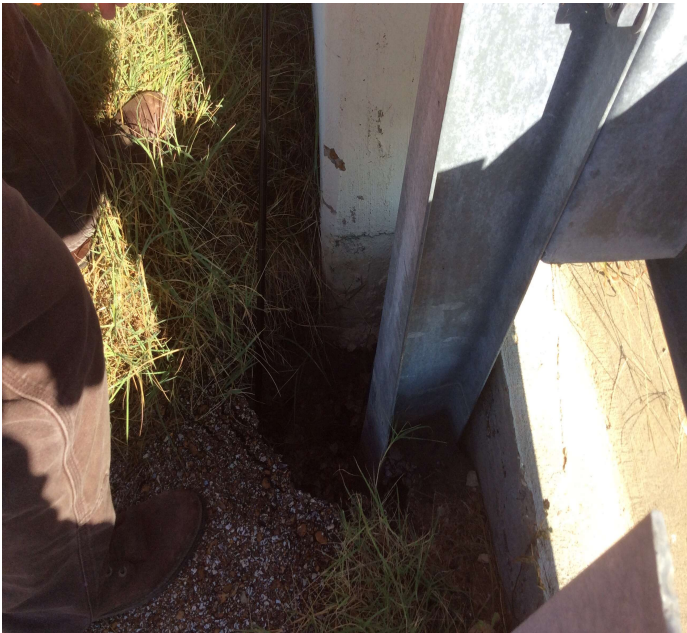
Abutment 2 right side at bridge rail has 2' deep erosion area.

PHOTO 1 Description Abutment 1 left side at bridge rail has 2' deep erosion area.
