# Bridge Inspection Report

**06999**  
**I-555/Sec-1/L-0.14**  
**over**  
**I-555 & I-55**

Structure Number: 06999

Facility Carried: I-555/Sec-1/L-0.14

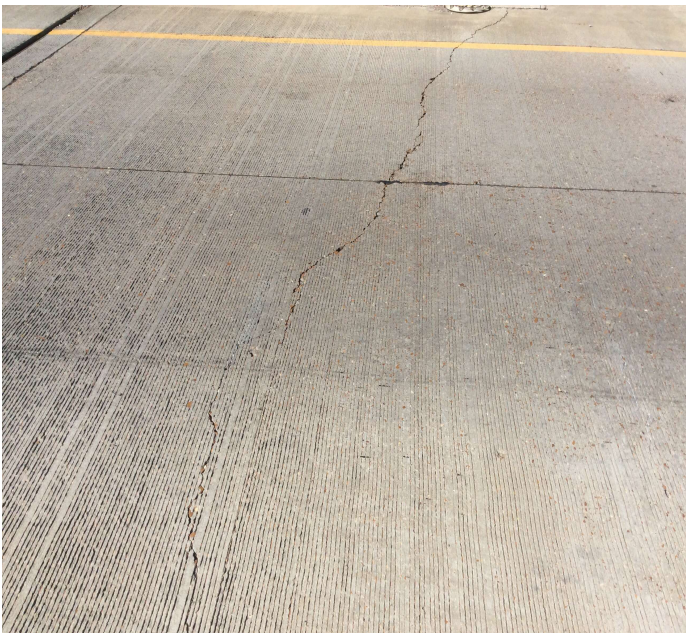
APPROACH SLABS HAVE SEVERAL OPEN TRANSVERSE CRACKS.

PHOTO 1    Description    Typical approach slab cracking.

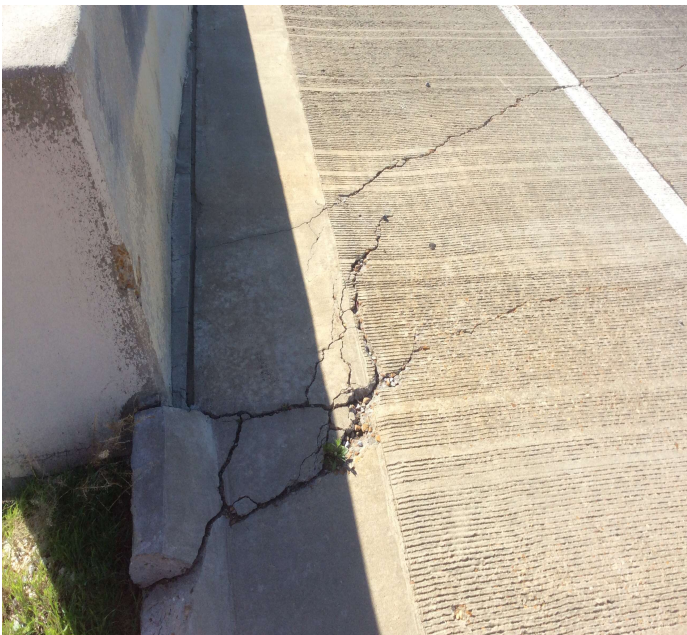
APPROACH SLAB GUTTERS LEFT AND RIGHT ALL GUTTERS ARE CRACKED AND SPALLED.

PHOTO 1    Description    Typical approach gutter cracking.

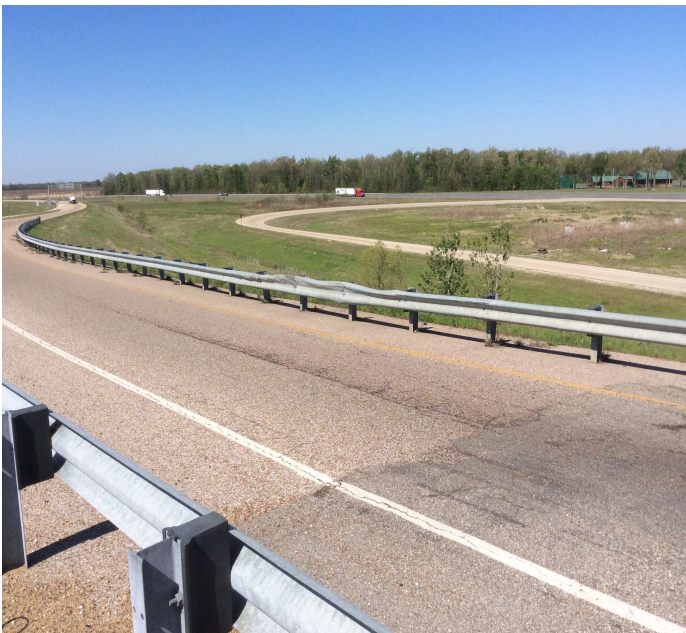
ABUTMENT #1 LEFT SIDE APPROACH RAIL HAS MINOR COLLISION DAMAGE.

PHOTO 1      Description      ABUTMENT #2 RIGHT SIDE  
APPROACH RAIL HAS MINOR  
COLLISION DAMAGE.
