Bridge Inspection Report

07012
I-555NB-02-LM 7.78
over
Dead Timber Lake

Structure Number: 07012

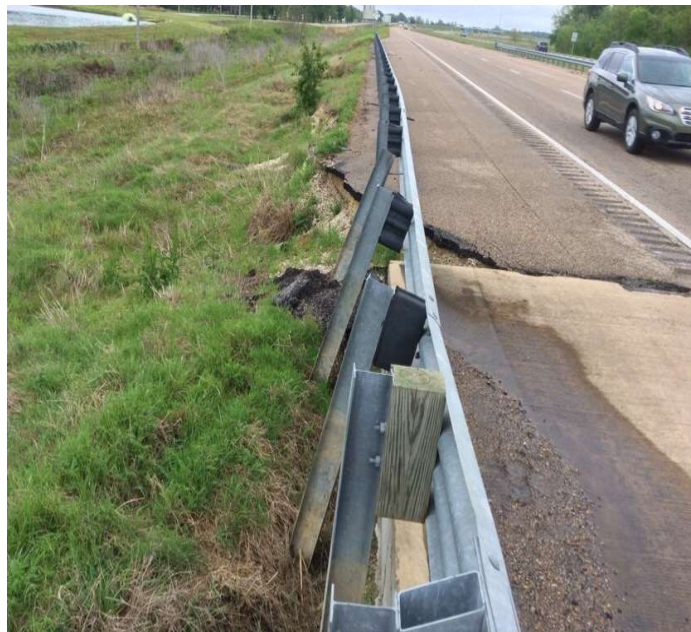
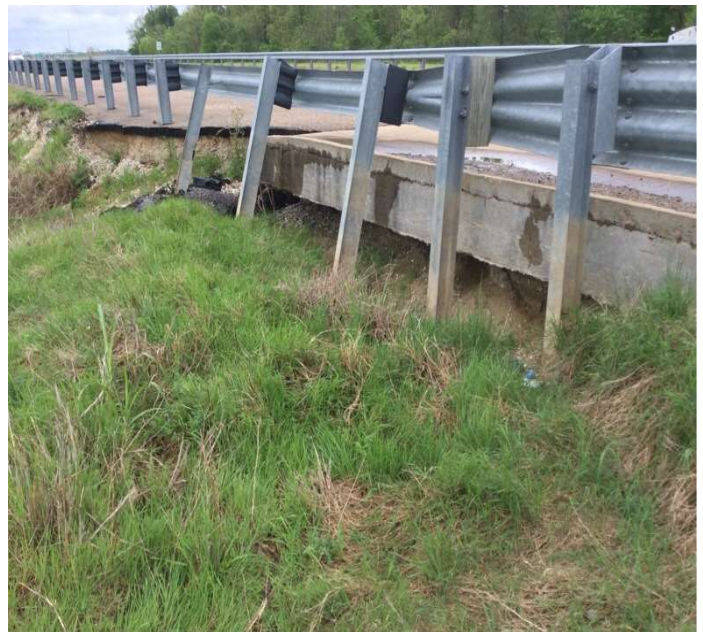
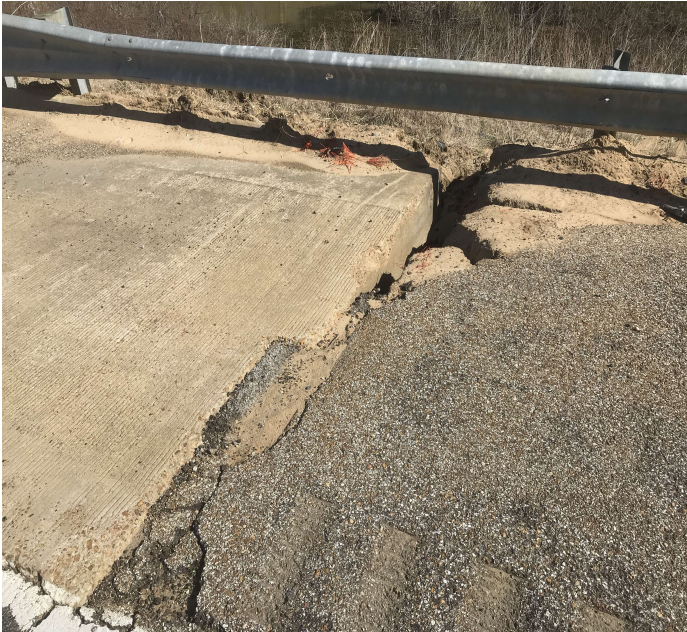
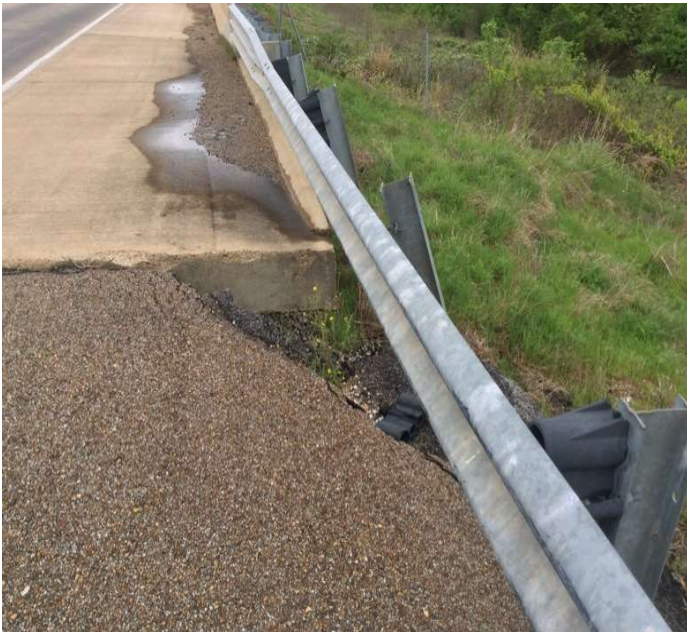
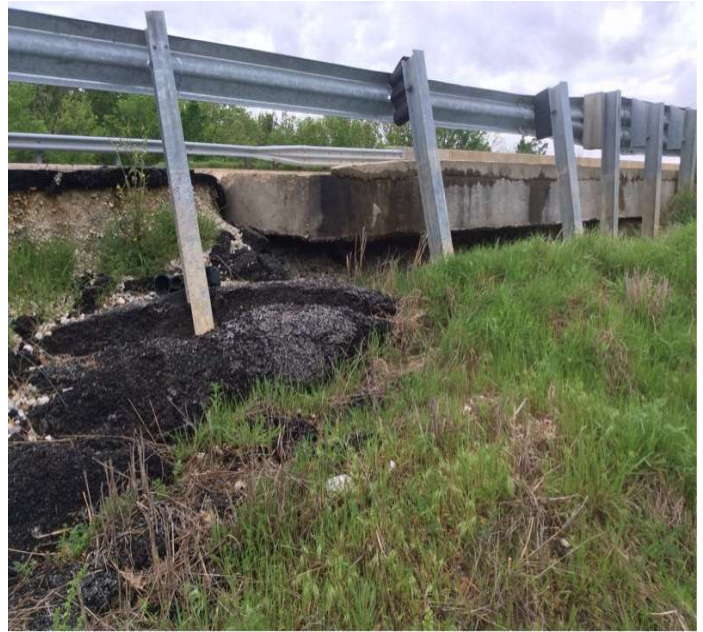
PHOTO 3 Description RT GUTTER at bent 1

Concrete Approach Gutter near Bent 1 has a 15ft. x up to 4ft. x up to 1ft. deep void under concrete, see 2017 photo. North East Approach Roadway right side has eroded causing a 6ft. x up to 4ft. x 2ft. deep hole 1 ft back under at end of approach gutter, see 2017 & 2019 photo.

Concrete Approach Gutter near Bent 1 has been repaired as of this inspection JFA/CWS

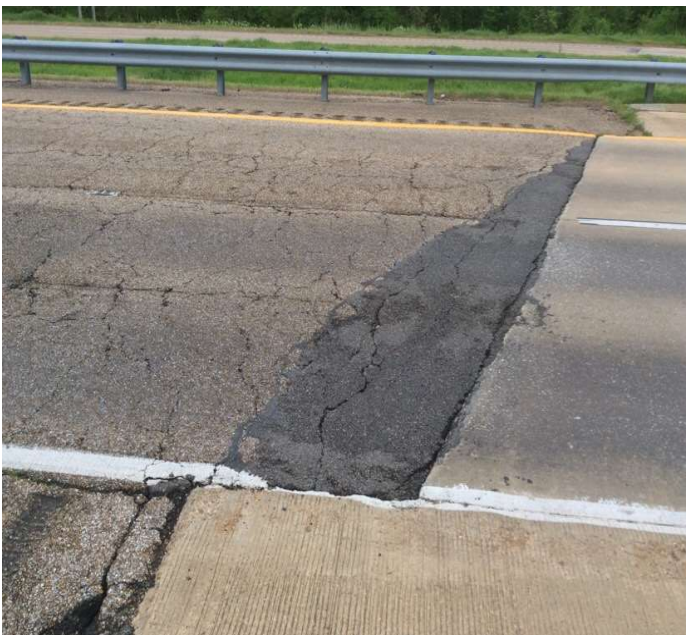
PHOTO 1 Description

Approach Roadway

1 in to 1 1/2 in. settlement to both bridge ends.

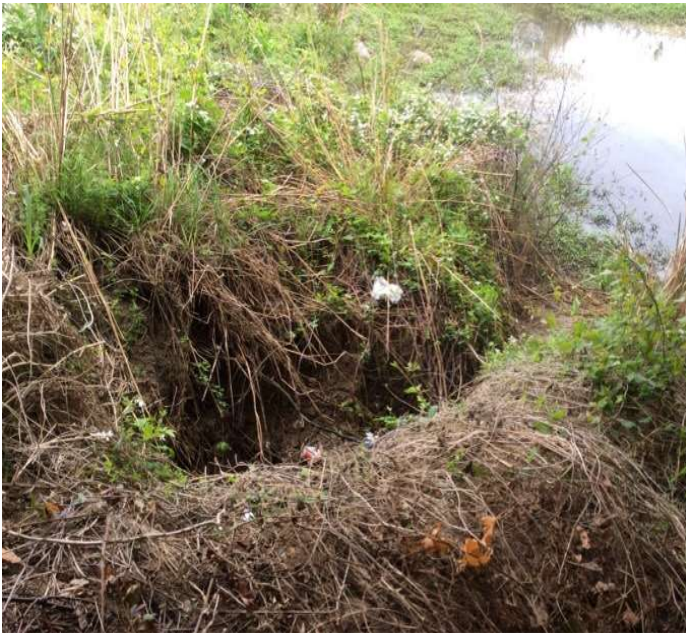
PHOTO 1 Description

Right side Embankment near Bents 1&4 has some erosion from roadway runoff.

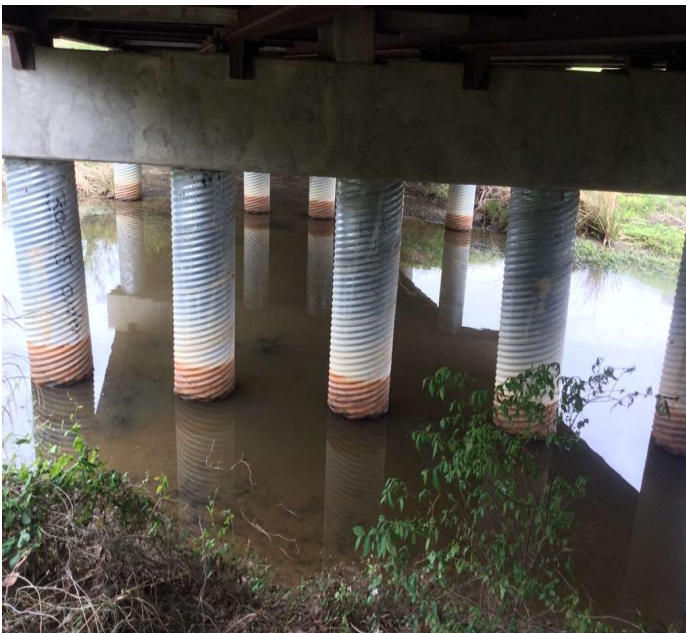
PHOTO 1 Description

Full Encased Steel Shell Piles are beginning to rust at waterline.
