Bridge Inspection Report

07013
SH 118-02-LM 6.23
over
I-555 - Sec. 02

Structure Number: 07013

Facility Carried: SH 118-02-LM 6.23

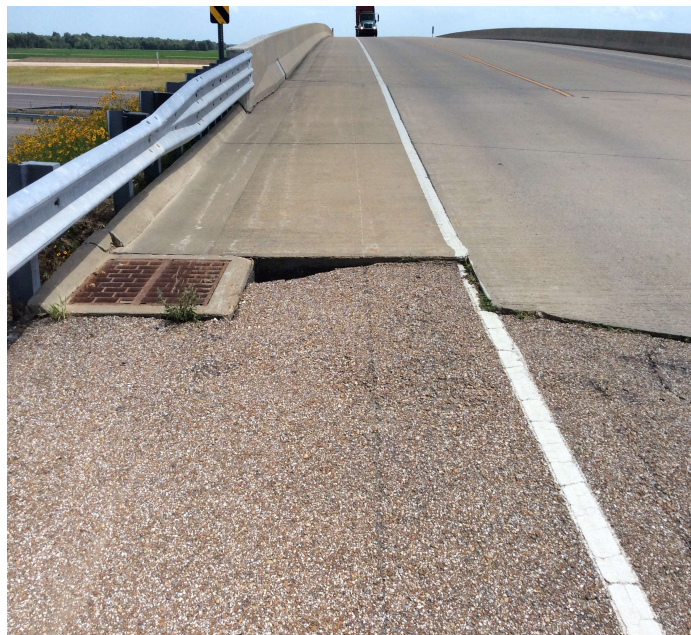
PHOTO 1 Description

Bent 1 approach roadway has settlement and a 1.5' x 3' x 1.5' hole at Lt drop inlet. Embankment on back side of Lt curb has a hole that has undermined the end of approach gutter.

to Poinsett Co Crew for review - KAW 7/5/2018
