Bridge Inspection Report

B6990
I-555NB/Sec1/L0.97
over
Little Cypress Bayou

Structure Number: B6990

Facility Carried: I-555NB/Sec1/L0.97

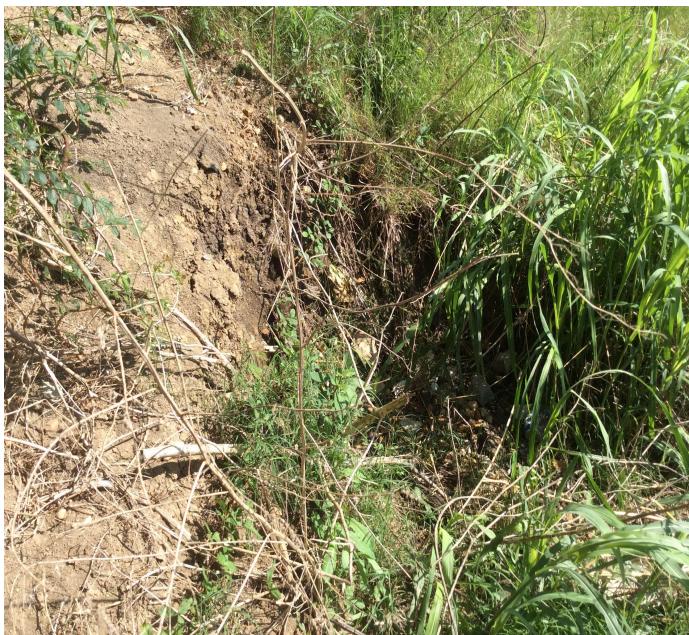
Northwest side of bridge - slope has slid leaving a vertical face four feet deep.
Abutment #2 right side has eroded area up to three feet deep.

PHOTO 1 Description abutment 2 right side has eroded area up to 3' deep.

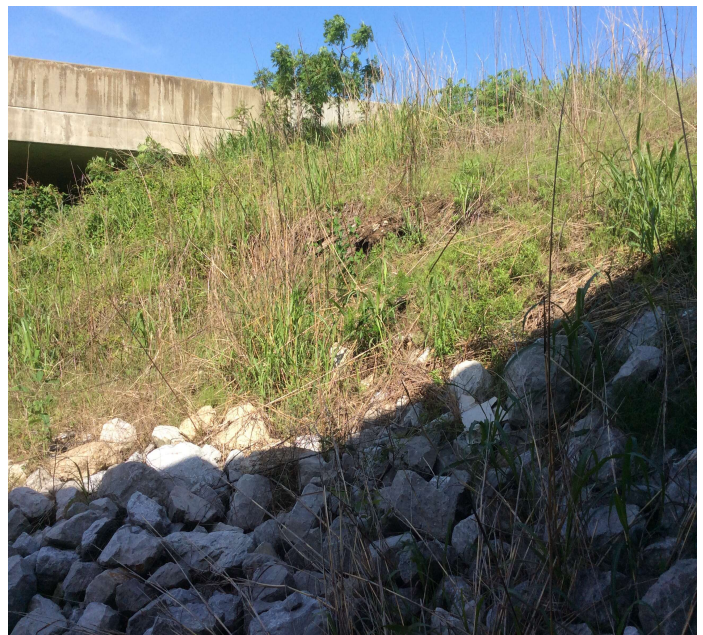
PHOTO 2 Description Slide north west side of bridge.

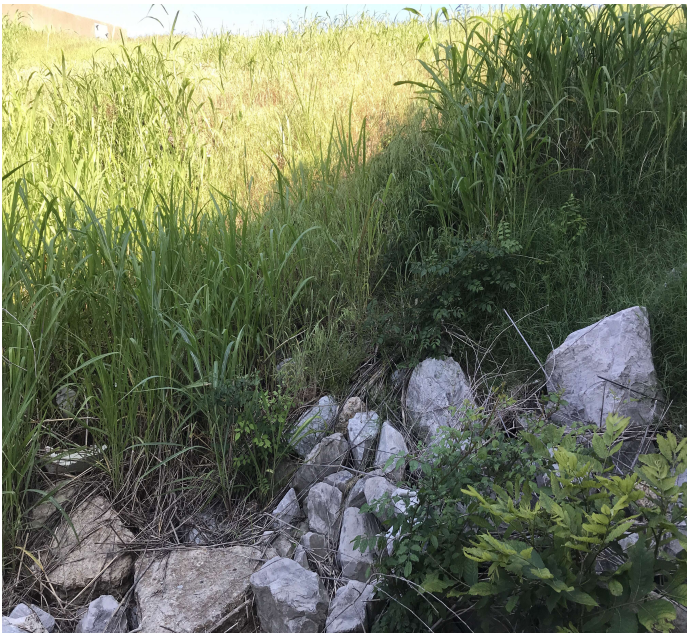
PHOTO 3 Description Abutment #2 left side.

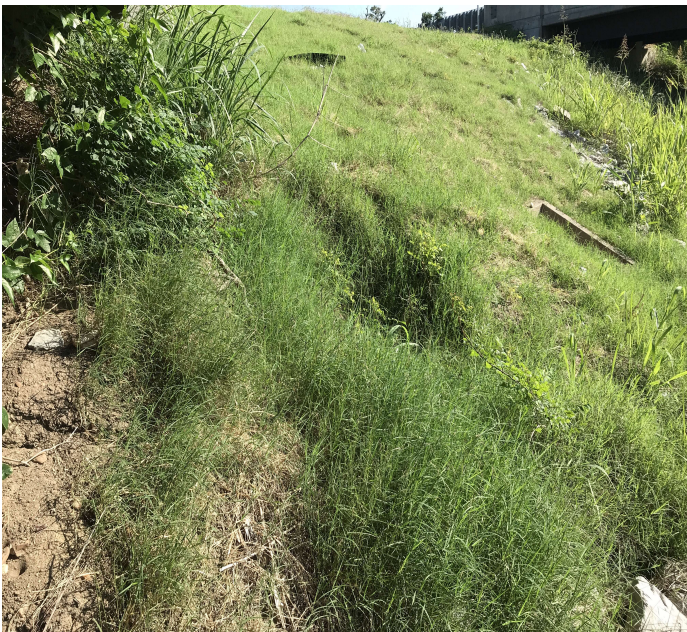
PHOTO 4 Description Abutment #2 right side

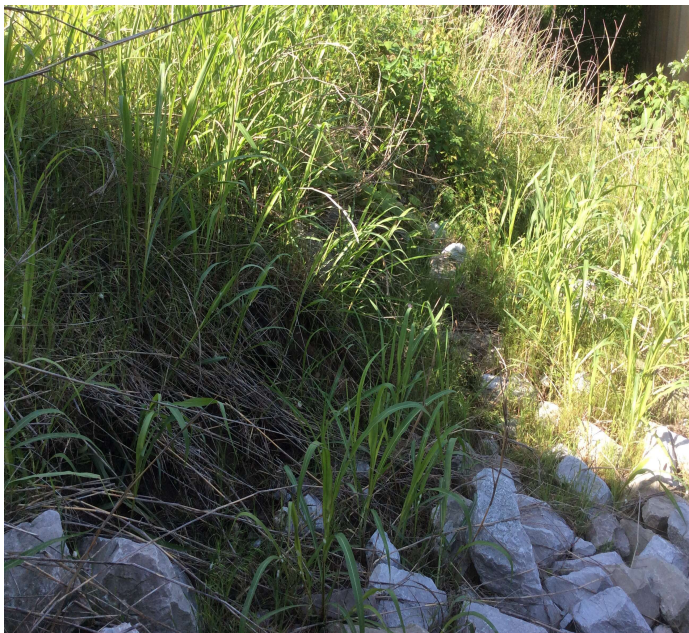
Abutment #1 left side slope has eroded and slide areas four feet deep extending down slope.

PHOTO 1 Description Abutment 1 left side slope.

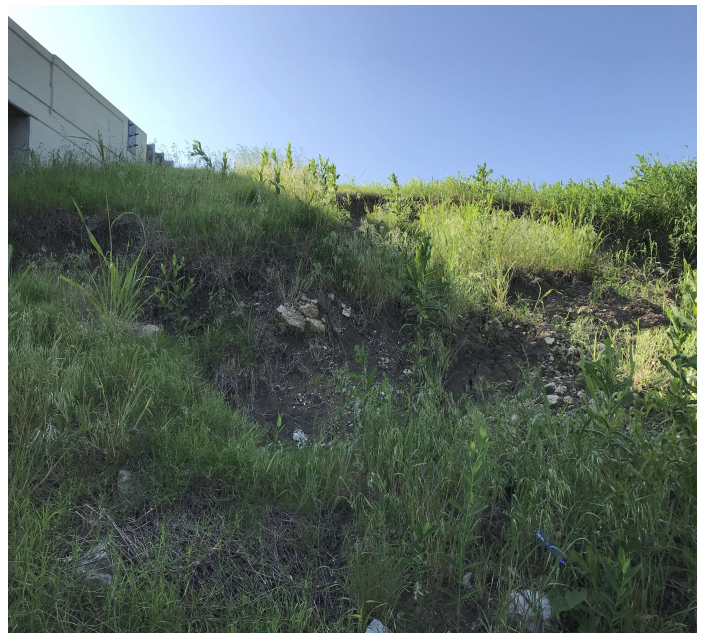
PHOTO 2 Description Abutment #1 left side.

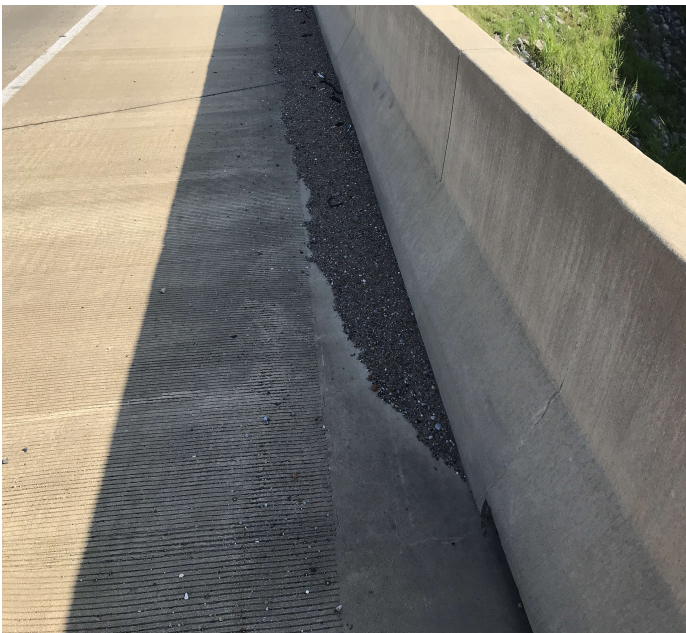
Gutters have debris in them.

PHOTO 1 Description Gutters have debris in them.

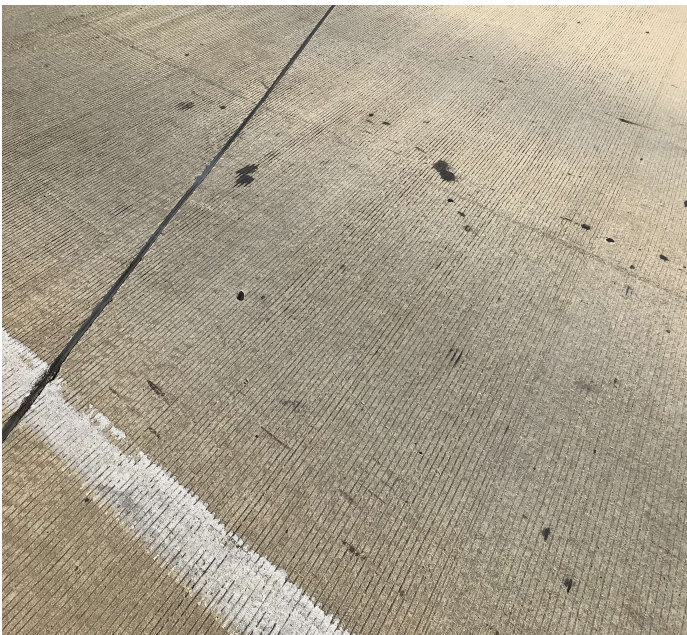
Deck has longitudinal and transverse hairline cracks spaced six feet apart.

PHOTO 1 Description Typical deck
