Bridge #06985(Routine, Underwater type 2)

SH 18-04-LM 12.60 over GUM SLOUGH

Location: 1.0 MI W JCT SH 158

Team Lead: Richard Jones **Inspection Date:** July 02, 2020

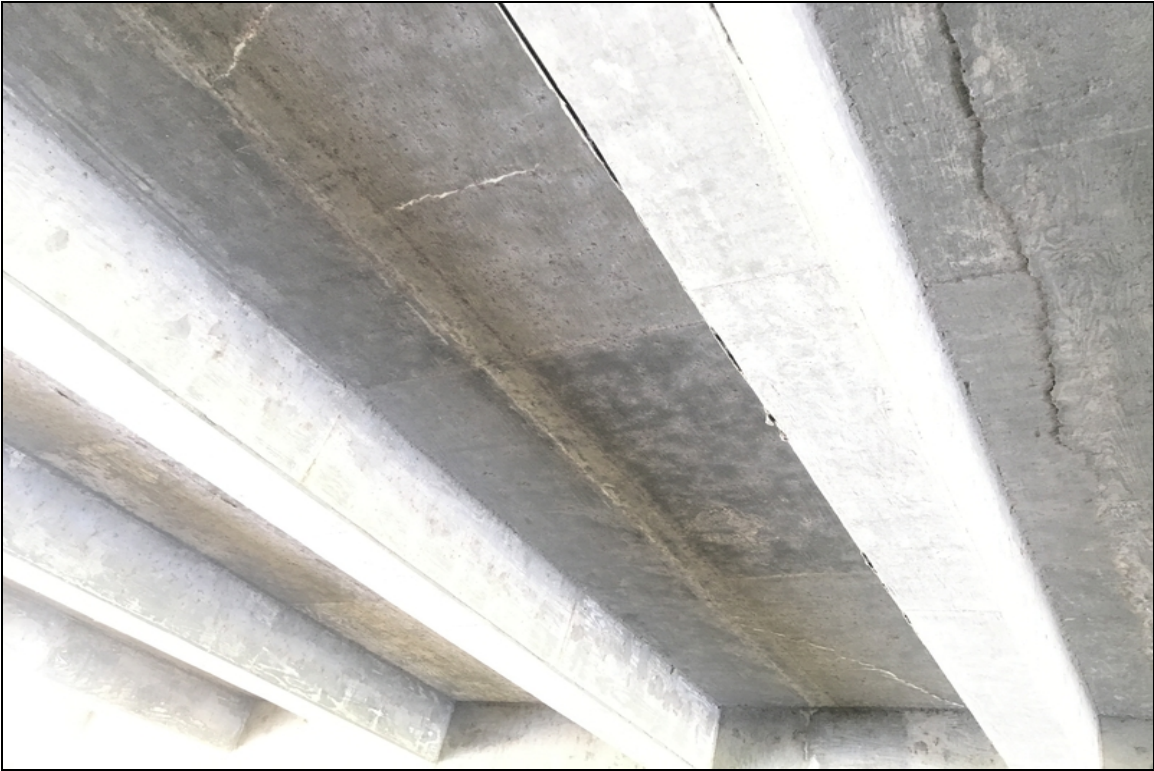
soffit

Soffit has a few cracks with efflorescence.

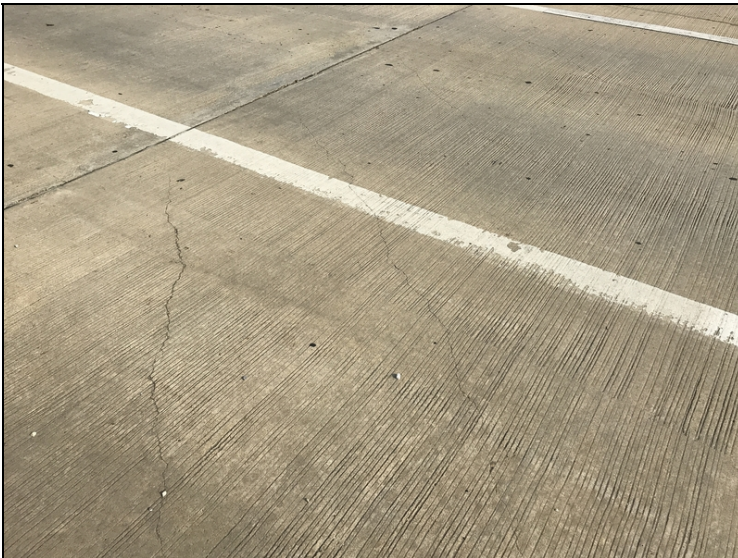
Top flange has a few unsealed longitudinal cracks. Corners of each span has diagonal unsealed cracks. Some cracks are up to 1/8" wide.

Corner cracks

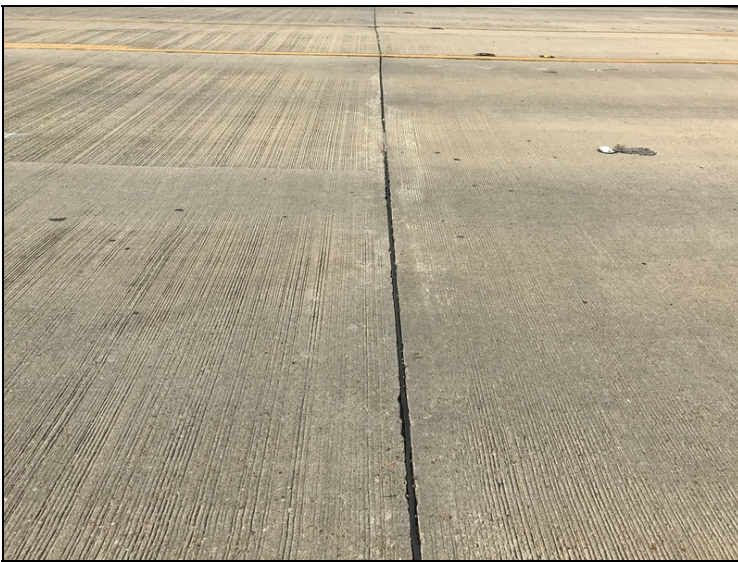
Poured joint material has some loss of adhesion with a few sections missing.

Poured joints

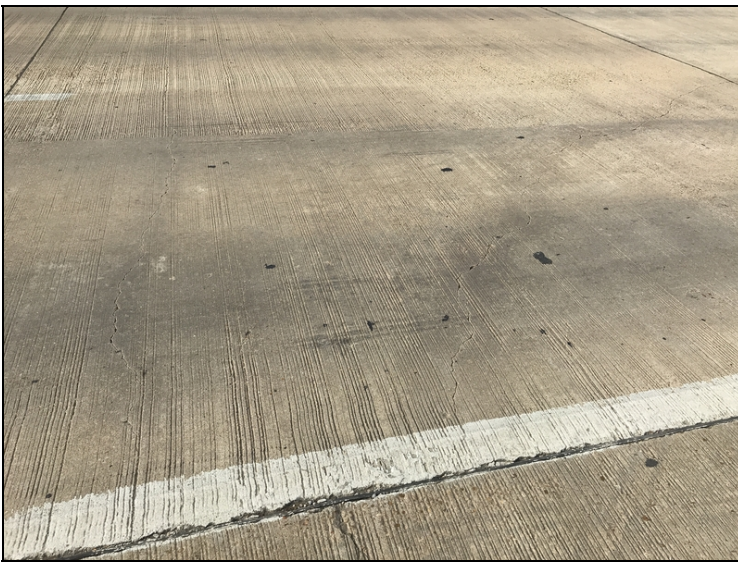
Approach slabs have open unsealed cracks.

Approach slab cracks
