Bridge #06986(Routine, Underwater type 2)

SH 18-04-LM 13.43 over BIG BAY

Team Lead: Richard Jones Inspection Date: July 02, 2020

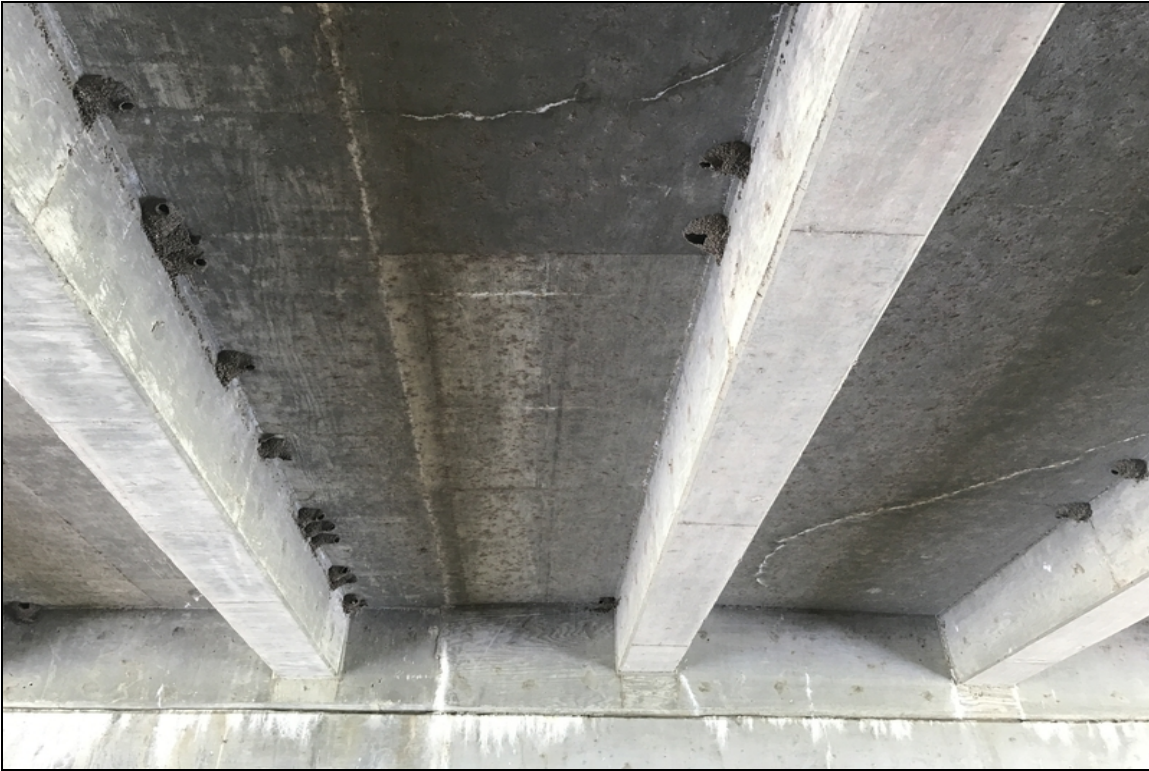
Span 2 soffit

Soffit has a few cracks with efflorescence.

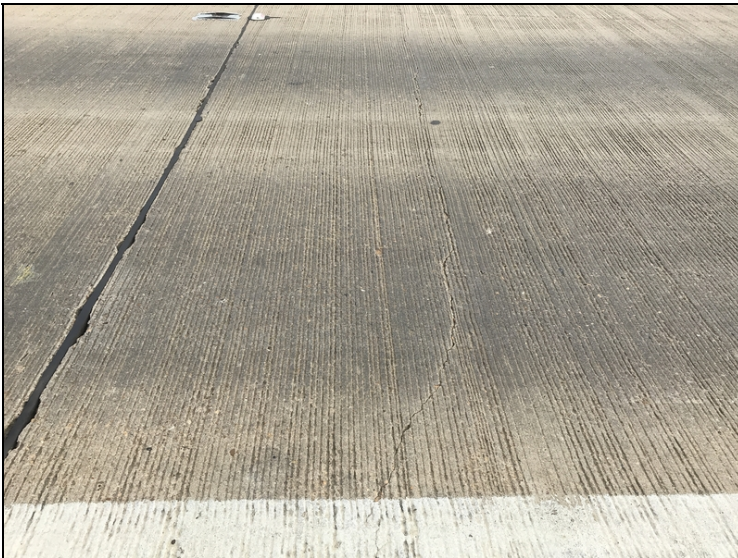
Approach slabs have unsealed transverse cracks.

Approach slab cracks

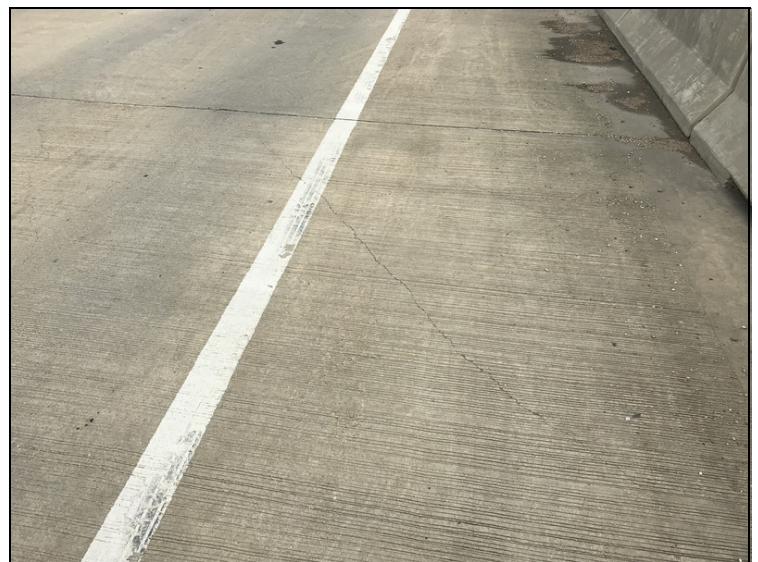
Top flange has a few unsealed longitudinal cracks. Corners of each span has diagonal unsealed cracks. Some cracks are up to 1/8" wide.

Typ top flange cracks near corners
