Bridge #05325(Routine)

I-430 SB over I-40 LOG 147.34

Location: I-430 & I-40 INTERCHANGE

Team Lead: Keith Harris Inspection Date: May 06, 2021

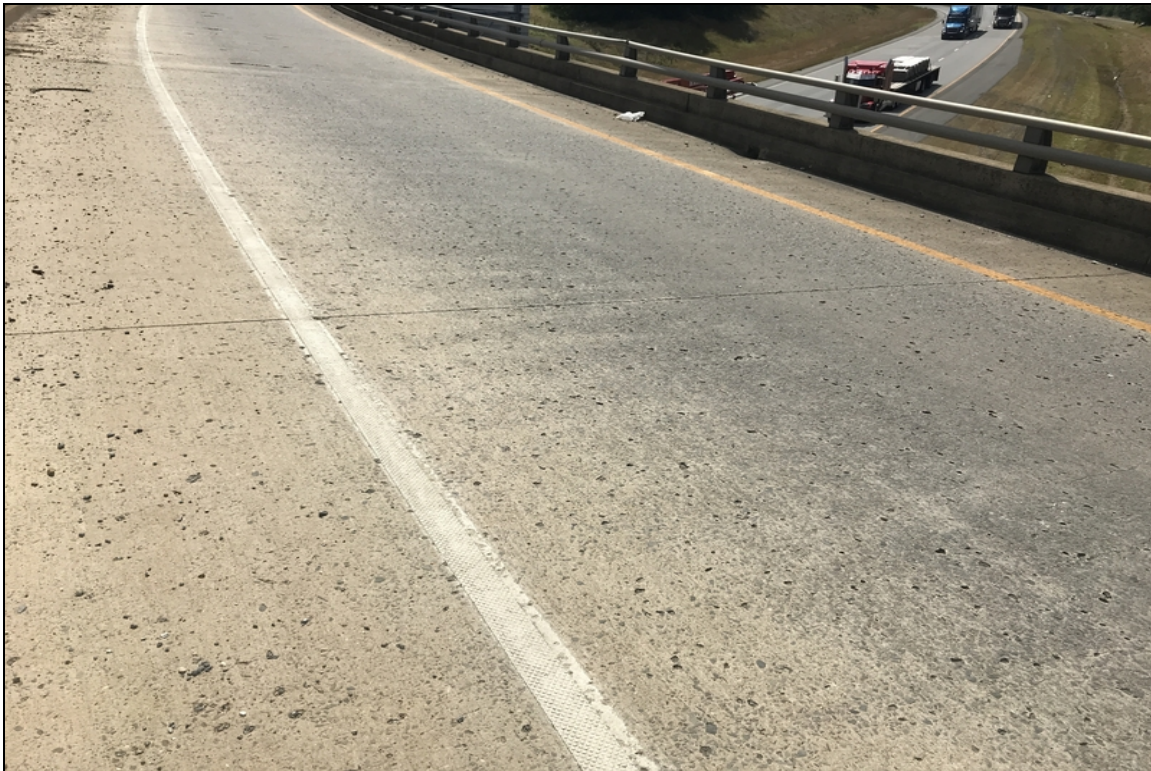
(12)	Large transverse unsealed cracks in all spans on three to four foot centers and up to 1/8" wide. Spans 1,2, 4 & 5 have Spalls with exposed rebar. Scattered small delaminations in the deck. All spans have minor abrasion in the travel lanes.						
107	Steel Open Girder/Beam	LF	2344	2259	72	13	0
1000	Corrosion	LF	85	0	72	13	0
515	Steel Protective Coating	SF	32816	0	19600	13126	90
3440	Effectiveness (Steel Protective Coatings)	SF	32816	0	19600	13126	90

Span 3 abrasion

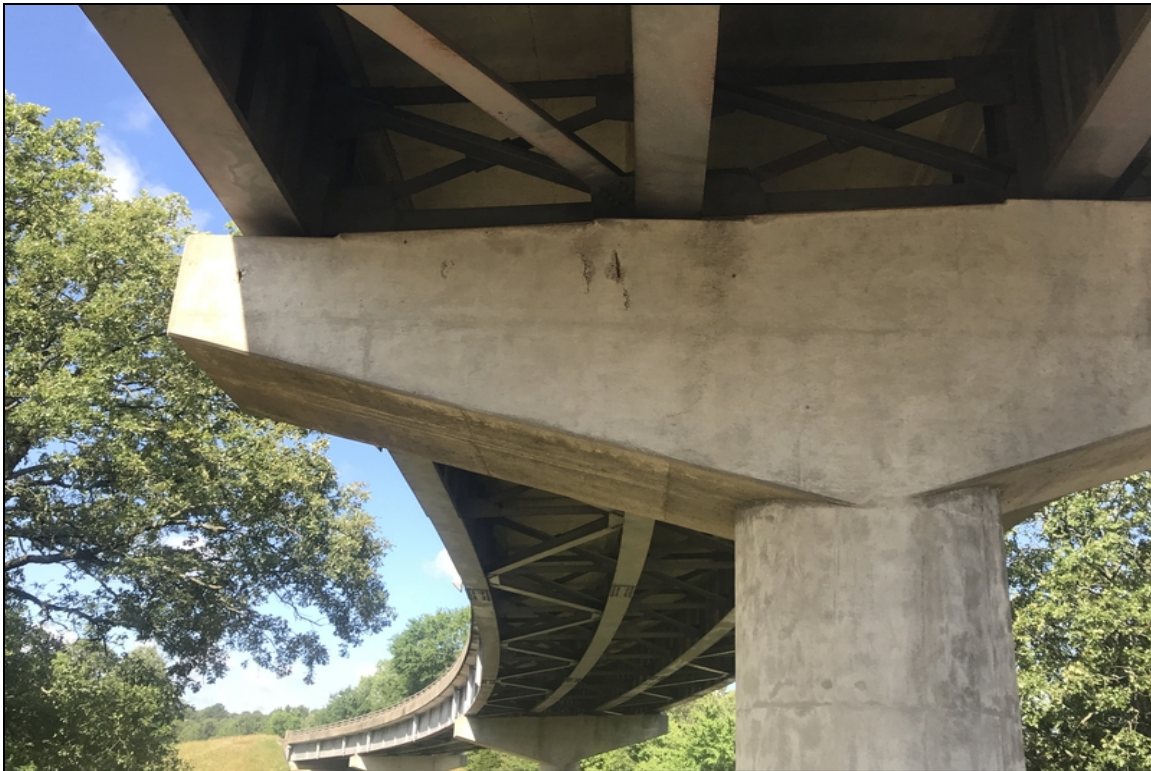
(234)	Bent 5, right end on the bottom, one small spall with exposed rebar. Bent 4, bottom right, small spall with exposed rebar. Bent 3, back face on the left small spalls with exposed rebar Bent 2, ahead face left end small spalls with exposed rebar						
303	Assembly Joint with Seal	LF	50	0	30	0	20

Bent 3 small spalls with exposed rebar on cap

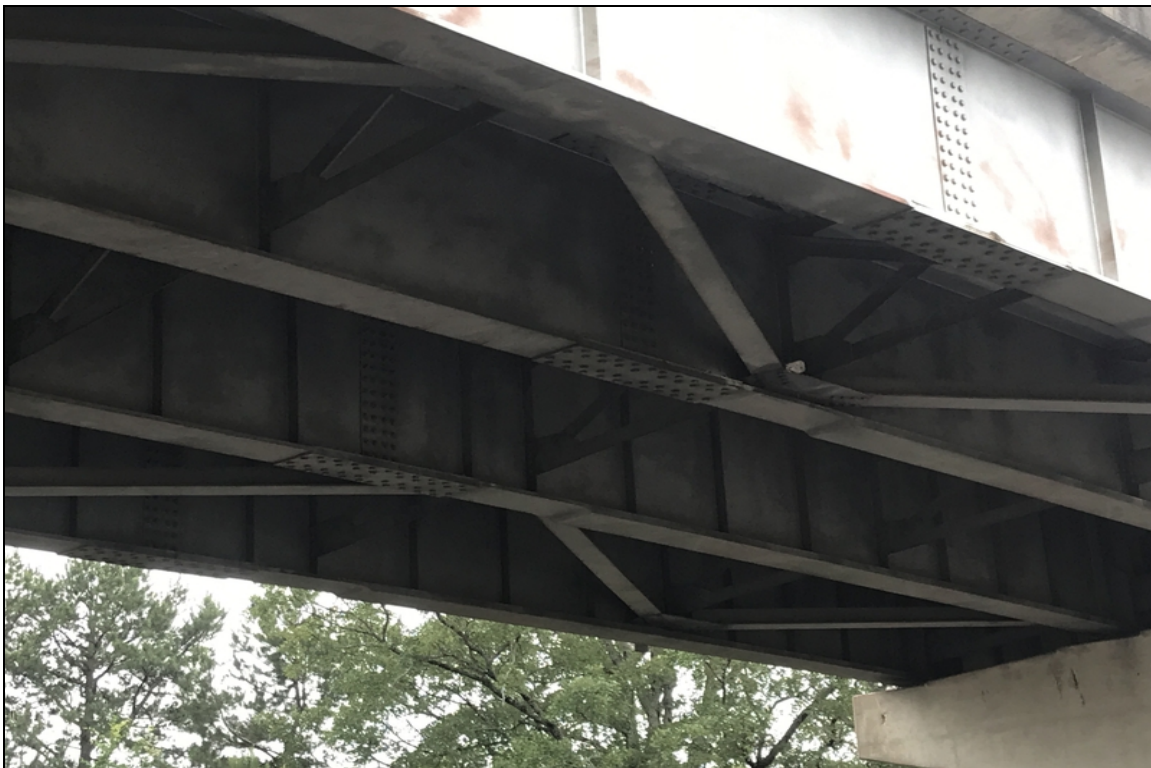
Span 4, girder 2 left side, at diaphragm 3: moderate sized piece of concrete is sitting on top of the diaphragm gusset about to fall off. This chunk of concrete is above I-40 west bound left lane.

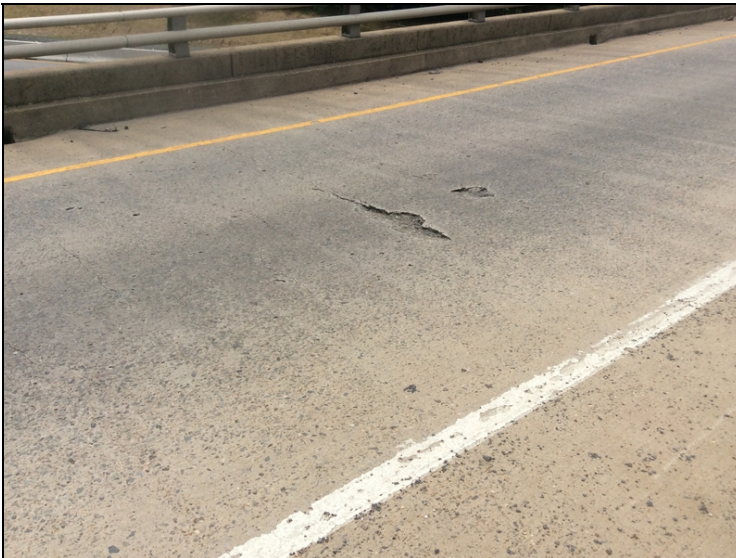
Spall in he deck at span 1.

Deck span 1,2,4 & 5  
Spalls with exposed rebar. Span 2 is in the worst condition.

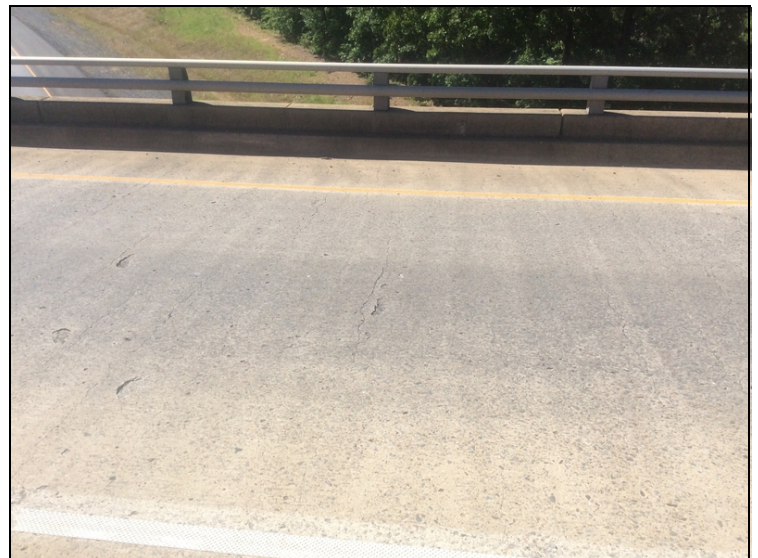
Large unsealed transverse cracks all span up to 1/8" wide on two foot centers. Most reflect thru the deck with light efflorescence.

Span 5 transverse unsealed cracking up to 1/8" on three to four foot centers. Common in all spans.

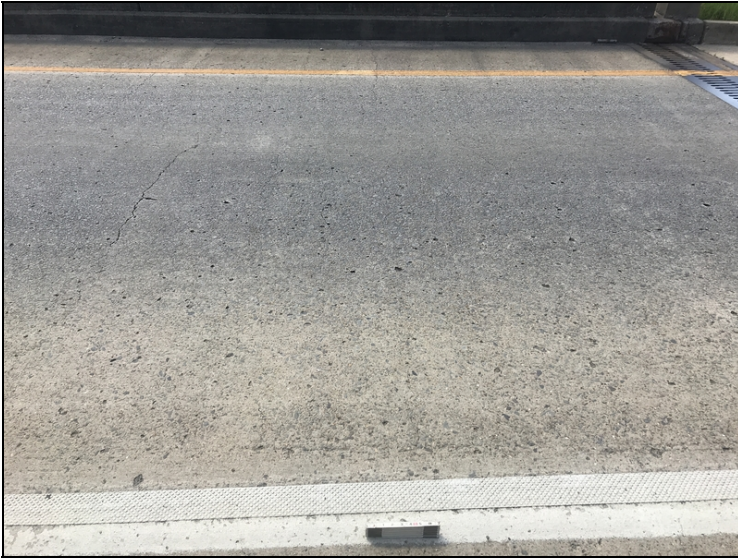
Typical deck cracking

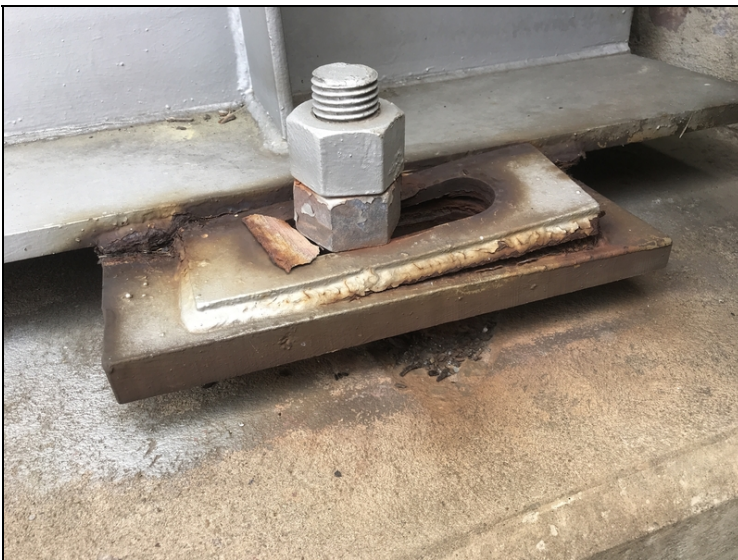
The bearing of girder #1 at the north abutment & Girder 4 at the south abutment.  
Pack rust has swelled between the bearing and the bottom flange, causing the welded connection to break.

Bent 6, girder 4: weld broke due to pack rust

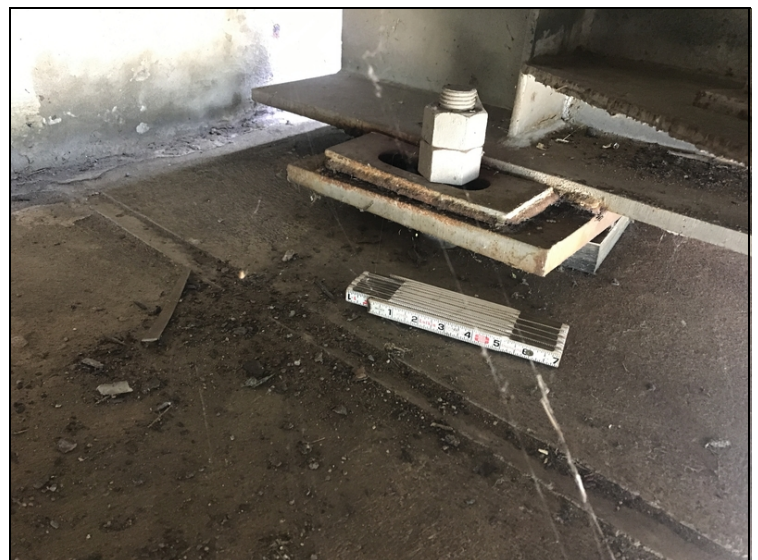
Pack rust has swelled between the bearing and the bottom flange, causing the welded connection to break. North abutment girder 1.

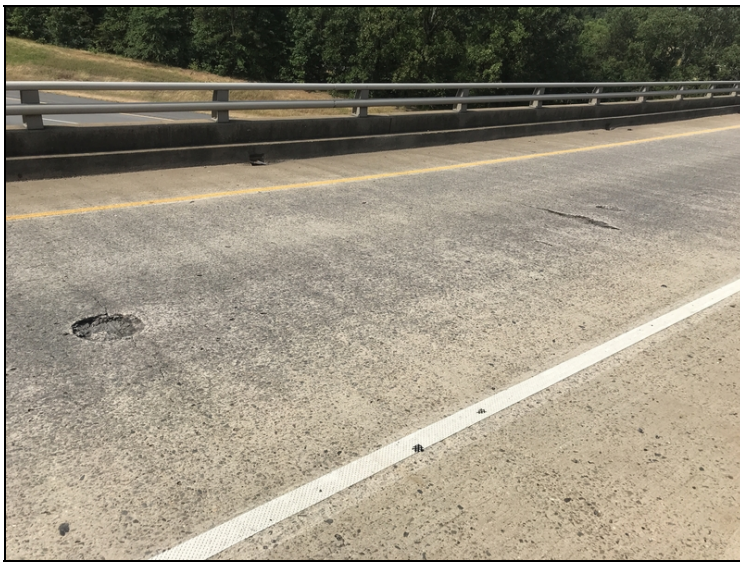
Span 5: large open spalls with exposed rebar in the deck surface

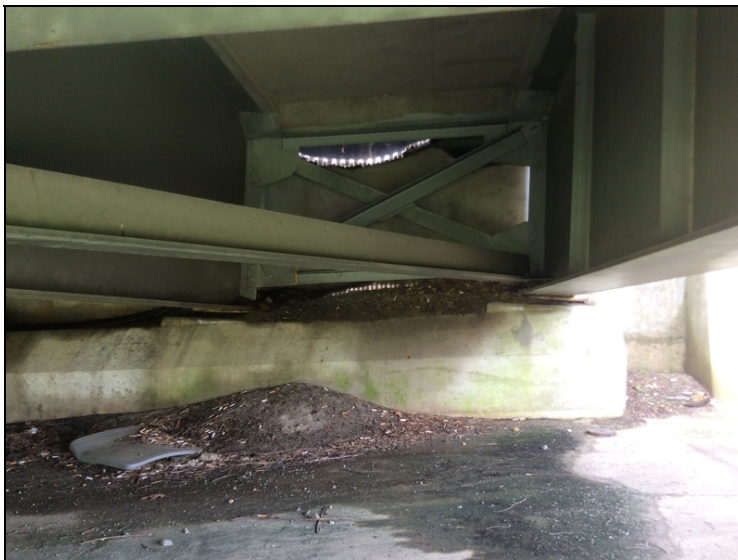
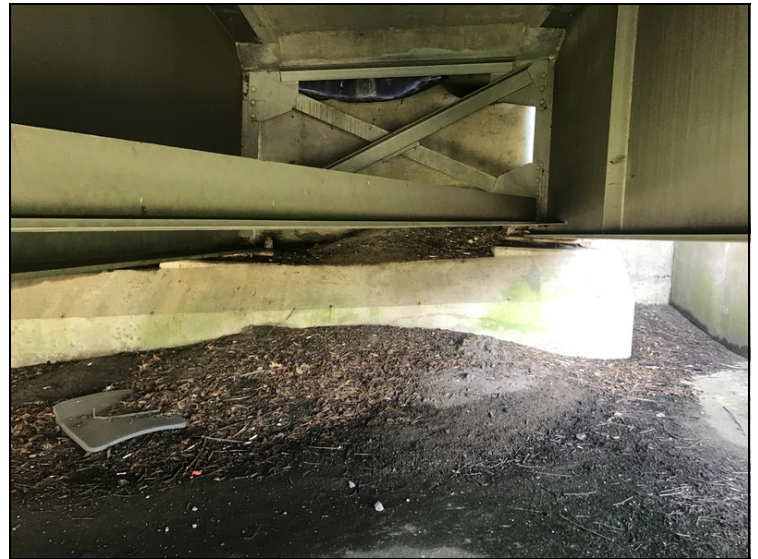
Abutments 1 & 2 girders 3 & 4 have dirt & debris on bearings and bottom flanges due to damaged joint seal.

Bent 6, debris on the beam seat and beam ends due to open joint.

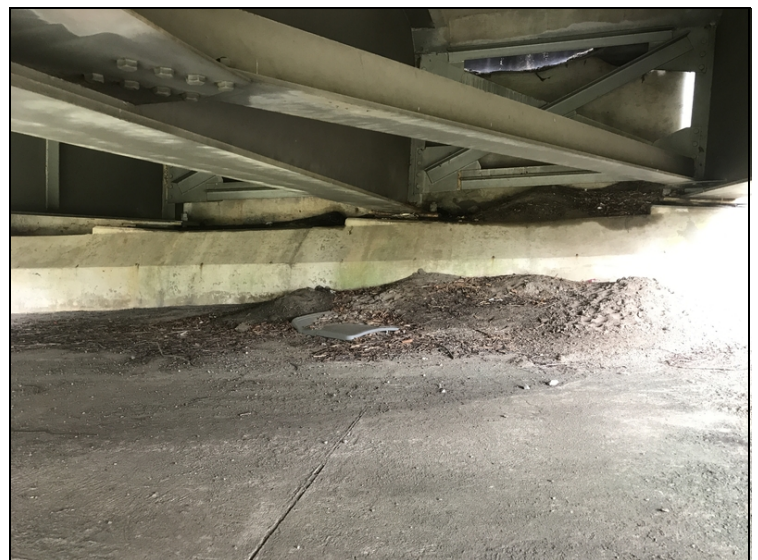
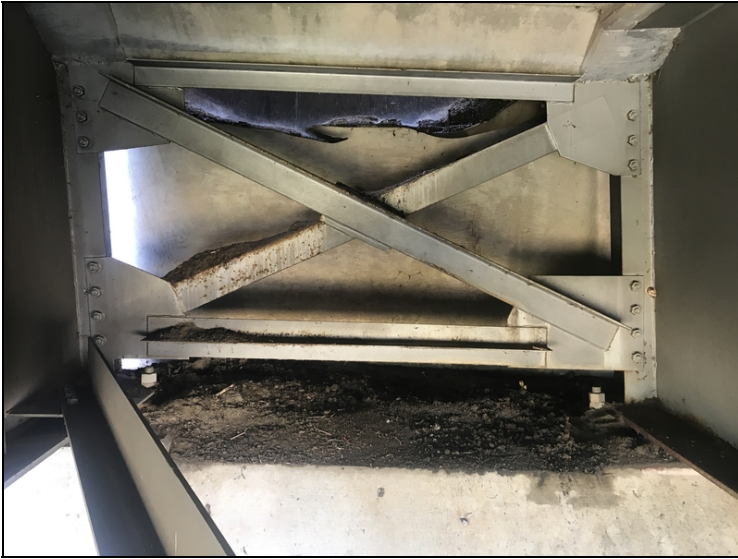
Bent 1: joint seal is open allowing debris to rest upon beam seat and bearings between girders 1 & 2. Similar condition at opposite abutment.

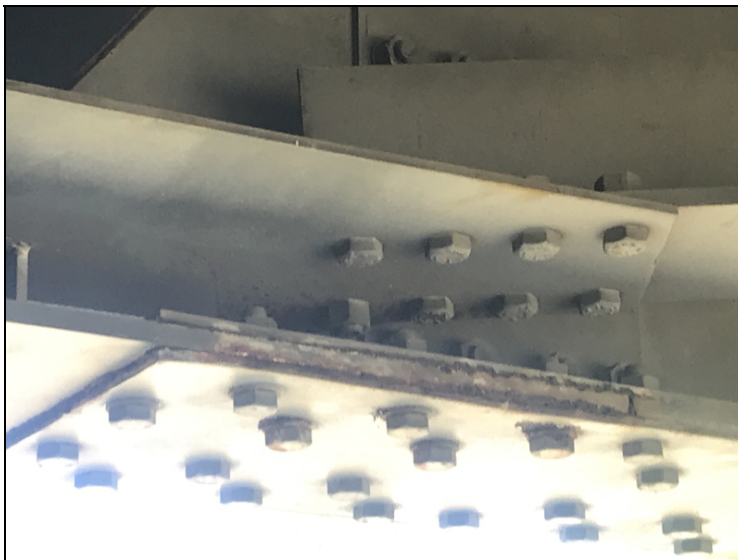
Girder 1 span 1 pack rust has formed on bottom flange splice plate causing minor deformation.  
Span 2, girders 1, 3, & 4 1st splice plates are in similar condition.

Girder 1 span 1 pack rust has formed on bottom  
flange splice plate.
