Bridge #01743(Routine)

SH 14 Marion over BUFFALO RIVER

Location: 15.79 MI S JCT US 62

Team Lead: Benjamin Smith Inspection Date: October 14, 2020

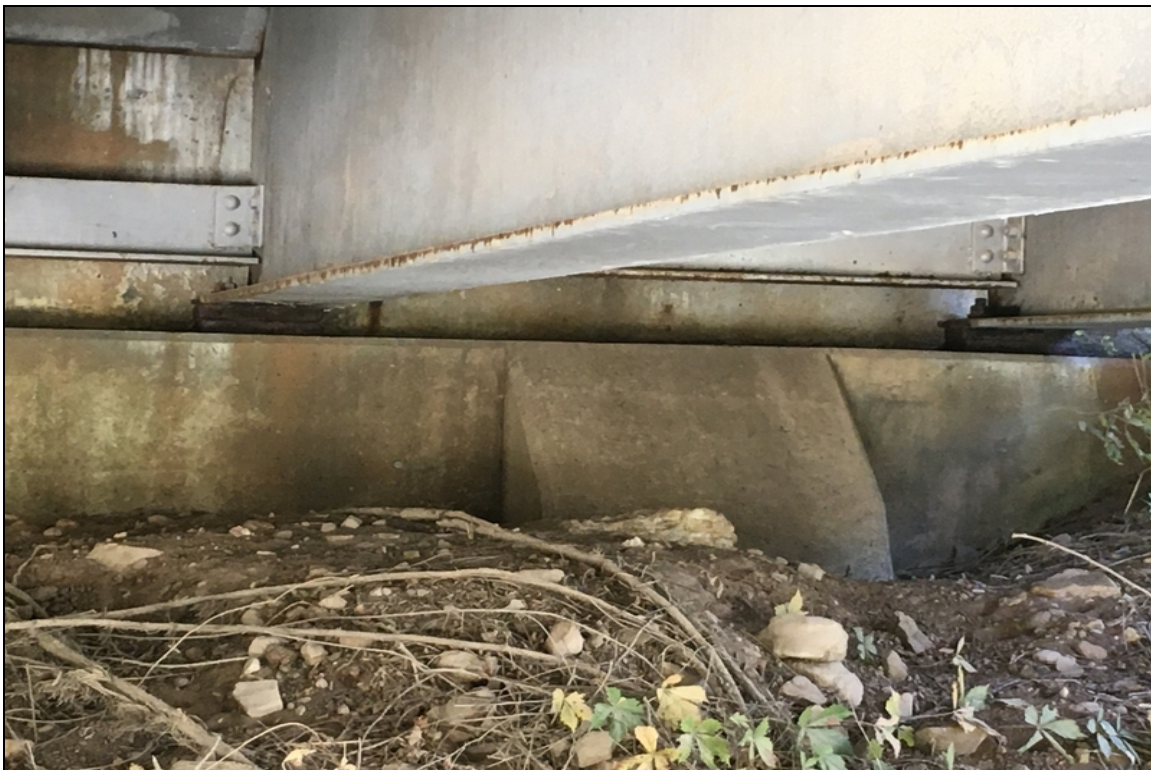
Abutment #2 bearing condition.

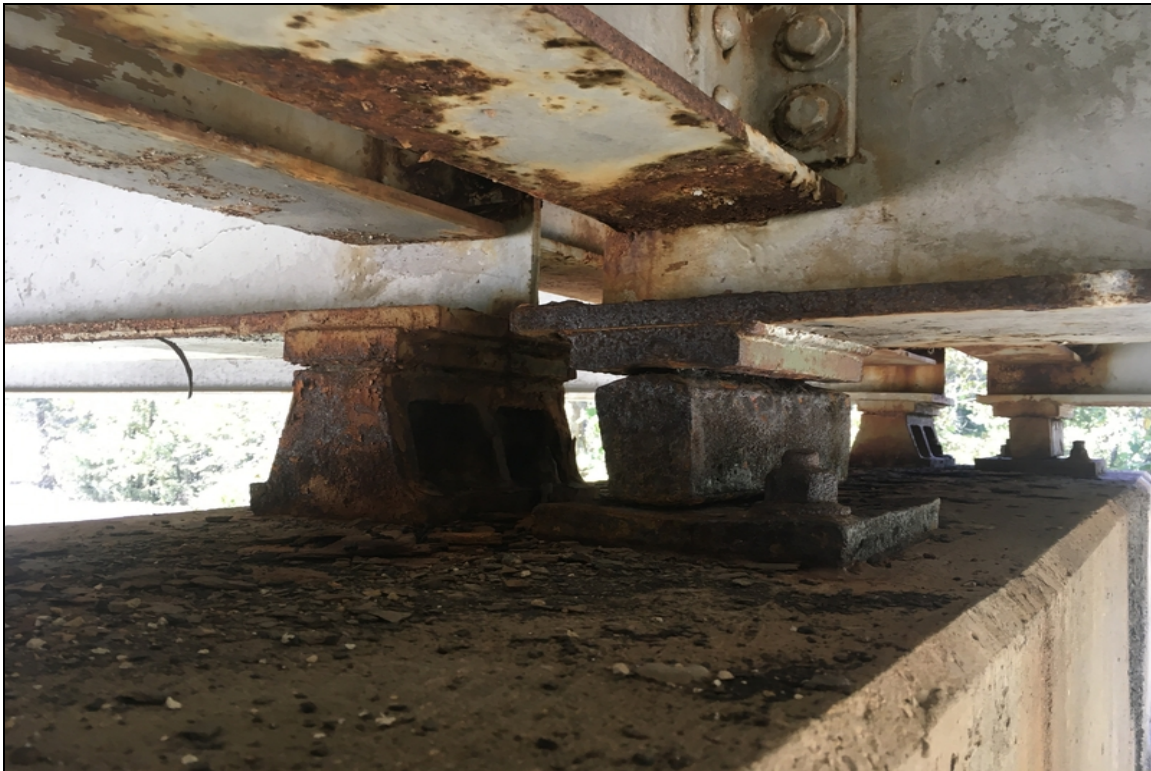
| ELEM | DESCRIPTION | UNITS | TOTAL | CS1 | CS2 | CS3 | CS4 |
|--|---|---|---|---|---|---|---|
| Bent #3 and #4 bearings- The movable bearing at steel bents #3 and 4 have cs3 corrosion and are expanded / contracted in different directions. Bearing #2 and #4 are contracted and bearings #1 and 5 are expanded. Bearing #3 is in the neutral position. Bearing 4 has section loss, the corrosion has been needle scaled. | | | | | | | |

Section loss on movable bearing #4 over steel bent #4.

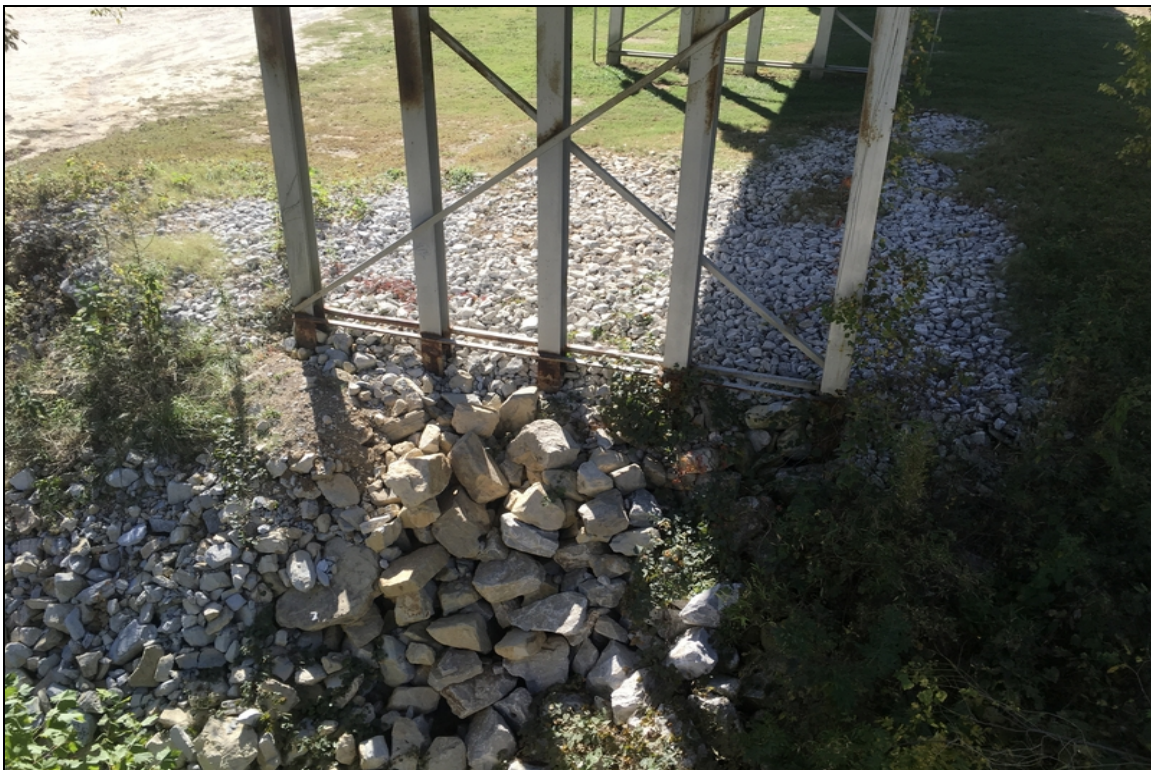
Repaired scour area around steel bent #4 is still holding at the 2020 inspection.

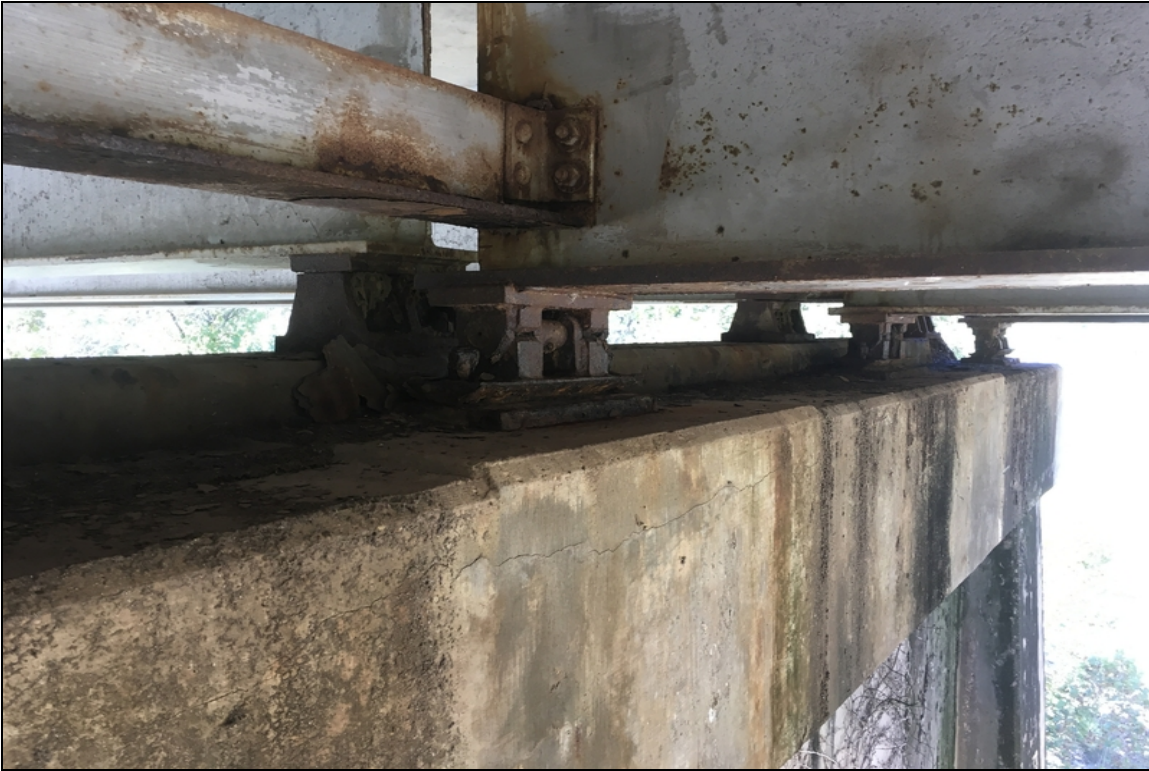
Pier #4 bearing condition. Showing corrosion that has been needle scaled and section loss.

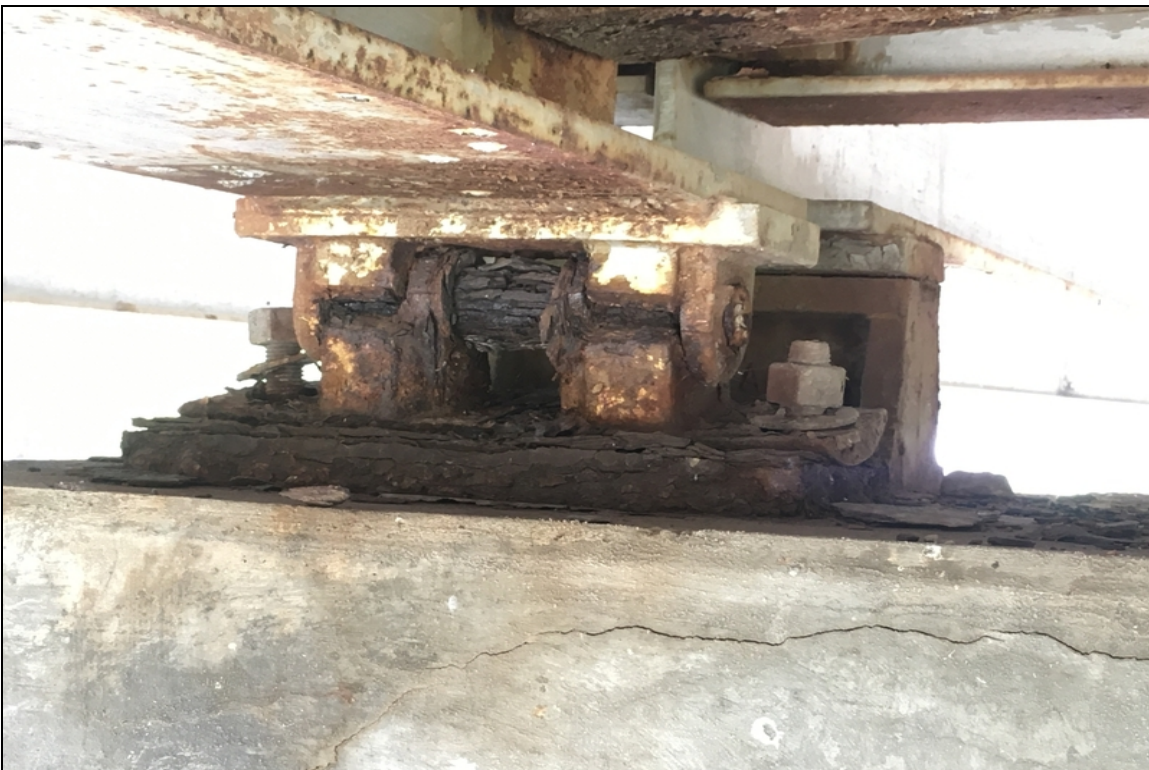
Movable bearing #2 condition over pier #3. Typical also of bearings #3,4 at the same location.

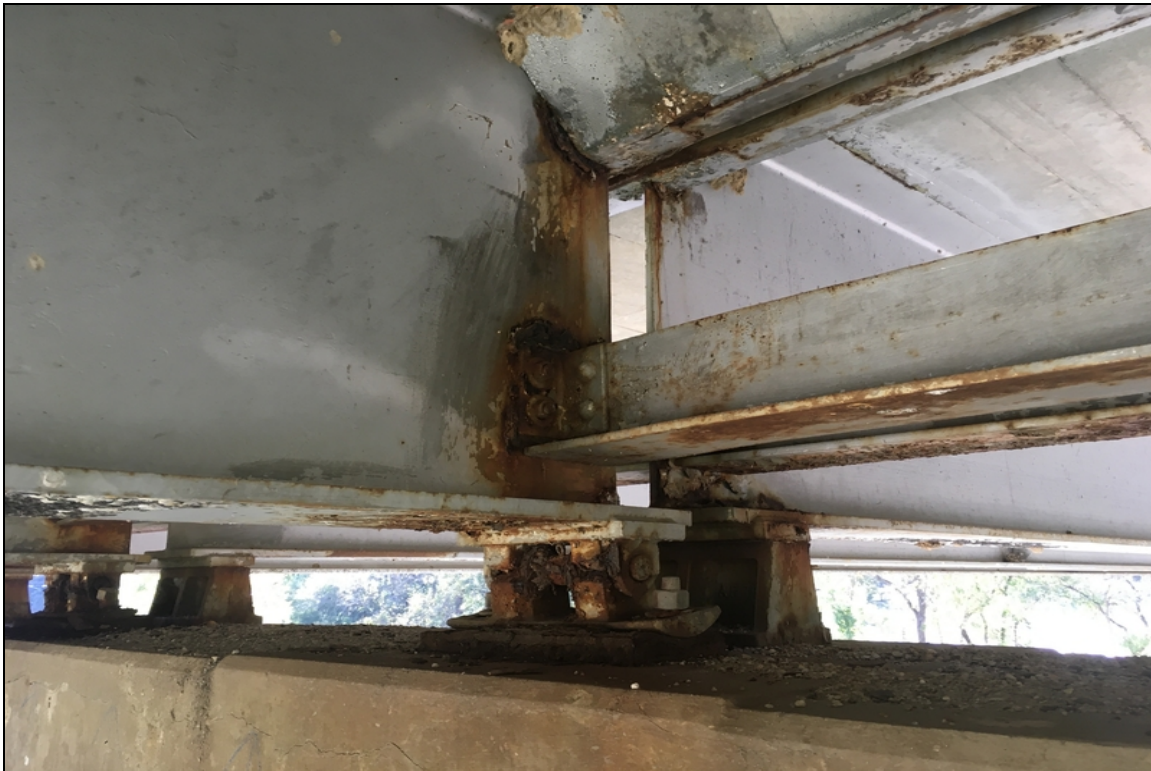
Beam end condition at the end of span #2.

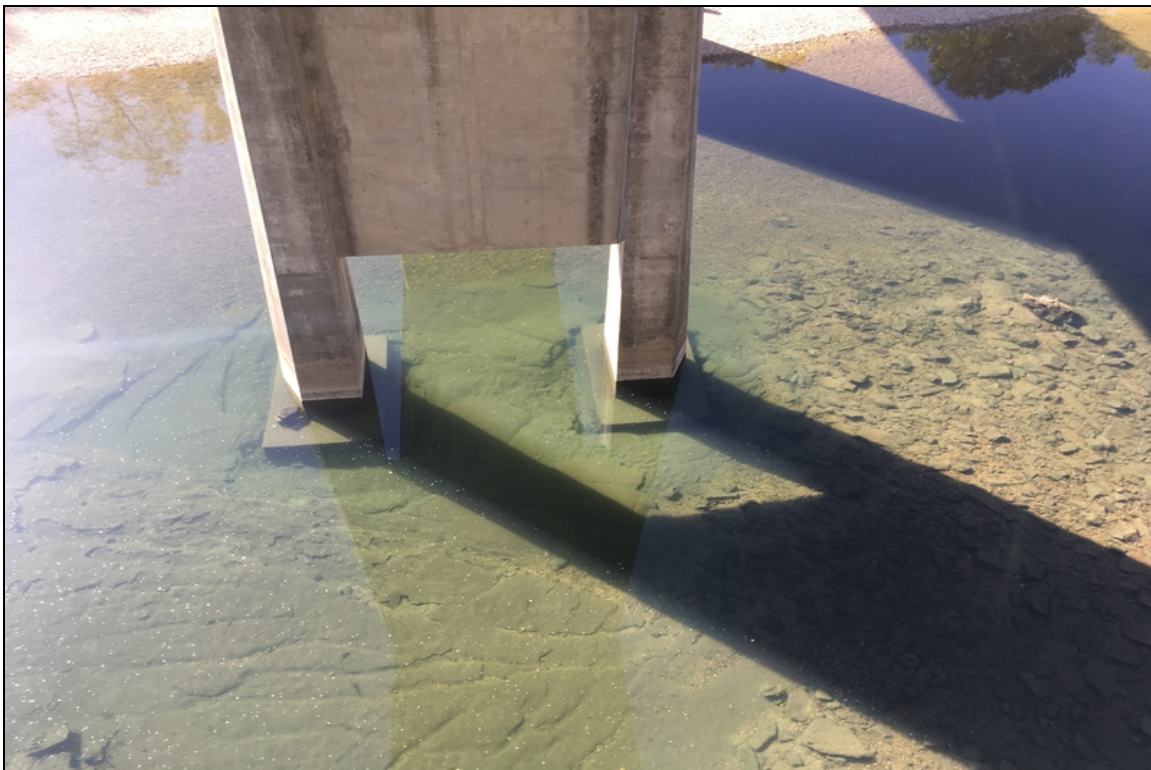
| ELEM | DESCRIPTION | UNITS | TOTAL | CS1 | CS2 | CS3 | CS4 |
|---|---|---|---|---|---|---|---|
| The footings are exposed at both columns of pier 2. The footings are cast in solid rock. | | | | | | | |

Exposed footings at the pier #2 columns.

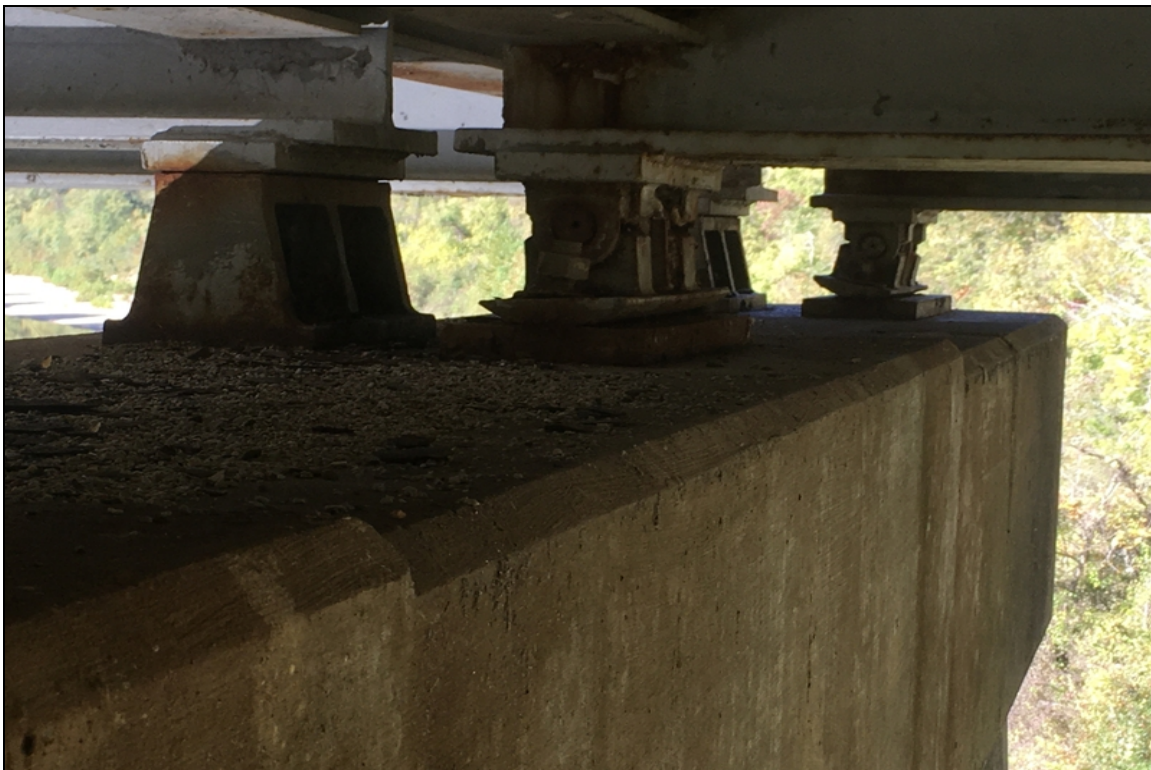
| ELEM | DESCRIPTION | UNITS | TOTAL | CS1 | CS2 | CS3 | CS4 |
|--|---|---|---|---|---|---|---|
| Span #2- The movable bearings #2-4 have heavy corrosion with section loss. Bearings #1,5 are tilted the other bearings are not. | | | | | | | |

Bearing 5 tilt at the end of span #1.

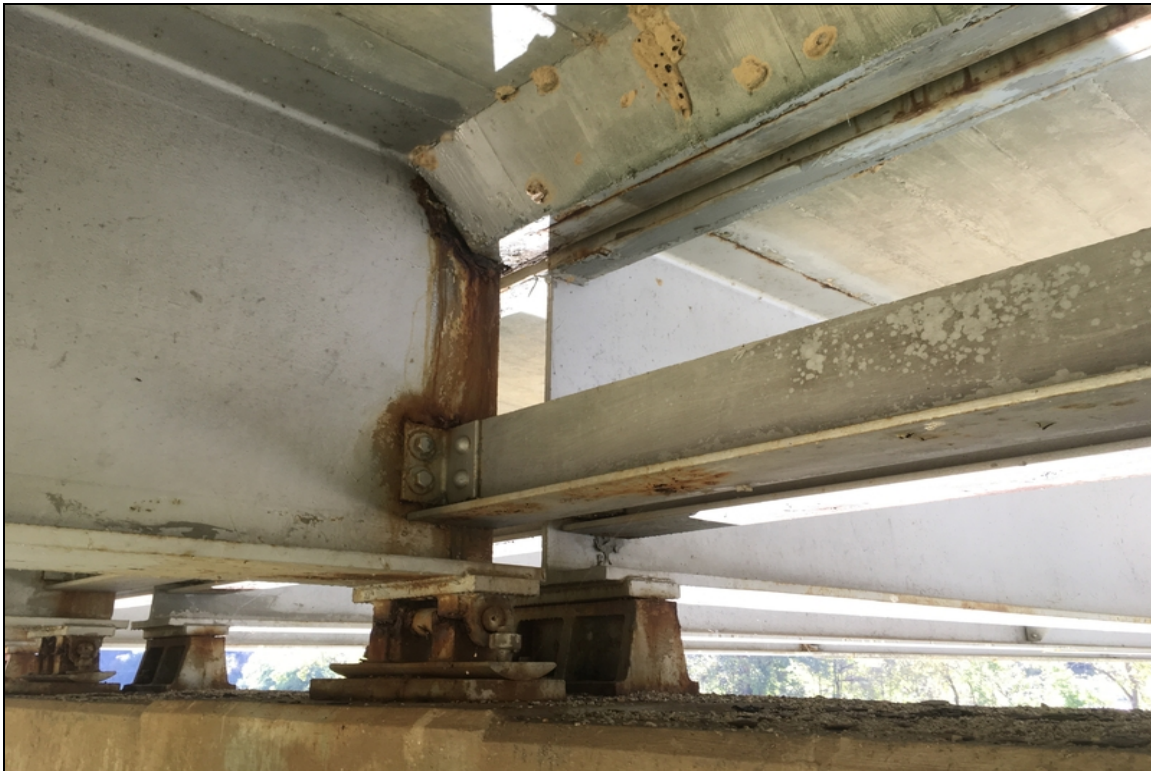
| ELEM | DESCRIPTION | UNITS | TOTAL | CS1 | CS2 | CS3 | CS4 |
|--|---|---|---|---|---|---|---|
| Span #1 movable bearings- all 5 have cs3 corrosion with section loss. | | | | | | | |

Beam end and bearing corrosion at the end of span #1.

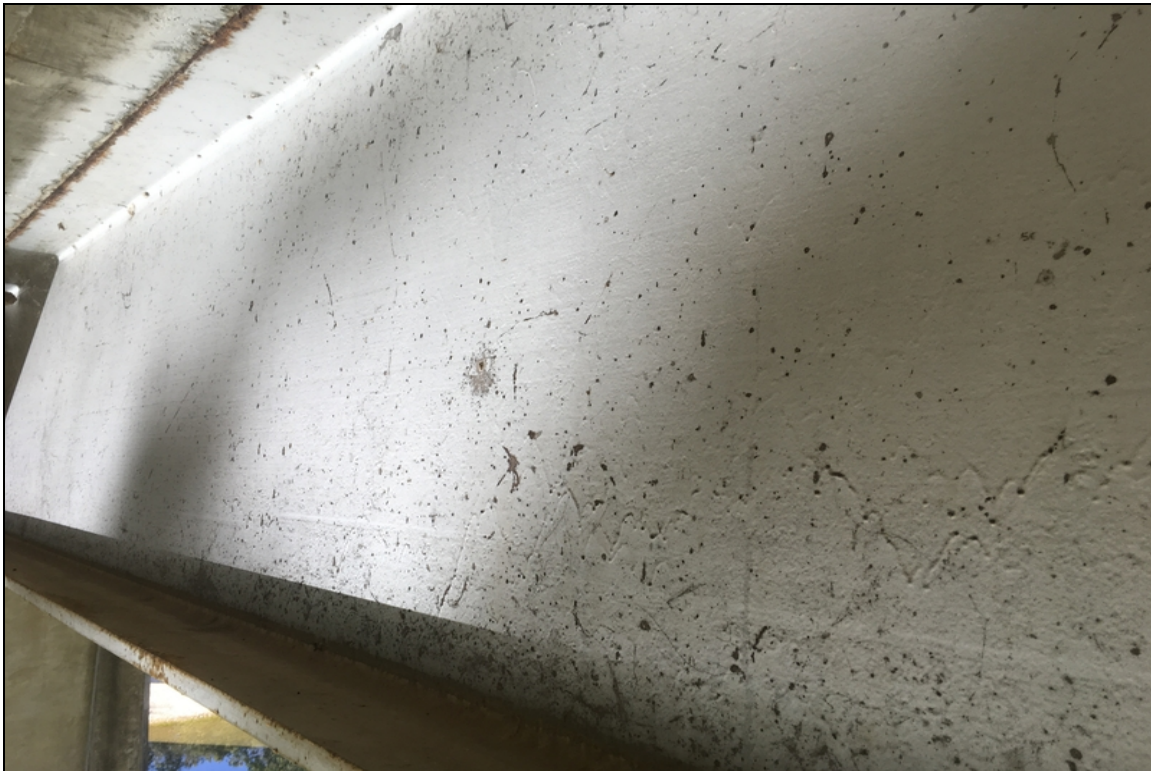
Typical view of the paint condition.

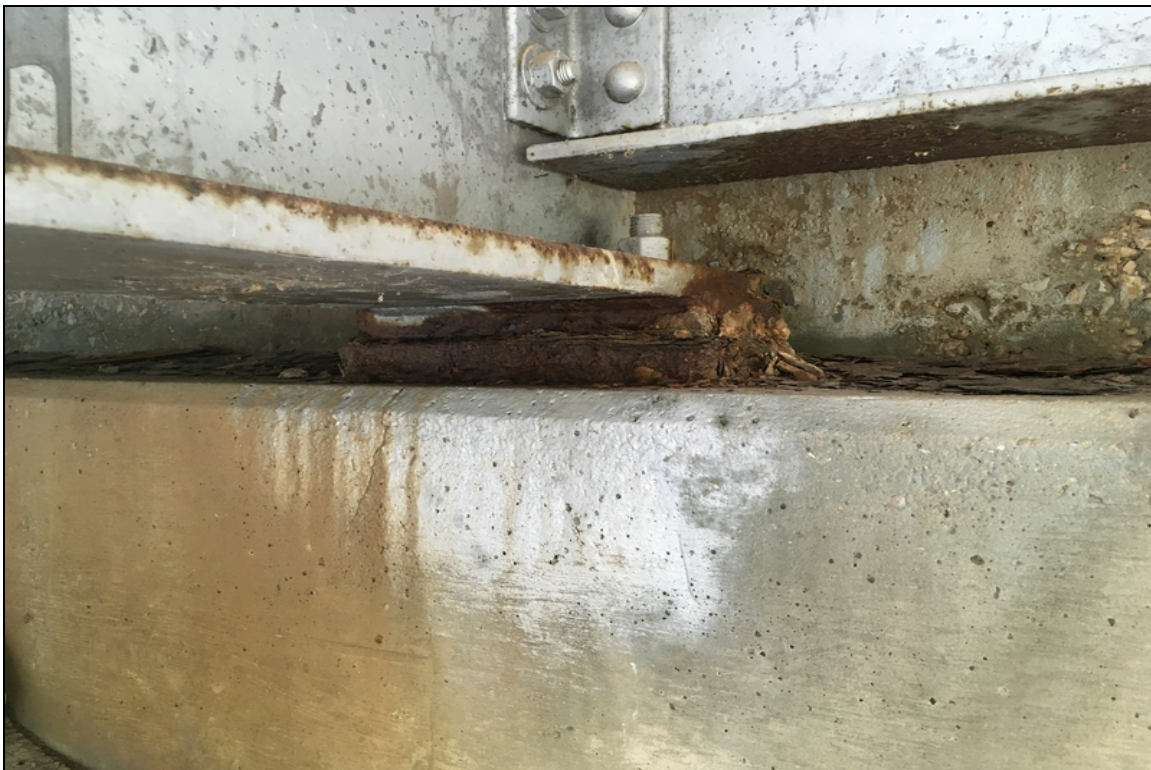
| ELEM | DESCRIPTION | UNITS | TOTAL | CS1 | CS2 | CS3 | CS4 |
|---|---|---|---|---|---|---|---|
| <p>Abutment #1 fixed bearings- all 5 have heavy corrosion with flaking rust, bearing #4 is not corroded as heavily as the other 4.</p> <p>Pier #1 fixed bearings- all 5 have a light rust coating with some flaking rust with a failing paint system.</p> <p>Pier #2 fixed bearings- have general rusting.</p> <p>Pier #3 fixed bearings- have general rusting.</p> <p>Pier #4 fixed bearings- bearing #5 has a spall beneath it that has caused a 2.5" loss of bearing area. All bearings have general rusting at this location.</p> <p>Steel bents #5,6,7 fixed bearings- have general corrosion with flaking rust at the bottom.</p> | | | | | | | |

Abutment #1 bearing corrosion. Typical except bearing #4.

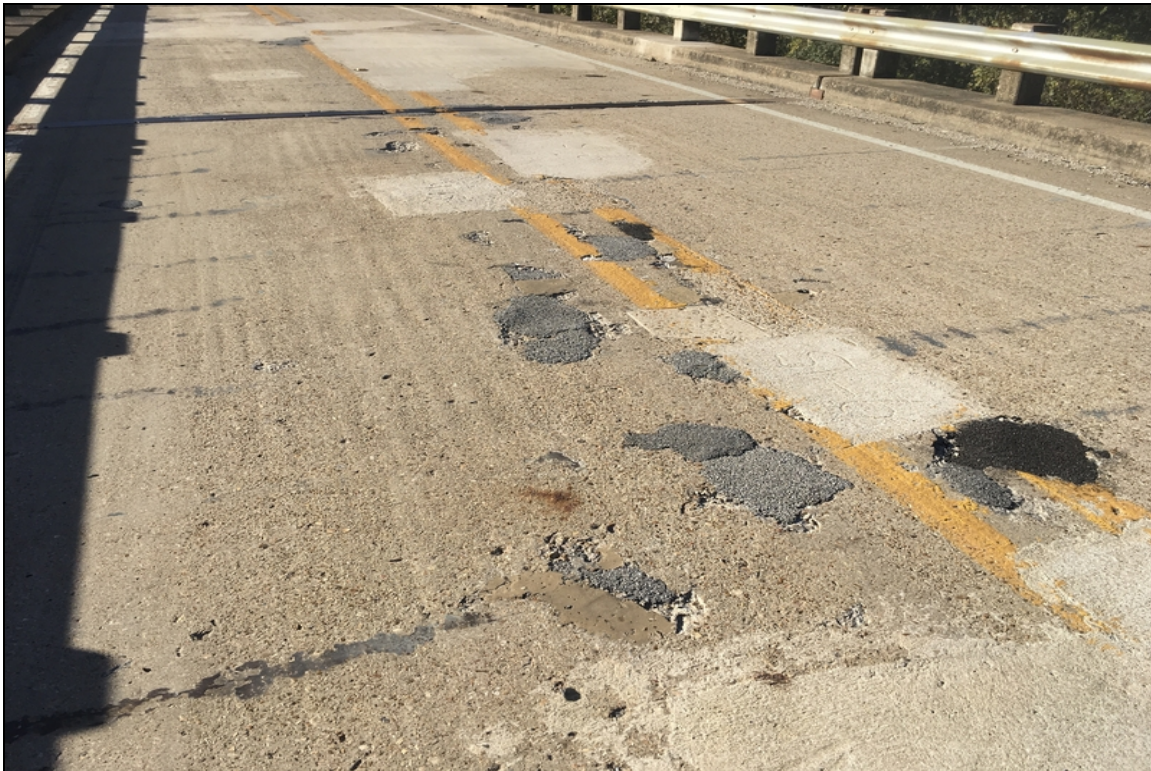
Typical spalling and delamination in the deck near the patched areas.

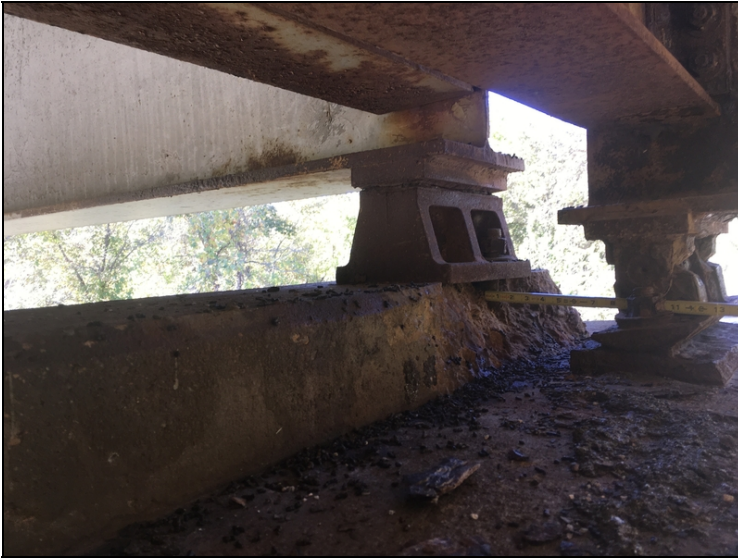
The Pier #4 cap is spalled under the #5 bearing exposing anchor bolts with a 2.5" loss of bearing.

Spalling with a 2.5" loss of bearing area under fixed bearing #5 over pier #4.

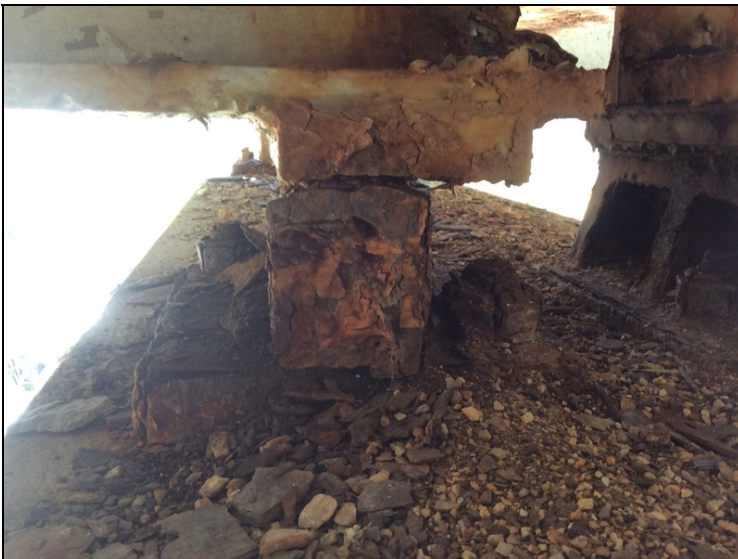
The moveable bearings at bent #5 have heavy pack rust that appears to be restricting movement and causing the bearings to shift out of their intended position. The most notable case is bearing #2 of span #5 over bent #5 which has shifted approximately 1-1/4" out of position.

Bent #5, bearing #2-Out of position.

It was noted during the routine inspection that this areas has been repaired.

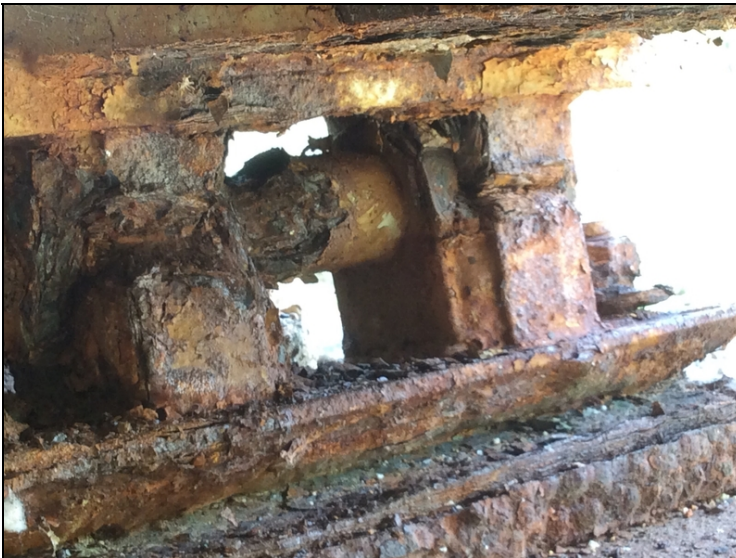
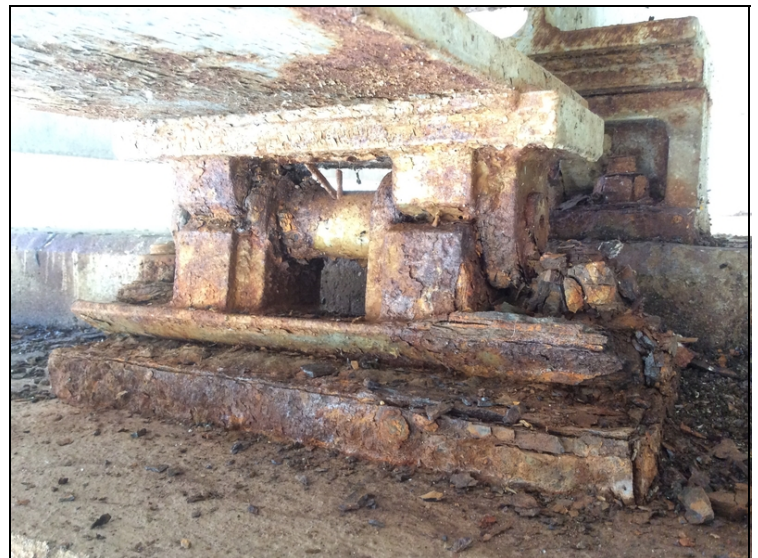
Fixed and moveable bearings have active corrosion with heavy pack rust throughout. Heavy pack rust in the pinned connections and between the rockers and masonry plates is preventing the bearings from expanding and contracting as designed. The moveable bearings over bents #3 and 4 have some bearings that are expanded and some that appear to be contracted indicating that the bearings are "frozen" due to extreme pack rust and are not functioning as intended.

Corrosion to moveable bearings.

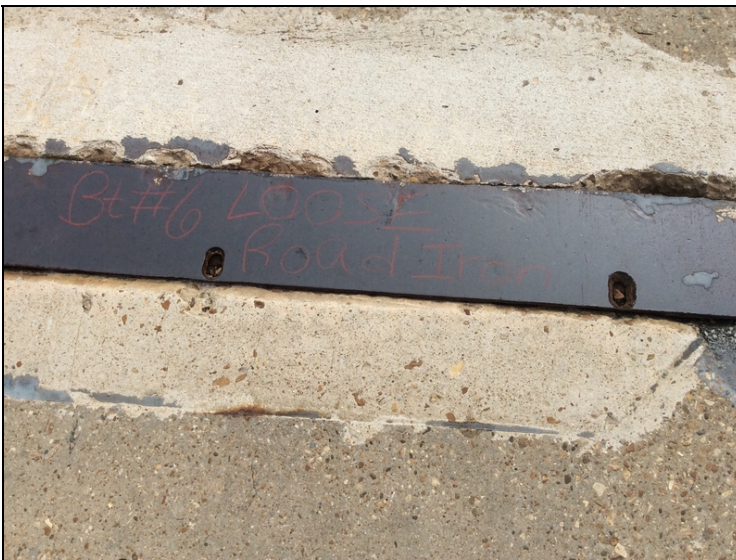
Sliding plate expansion joint assembly at bent # 6 -
Approximately 14' of the sliding plate assembly at bent # 6 has loose anchorage and is noisy when impacted by traffic.

It was noted during the routine inspection that this joint has been replaced by the bridge crew.

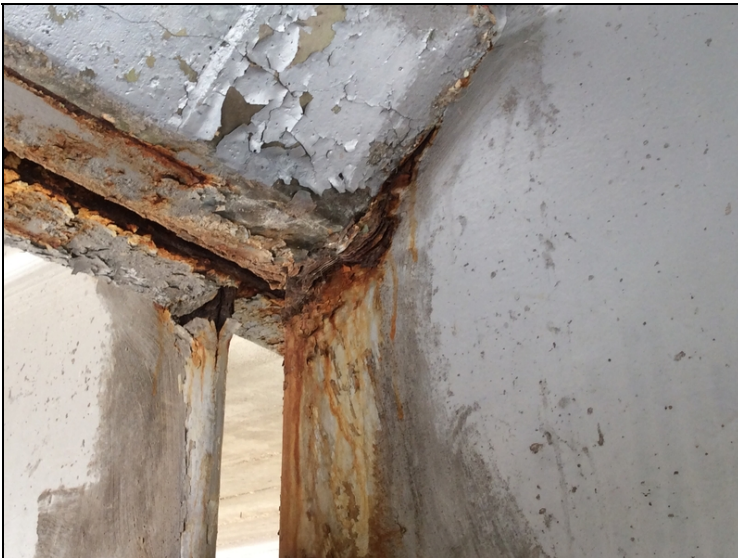
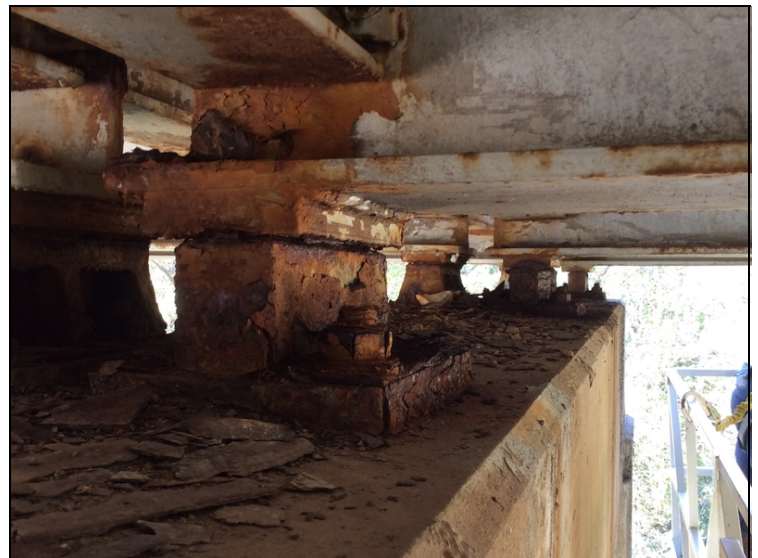
The beams have flaking rust and measurable section loss to the beam ends and to the top flanges where the deck drains and deck joints discharge water onto the beams and in other random locations. The webs of beams have active corrosion with measurable section loss adjacent to the deck haunches.

Corrosion to beam ends and bearing devices.

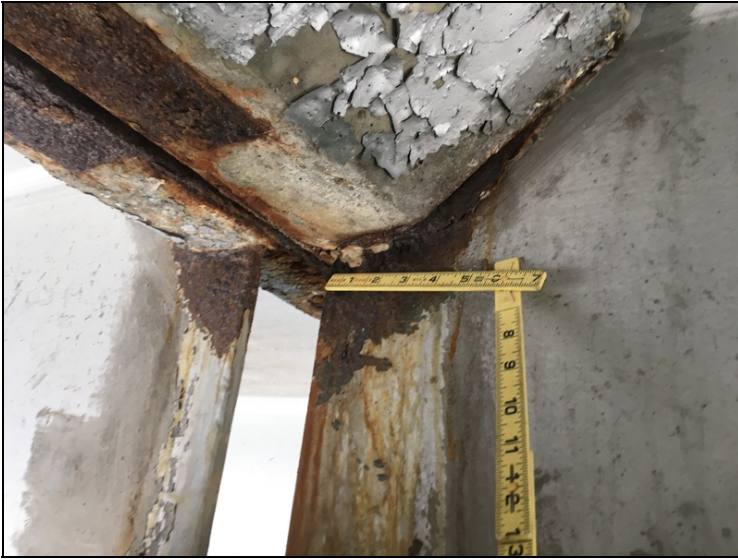
Beam #3 has a 2" rust hole in the extreme upper portion of the web at the end of span #5.

2" rust hole in the upper portion of the web at the end of beam #3 in span #5.

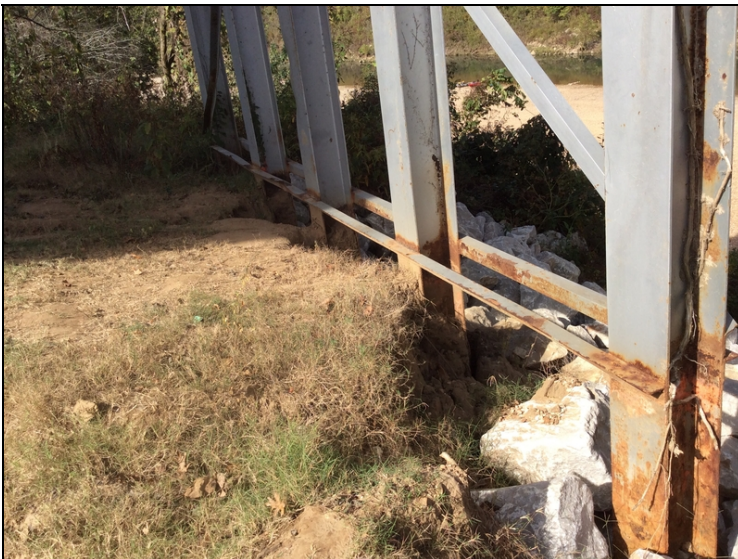
The lower portion of bent #5 steel piling has corrosion with significant section loss to the flanges and moderate pitting with heavy flaking rust to the webs where the piling has been exposed due to erosion from previous high water events. The most notable case is pile #4 which has near knife edged section loss to the flange at ground level for 1'.

General view of erosion to bent #5 piling.

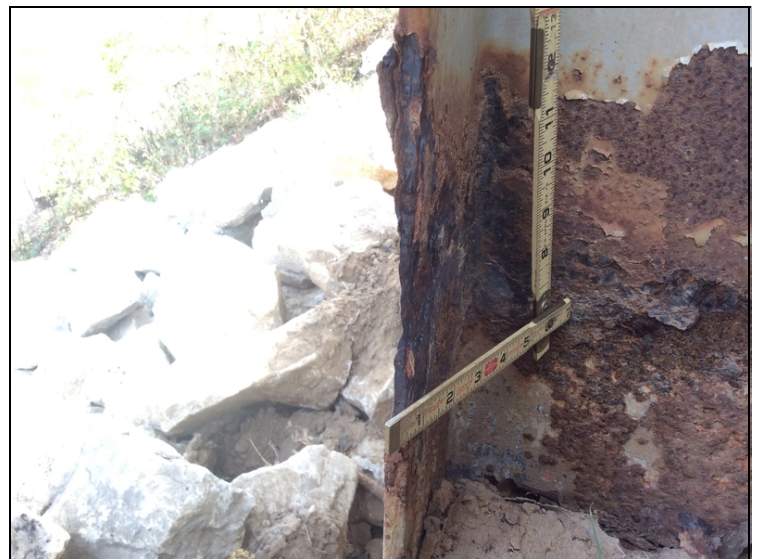
Bent #5, pile #4-Section loss.
