Bridge #03144(Record Change)

SH 14 Marion over TOWN BRANCH

Team Lead: Benjamin Smith Inspection Date: July 22, 2020

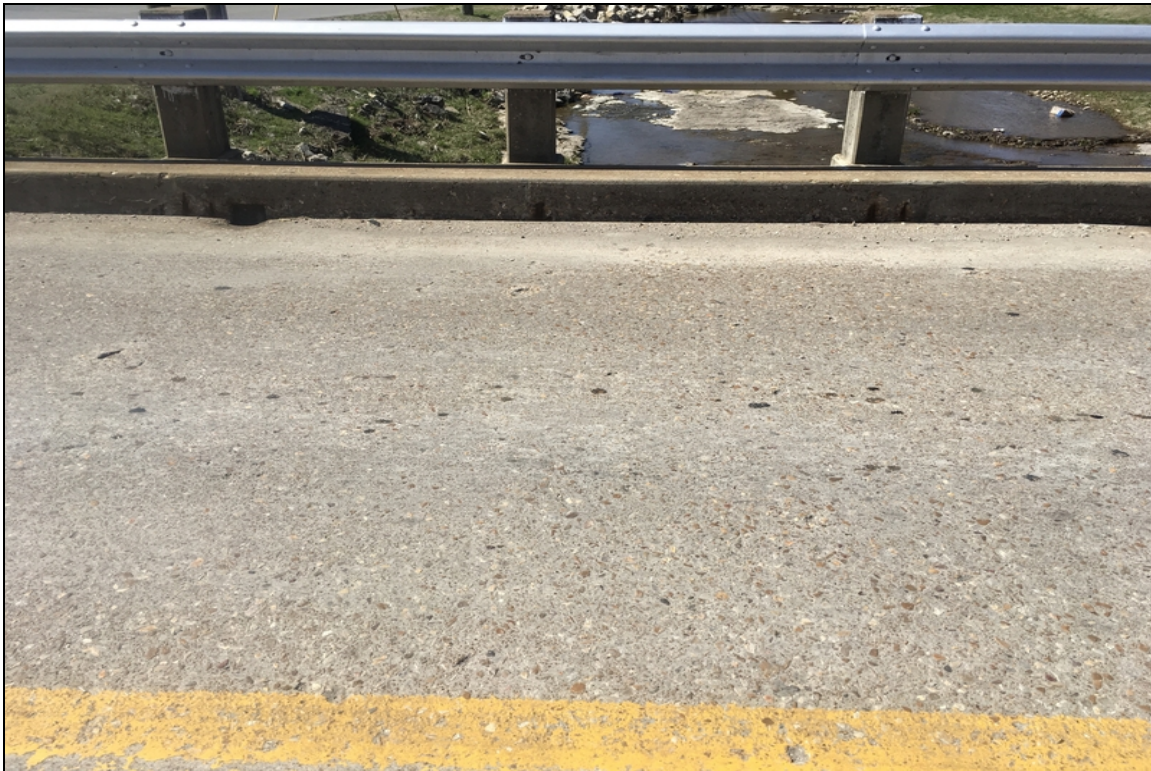
Exposed rebar on the vertical face of the curb.

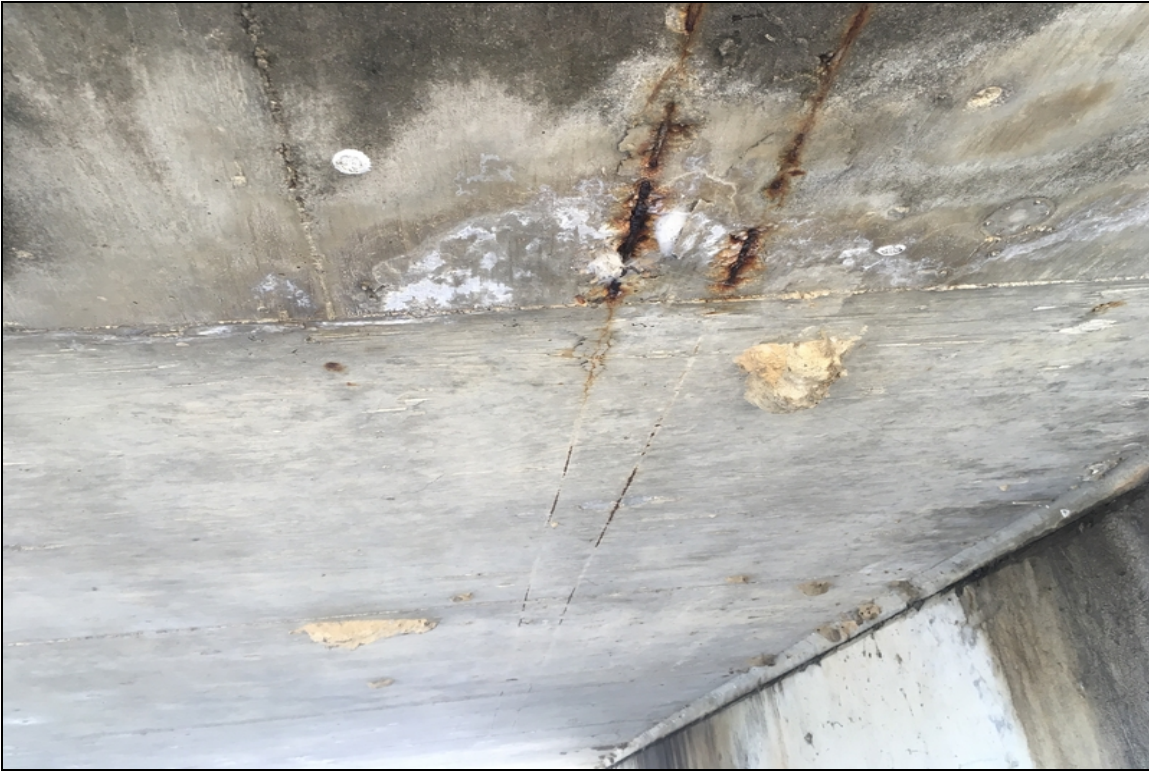
Shallow exposed reinforcing wire in the bottom of the slab. Typical of several locations.

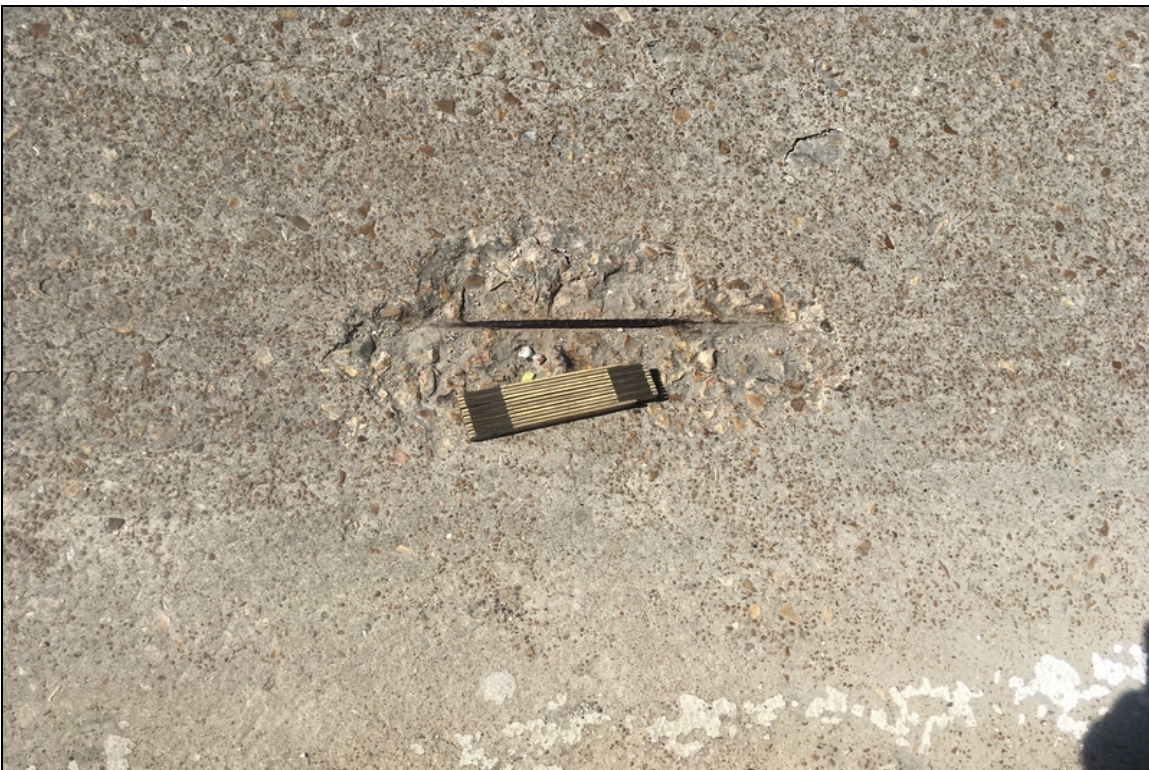
Spall with rebar exposed in left driving lane of span #1.

The driving surface of the deck has spalls with exposed rebar at the left lane of span #1, and in span #4 at the beginning of the span at the centerline and at the right gutter line.

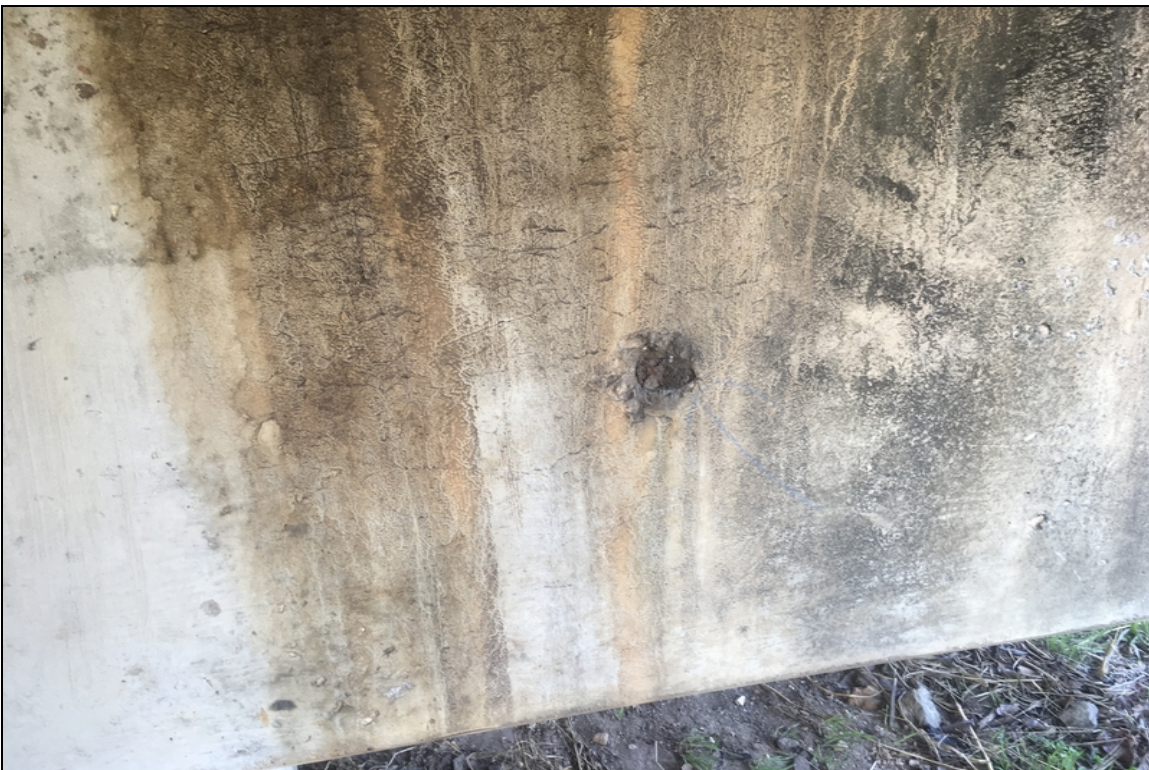
Pop out with rebar exposed. Typical.

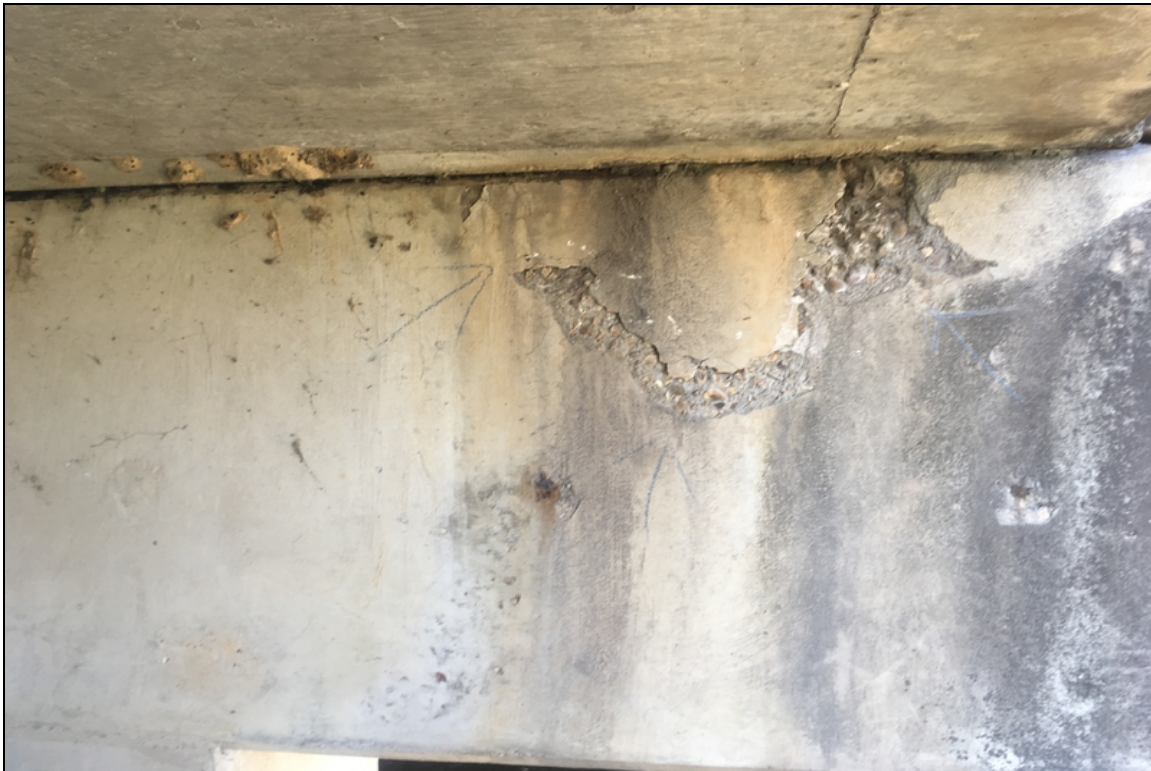
2' area of delamination on the span #4 side of pier cap #3

Pier cap #3 has a 2' delamination at the midsection of the span #3 side, and the near the left end on the span #4 side.

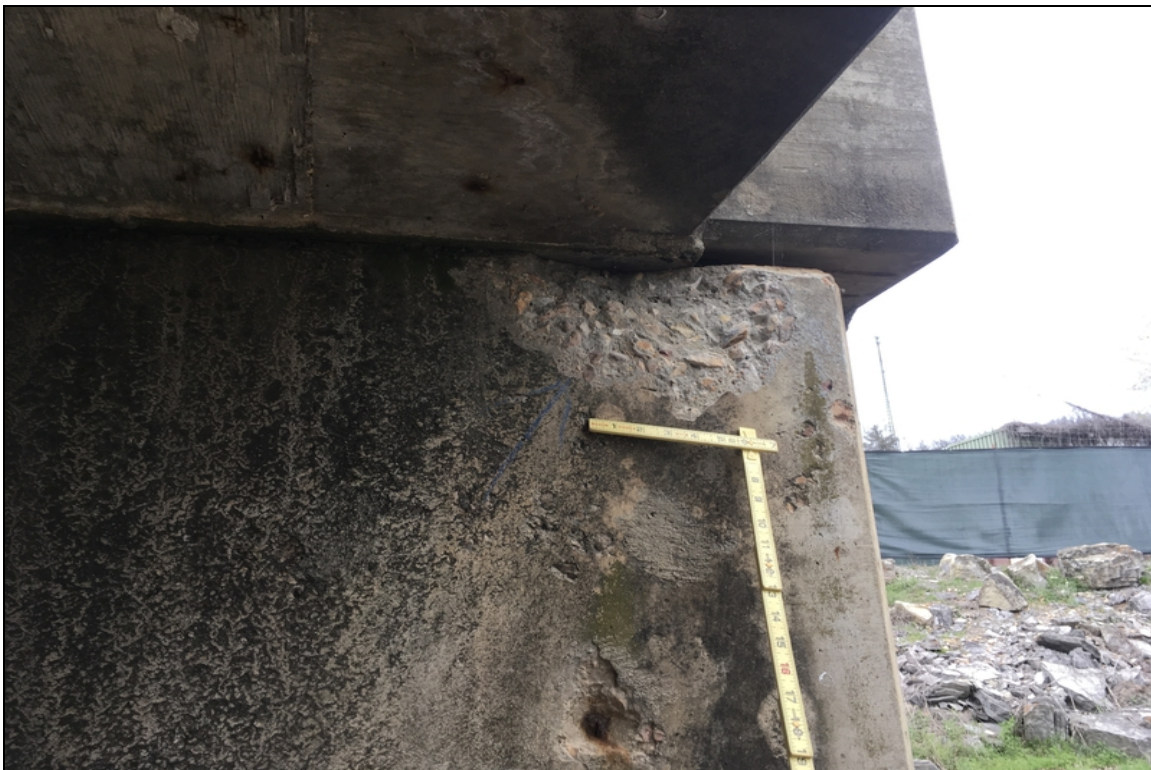
Spall near the left cap end of bent #2 cap on span #3 side.

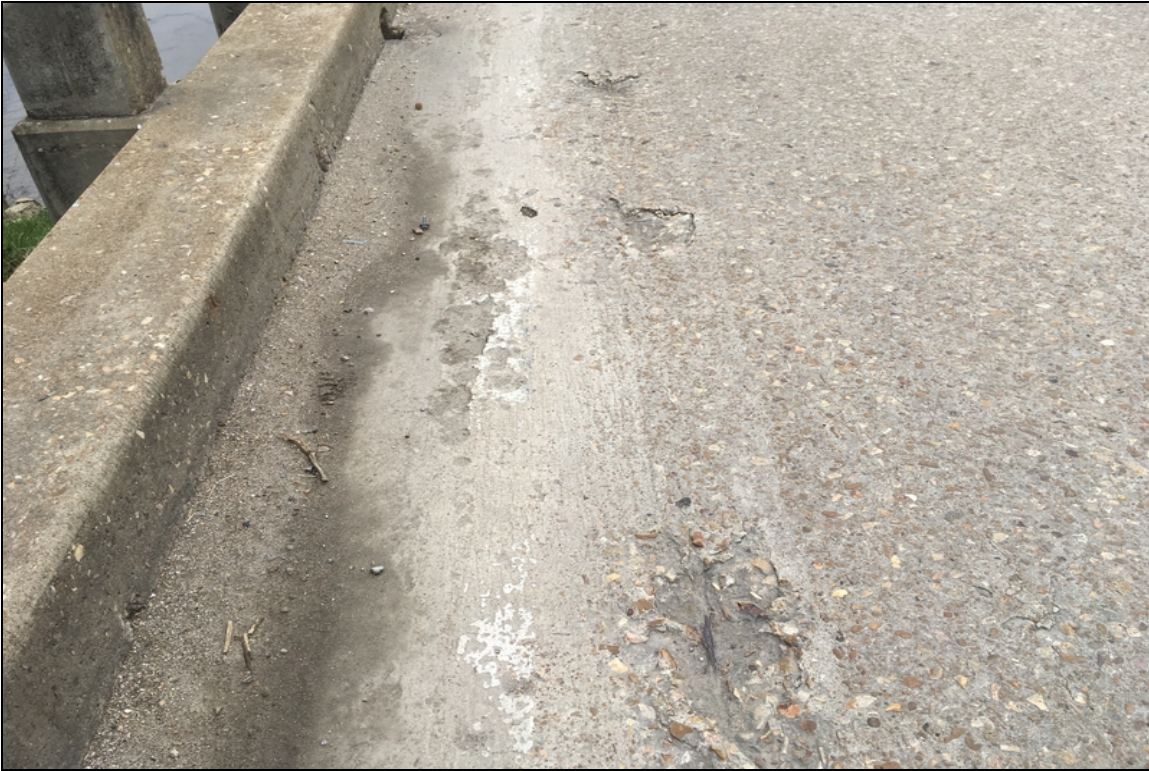
Span #4 has spalling with exposed rebar at the beginning of the span on the center line and at the right gutter line.

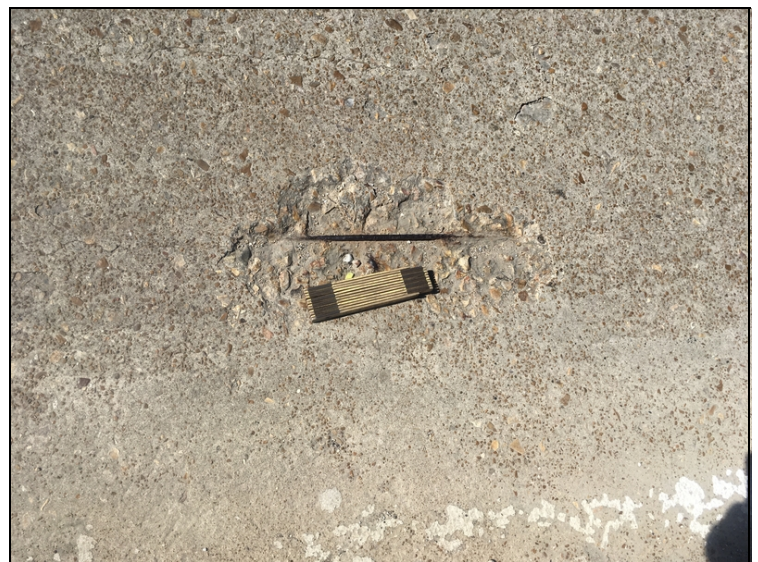
Exposed rebar in span #1 right whiteline
