Bridge #03519(Routine, Underwater type 2)

SH 95 over Caney Creek

Location: .75 M N I-40 Interchange

Team Lead: Kevin Milligan Inspection Date: December 02, 2020

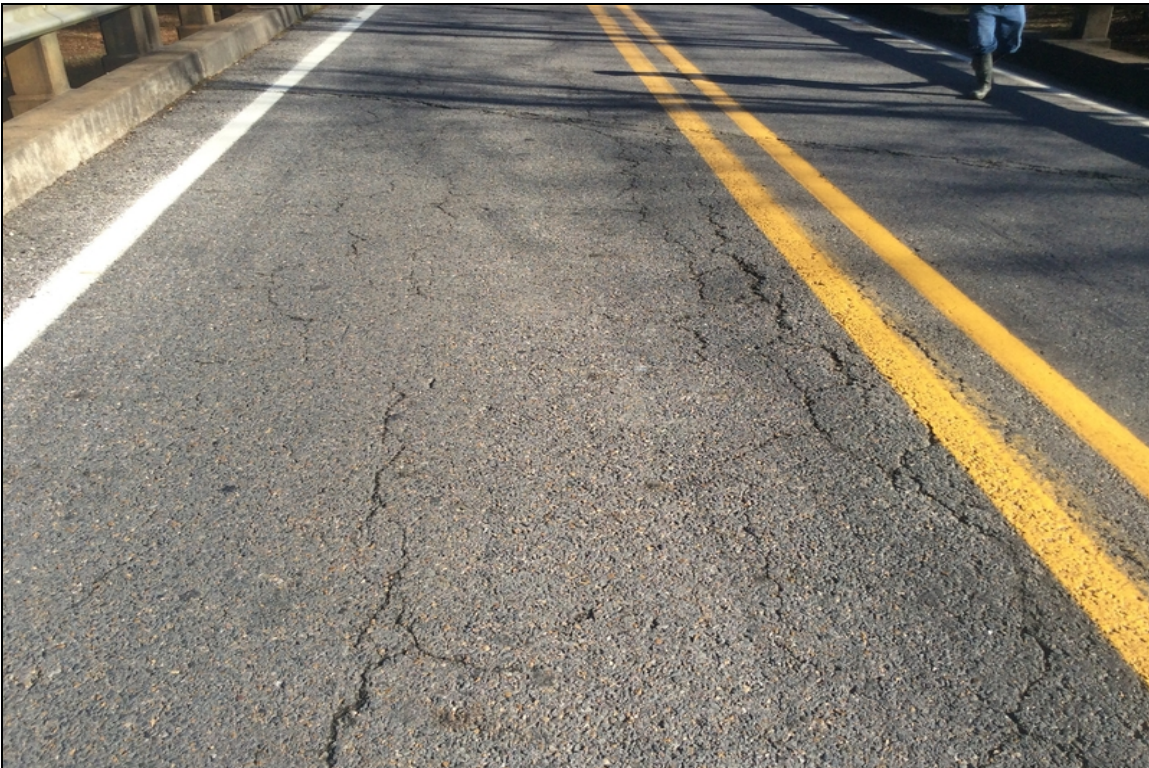
Moderate to large longitudinal cracks in wearing surface throughout.

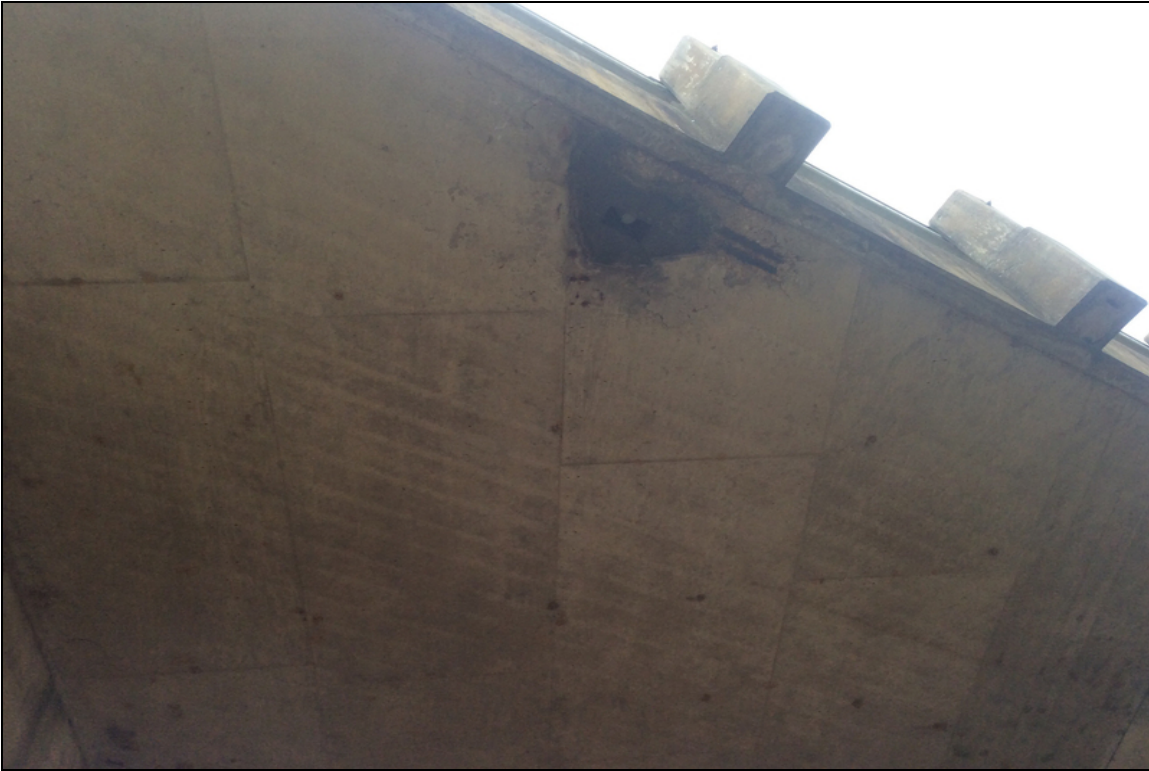
(38)							
12/02/2020 Inspection KRM and MLM Span #4 on the right side has exposed rebar at the drain area. There is one area of minor delam near pier 3 and there are also a couple small spalls with exposed rebar in a few other areas in this span.							
MINOR TO MODERATE CRACKING & MINOR SPALLING IN OVERLAY AT JOINTS. SOFFIT - MINOR CRACKING W / EFFLOR. MINOR TO MODERATE DELAM, CRACKING & SPALLING W / REBAR EXPOSED AROUND DECK DRAIN IN SPAN 4 RT. SIDE.							
(38-510)							
12/02/2020 Inspection KRM and MLM Moderate to large longitudinal cracks in wearing surface throughout.							
205	Reinforced Concrete Column	EA	8	1	5	2	0
1090	Exposed Rebar	EA	4	0	2	2	0
1130	Cracking (RC and Other)	EA	1	0	1	0	0
1190	Abrasion/Wear (PSC/RC)	EA	2	0	2	0	0

Span #4 on the right side has exposed rebar at the drain area.
There are also a couple small spalls with exposed rebar in a few other areas in this span.

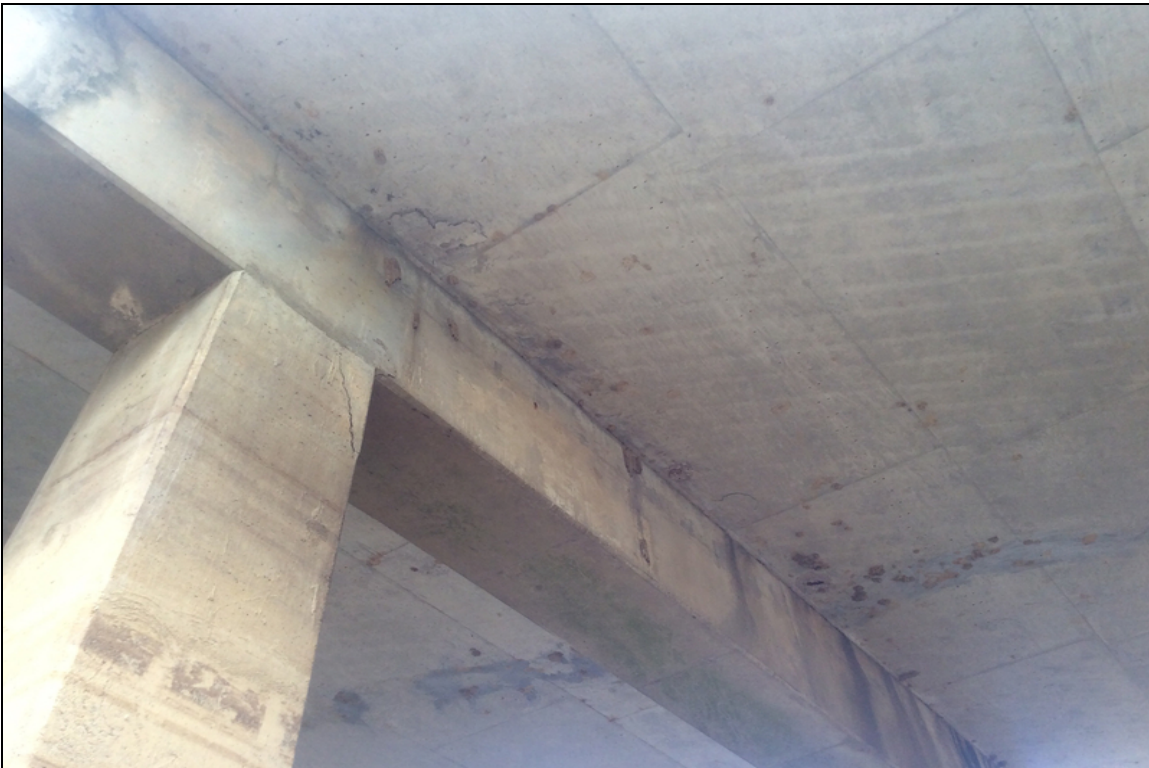
Span #4 has minor delam in the bottom of the slab.

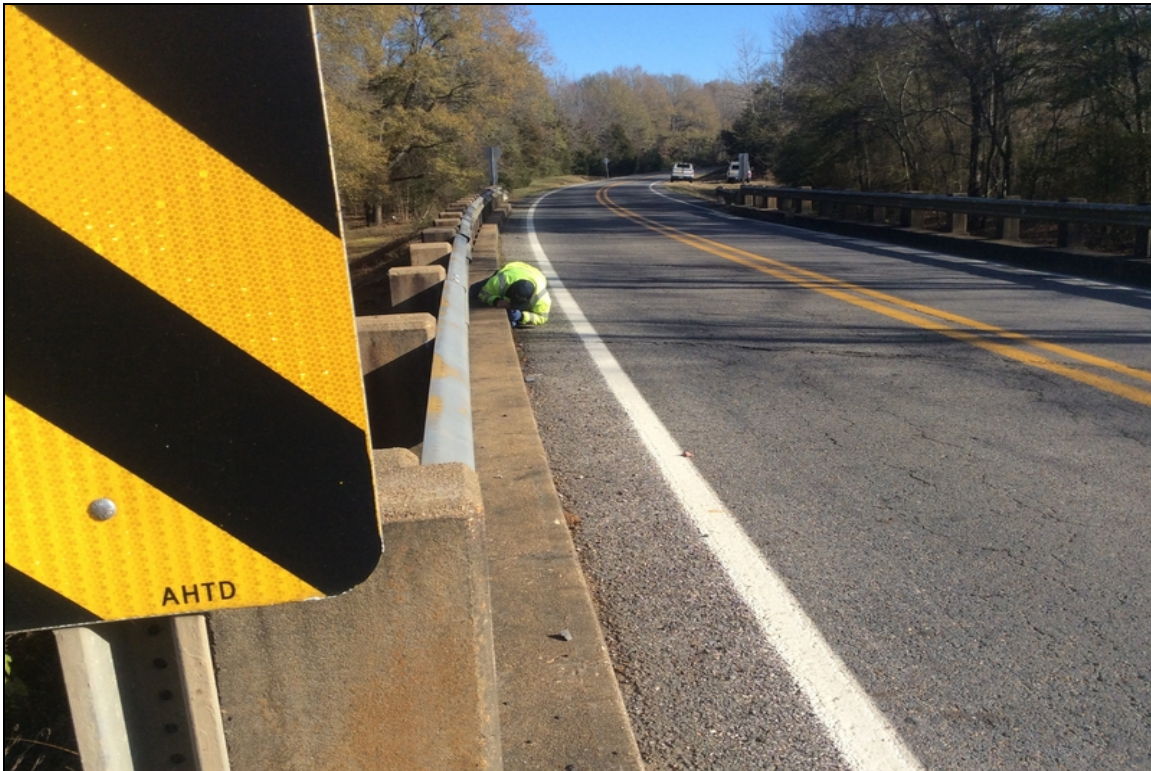
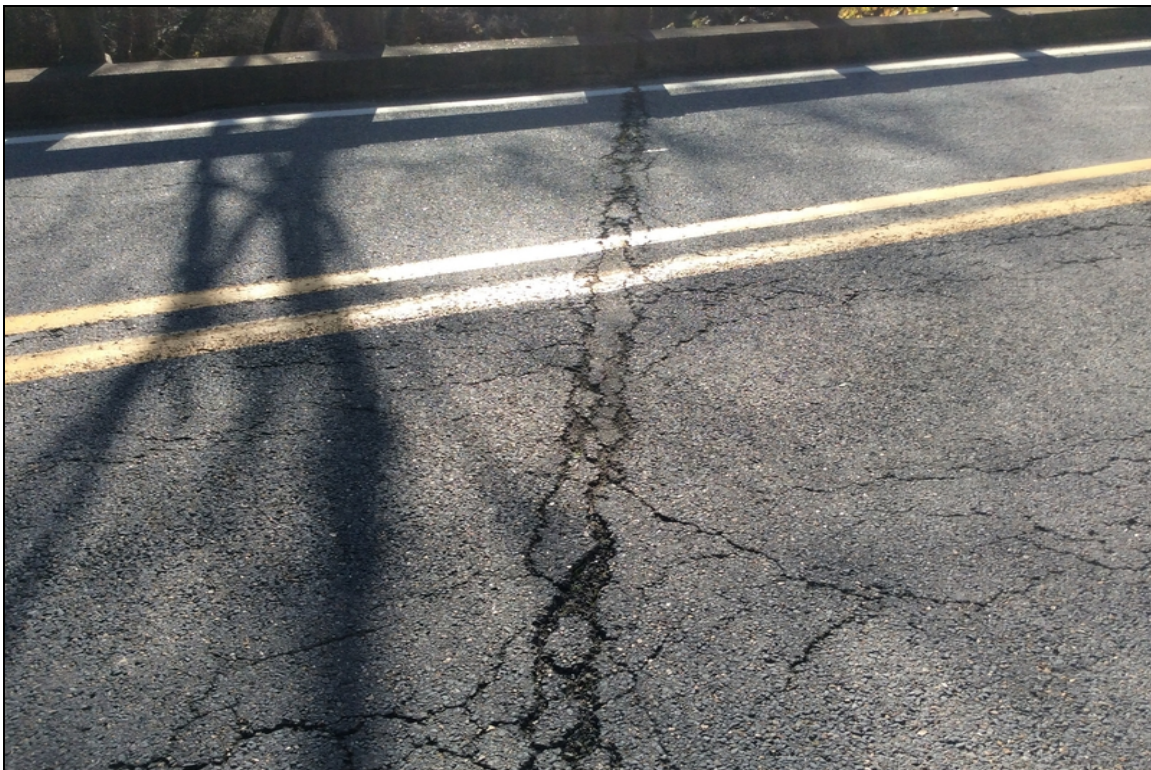
(301)							
12/02/2020 Inspection KRM and MLM Joint #1 has complete debris impaction (asphalt) the full length. All joints are typical.							
330	Metal Bridge Railing	LF	250	170	80	0	0
1000	Corrosion	LF	75	0	75	0	0
7000	Damage	LF	5	0	5	0	0
515	Steel Protective Coating	SF	750	600	100	50	0
3440	Effectiveness (Steel Protective Coatings)	SF	150	0	100	50	0

Joint #1 has complete debris impact (asphalt) the full length.
All joints are typical.

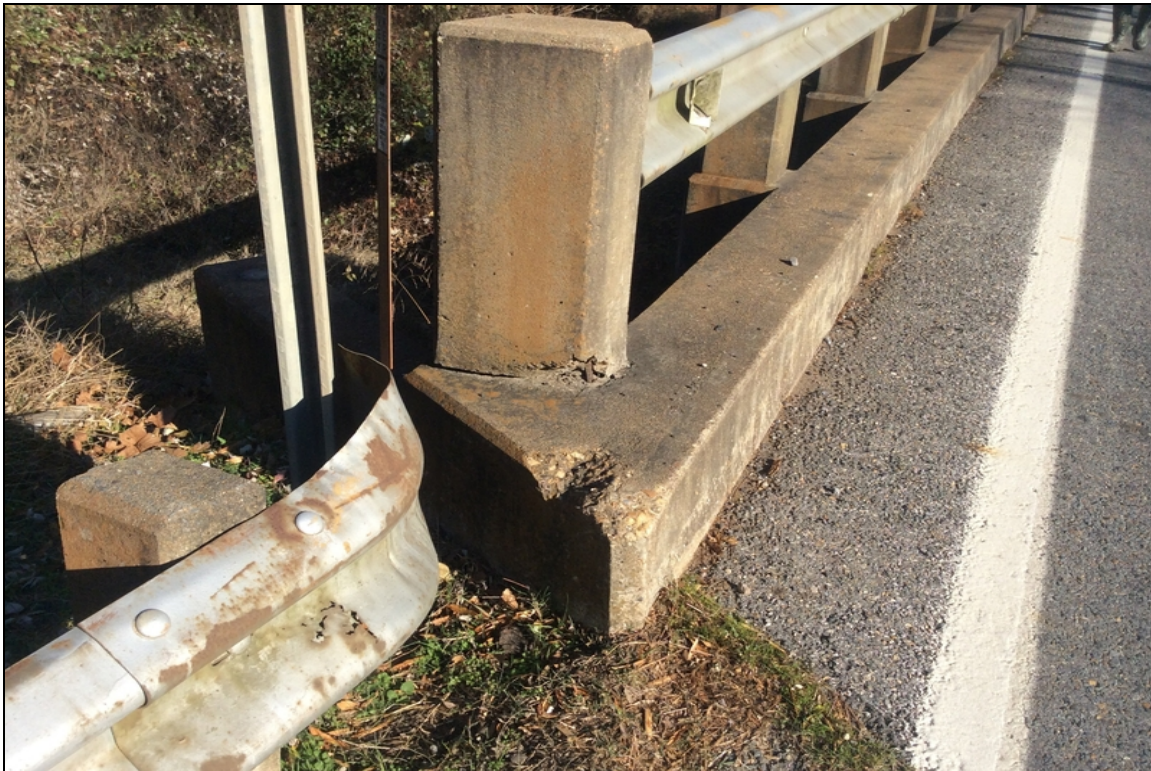
(330)							
12/02/2020 Inspection KRM and MLM Left side post #1 has old impact damage at the bottom of the post.

Left side post #1 has old impact damage.

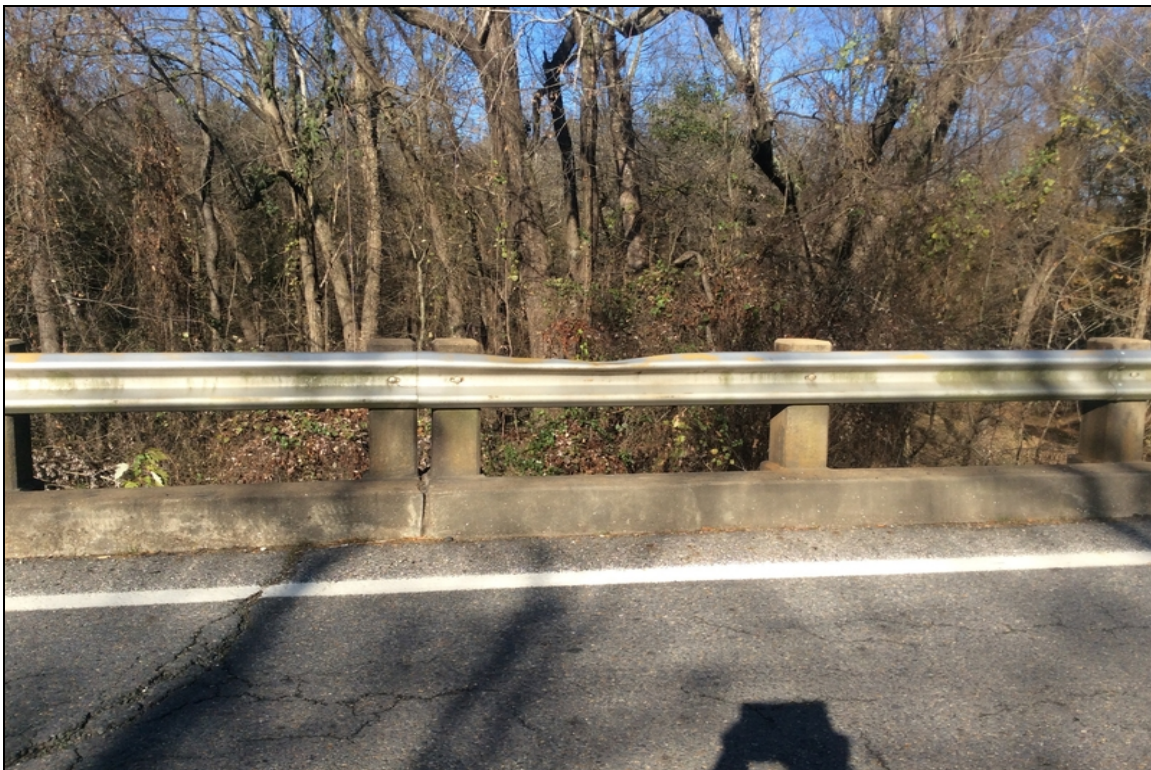
ELEM	DESCRIPTION	UNITS	TOTAL	CS1	CS2	CS3	CS4
	Beginning of span 2 on left side has old rail damage. Minor corrosion throughout rail.						
	MINOR IMPACT DAMAGE TO RAIL & POST AT ABUTMENT 1 LT. SIDE & ABUTMENT 4 RT. SIDE.

Beginning of span 2 on left side has old rail damage.

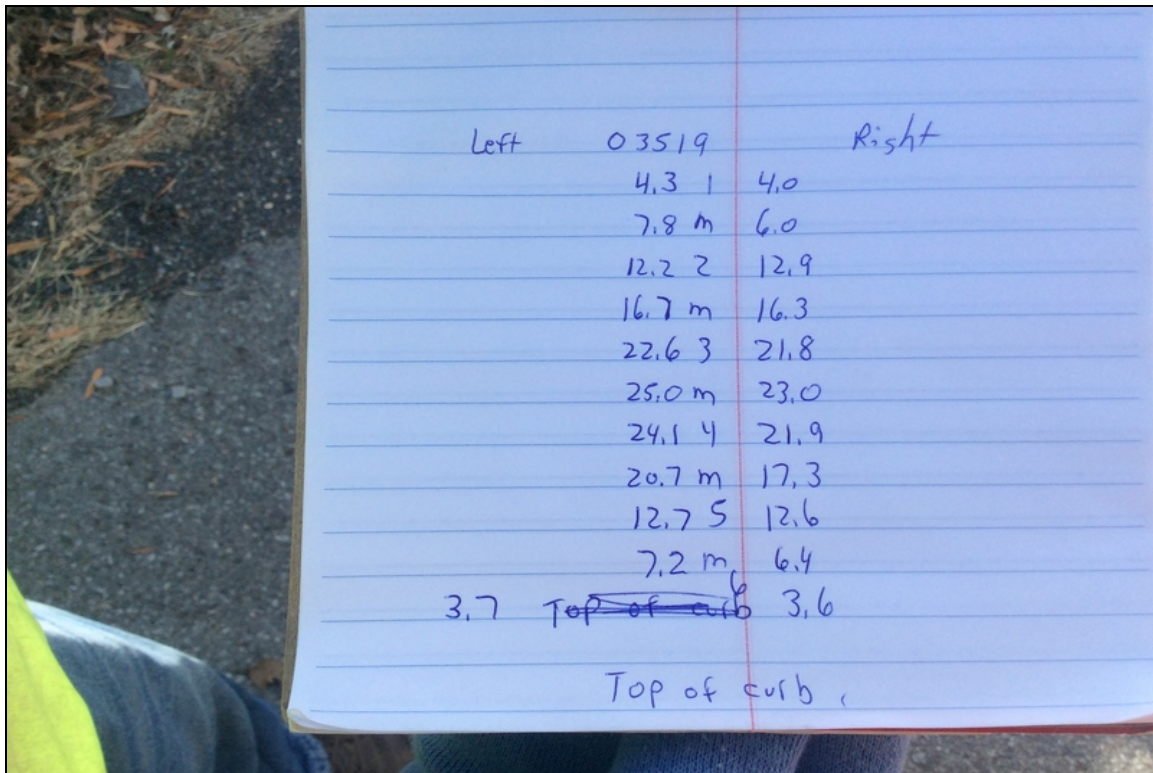
Left	03519	Right
4.3	1	4.0
7.8	m	6.0
12.2	2	12.9
16.7	m	16.3
22.6	3	21.8
25.0	m	23.0
24.1	4	21.9
20.7	m	17.3
12.7	5	12.6
7.2	m	6.4
3.7	Top of curb	3.6
Top of curb

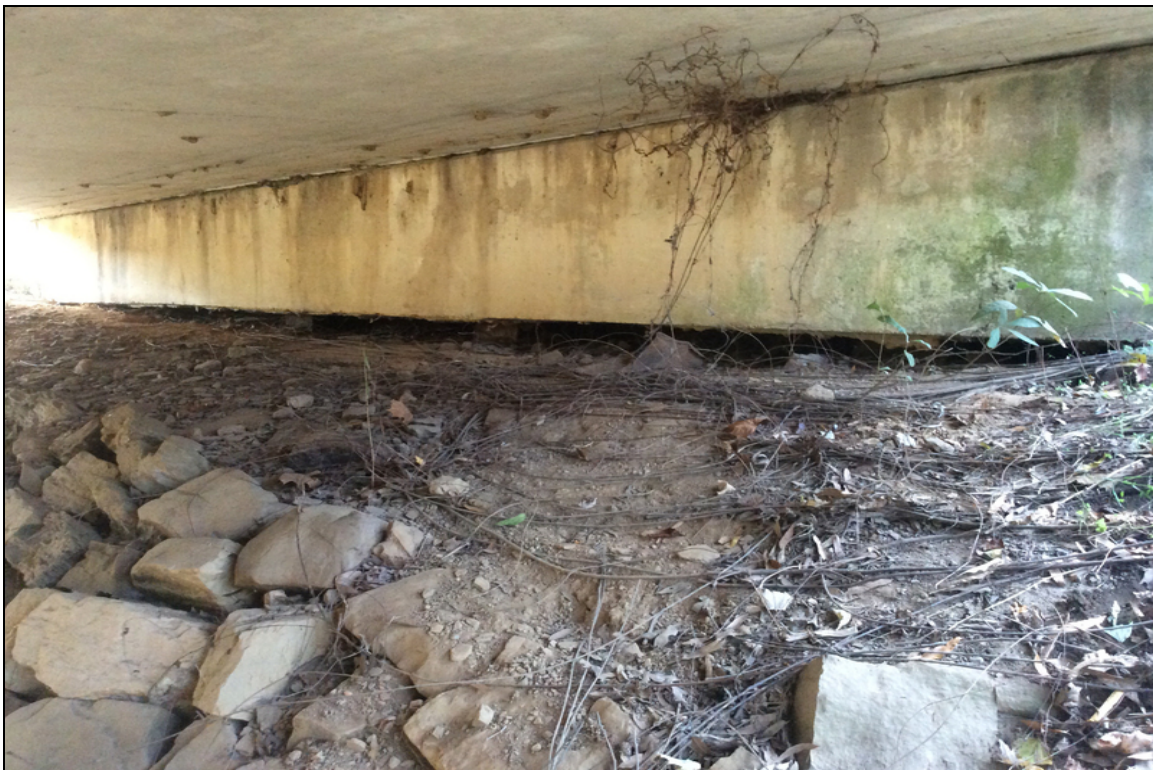
ELEM	DESCRIPTION	UNITS	TOTAL	CS1	CS2	CS3	CS4
Abut.#1 has erosion the full length and steel piles are exposed with very minor section loss.							
MINOR SECTION LOSS ON EXPOSED PILES AT ABUTMENT 1.							
225	Steel Pile	EA	4	0	4	0	0
1000	Corrosion	EA	4	0	4	0	0

Abut.#1 has erosion the full length and steel piles are exposed with very minor section loss.

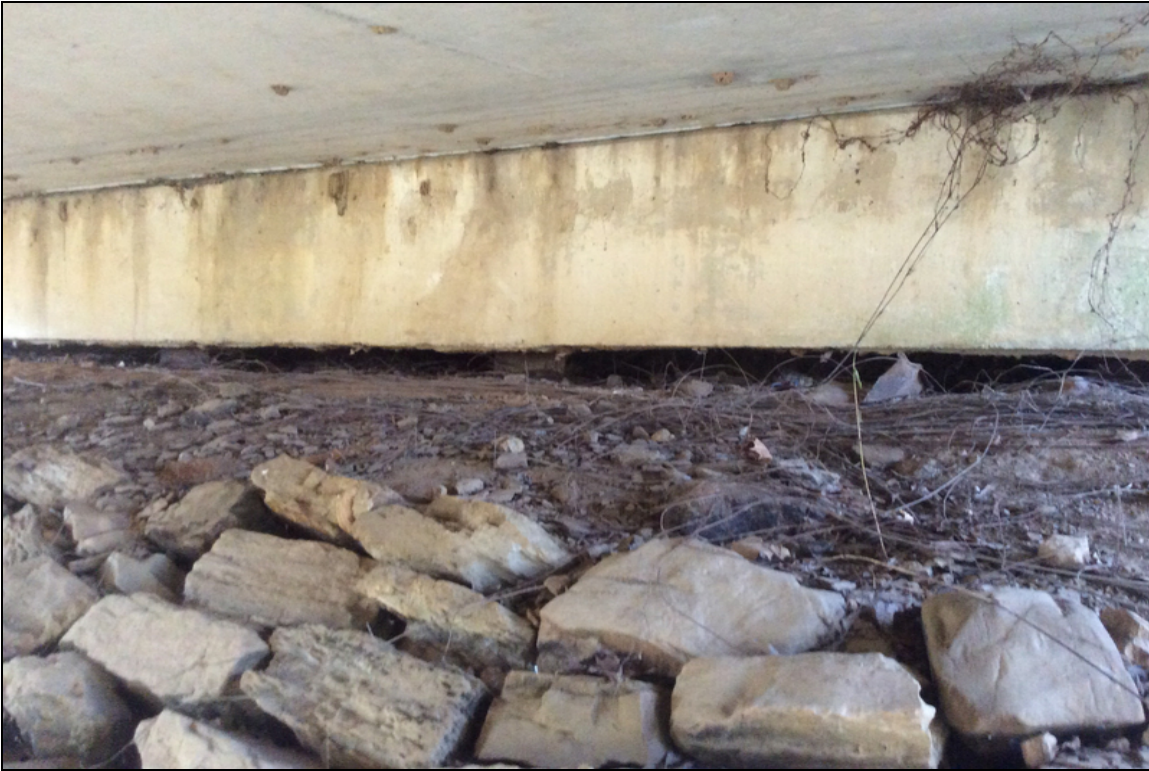
(225)							
12/02/2020 Inspection KRM and MLM Piles are exposed at abutment #1 and have minor corrosion with minor section loss.							
234	Reinforced Concrete Pier Cap	LF	132	118	7	7	0
1080	Delamination/Spall/Patched Area	LF	5	0	5	0	0
1090	Exposed Rebar	LF	7	0	0	7	0
1130	Cracking (RC and Other)	LF	2	0	2	0	0

Piles are exposed at abutment #1 and have minor corrosion with minor section loss.

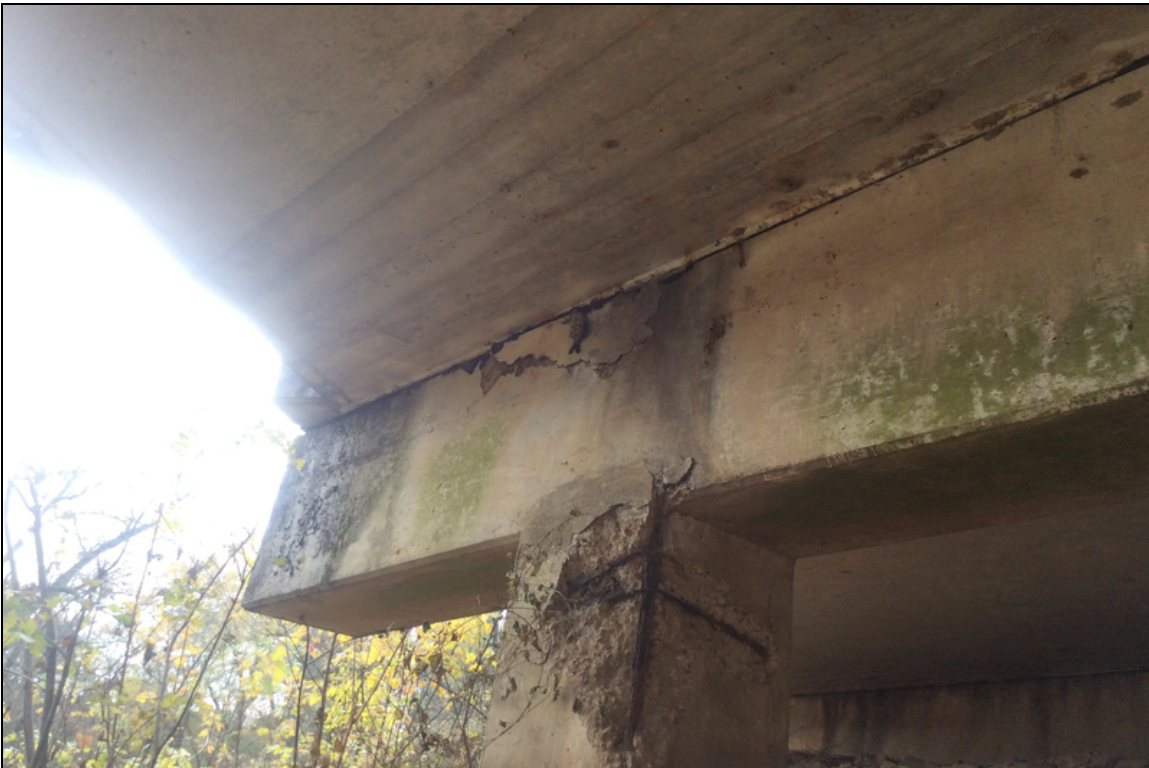
(234)							
12/02/2020 Inspection KRM and MLM A few minor cracks in a couple places on pier caps. Right ahead side of pier #2 has moderate delam above column #2. Pier #4 left ahead side has exposed rebar due to being to close to the surface.							
COND. 1 - 100 LF - GOOD COND. 2 - 22 LF - MINOR TO MODERATE DELAM & CRACKING AT VARIOUS LOCATIONS THROUGHOUT CAPS. MODERATE CRACK IN CAP 2 AHD FACE ABOVE COLUMN 2. COND. 3 - 10 LF - MINOR TO MODERATE DELAM, CRACKING & SPALLING W / REBAR EXPOSED IN LT & RT ENDS OF CAPS 4 (AHD FACE) & RT END OF 5 (BK FACE).							
301	Pourable Joint Seal	LF	111	0	0	111	0
2350	Debris Impaction	LF	111	0	0	111	0

Right ahead side of pier #2 has moderate delam above column #2.

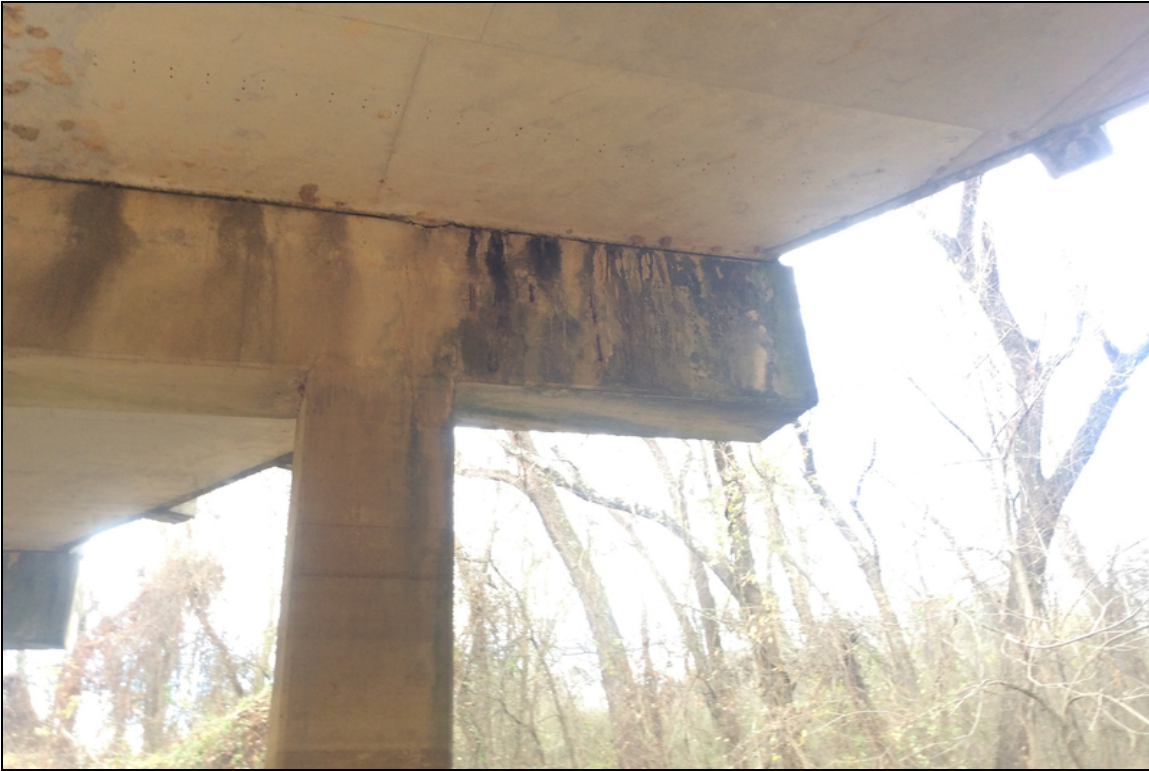
Pier #4 left ahead side has exposed rebar due to being too close to the surface.

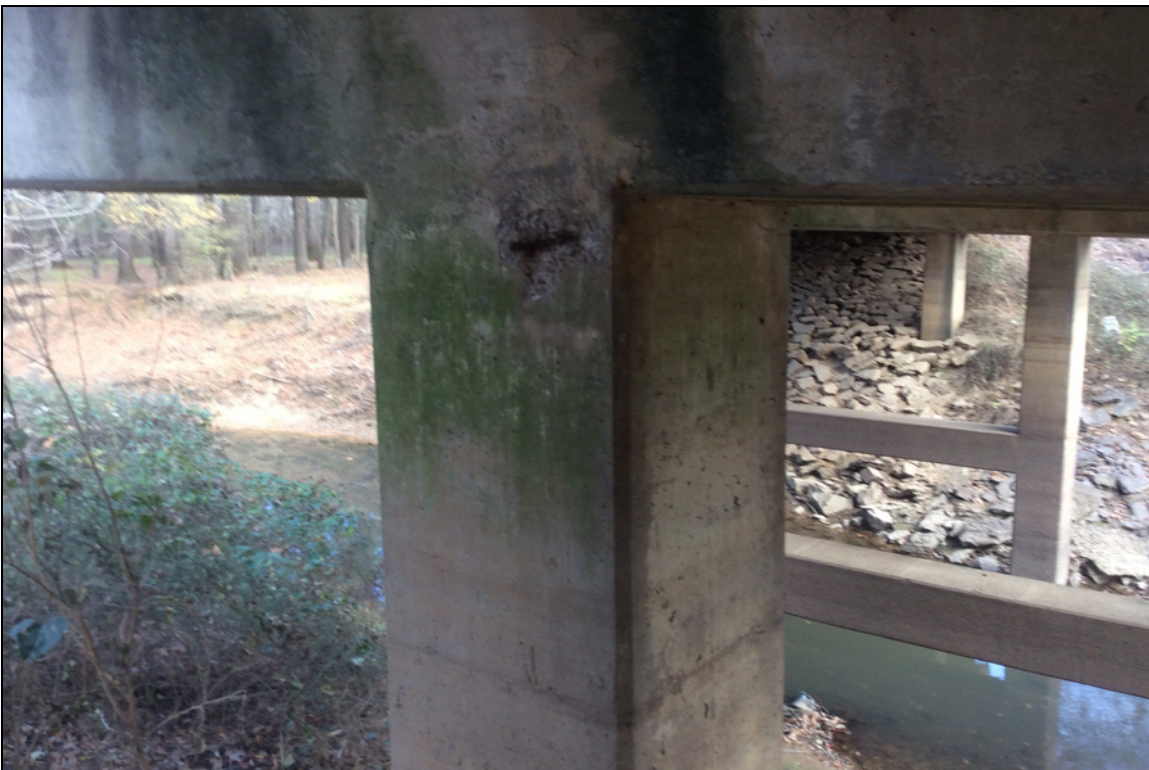
Col. #1 at pier #2 backside

(205)							
12/02/2020 Inspection KRM and MLM Pier #2, back side, column #1 has a minor spall with exposed rebar. Pier #2, ahead side, column #2 has some large spalls and rear exposed with moderate section loss. Columns at piers 3 and 4 have moderate abrasion below the R/C pier walls and a few small areas of exposed rebar due to being to close to the surface.							
COND. 1 - 4 EA - GOOD COND. 2 - 1 EA - MINOR TO MODERATE CRACKING IN COLUMN 2 AT PIER 4. COND. 3 - 3 EA - MINOR TO MODERATE DELAM, CRACKING & SPALLING W / REBAR EXPOSED IN COLUMNS 1 & 2 AT PIER 2 & COLUMN 1 AT PIER 4 AHD SIDE.							
210	Reinforced Concrete Pier Wall	LF	32	32	0	0	0
215	Reinforced Concrete Abutment	LF	83	83	0	0	0

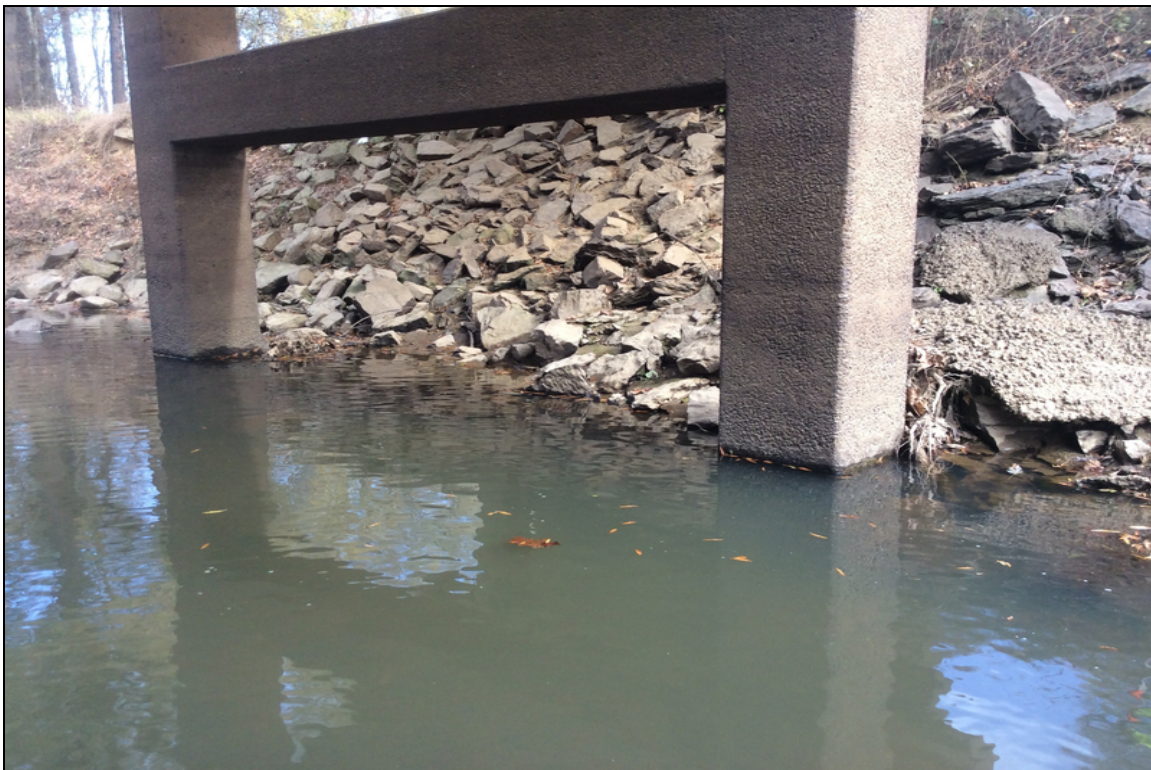
Columns at piers 3 and 4 has moderate abrasion below the R/C pier walls.

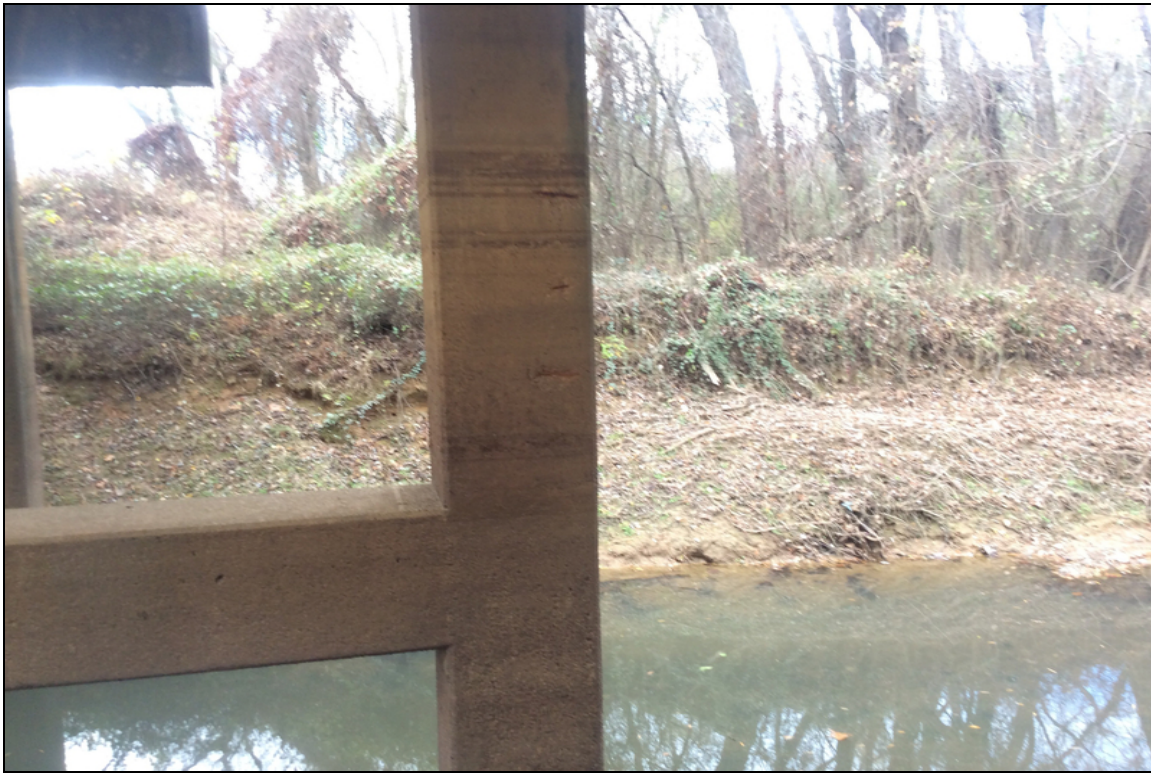
Columns 3 and 4 have a few small areas of exposed rebar due to being too close to the surface.

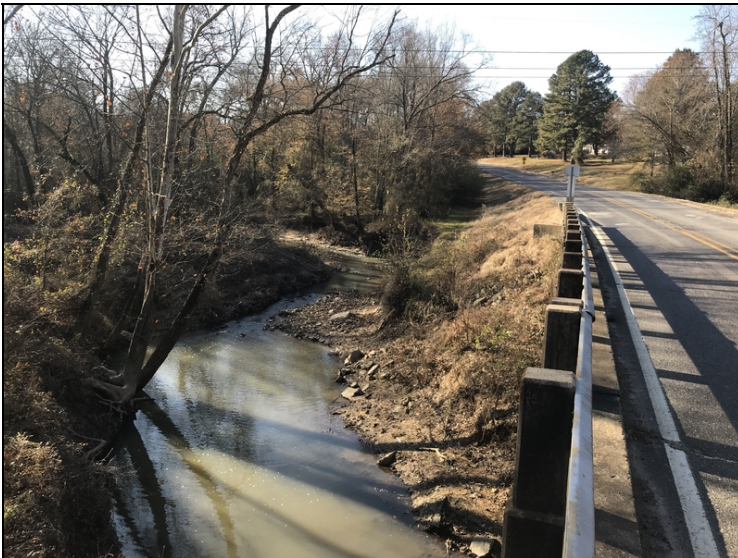
CHANNEL ON SKEW TO BRIDGE ON RT. (UP) SIDE. CHANNEL IS CAUSING EMBANKMENT EROSION BEHIND ABUTMENT 1 ON RT. SIDE.

Embankment Erosion Behind Abutment 1 on Rt.
(UP) Side.
Channel on skew to Bridge.

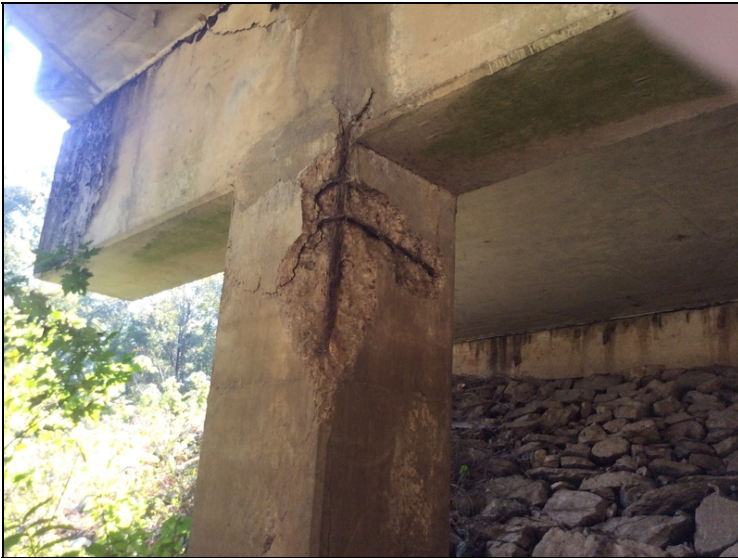
Right column at pier # 2.

Moderate spalling with rebar exposed, exposed rebar has section loss.

Pier #2, column #2 - Ahead side has major spall with rebar exposed, rebar has section loss. Cond. 3 for spall.

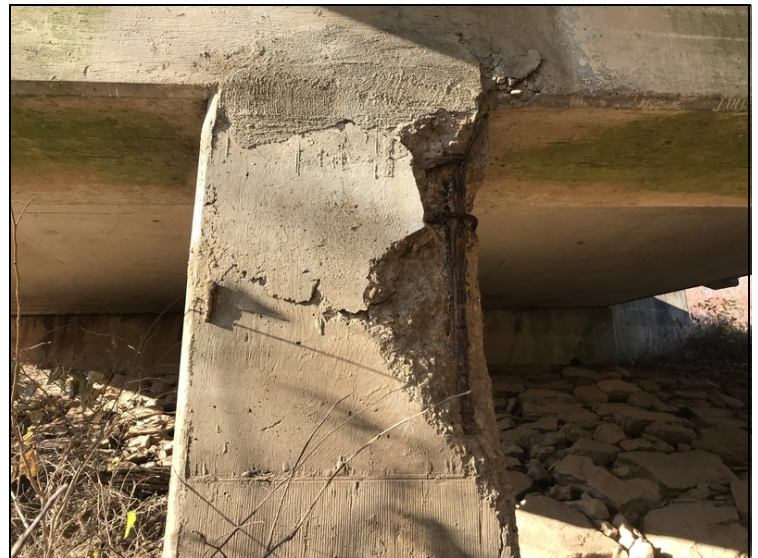
Delam, Cracking & Spalling W / Rebar Exposed in Column 2 at Pier 2.

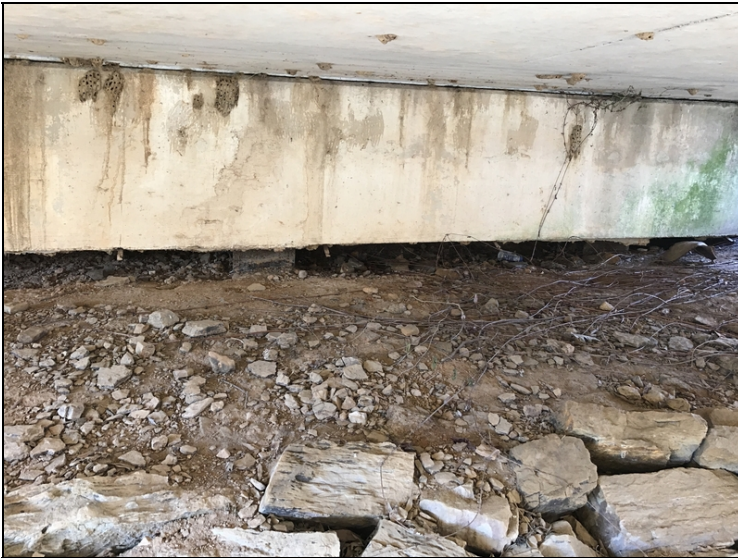
Minor to moderate erosion has exposed the tops of all piles at this location, exposed pile have section loss.

Erosion at Abutment 1.

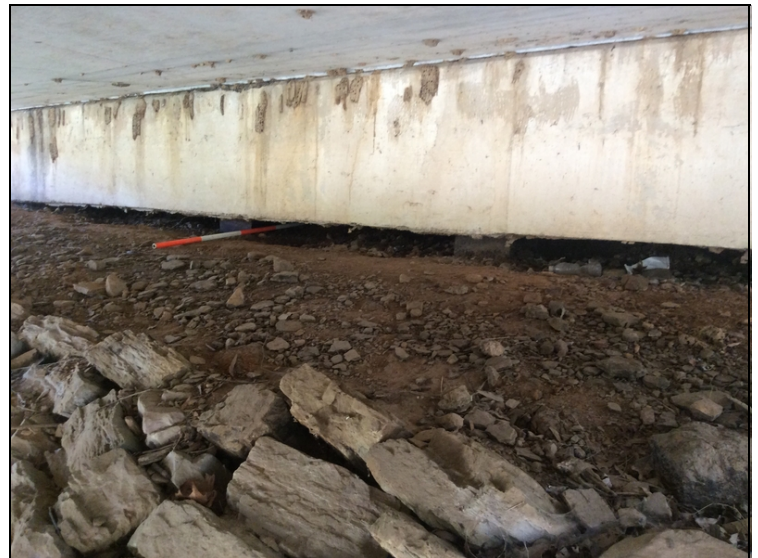
Abut. #1 - Erosion extends the full length of abutment and extends back 2 foot under abutment. All piles are exposed.

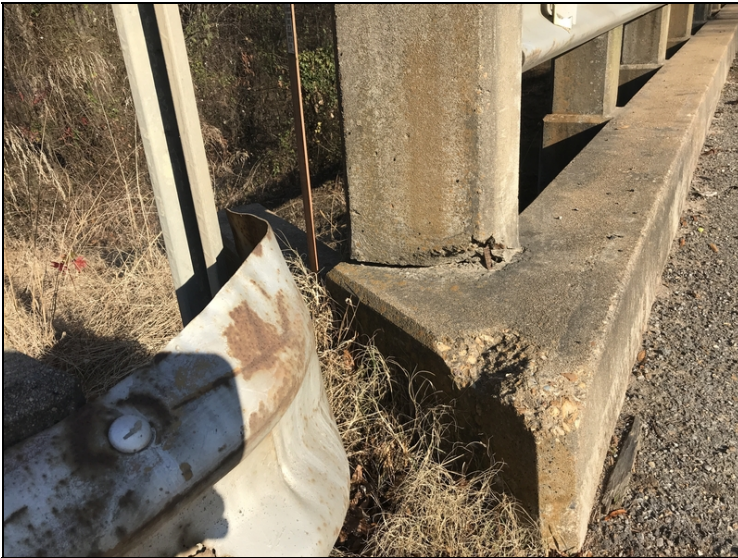
End post at the left side of abutment # 1.

Minor collision damage.

End Post at Abutment 1 Lt. Side Broken due to Impact.
