Bridge #05669(Routine)

SH 102 Benton 2 over OVER KCS RR

Team Lead: Nathan Rowland Inspection Date: June 16, 2020

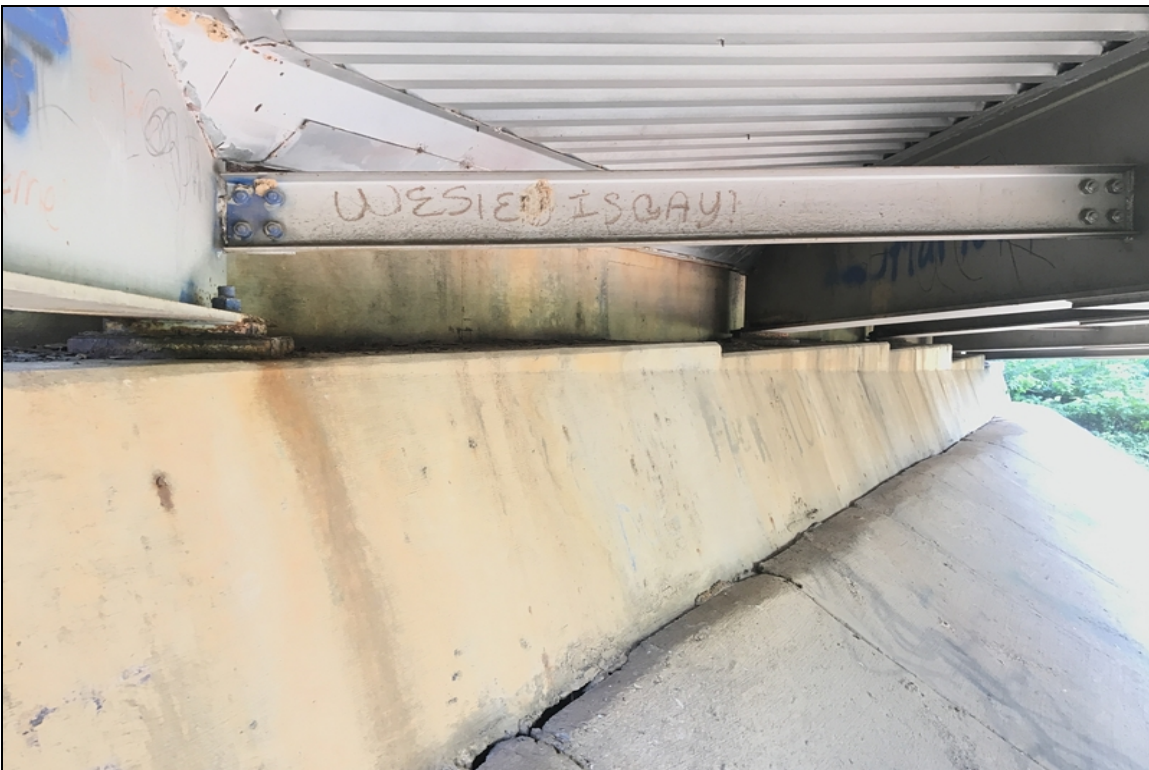
(311)							
06/16/2020 WNR & DBM:							
-All bearings at abut #1 have moderate corrosion. Anchor bolt missing at girder #4 at abut #1.							
313	Fixed Bearing	EA	10	10	0	0	0

Abutment #1 view of bearings.

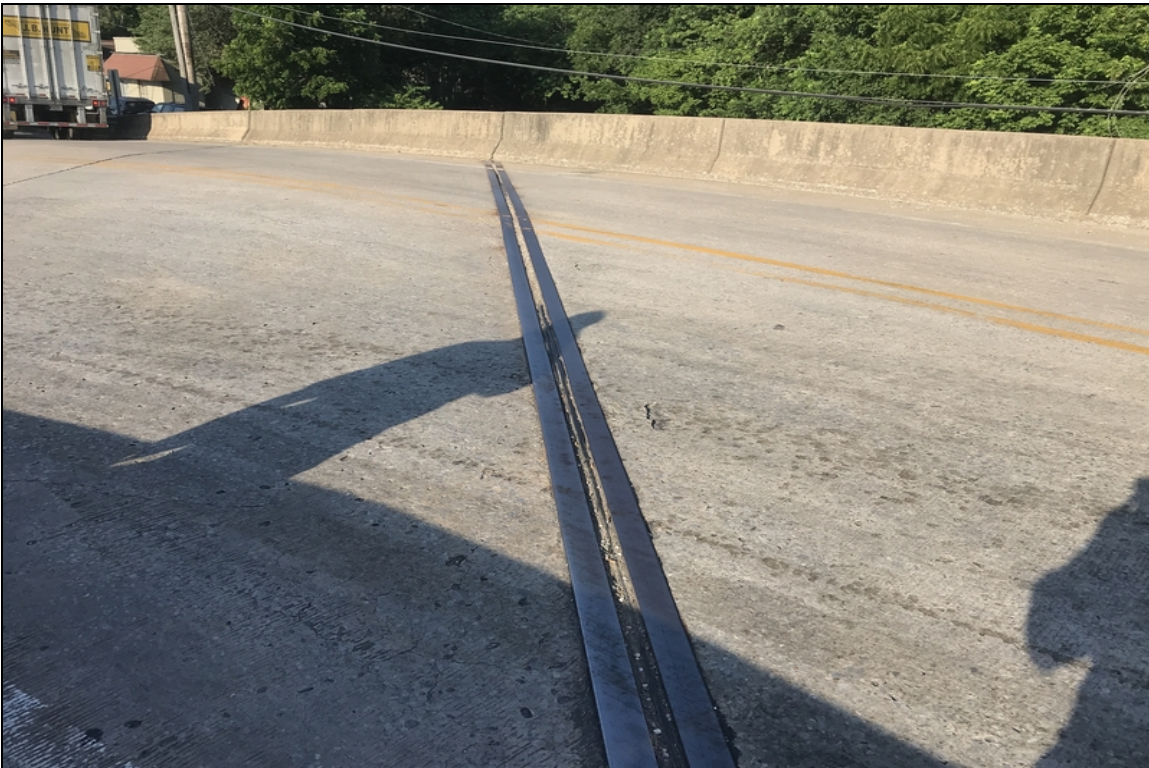
(302)							
06/16/2020 WNR & DBM:							
-Deck joints at bents #2 & #3 leaking with debris build up in joints.							
311	Movable Bearing	EA	10	0	0	10	0
1000	Corrosion	EA	10	0	0	10	0

Bent #2 joint debris impaction.

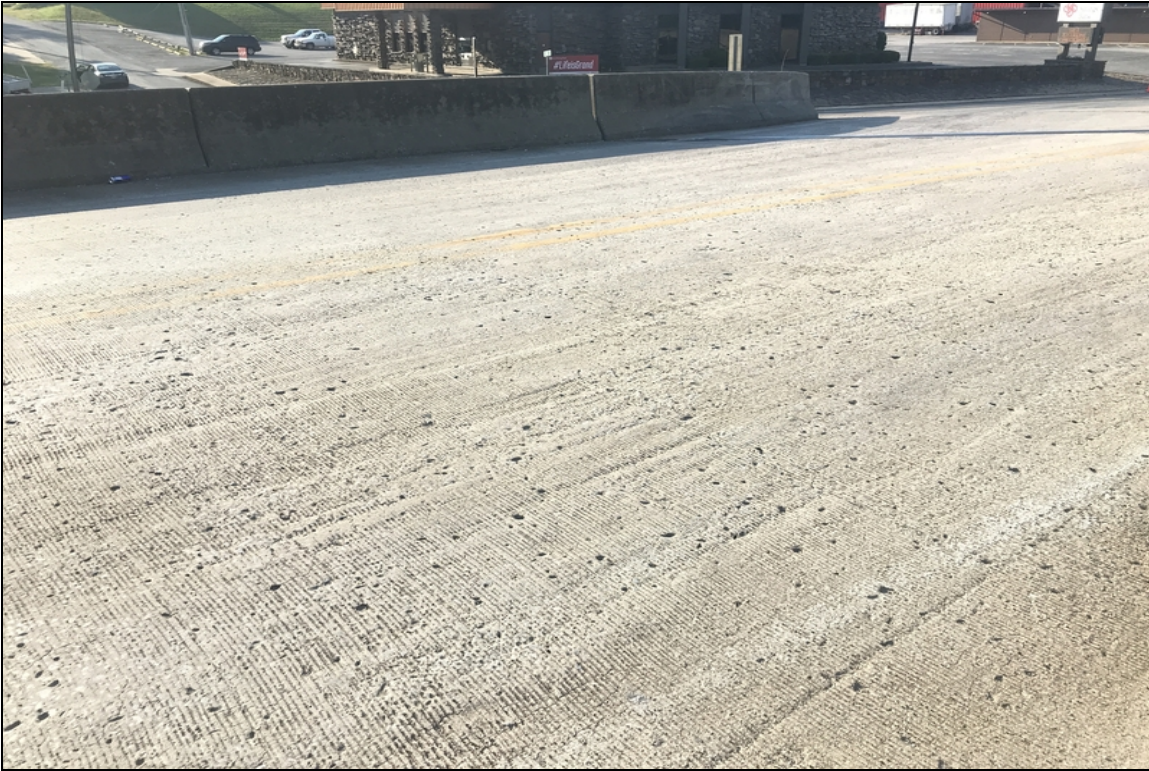
Span #2 typical condition of deck.

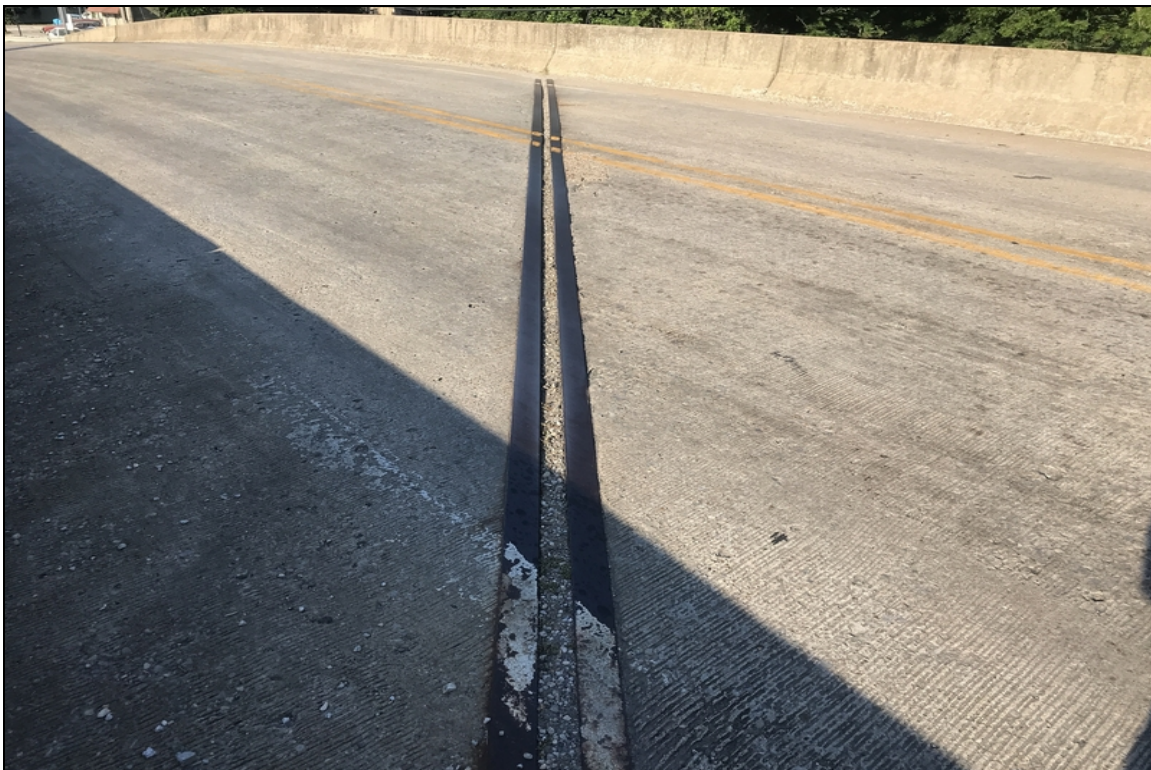
Bent #1 joint debris impaction.

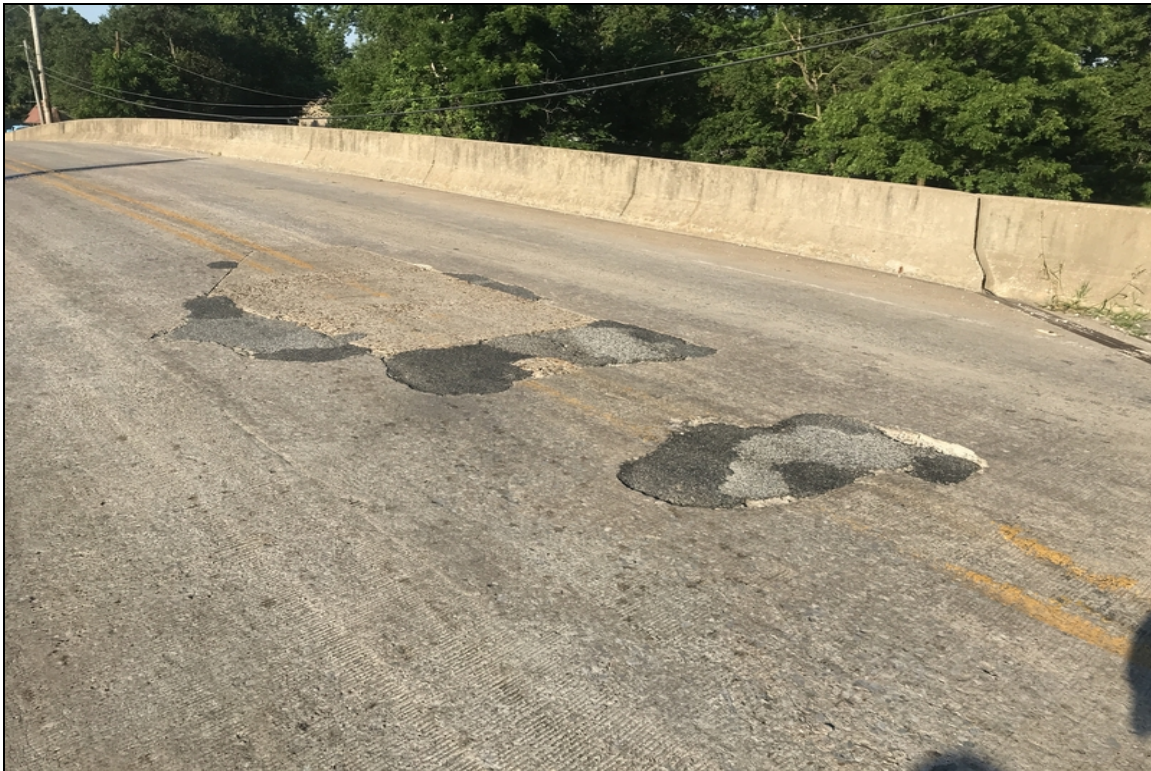
(12)							
06/16/2020 WNR & DBM: -Both left and right driving lanes have map cracking and minor aggregate pop outs throughout spans #1 & #2. -Span #1 has spalling and patched areas at or near the centerline.							
38	RC Slab	SF	2535	671	1864	0	0
1130	Cracking (RC and Other)	SF	1864	0	1864	0	0

Span #1 large spalled patched areas near centerline.

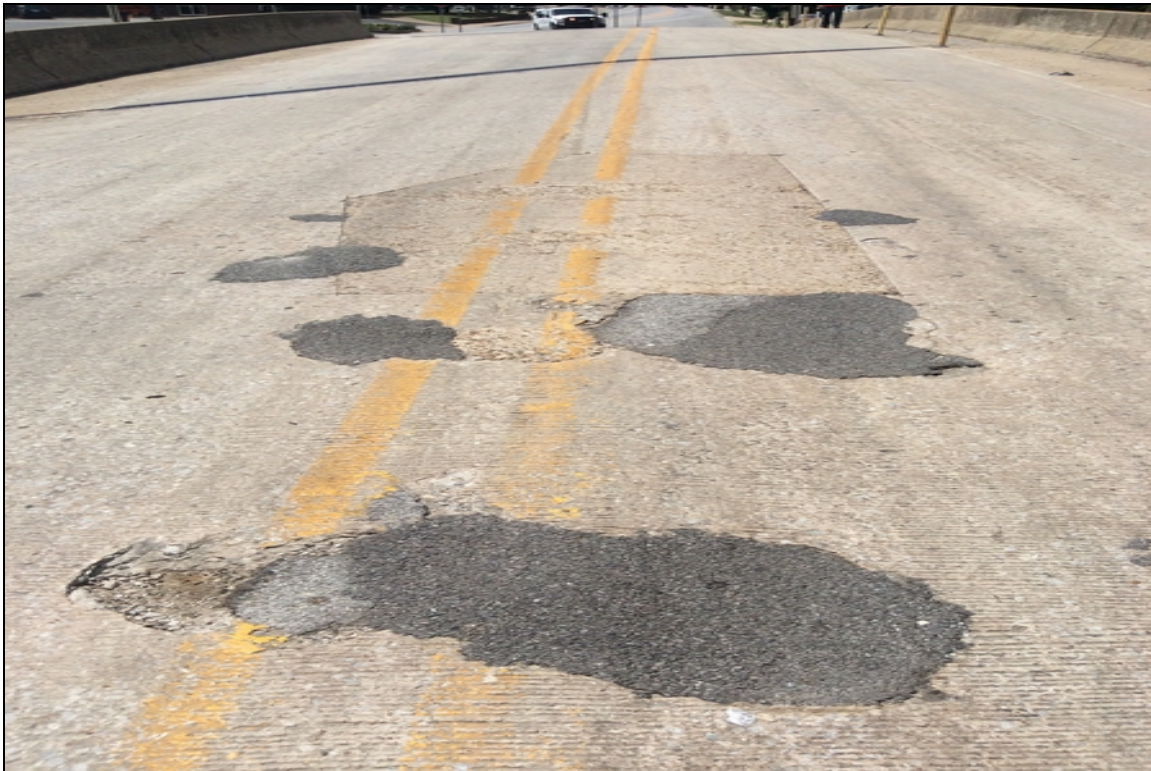
Span 1 has spalled patched areas.

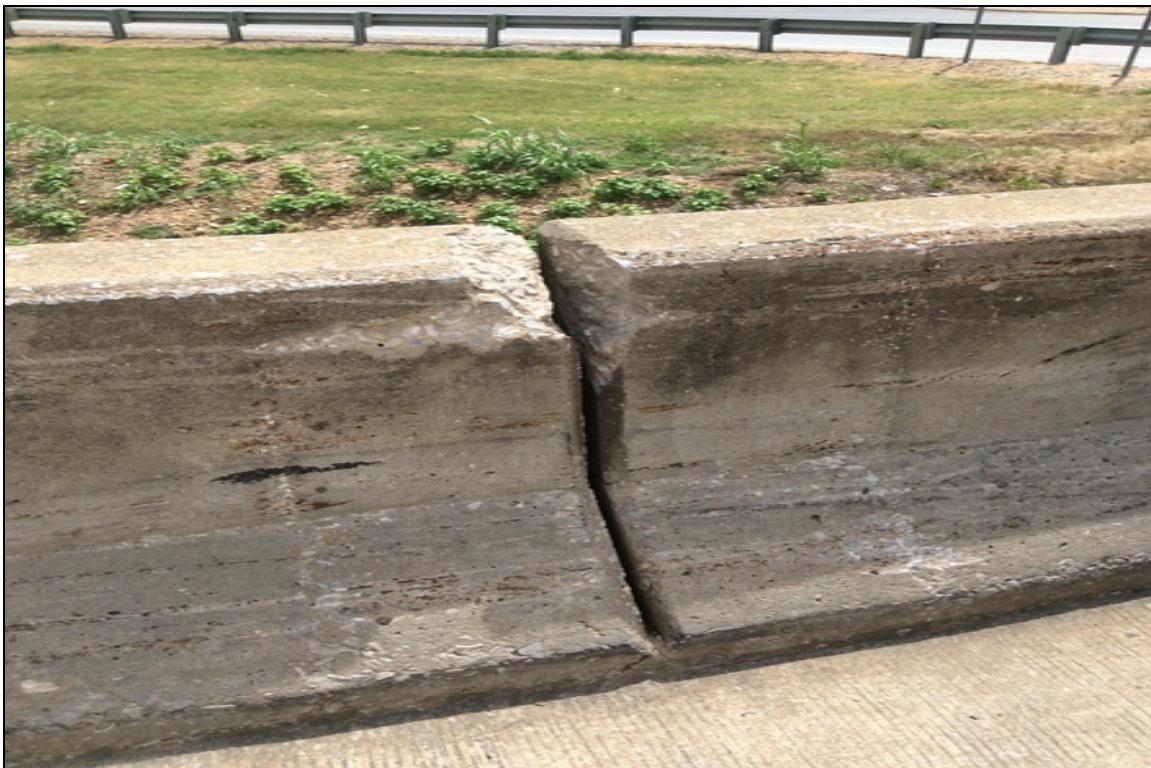
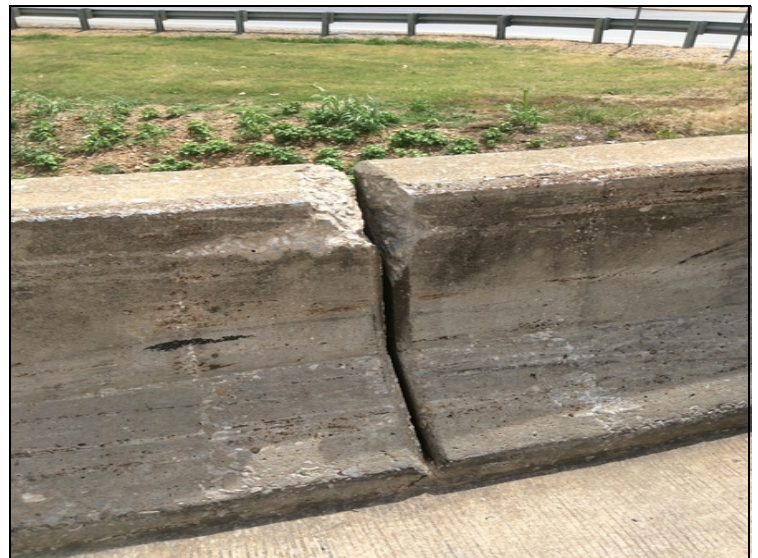
Large spall due to collision damage on railing left side span 3.

-Spans #3 & #4 left railing has collision damage.

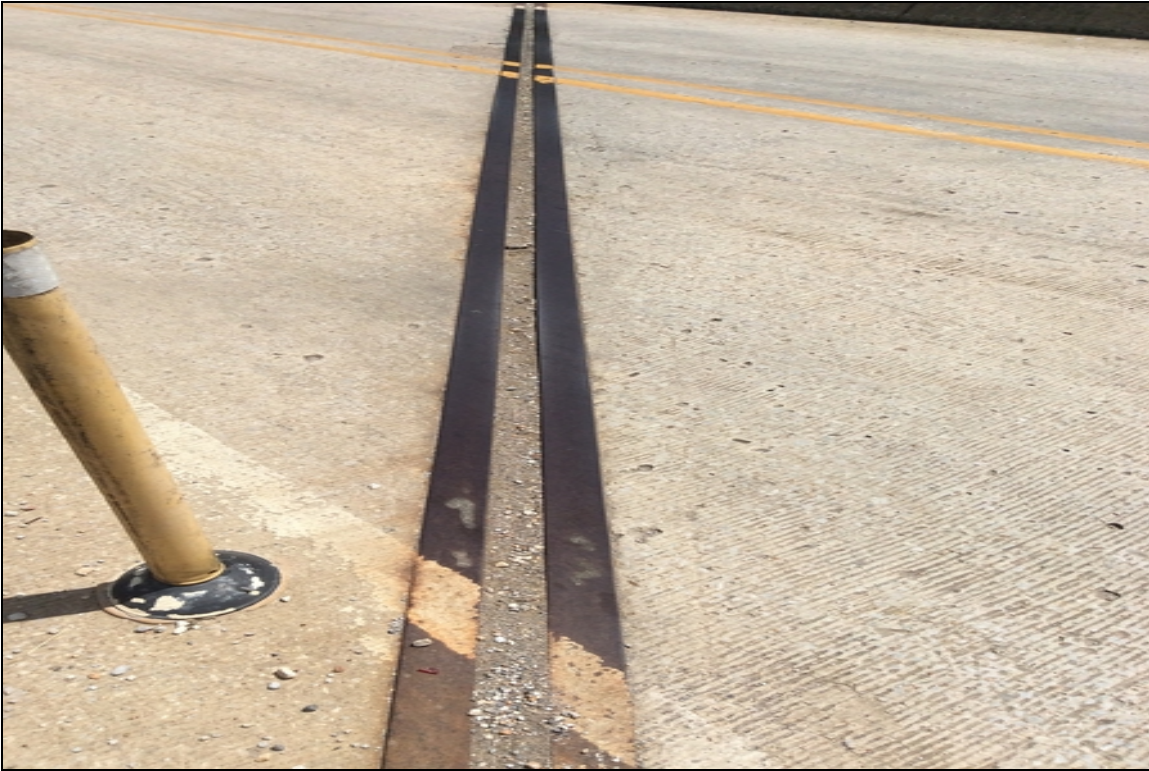
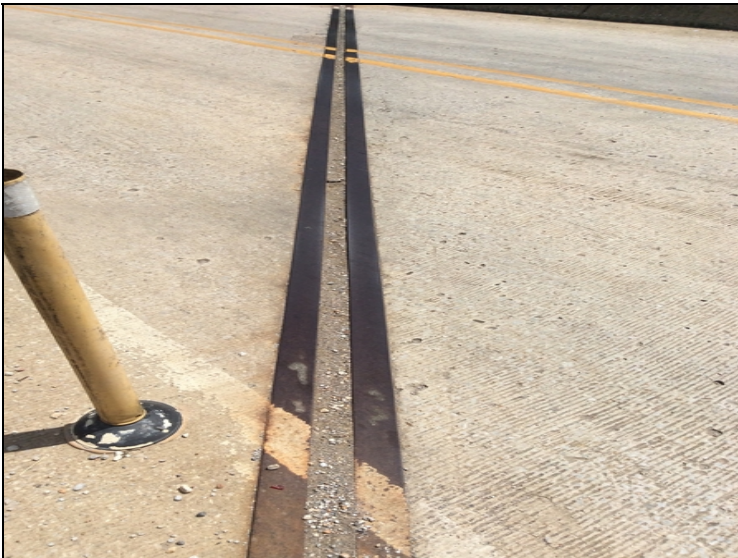
Bent 2 joint material has debris impaction

Debris Impaction;
-Deck expansion joints at bents #2 & #3 have Excessive leakage and debris build up.

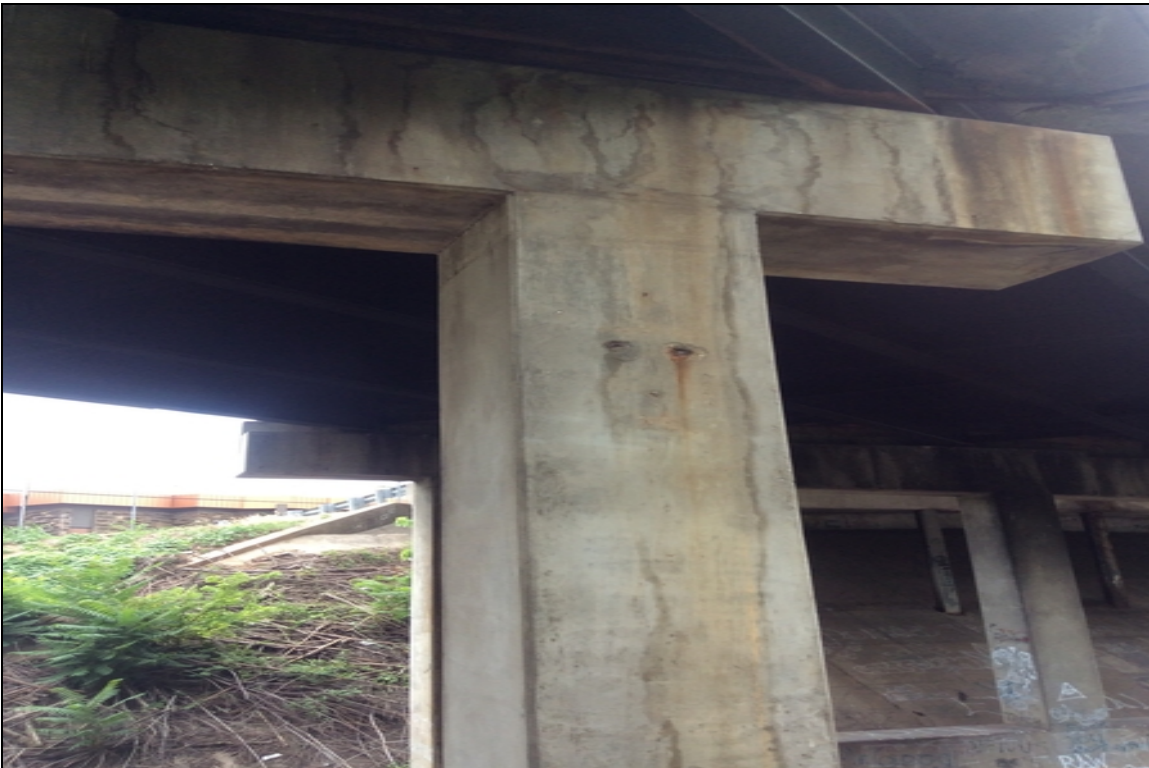
(205)							
06/16/2020 WNR & DBM: -Bent 1 column 3 behind side has minor spalls with steel exposed. -Bent 2 column 1 left side has a delaminated area.							
210	Reinforced Concrete Pier Wall	LF	70	68	2	0	0
1130	Cracking (RC and Other)	LF	2	0	2	0	0

Bent 1 column 3 behind side has minor spalls with steel exposed.

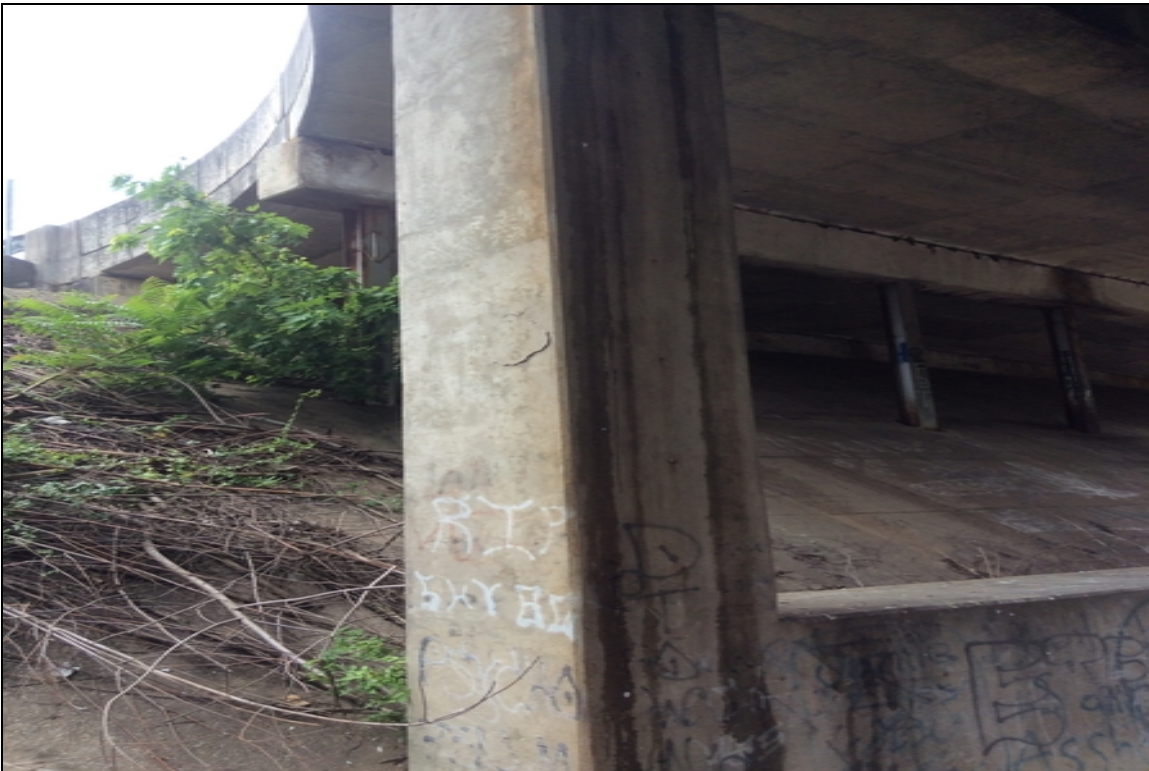
Bent 2 column 1 left side has a delaminated area.

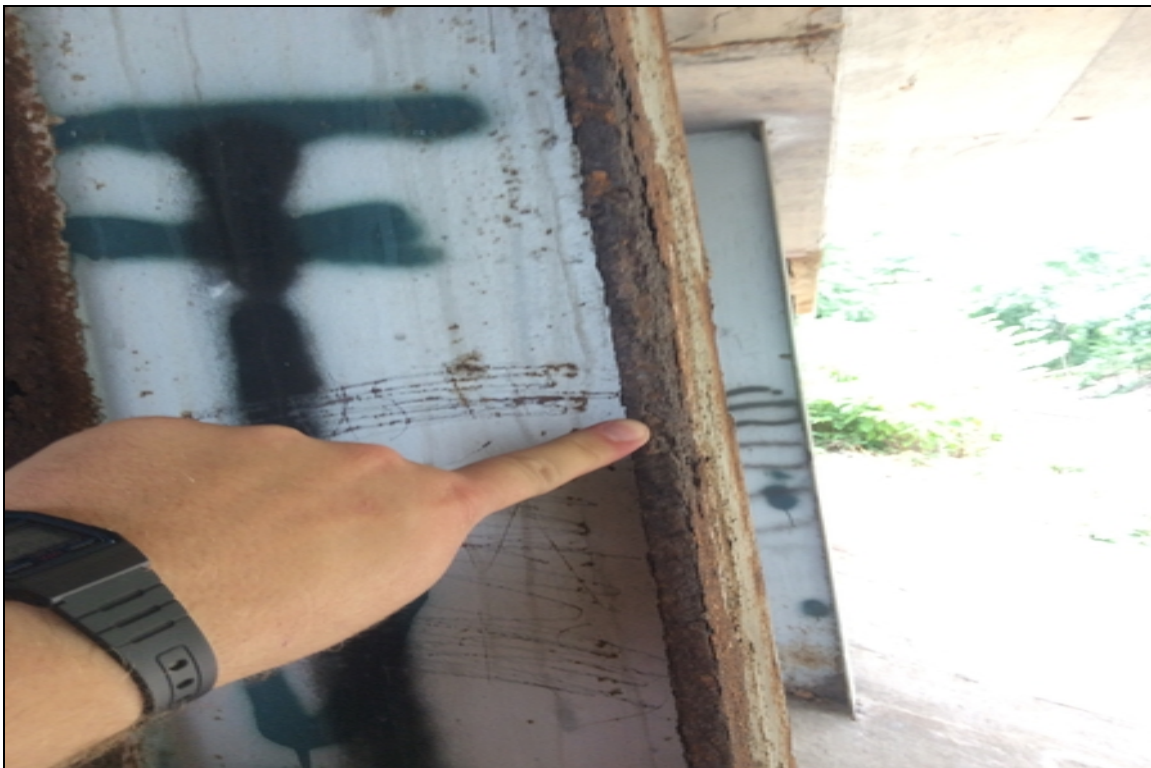
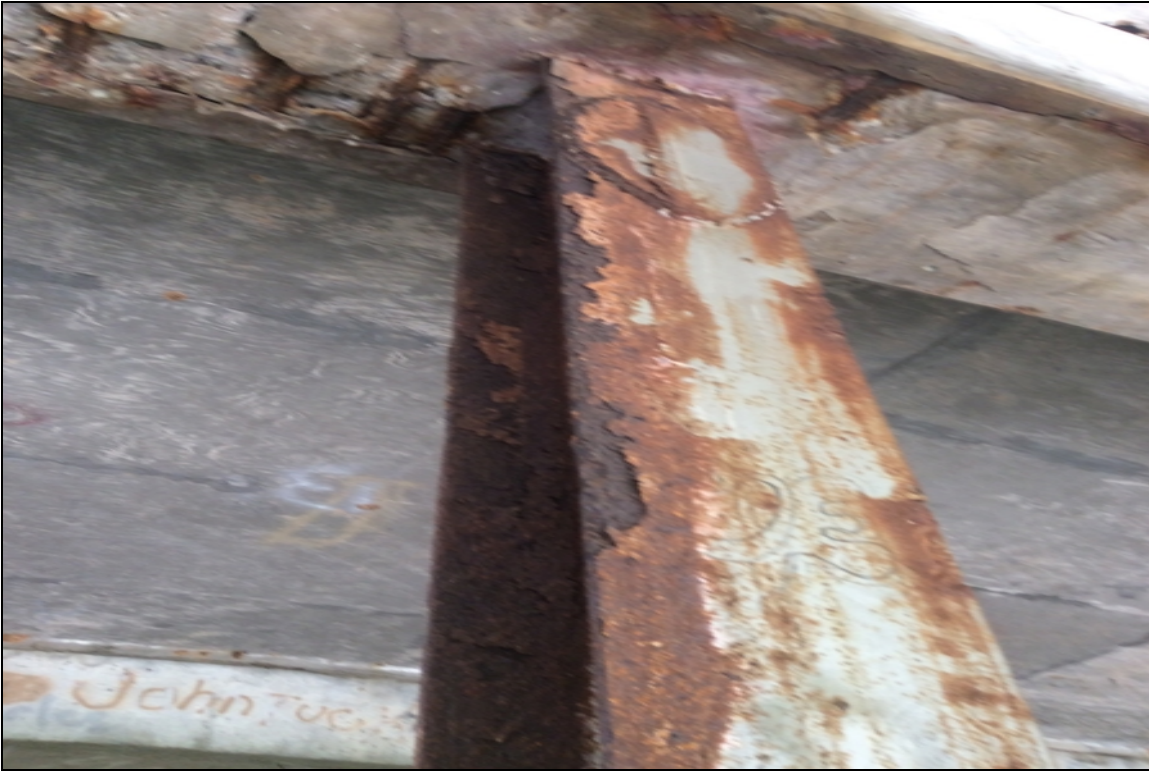
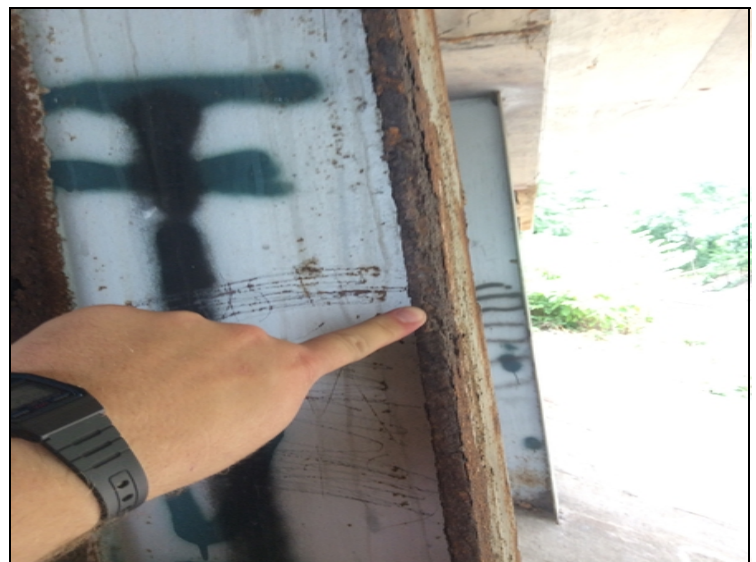
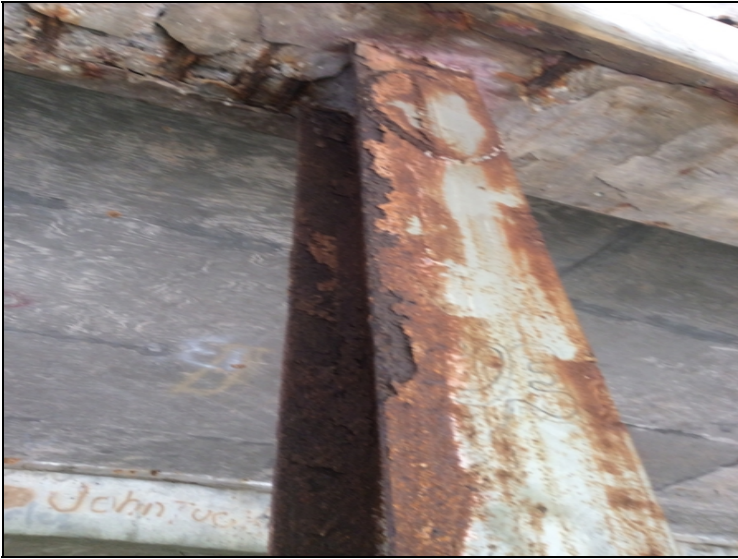
(225)							
06/16/2020 WNR & DBM:							
-All 7 steel pile at bent #3 have minor to moderate corrosion localized to the base and tops of piling.							
-The worst cases are pilings 2, 4, 6, & 7. Where there areas of flaking rust in random locations.							
-Piling #4 behind side has flaking rust and minor section loss.							
234	Reinforced Concrete Pier Cap	LF	179	164	14	1	0
1080	Delamination/Spall/Patched Area	LF	3	0	3	0	0
1090	Exposed Rebar	LF	1	0	0	1	0
1130	Cracking (RC and Other)	LF	11	0	11	0	0

Bent 3 piling number 4 has active corrosion with minor section loss.

Due to the flaking rust and minor section lose to the steel piling at bent #3 NBI Item #60 is lowered to a 5.

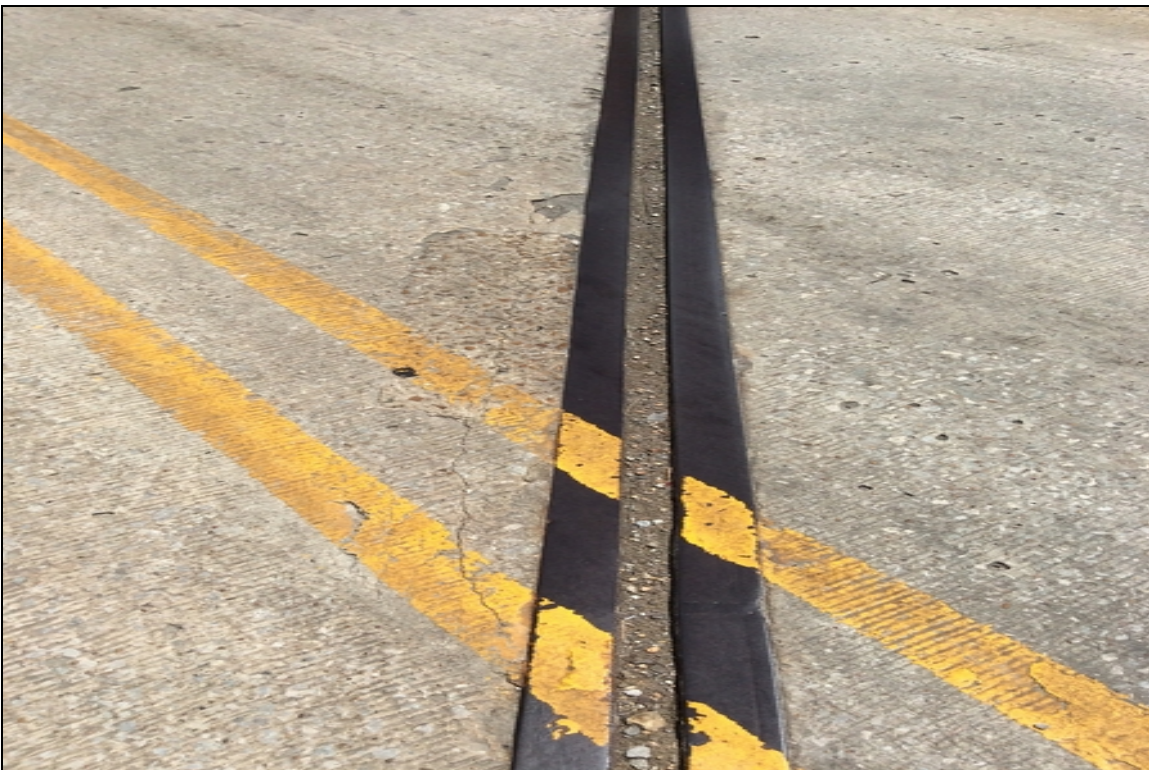
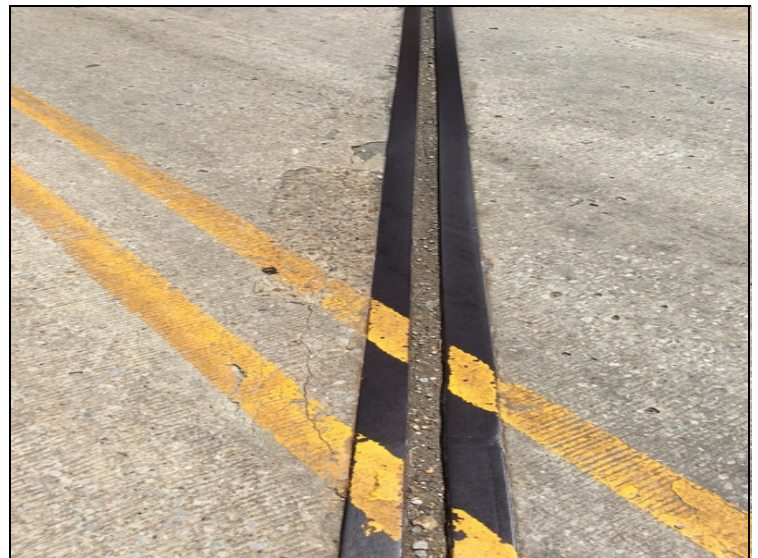
Span 1 spalling adjacent to road iron at bent 2.

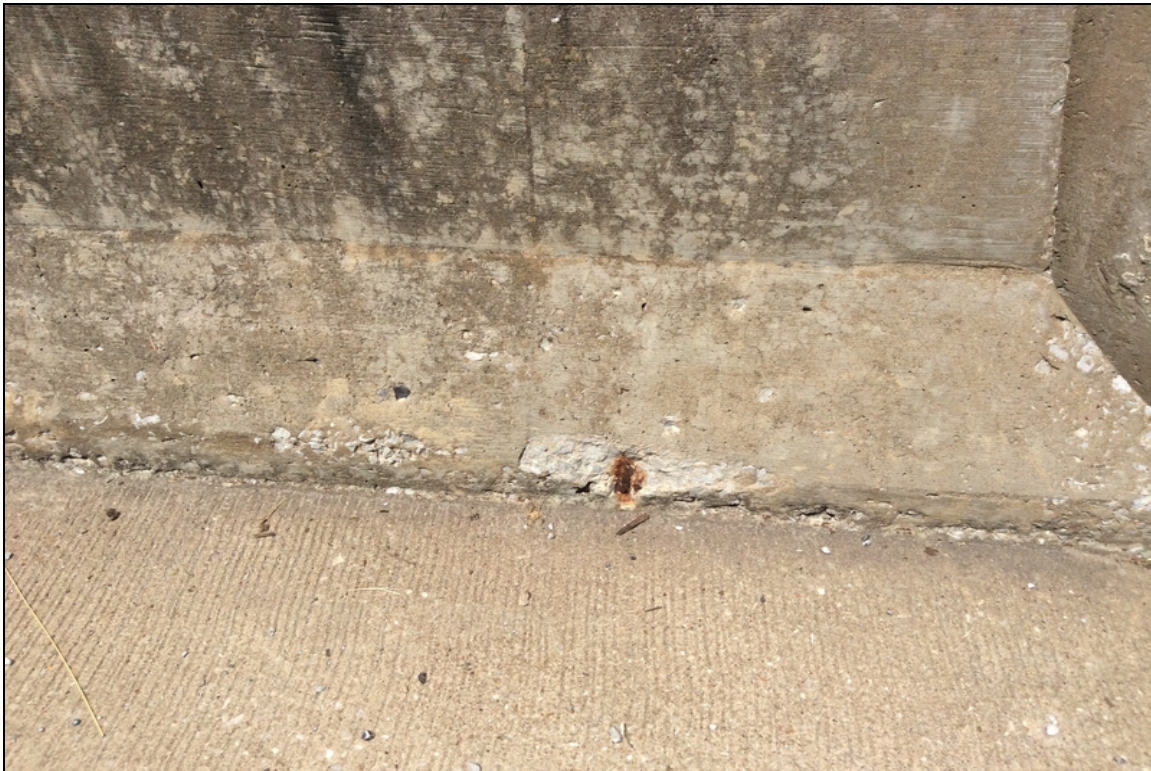
ELEM	DESCRIPTION	UNITS	TOTAL	CS1	CS2	CS3	CS4
1130	Cracking (RC and Other)	LF	158	0	158	0	0
(331)	06/16/2020 WNR & DBM: -Span 1 right has spalling with still exposed. -Span 4 right has spall due to collision damage. -The majority of railing left and right has map cracking.

Span 1 right railing has spalling with steel exposed.

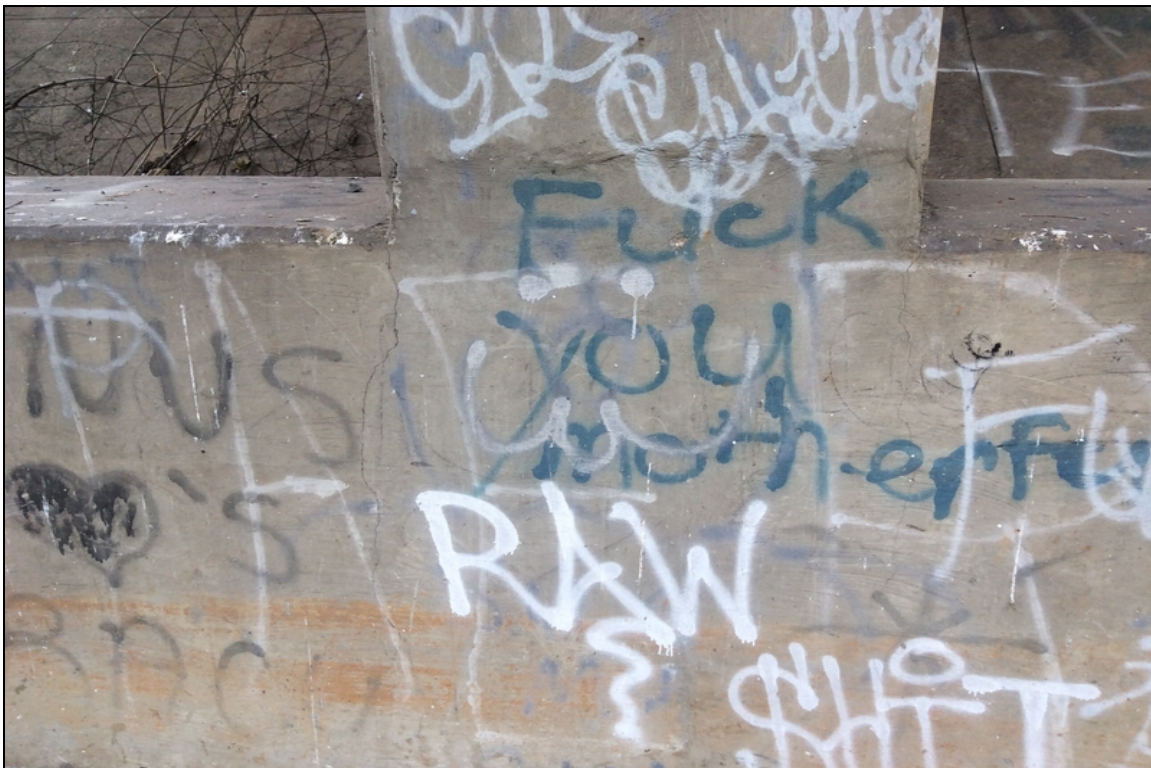
(210)							
06/16/2020 WNR & DBM: -Bent 2 behind side adjacent to both sides of column 2 has vertical cracking.							
215	Reinforced Concrete Abutment	LF	149	141	8	0	0
1130	Cracking (RC and Other)	LF	8	0	8	0	0

Bent 2 behind side has cracks in pier wall adjacent to column 2.

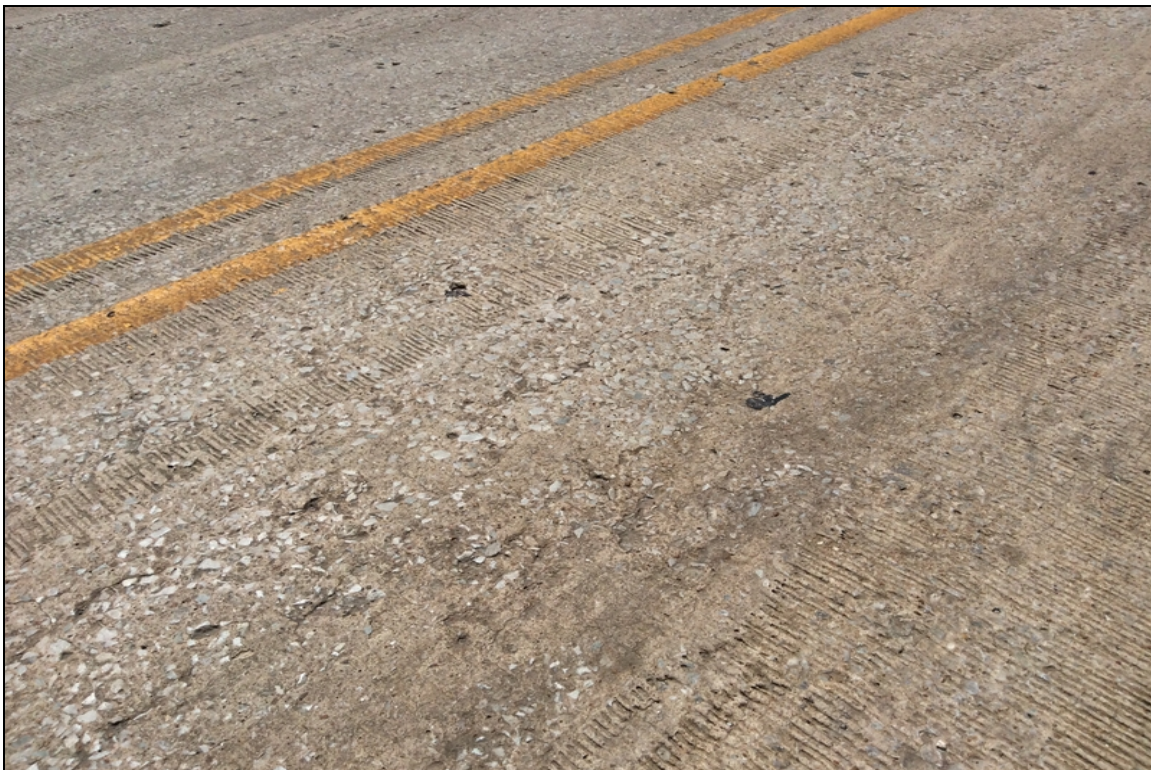
Span 1 typical wearing of driving surface.

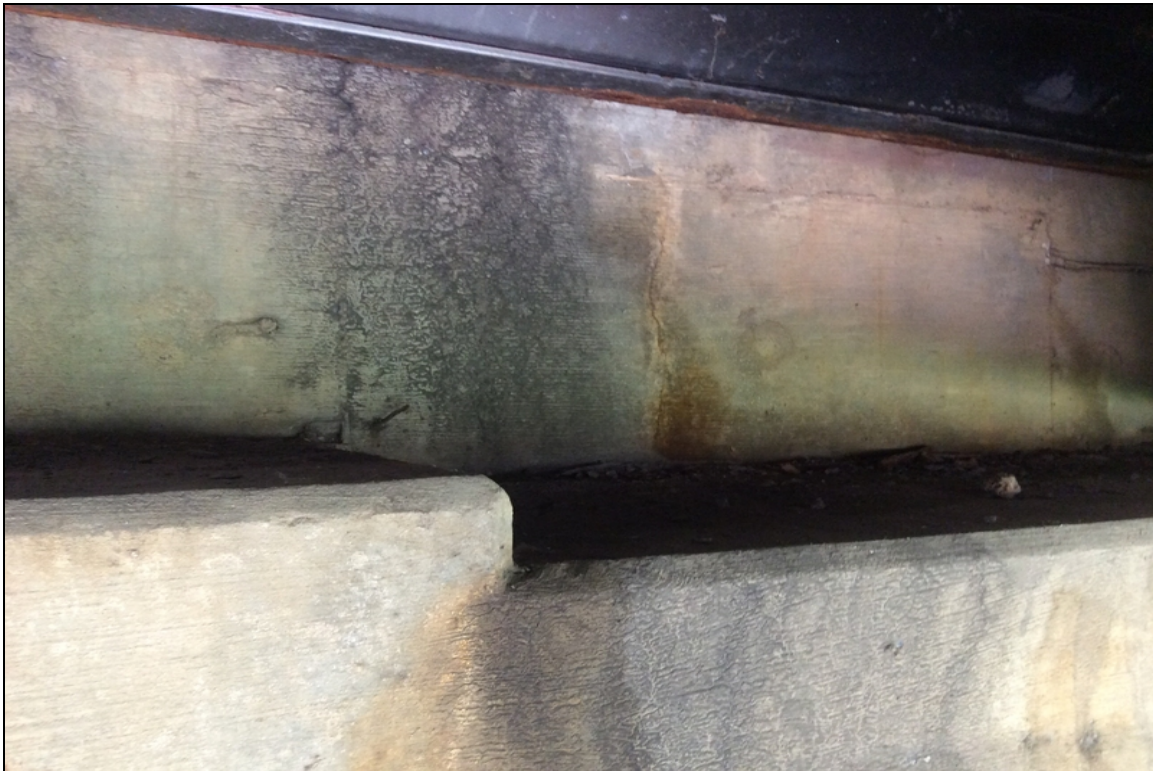
ELEM	DESCRIPTION	UNITS	TOTAL	CS1	CS2	CS3	CS4
-Both Abutments have full height vertical cracking in the backwall in random locations.							
225	Steel Pile	EA	7	0	5	2	0
1000	Corrosion	EA	7	0	5	2	0
515	Steel Protective Coating	SF	356	156	84	0	116
3440	Effectiveness (Steel Protective Coatings)	SF	200	0	84	0	116

Abutment 1 bay 3 backwall has vertical cracking.

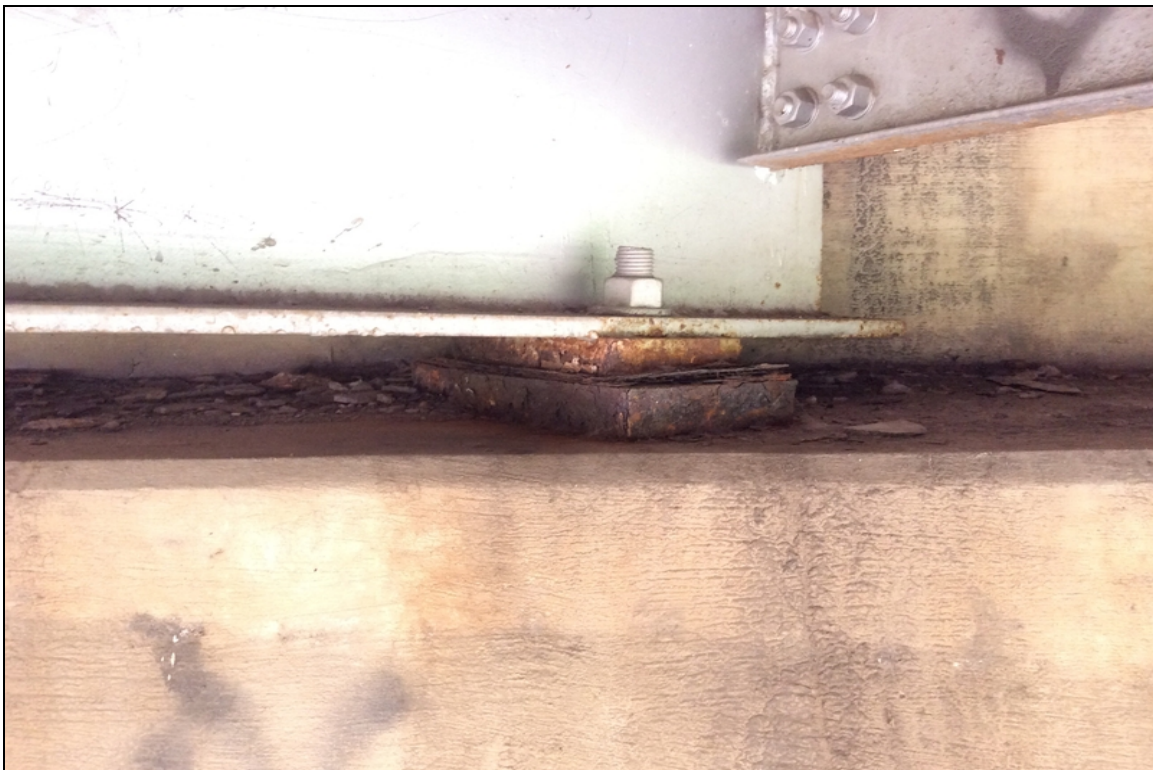
Typical view of bearing corrosion.

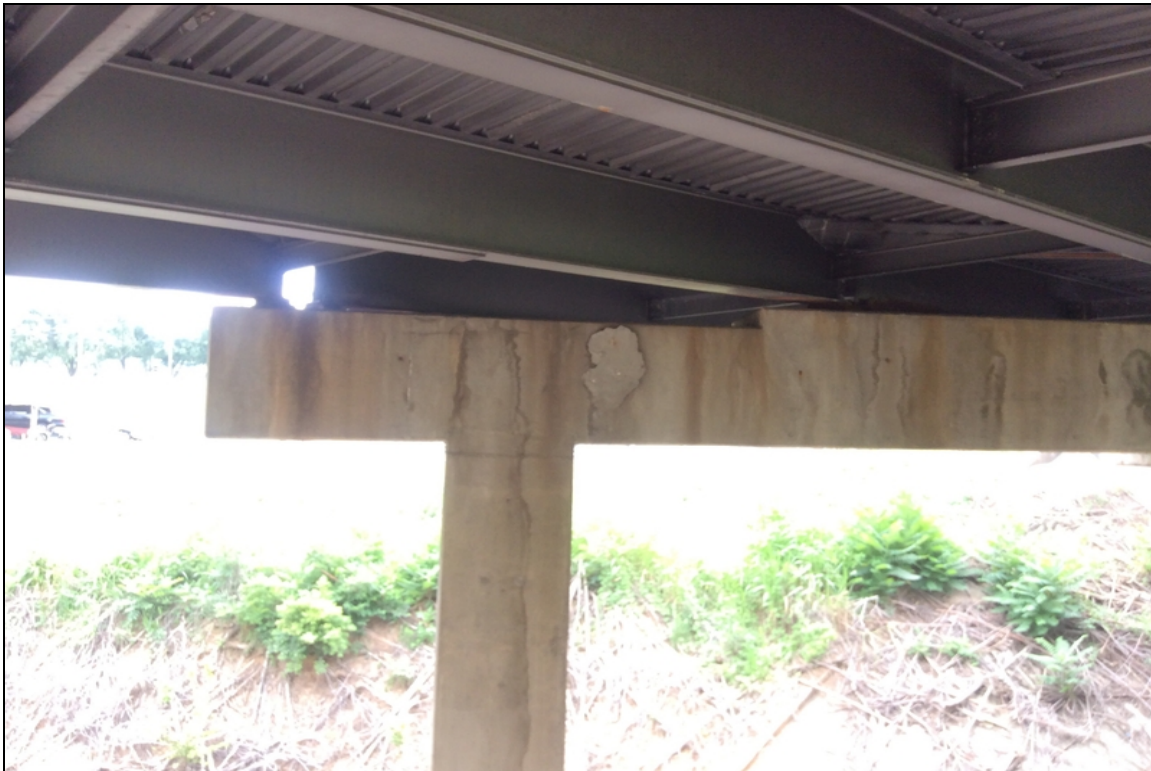
(234)							
06/16/2020 WNR & DBM:							
-Bent #1 cap has 5' vertical crack under girder #5.							
-Bent 2 underneath cap left side has spalling with steel exposed.							
-Bent 1 cap behind side left has large delaminated area.							
302	Compression Joint Seal	LF	156	100	56	0	0
2350	Debris Impaction	LF	56	0	56	0	0

Bent 1 cap behind side left has large delaminated area.

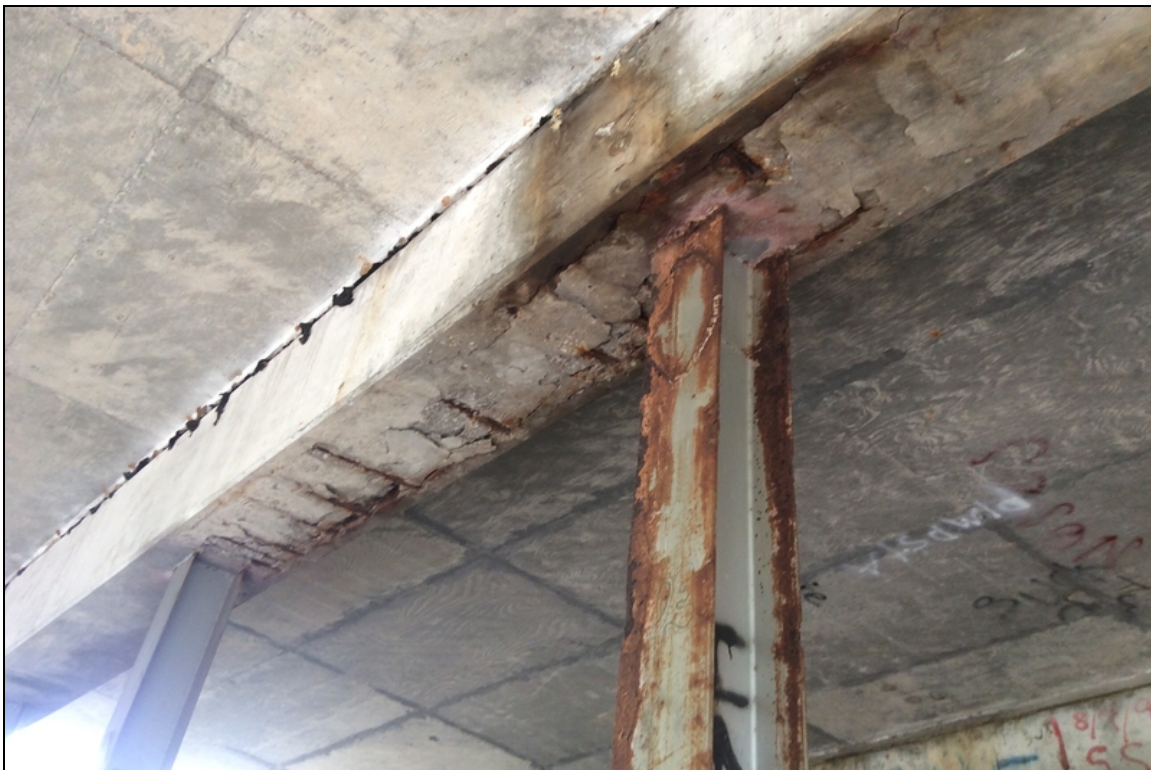
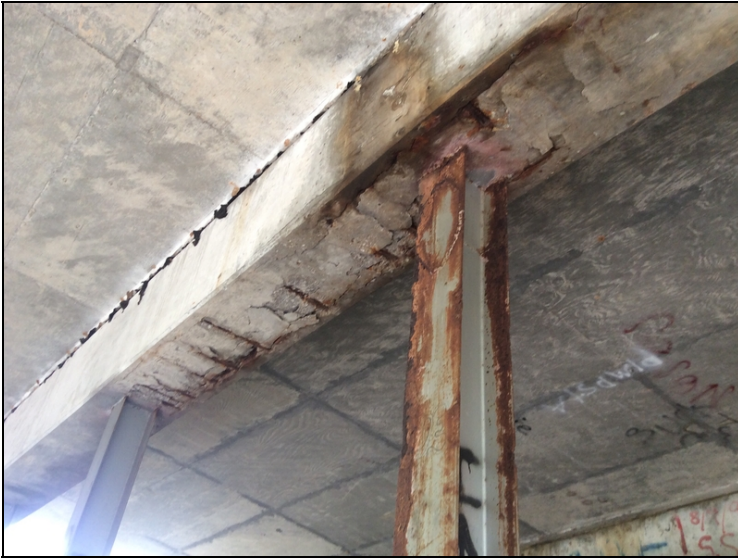
Bent 3 cap between steel piling 3 and 4 has spalling with steel exposed.

-Bents #1 & #3 concrete caps- Deterioration, cracking and spalls with steel exposed. The undersurface of bent #3 has medium spalls with section loss to exposed steel.

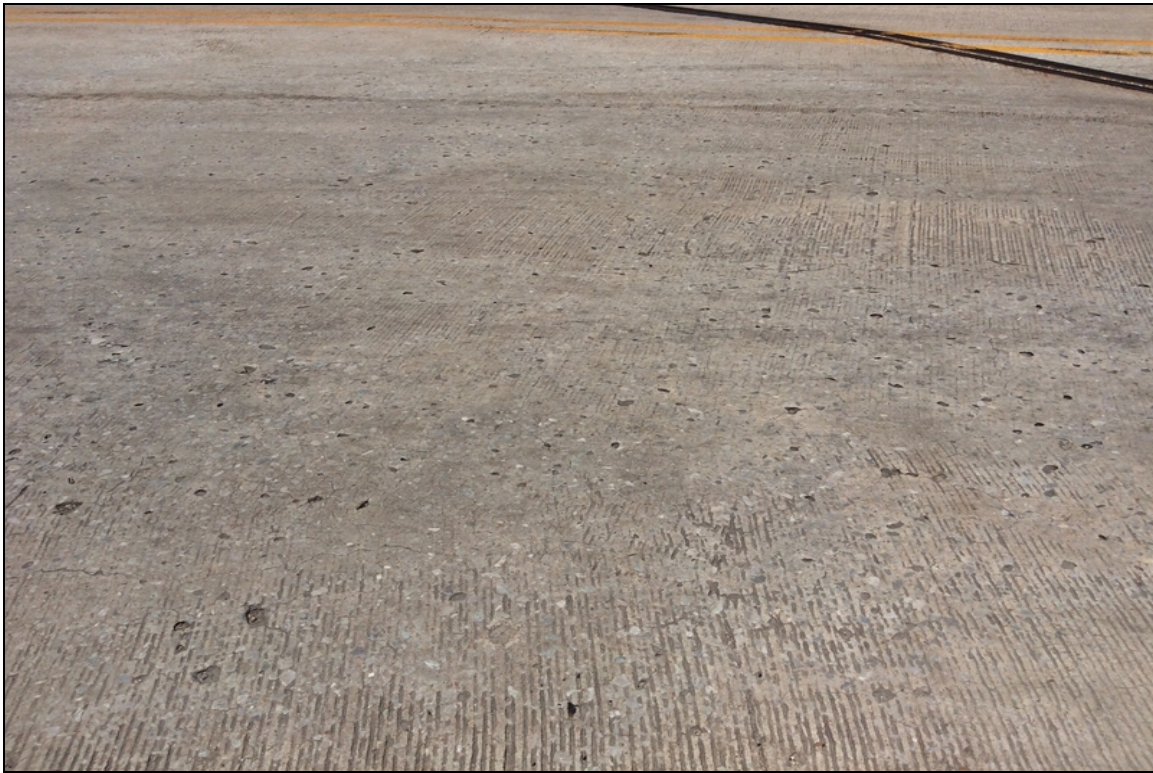
(38)							
06/16/2020 WNR & DBM: -Spans #3 & #4 are concrete slabs. -The driving lanes of spans #3 & #4 have map cracking and minor aggregate pop outs.							
107	Steel Open Girder/Beam	LF	590	590	0	0	0
515	Steel Protective Coating	SF	3540	3540	0	0	0

Span 3 left lane typical view of map cracking.
