Bridge #05669(Routine)

SH 102 Benton 2 over OVER KCS RR

Team Lead: Nathan Rowland Inspection Date: June 16, 2020

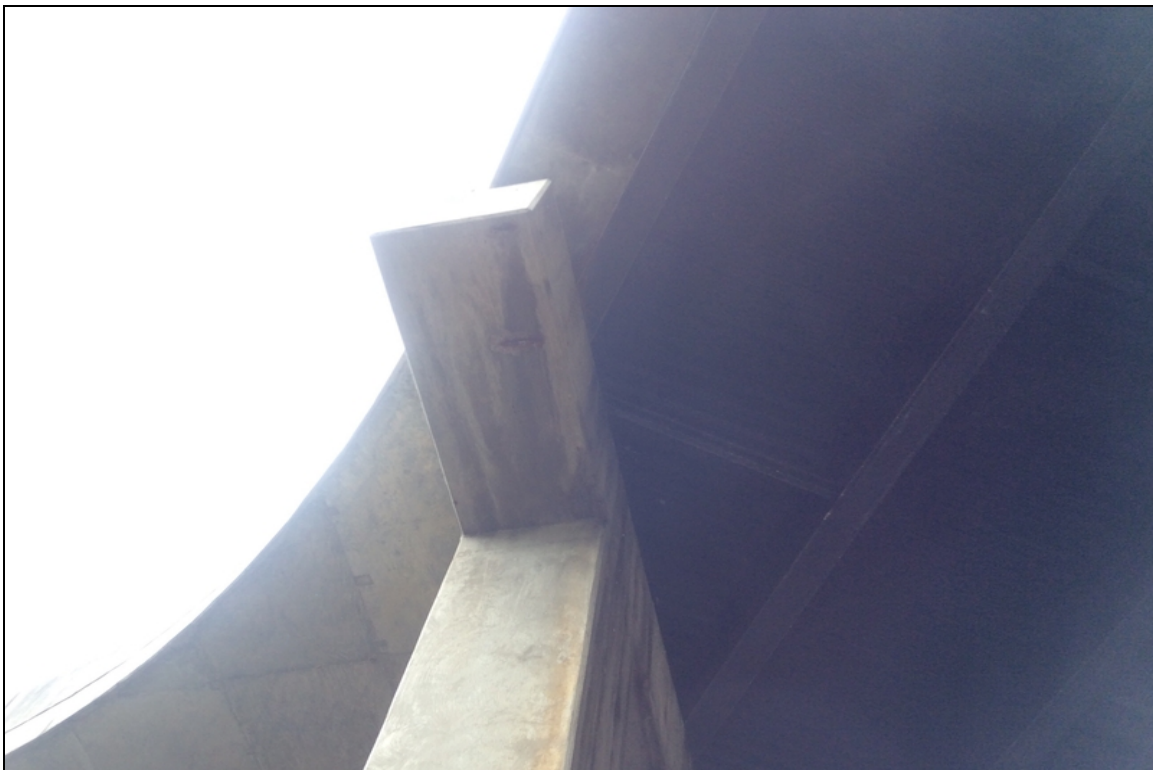
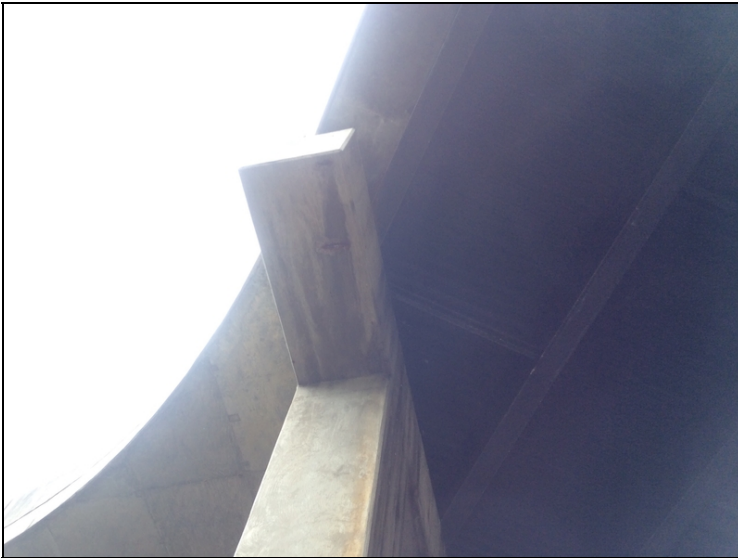
Bent 2 underneath cap left side has spalling with steel exposed.

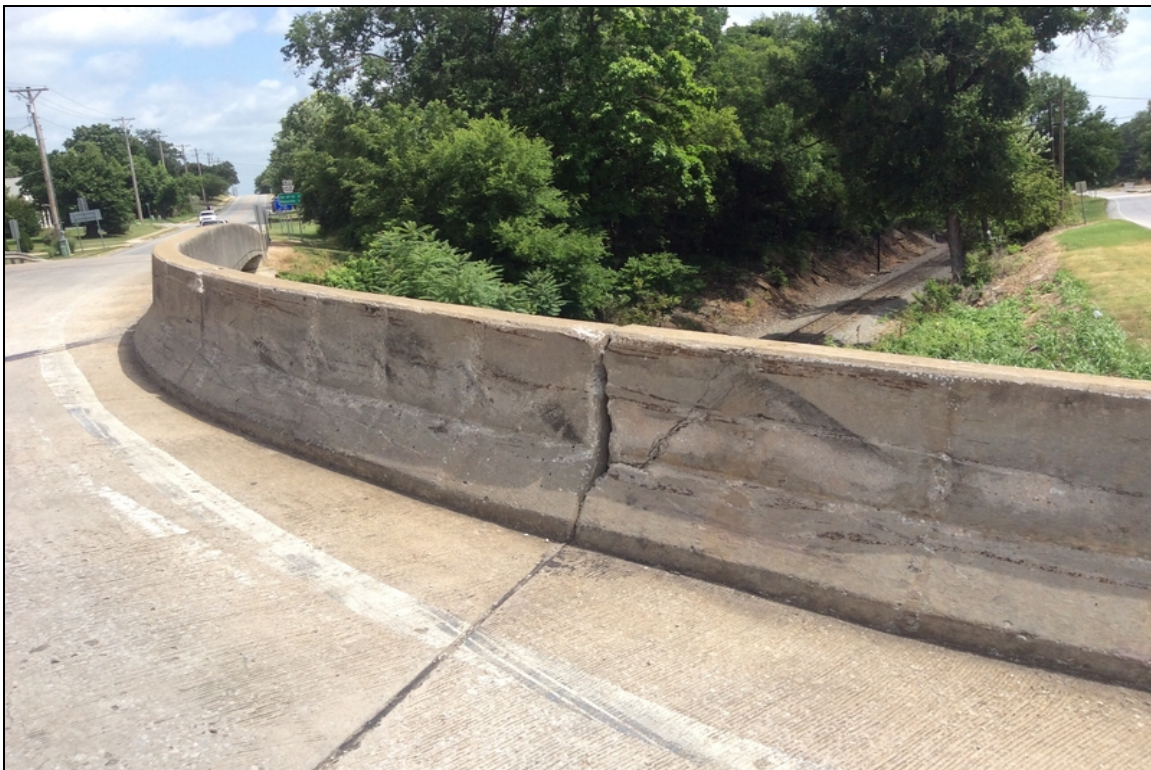
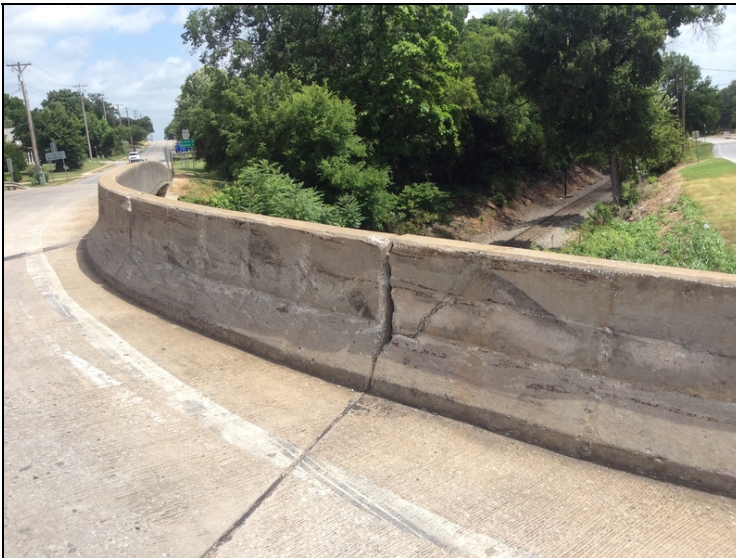
Railing left in spans 3 and 4 has Collision damage.

-Spans #3 & #4 left railing has collision damage.

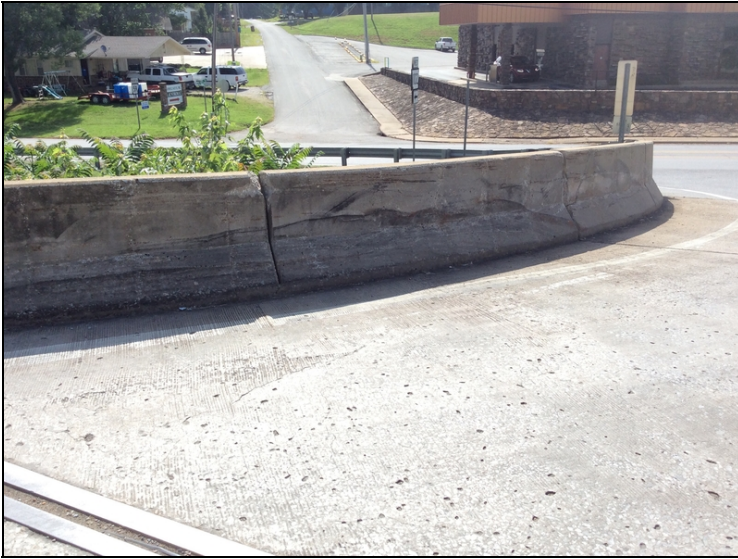
Concrete bridge railing span 4 left - collision marks.

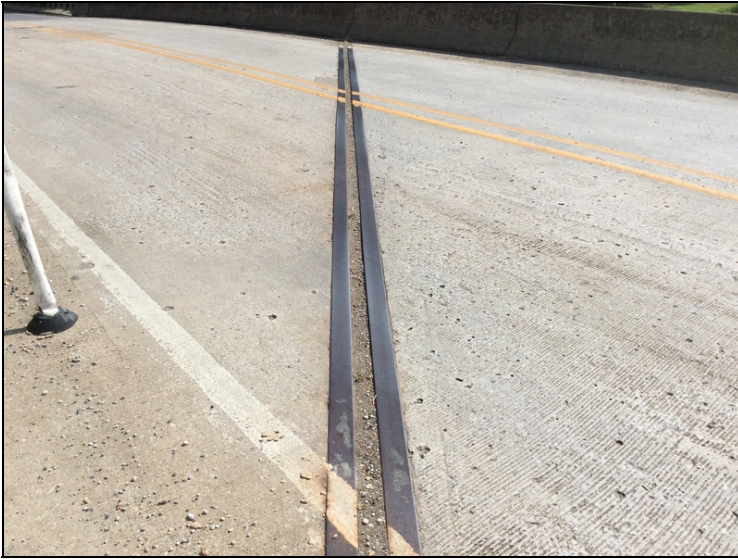
Debris Impaction;
-Deck expansion joints at bents #2 & #3 have Excessive leakage and debris build up.

Deck joint bent 2 - debris impaction.

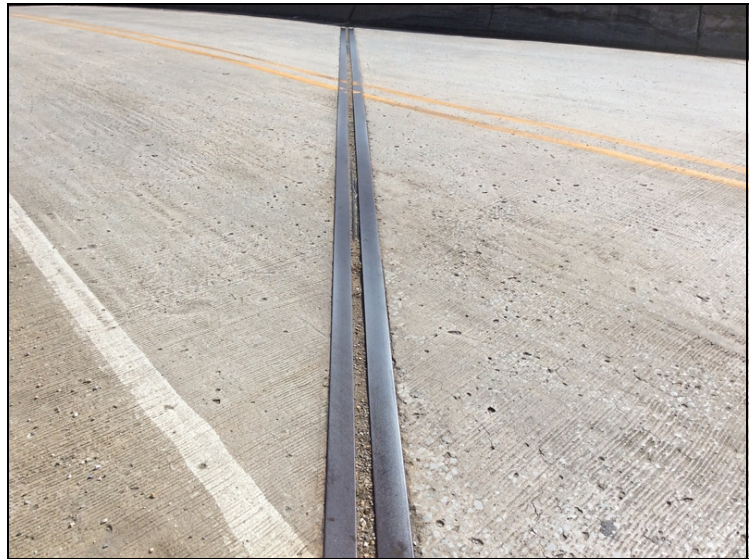
Deck joint bent 3 - debris impaction.

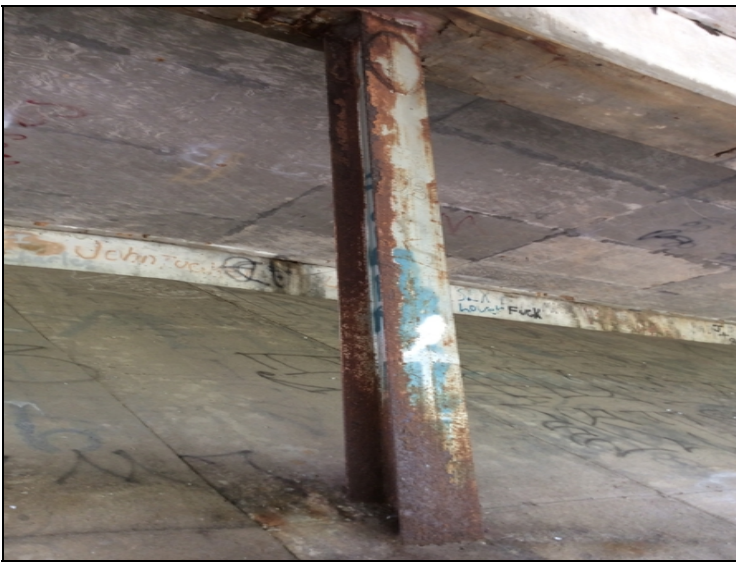
Bent # 4 steel piles-Visible rust and corrosion.

Bent 4 piling 4 - active corrosion and pitting.

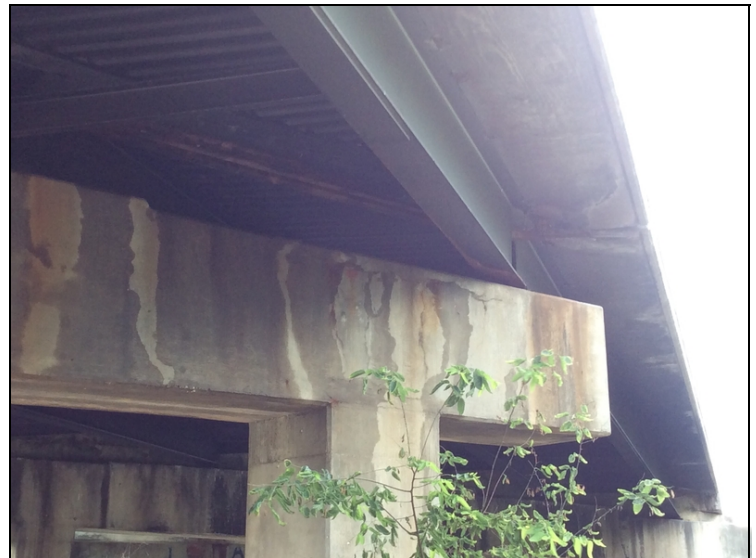
Bent 2 cap right behind - vertical cracking.

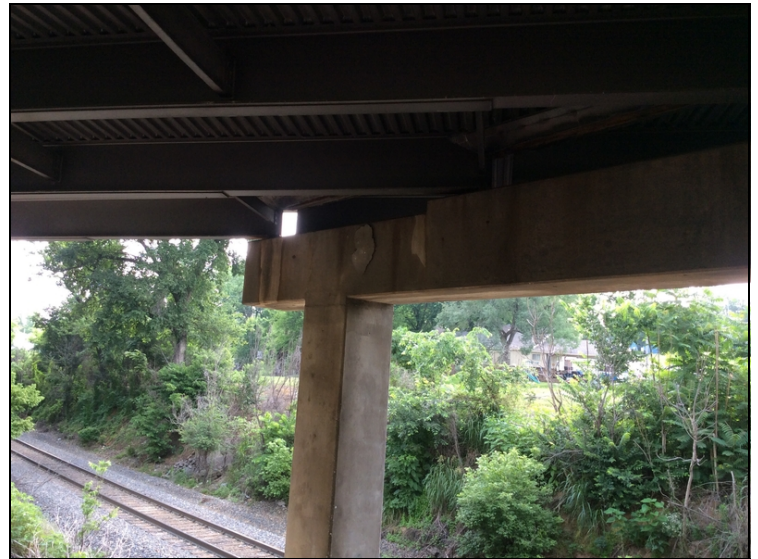
Bent 2 cap behind left - delaminated area.

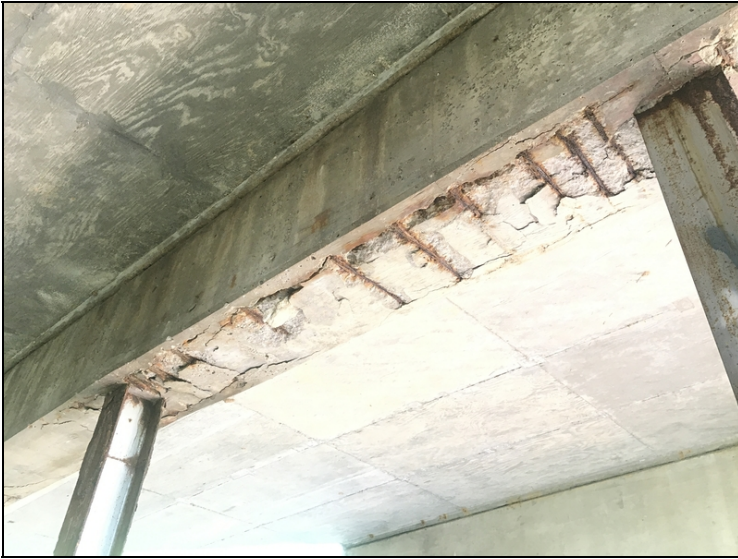
-Bents #1 & #3 concrete caps- Deterioration, cracking and spalls with steel exposed. The undersurface of bent #3 has medium spalls with section loss to exposed steel.

Bent #3 cap undersurface spalling with steel exposed section lose present in steel.
