Bridge #01446(Routine, Underwater type 2)

SH 367 White Co. over LAWRENCE BAYOU

Team Lead: Nathan Edwards Inspection Date: August 17, 2021

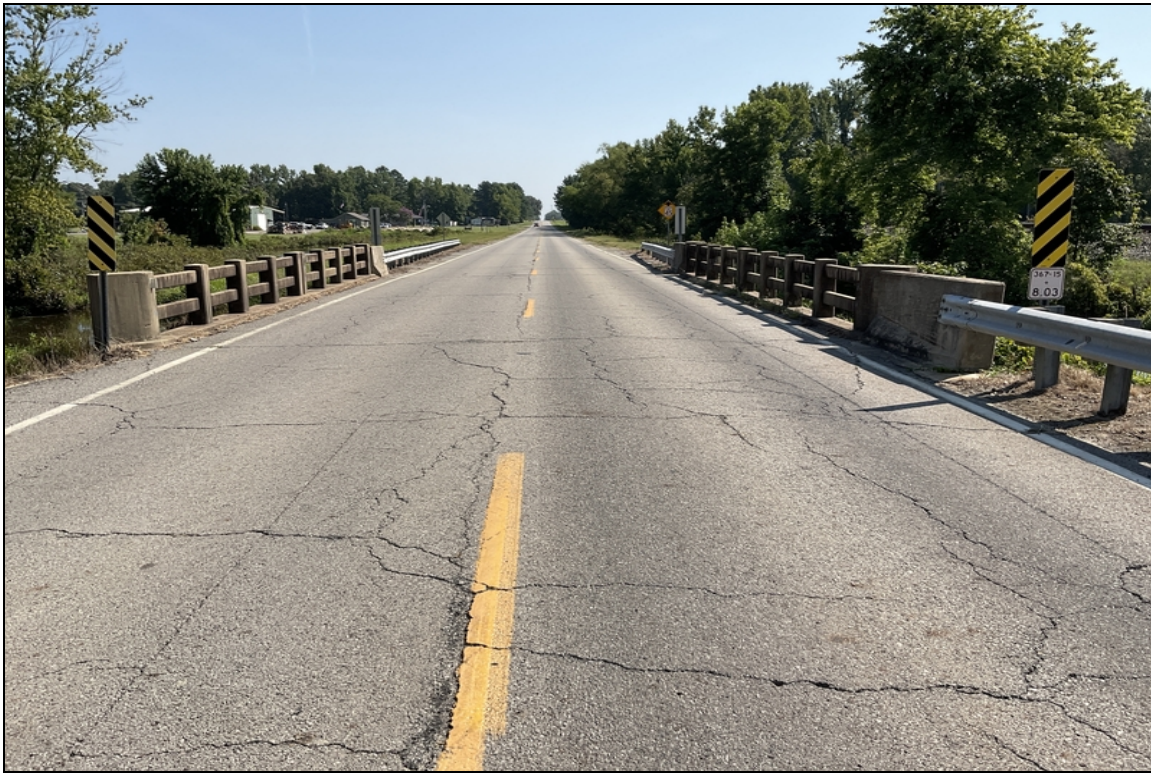
Roadway with Log Mile running Southwest to Northeast.

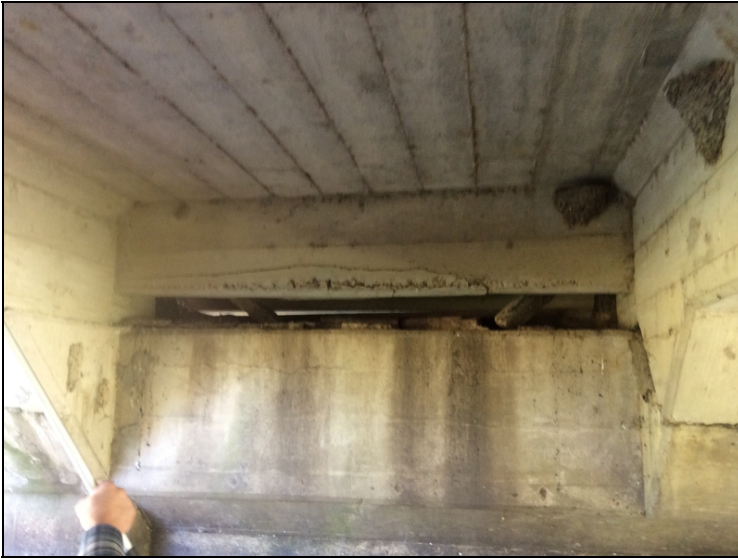
Cracking & spalls with rebar exposed to diaphragms between Girders 1-4 @ Bent 1.

Diaphragms/Cross Frames: Cracking & spalls with 16' of rebar exposed to concrete diaphragms on back & ahead sides of Bent 1.

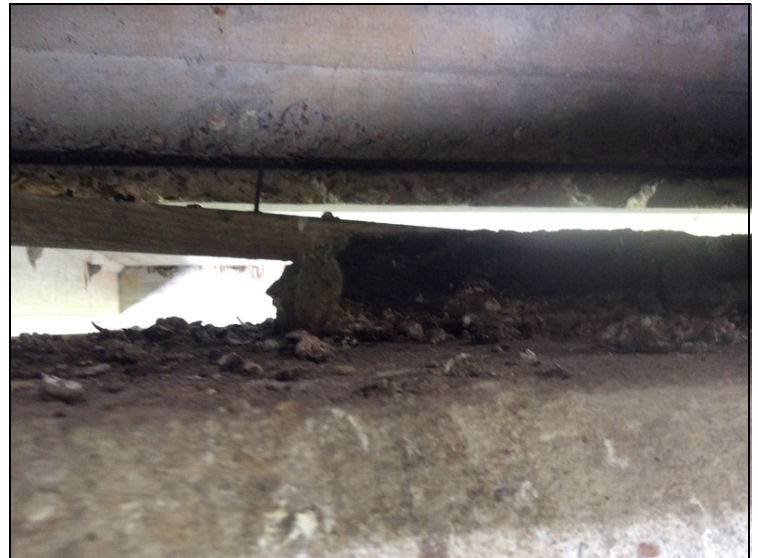
Cracking & spalls with rebar exposed to diaphragms between Girders 1-4 @ Bent 1.

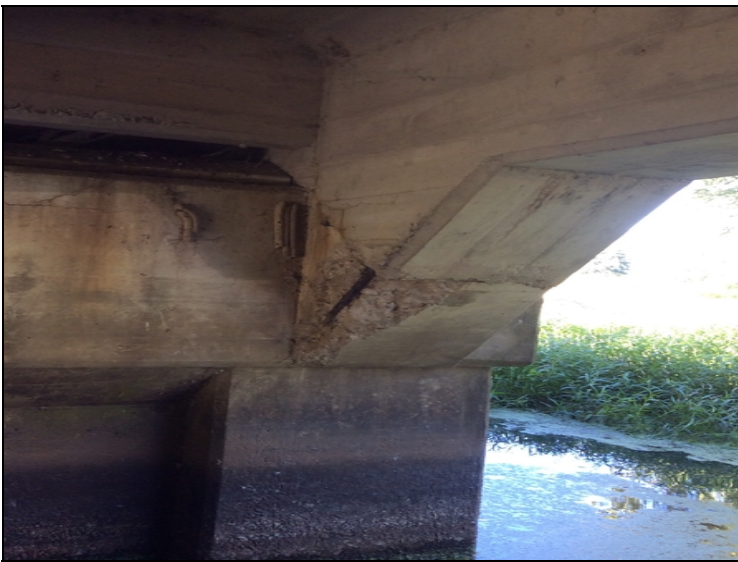
| ELEM | DESCRIPTION | UNITS | TOTAL | CS1 | CS2 | CS3 | CS4 |
|--|---|---|---|---|---|---|---|
| Span 2 - Girder 1 has spall with 1' rebar exposed to concrete haunch. | | | | | | | |

Span 2, Girder 1 has spall with 1' rebar exposed to concrete Haunch.

Span 2 Girder 1 has spall with 1' rebar exposed to concrete Haunch.

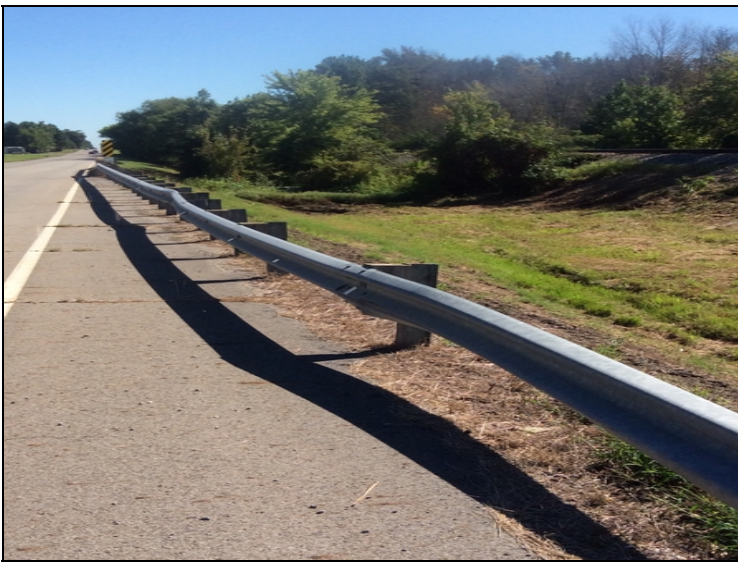
| ELEM | DESCRIPTION | UNITS | TOTAL | CS1 | CS2 | CS3 | CS4 |
|--|---|---|---|---|---|---|---|
| Damage to concrete end post @ Abutment 1 Left. | | | | | | | |

Impact damage to right guard @ approach at Abutment 1.

Impact damage to right guard @ approach at
Abutment 1.

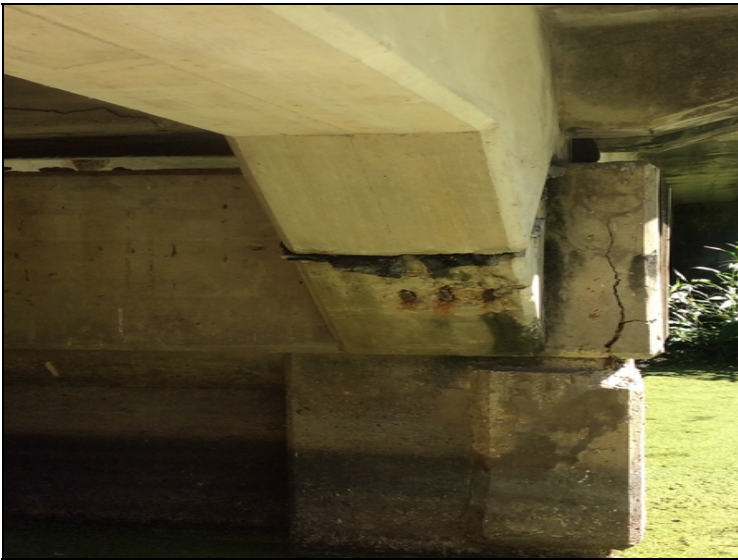
| ELEM | DESCRIPTION | UNITS | TOTAL | CS1 | CS2 | CS3 | CS4 |
|--|---|---|---|---|---|---|---|
| Span 1 - Girder 4 has spall with 1' rebar exposed to end of girder over cap. | | | | | | | |

Spall with 1' of rebar exposed to concrete haunch of Girder 4 @ Span 1.

Spall with 1' of rebar exposed to concrete haunch
of Girder 4 @ Span 1

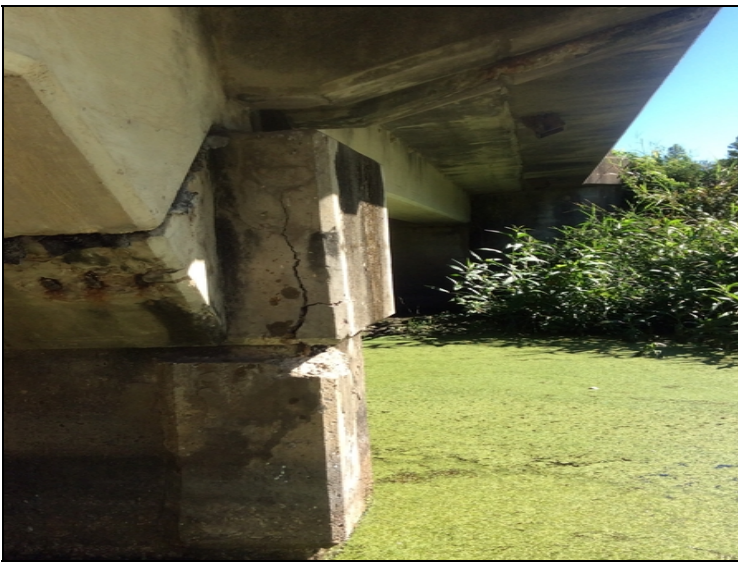
Large spall with rebar exposed to the right end of cap @ Bent 1.

Large cracks and area of delamination to the right end of cap @ Bent 1.

Pier Cap: Large cracks to right end of cap at bent 1.
