Bridge #01462(Routine, Underwater type 2)

SH 367 White Co. over GUM BAYOU

Location: 1.10 MI NE JCT OF SH 31

Team Lead: Nathan Edwards Inspection Date: September 20, 2021

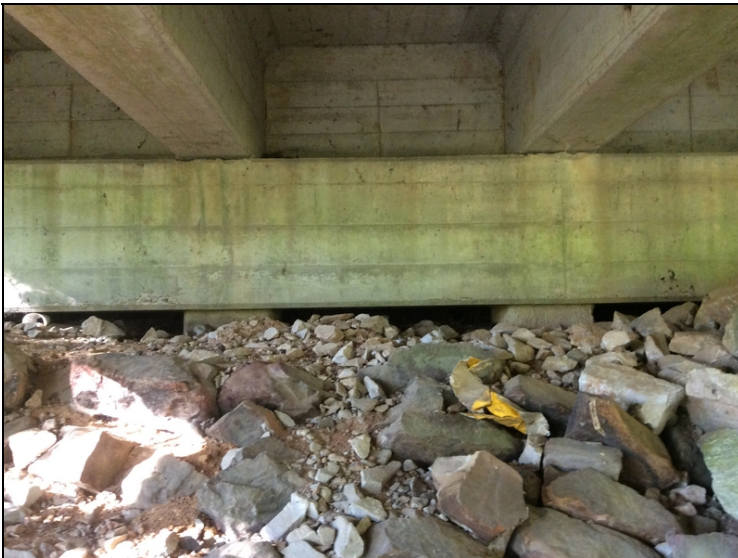
(215)	Minor cracks to abutments. Abutment 1 - Erosion to slope with 2 piles exposed. Abutment 2 - Erosion to slope with 3 piles exposed. SEE FORM III for detailed descriptions and locations of deficiencies.						
227	Reinforced Concrete Pile	EA	25	4	17	4	0
1080	Delamination/Spall/Patched Area	EA	2	0	2	0	0
1190	Abrasion/Wear (PSC/RC)	EA	19	0	15	4	0

Abutment 1 has settlement with 2 Piles exposed.

Abutment 2 has settlement with 3 Piles exposed.

Abutment 1 & 2 has settlement with piles exposed.

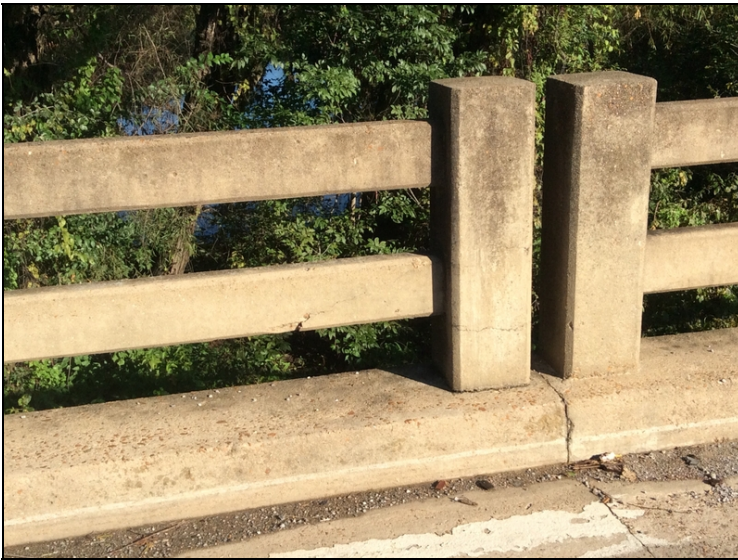
(331)	Concrete railing & post cracking & spalling SEE FORM III for detailed descriptions and locations of deficiencies.

Random cracking & spalls to concrete post & bridge railing @ all spans.

Random cracking & spalls to concrete post &
bridge railing @ all spans.

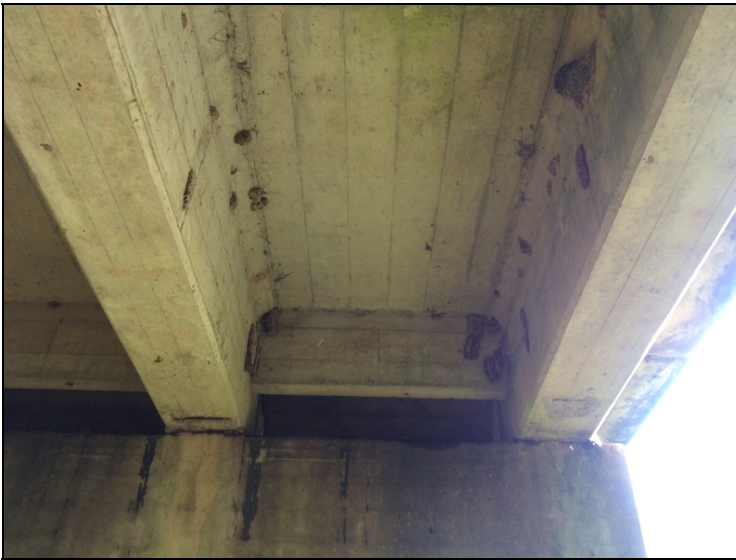
(110)	Spalls with rebar exposed to girders @ all spans SEE FORM III for detailed descriptions and locations of deficiencies.						
215	Reinforced Concrete Abutment	LF	60	18	41	1	0
1130	Cracking (RC and Other)	LF	2	0	1	1	0
6000	Scour	LF	40	0	40	0	0

Spalls with rebar exposed to Girders @ Spans 1 - 5.

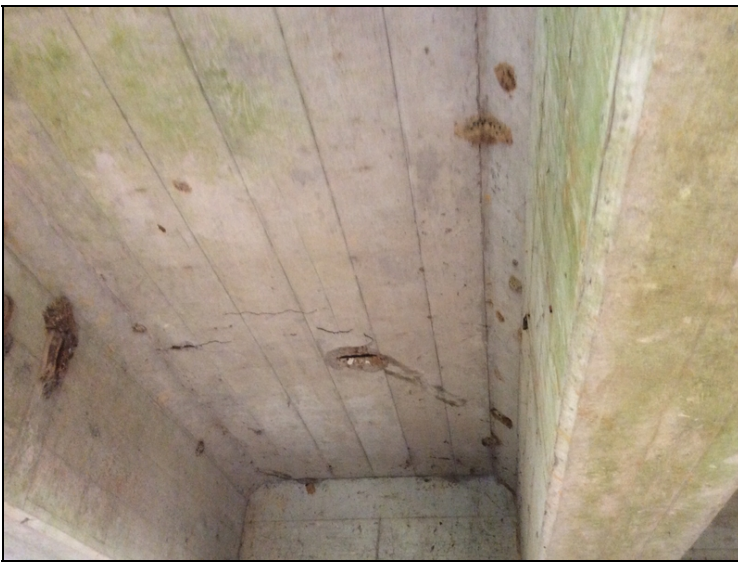
Soffit has Spalls with rebar exposed at various locations @ Spans 1 thru 5

Typical of Spalls to soffit with rebar exposed at various locations @ Spans 1 thru 5

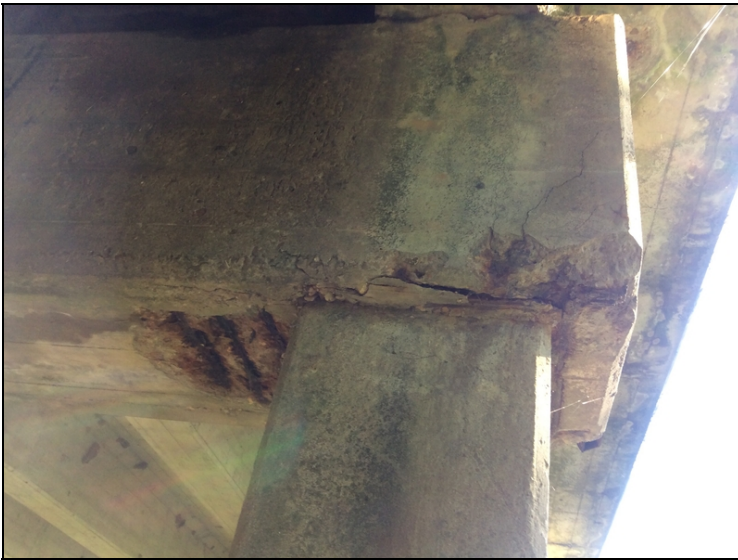
ELEM	DESCRIPTION	UNITS	TOTAL	CS1	CS2	CS3	CS4
1090	Exposed Rebar	LF	7	0	0	7	0
1130	Cracking (RC and Other)	LF	3	0	3	0	0
(234)	Bent 1 - Spall with 3' rebar exposed to bottom of cap between Piles 4 & 5. Vertical crack to Left end of cap. Cracks to back of cap @ Piles 2 & 3. Bent 2 - Spall with 1' rebar exposed to Left end of cap. Area of delamination to bottom of cap. Bent 3 - Spall with 3' rebar exposed to bottom of cap between Piles 4 & 5. Bent 4 - 1 square foot cracked & delaminated area to Left end of cap.						
301	Pourable Joint Seal	LF	48	0	0	31	17
2310	Leakage	LF	48	0	0	31	17

Spalls with rebar exposed to caps @ Bents 1 - 3.

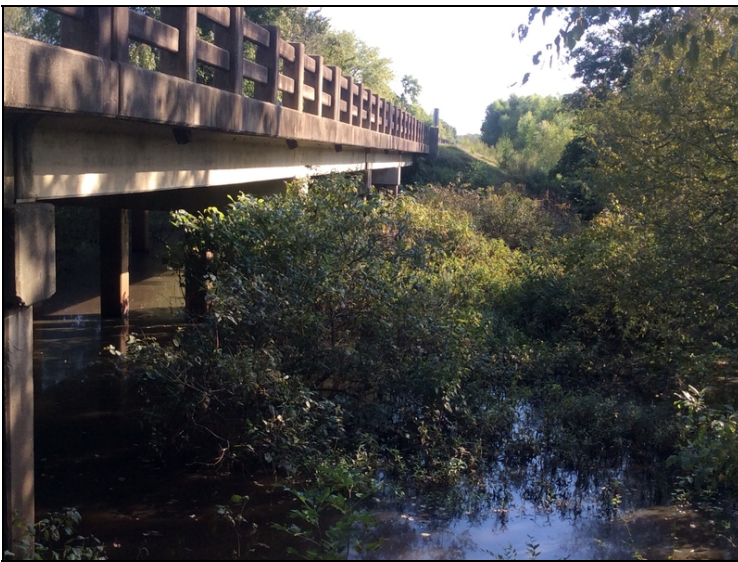
Heavy vegetation on Left & Right sides of bridge.

Vegetation on Right side of bridge.

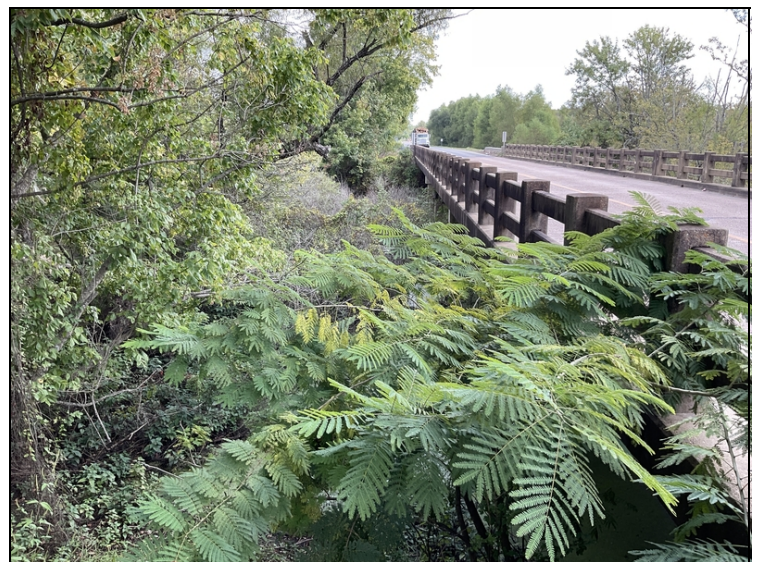
Vegetation on Left side of bridge.

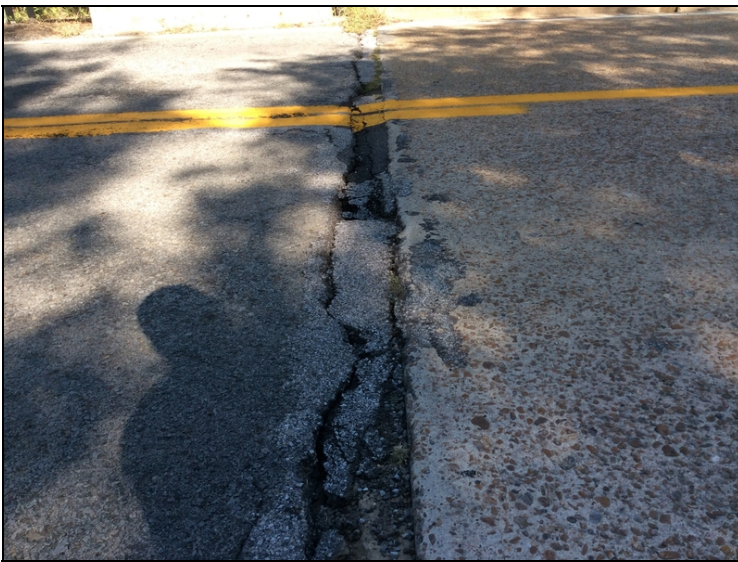
Roadway settlement @ Abutment 1.

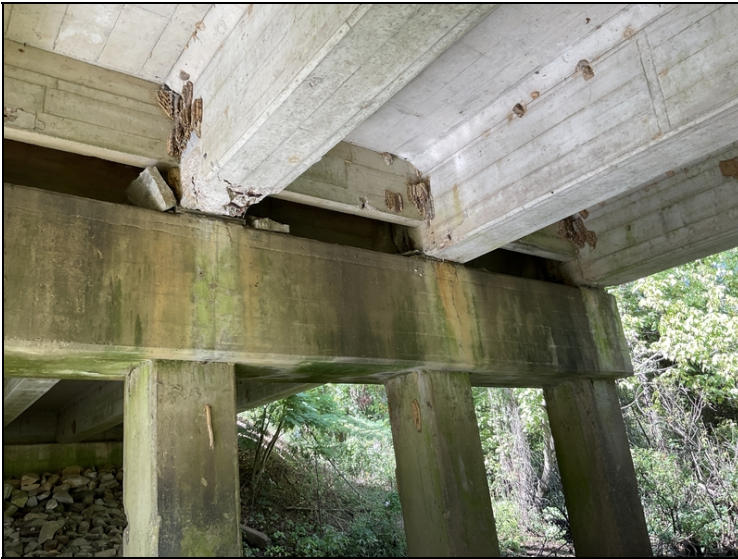
(311)	Loss of bearing area @ ends of Girders 1, 2 & 3 @ beginning of Span 2. Loss of bearing area to Moveable Bearings 3 & 5 @ beginning of Span 4.						
331	Reinforced Concrete Bridge Railing	LF	362	330	6	26	0
1090	Exposed Rebar	LF	2	0	0	2	0
1130	Cracking (RC and Other)	LF	7	0	6	1	0
7000	Damage	LF	23	0	0	23	0

Loss of bearing area @ ends of Girders 1, 2 & 3 @ beginning of Span 2.
Loss of bearing area @ ends of Girders 3 & 5 @ beginning of Span 4.

Loss of bearing area @ ends of Girders 1, 2 & 3 @ beginning of Span 2.

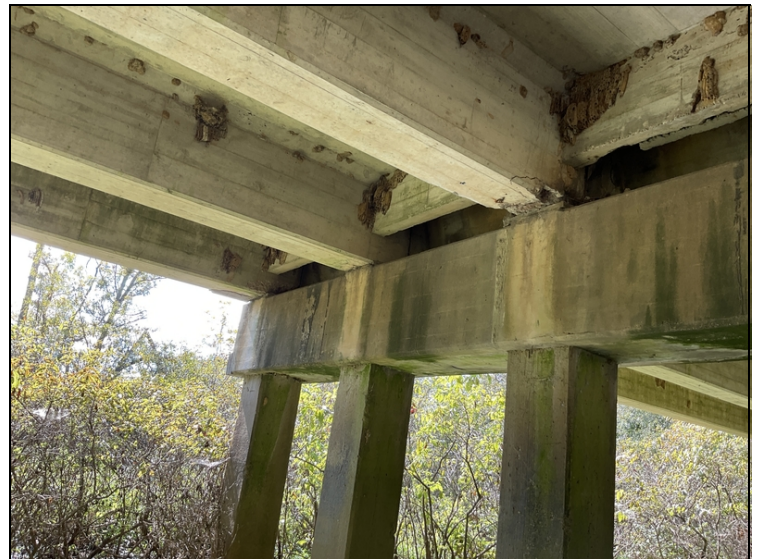
Loss of bearing area @ ends of Girders 3 & 5 @ beginning of Span 4.
