**Bridge #03011(Routine)**  
**US79 S-7 LM 7.70 over SALINE RIVER**

**Location: 4.89 MI S JCT SH 35**

**Team Lead: Jimmy Reynolds Inspection Date: August 31, 2021**

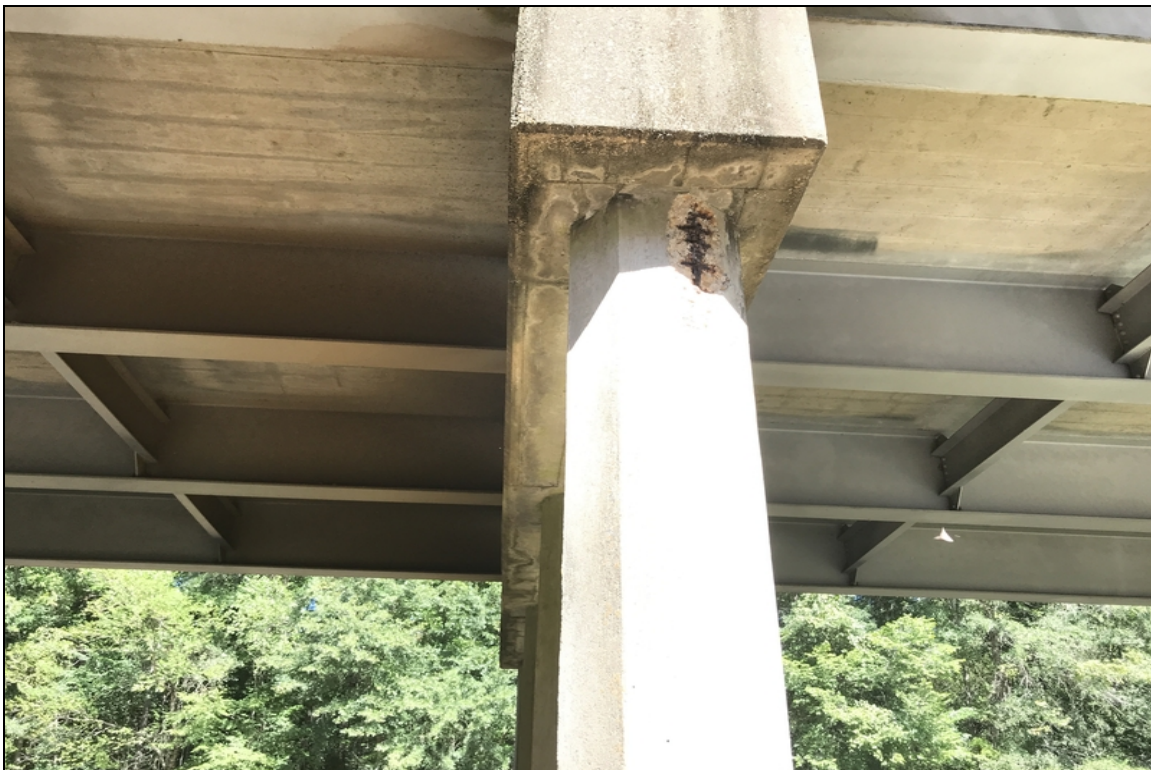
Bent 41 pile 4 spalled

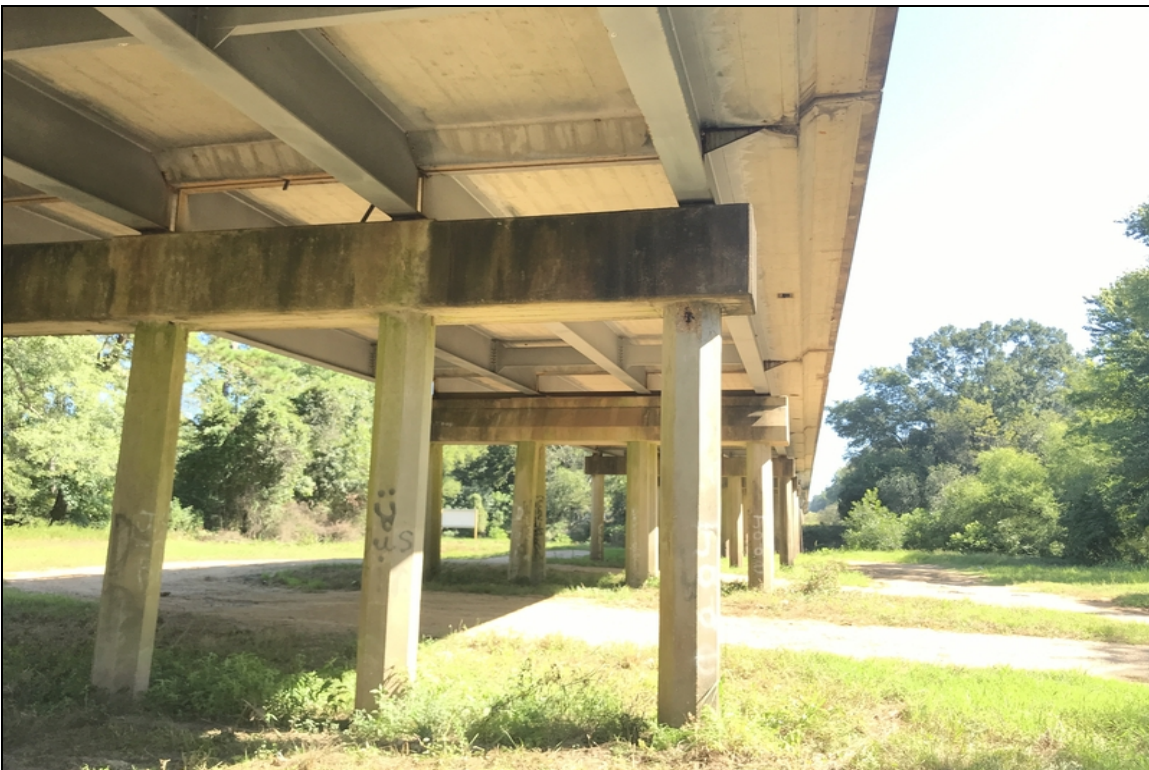
Bent 21 pile 4 spalled

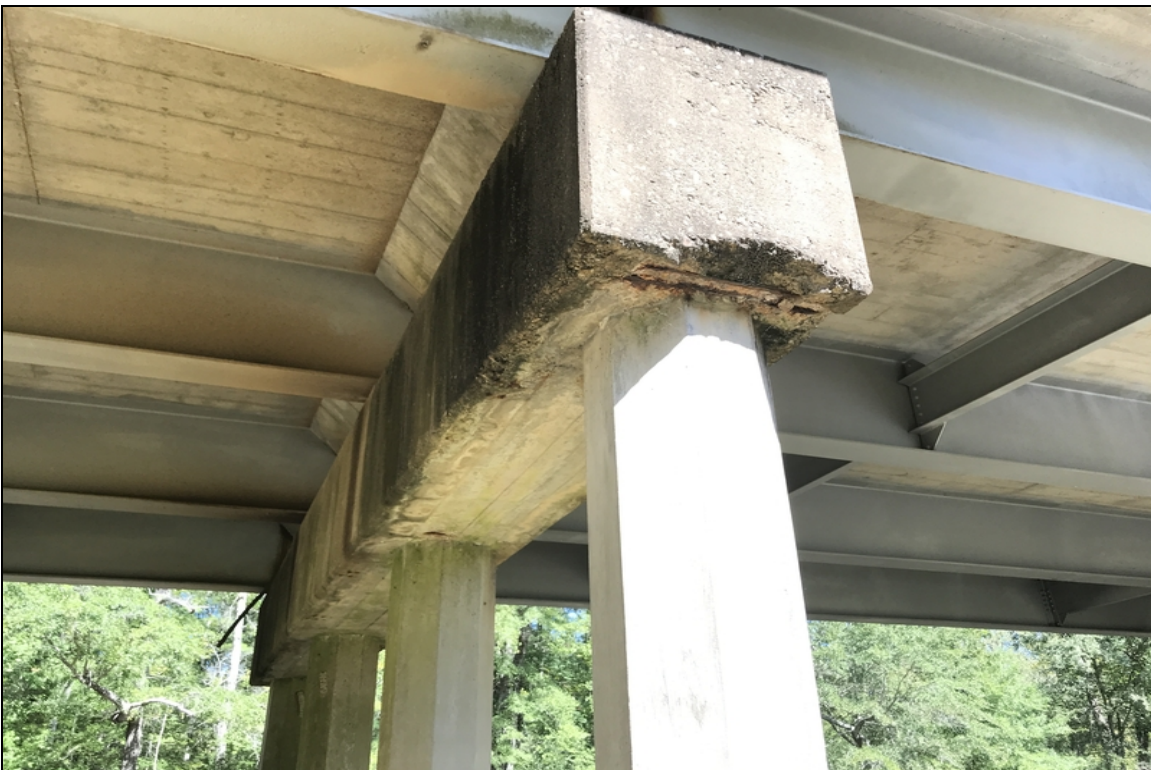
Bent 15 cap spalled right side

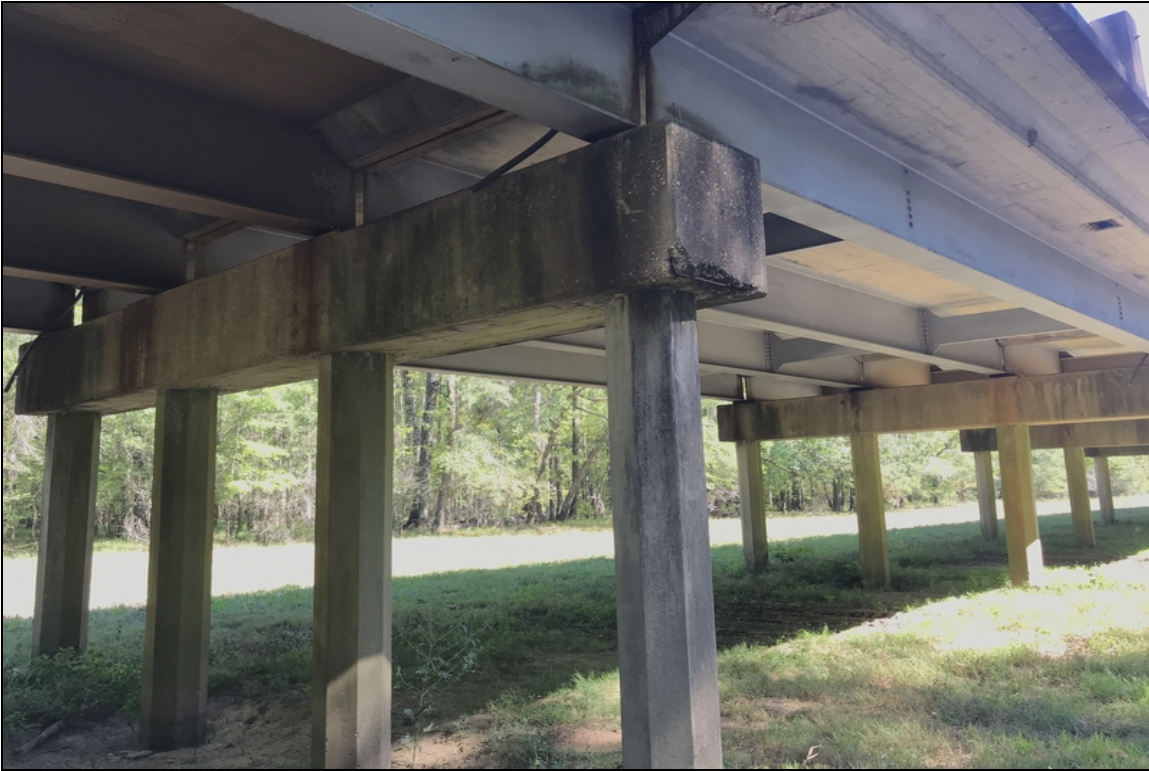
Bent 9 cap spalled right side

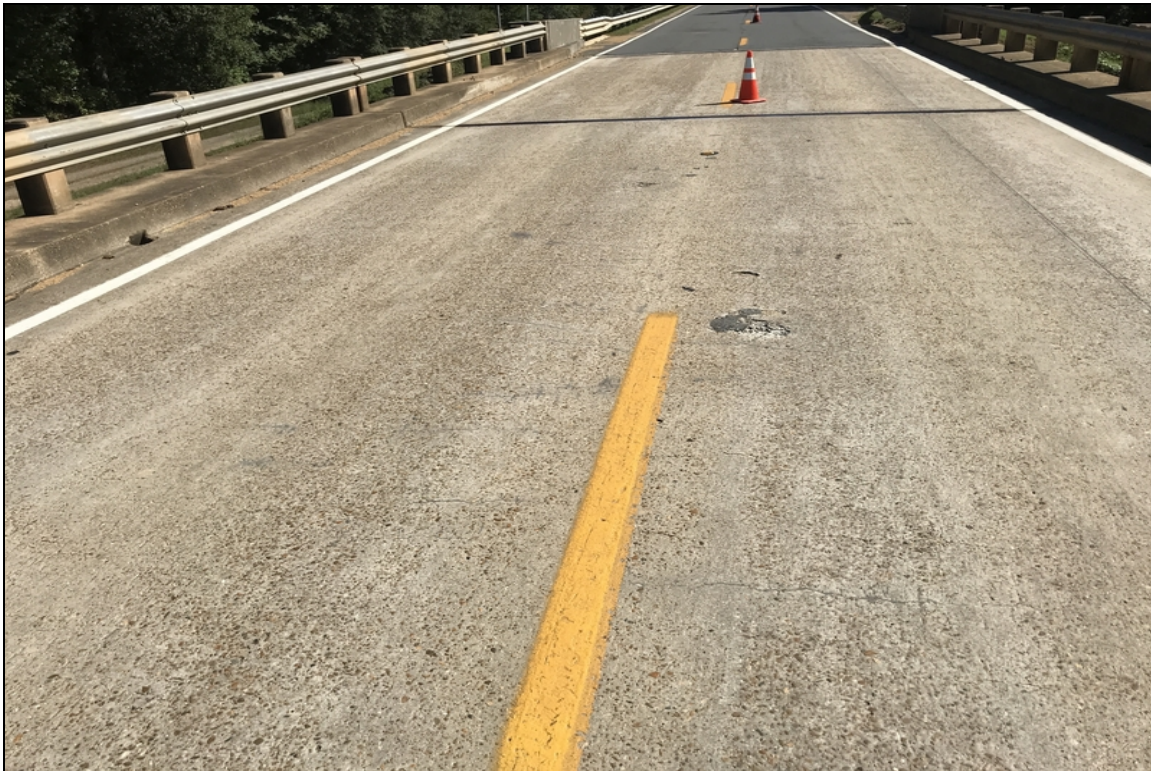
Span 48 looking ahead @ deck overview with some minor spalls.

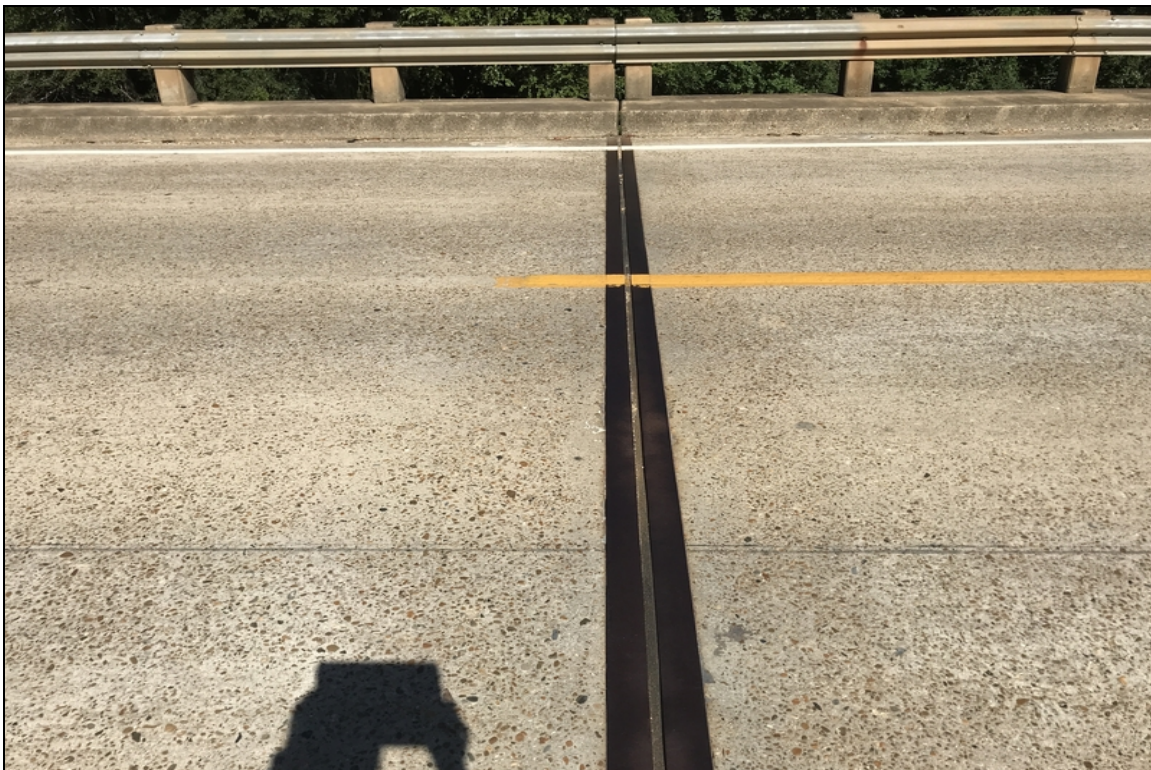
Bent 44 looking across @ joint repair.

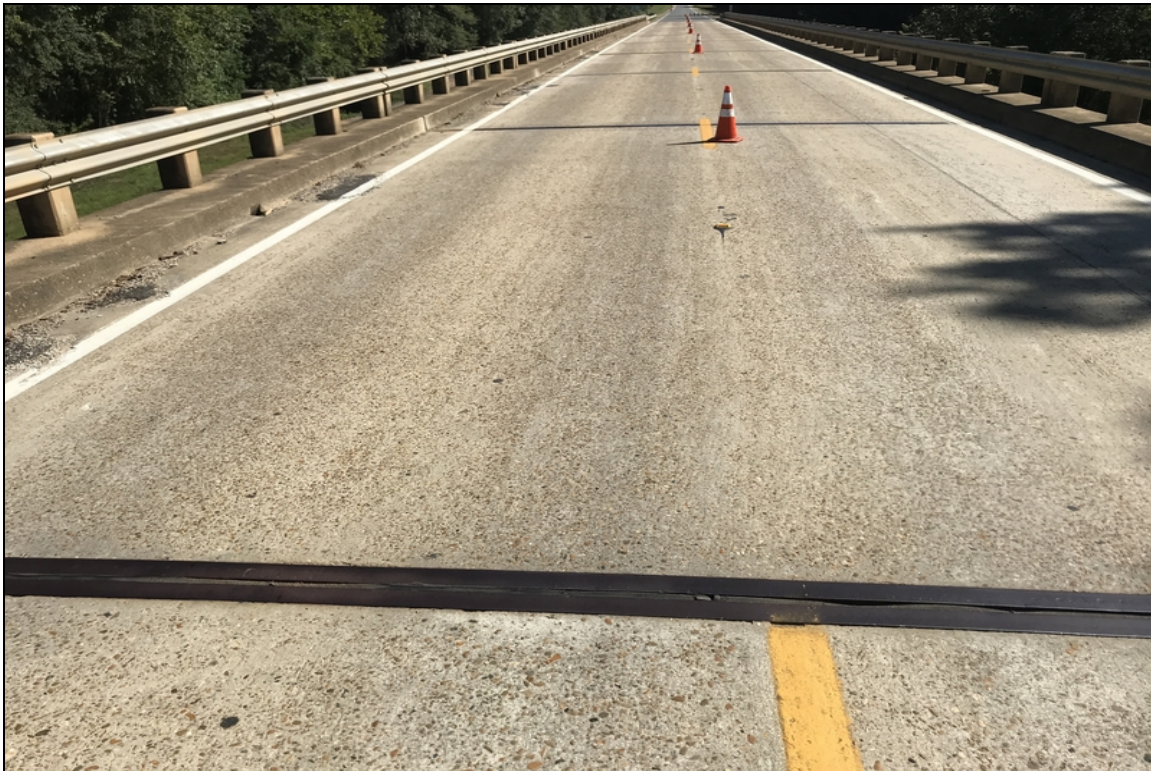
Span 40 looking ahead @ deck overview with some spalls in Lt. gutterline.

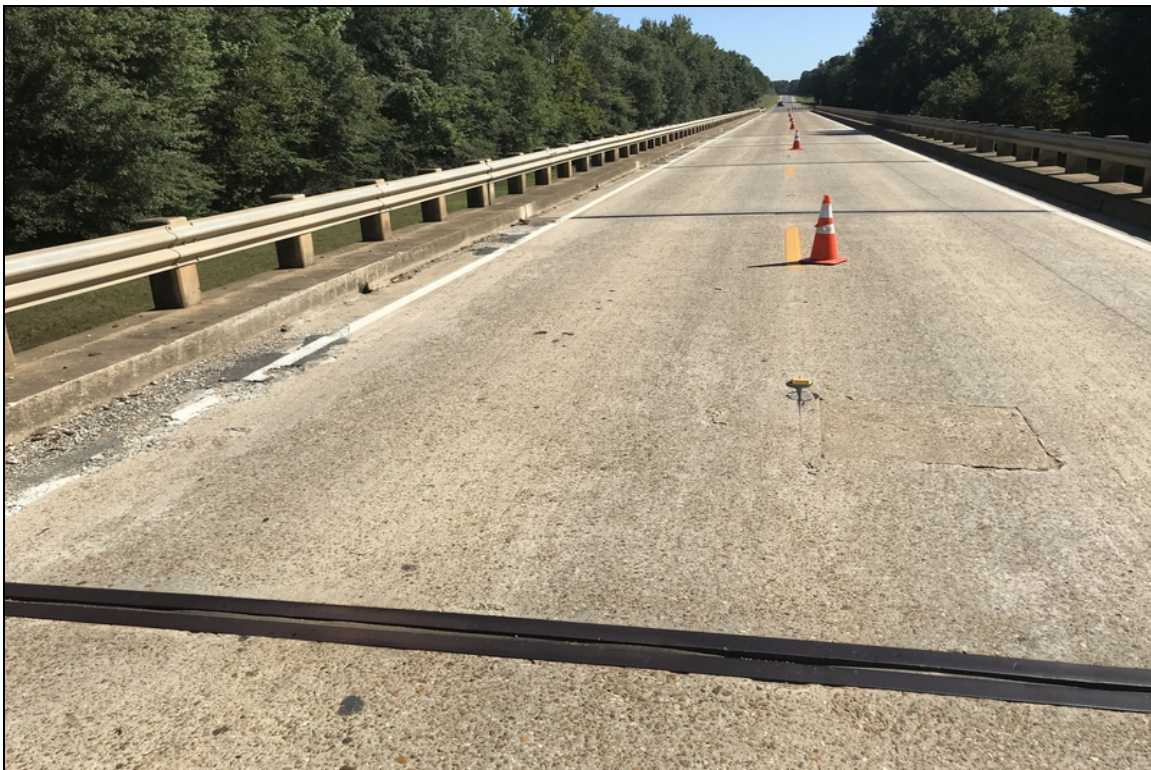
Span 36 looking ahead @ deck overview with some spalls mainly in Lt. Gutterline.

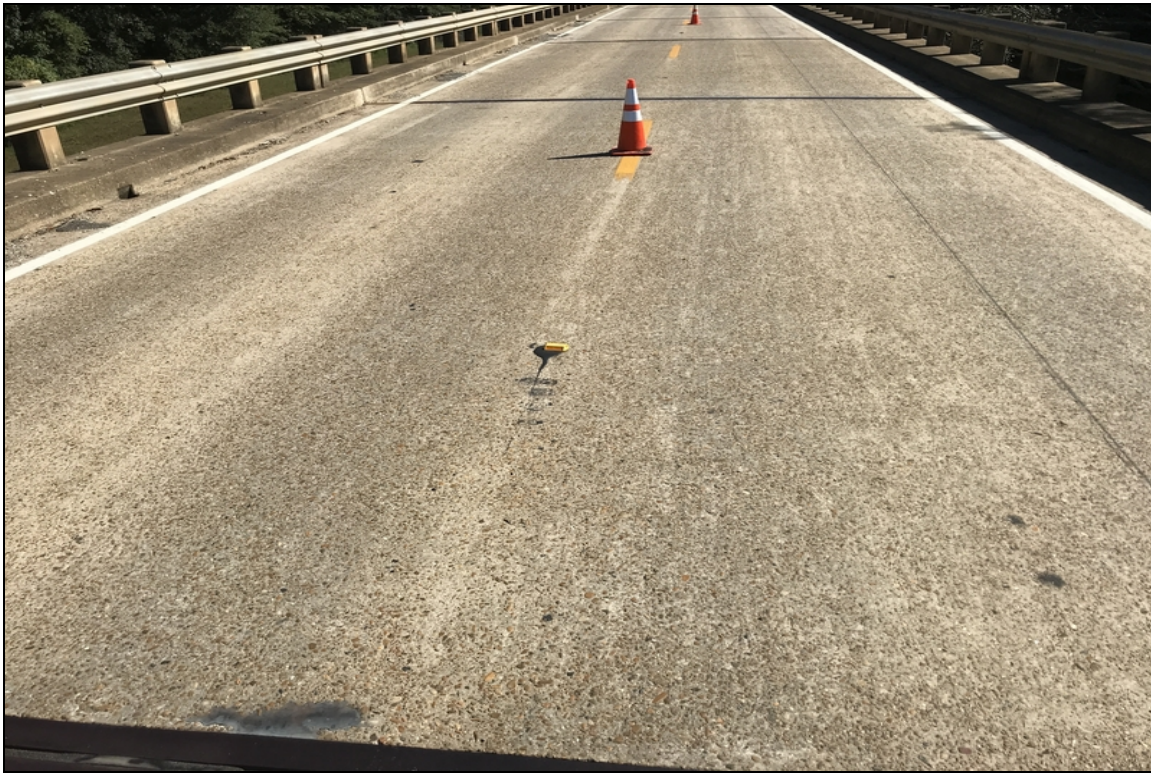
Span 34 looking ahead @ deck overview. There are some small spalls in Lt. gutterline.

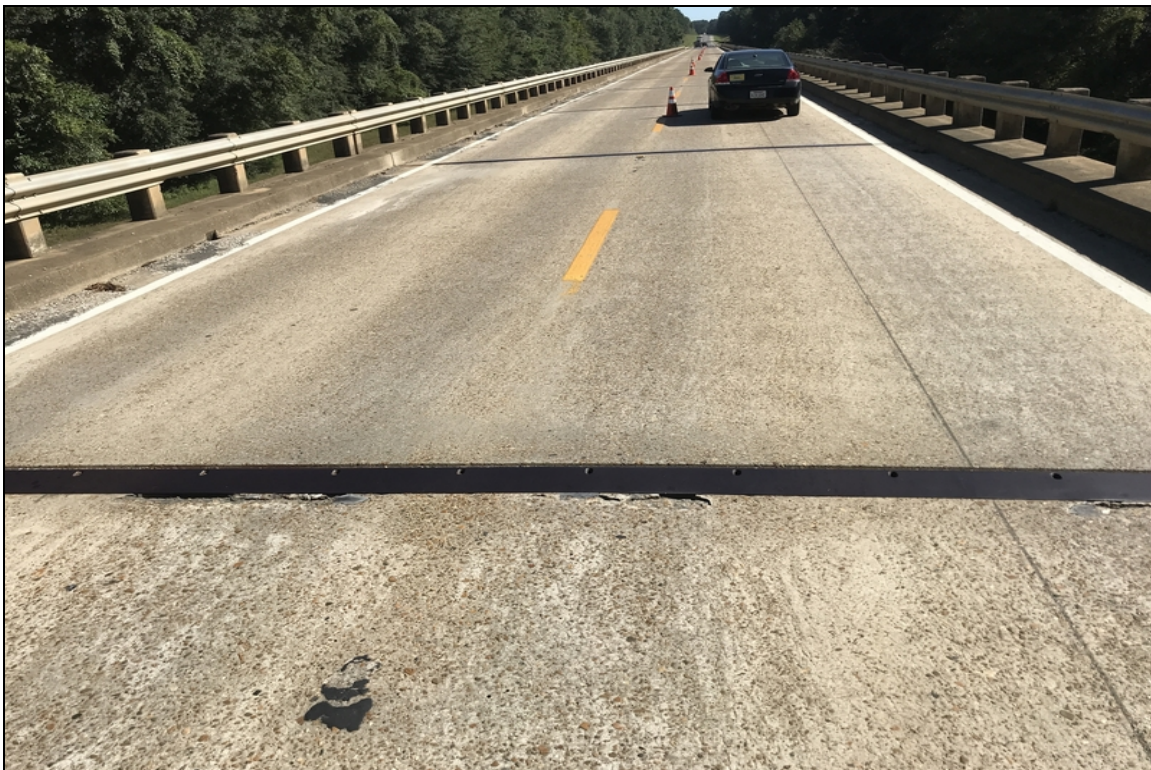
Span 28 looking ahead @ span 28. There is some minor spalling on the back side of joint between 28 & 29. There is also some deck spalls in Lt. gutterline.

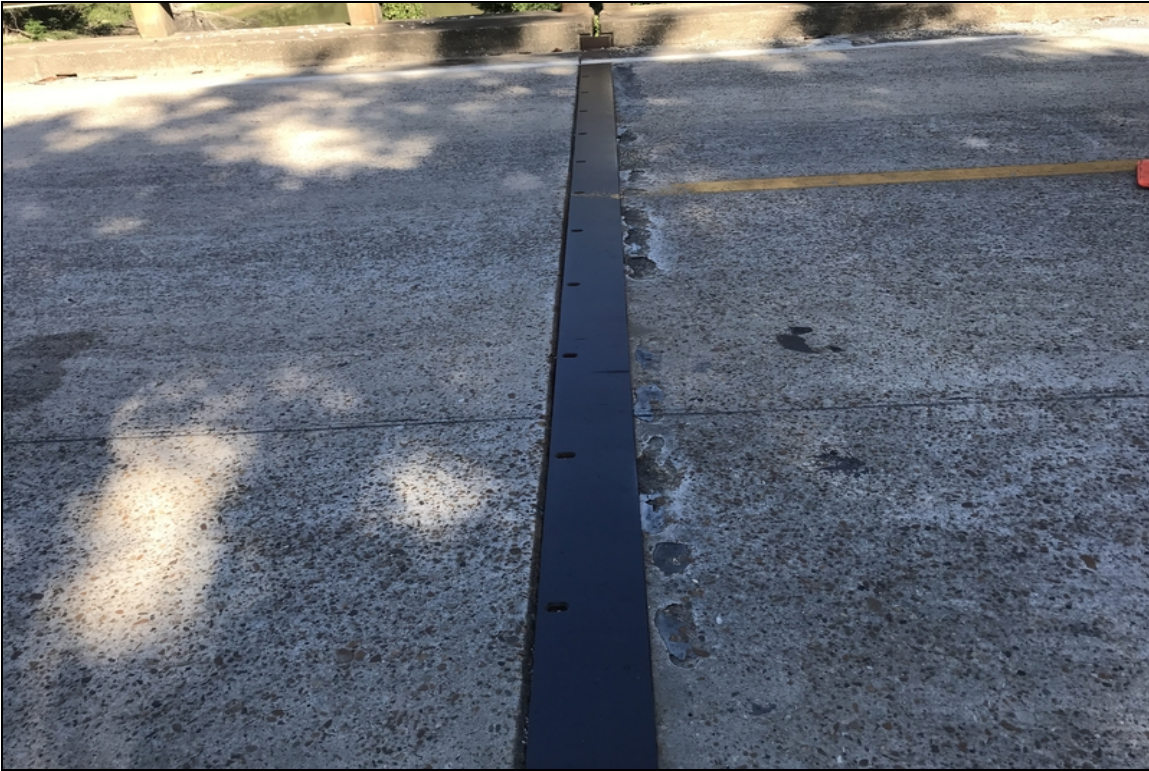
Bent 27 looking across @ joint between spans 27 & 28. There is some minor spalls on the ahead side of the joint.

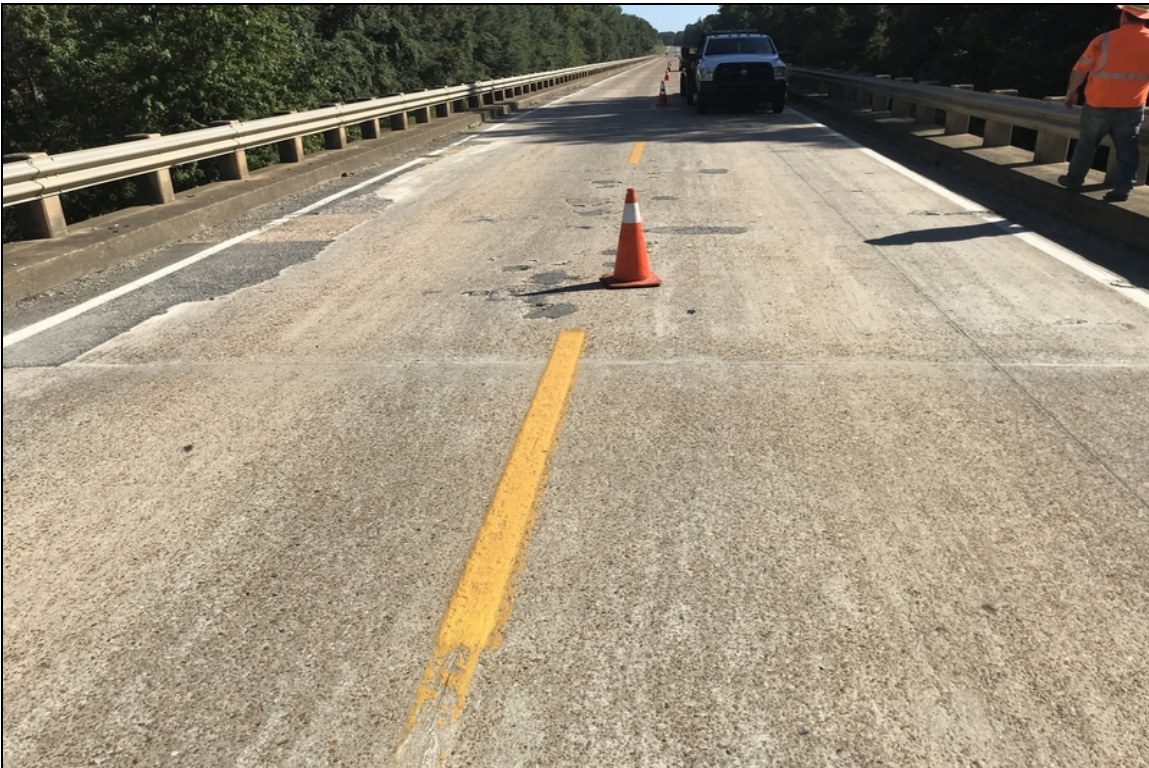
Span 26 looking ahead @ numerous deck spalls on entire span.

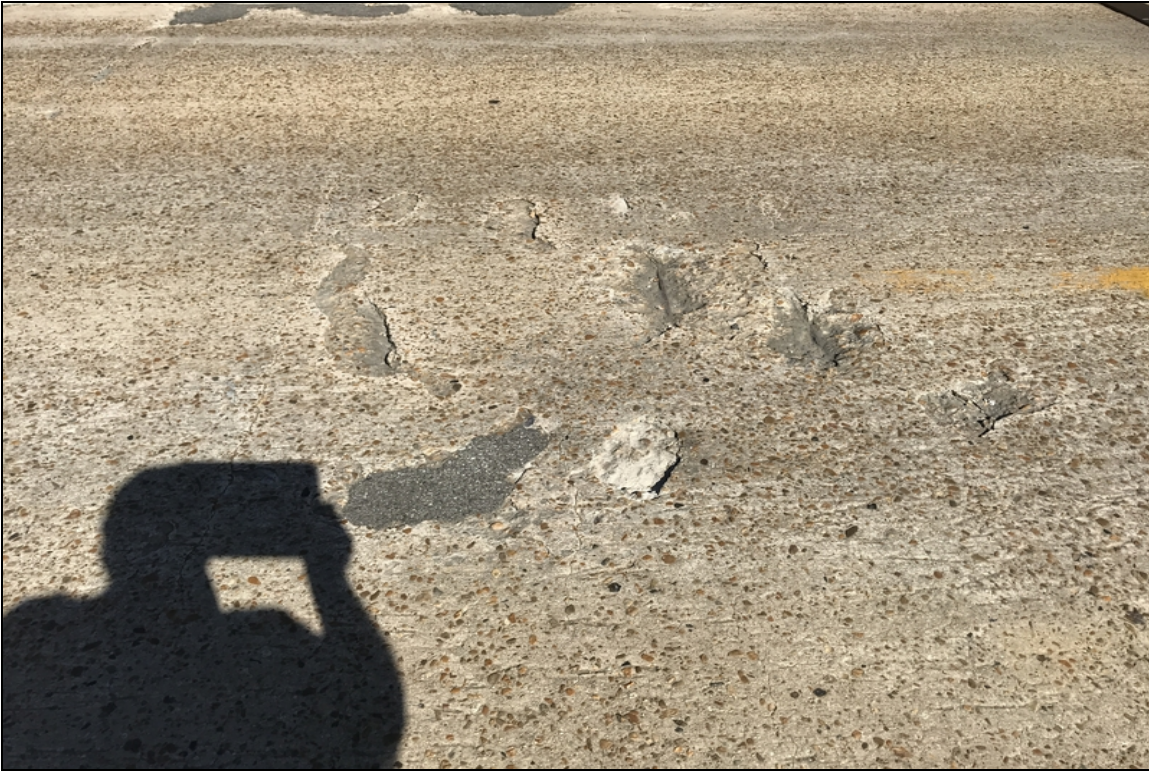
Span 23 @ C/L & 10' back of Bent 24 there is a spall with exposed rebar.

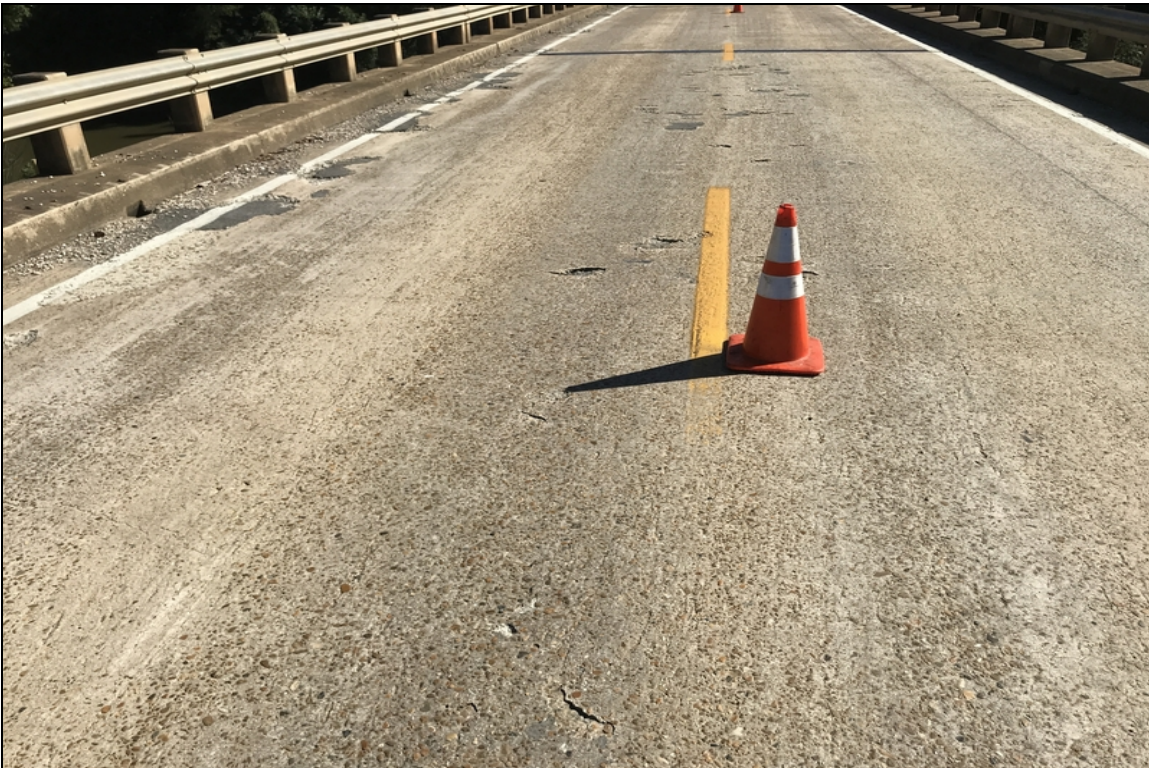
Span 23 looking ahead at deck overview with numerous spalls. There are several fairly large patched spalls in Lt. Gutterline & several smaller spalls Lt. & Rt. Of C/L. There are also numerous scaling & light spalls in the Rt. gutterline.

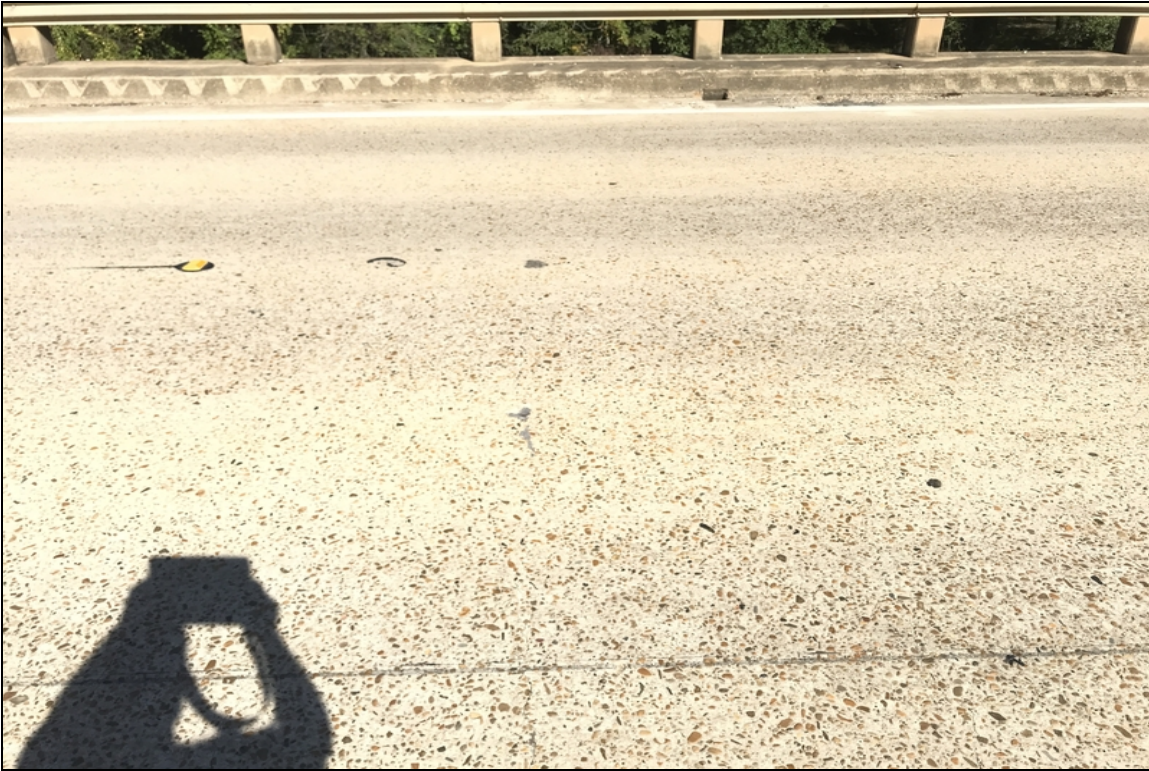
Span 21 looking across from Rt. to Lt. @ deck cracking, this is typical of numerous spans.  
There is also significant wear & abrasion to the spans.

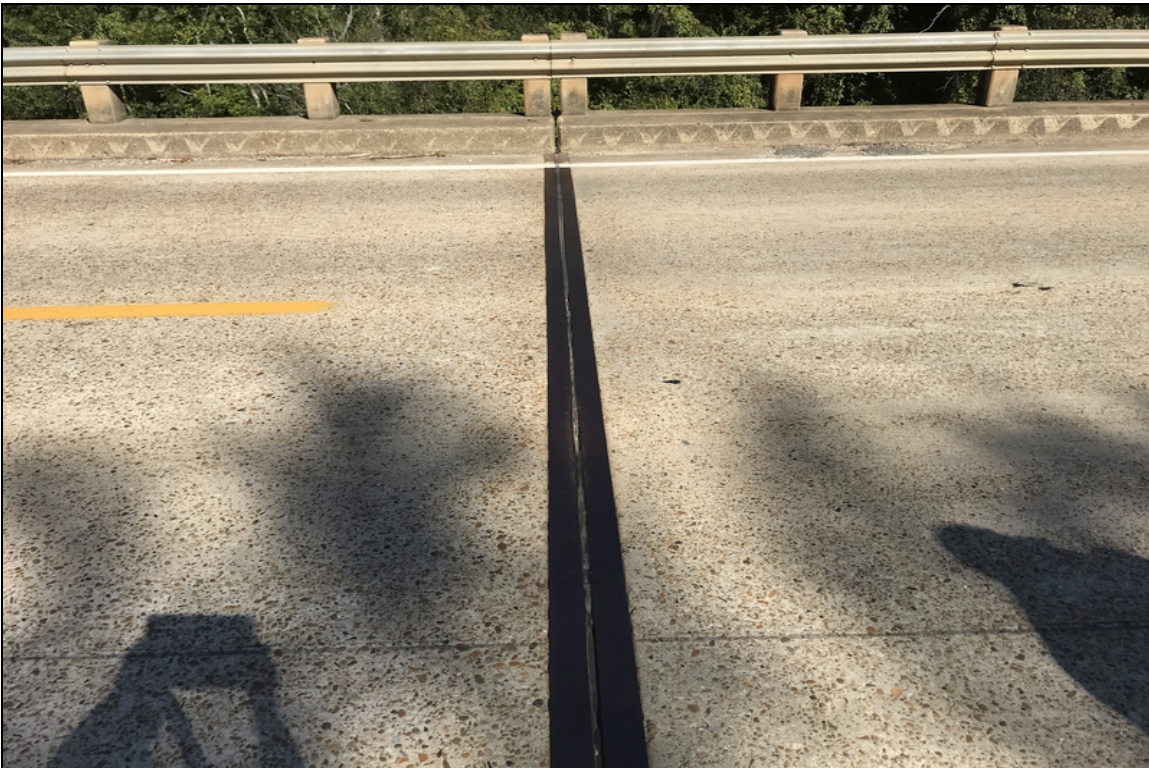
Bent 20 looking across @ joint repair, this joint is in good shape.

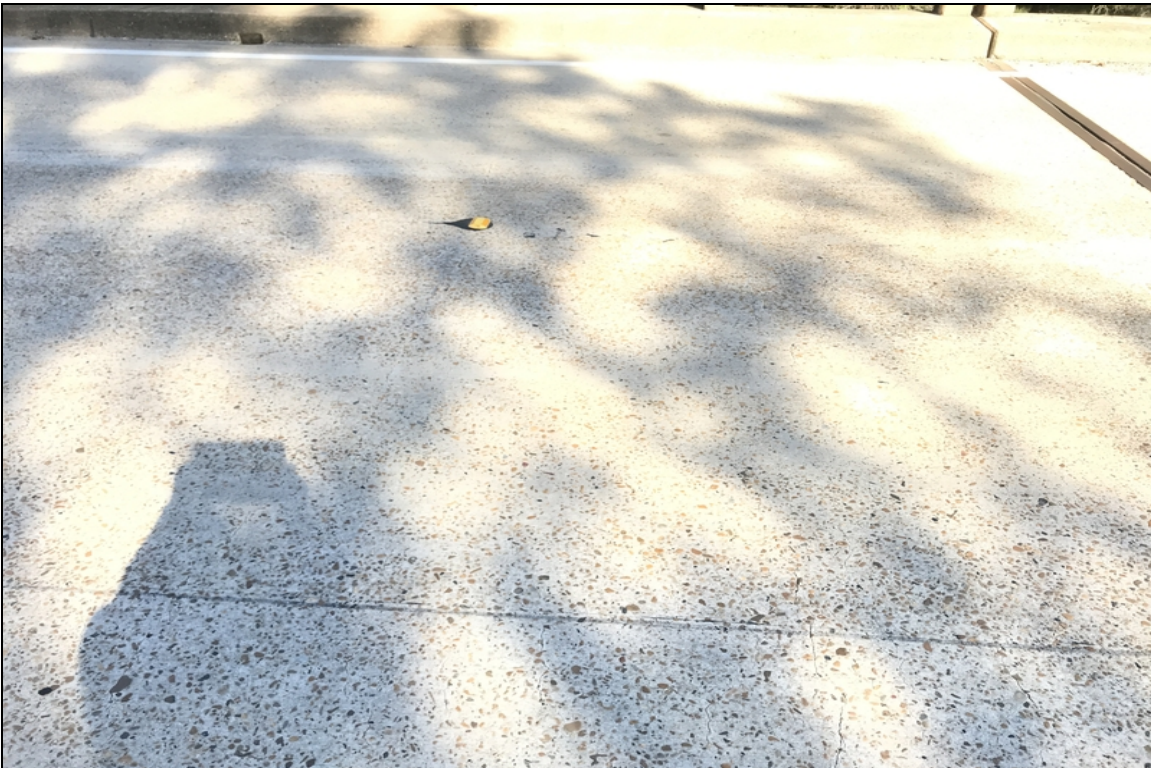
Span 8 looking across from Rt. to Lt. @ deck cracking

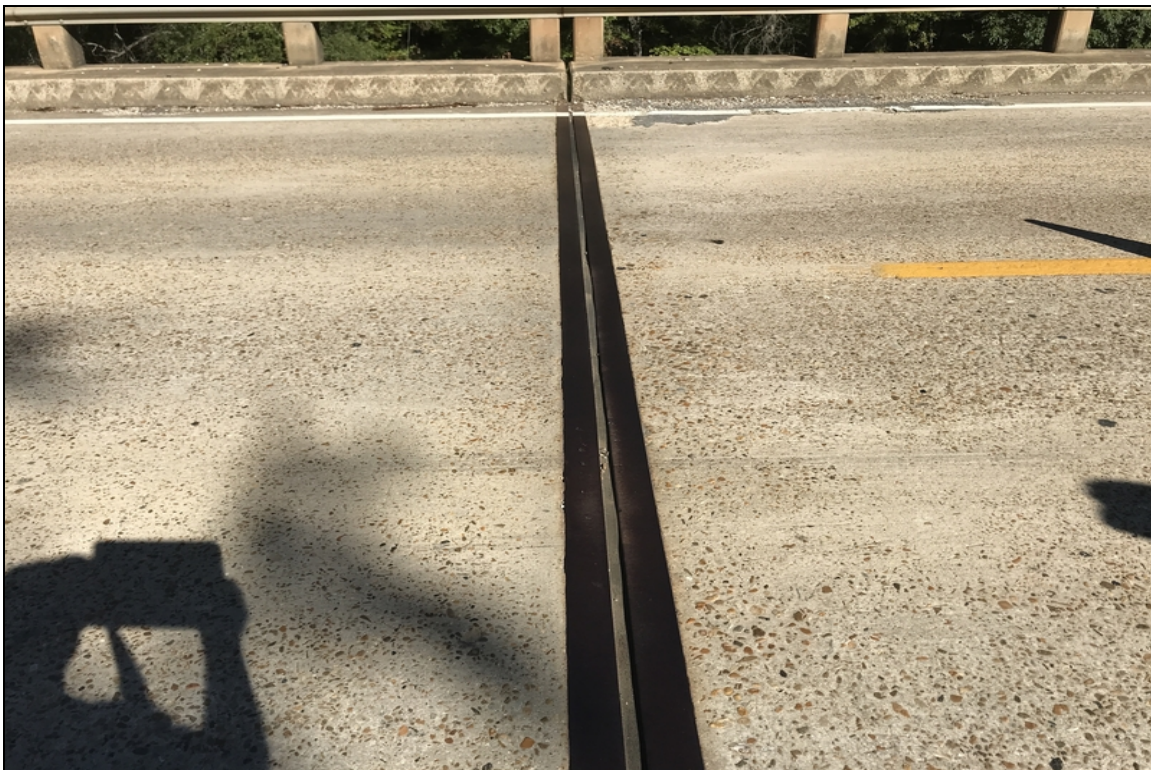
Bent 5 joint material has been repaired, typical of all joints.

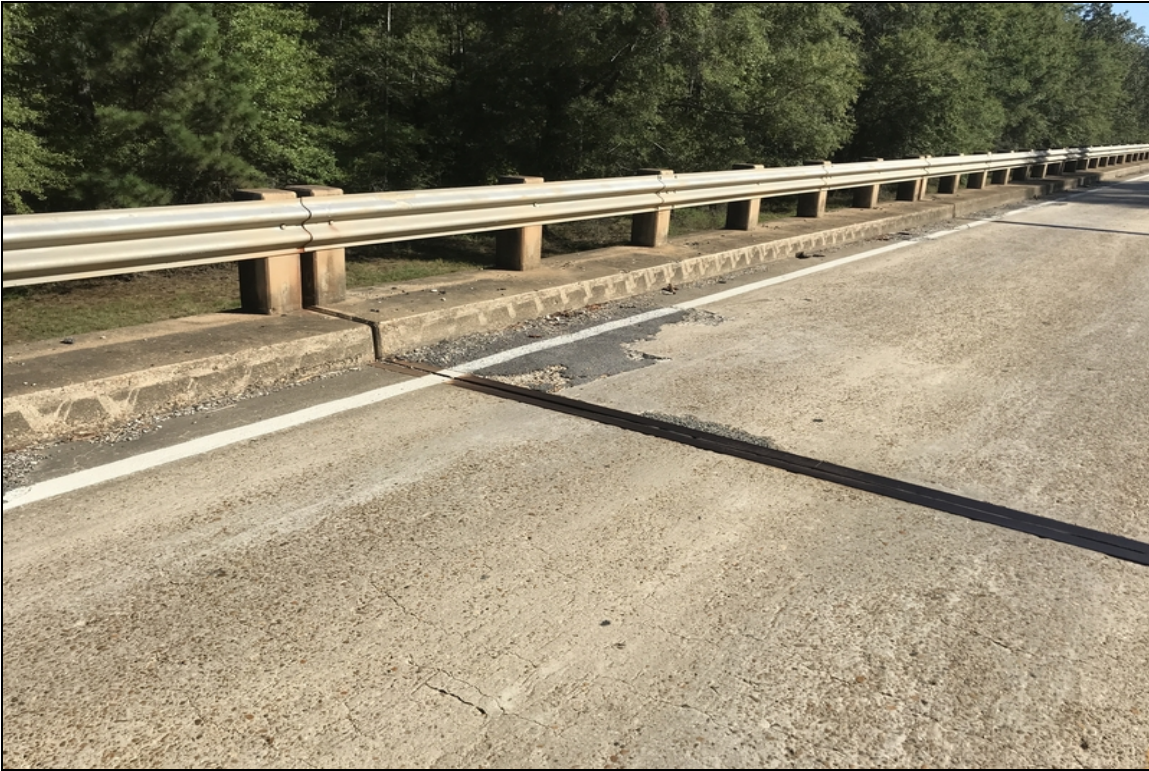
Span 2 Lt. Side from bent 2 ahead there is a patched spall in gutter line approx. (2 1/2' x 6').  
This is typical of spans 1 - 5.

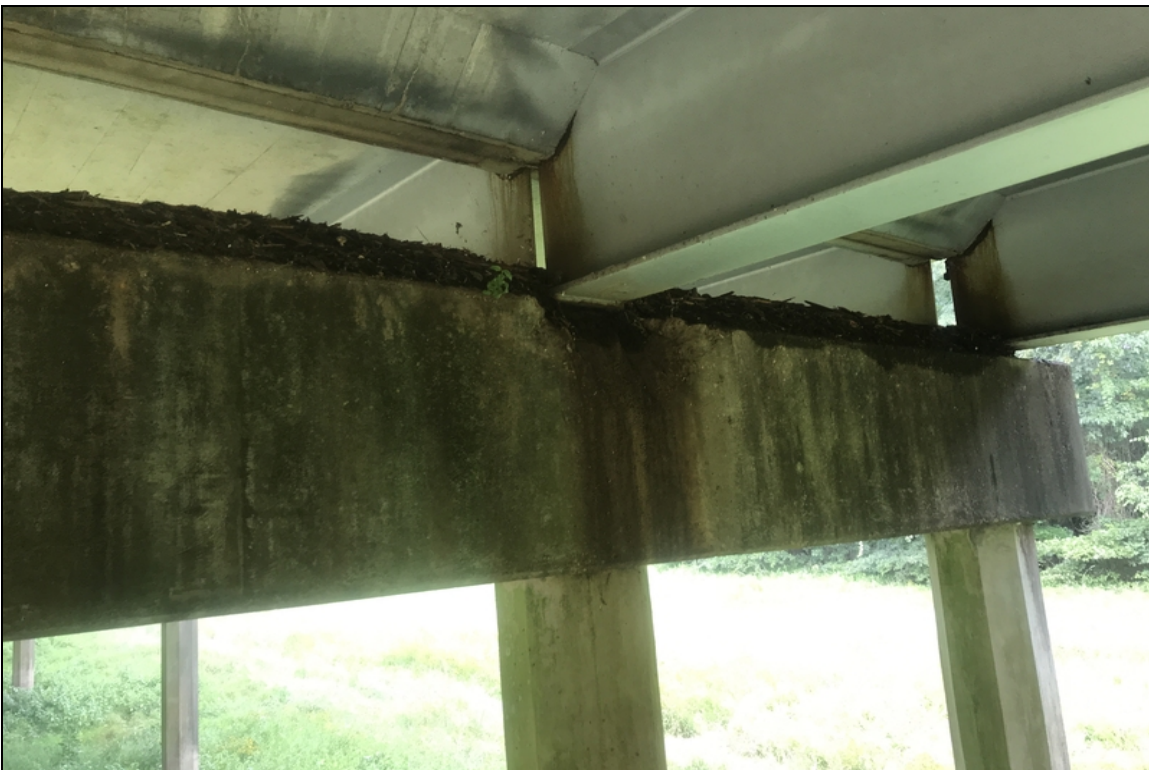
Bent33 cap spall

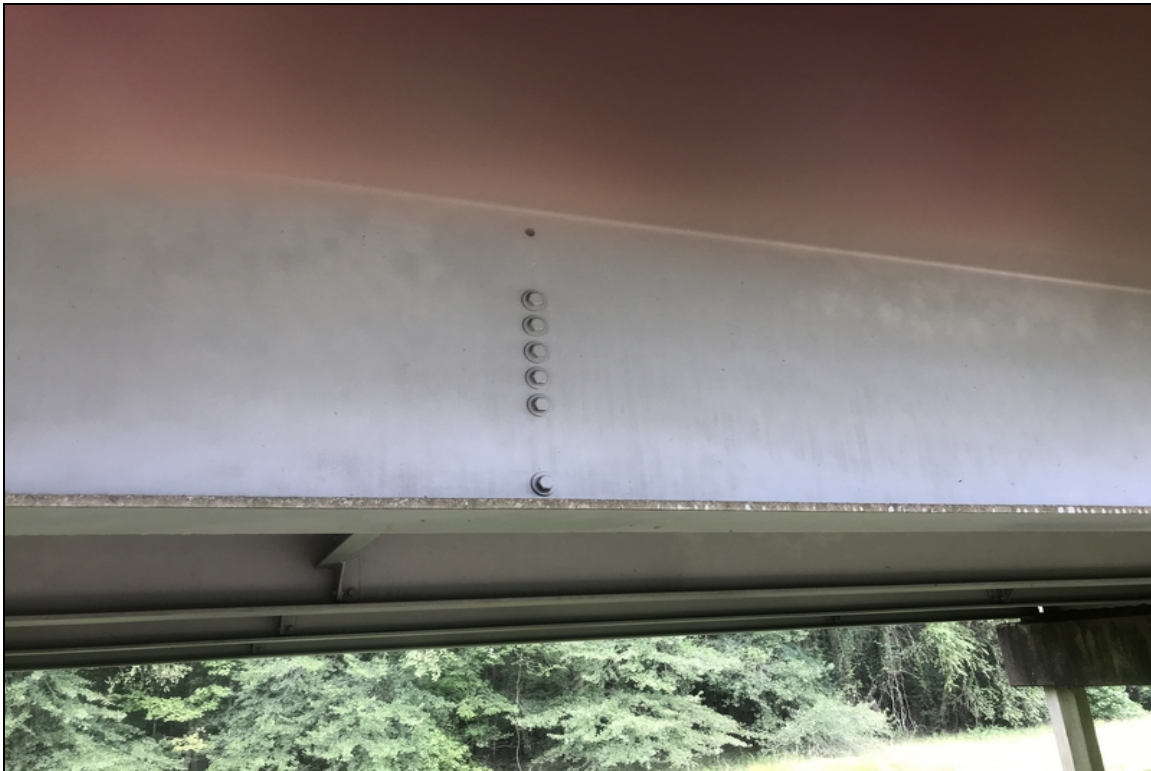
Span 41 beam 4 top bolt missing from diaphragm

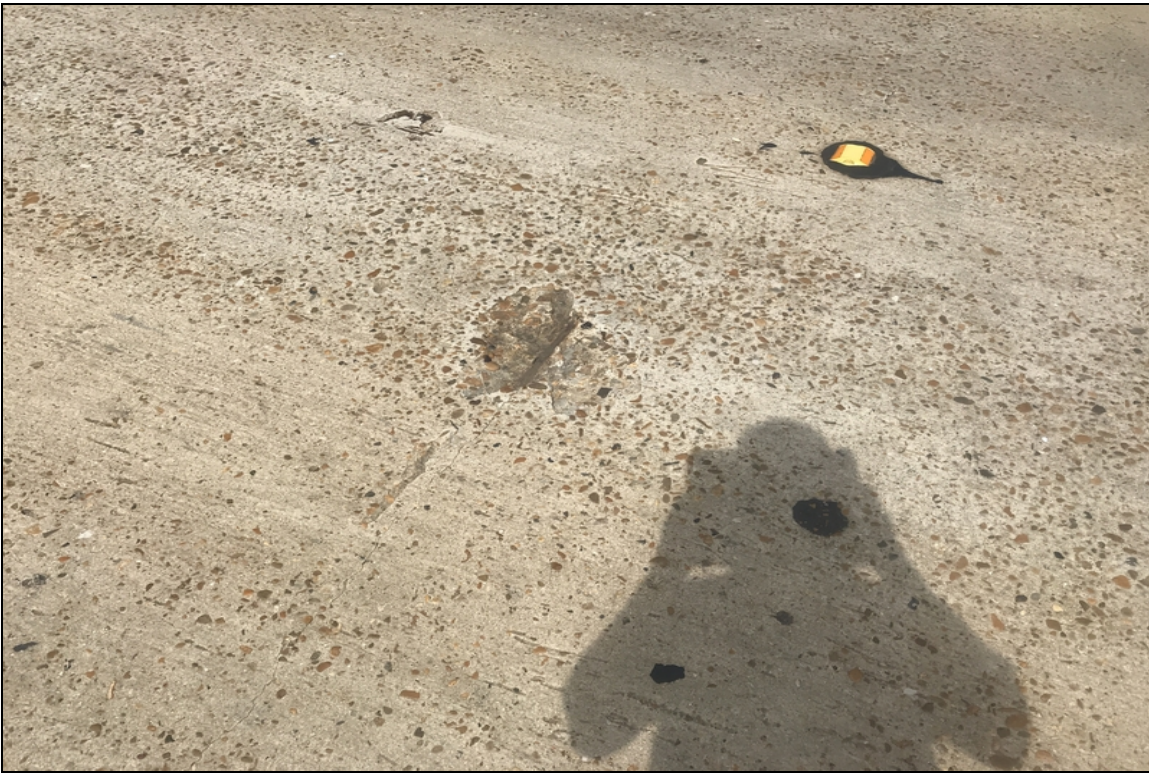
Span 26, spall with exposed rebar.

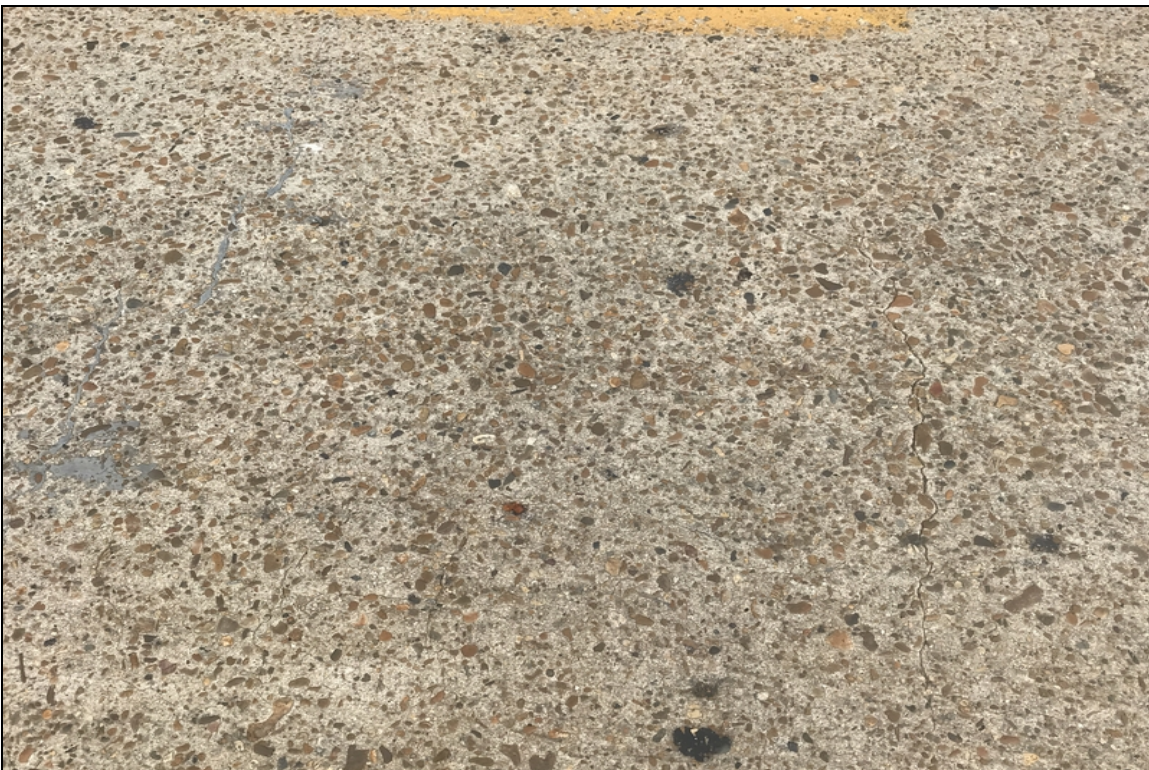
Span 43, open and sealed cracks.

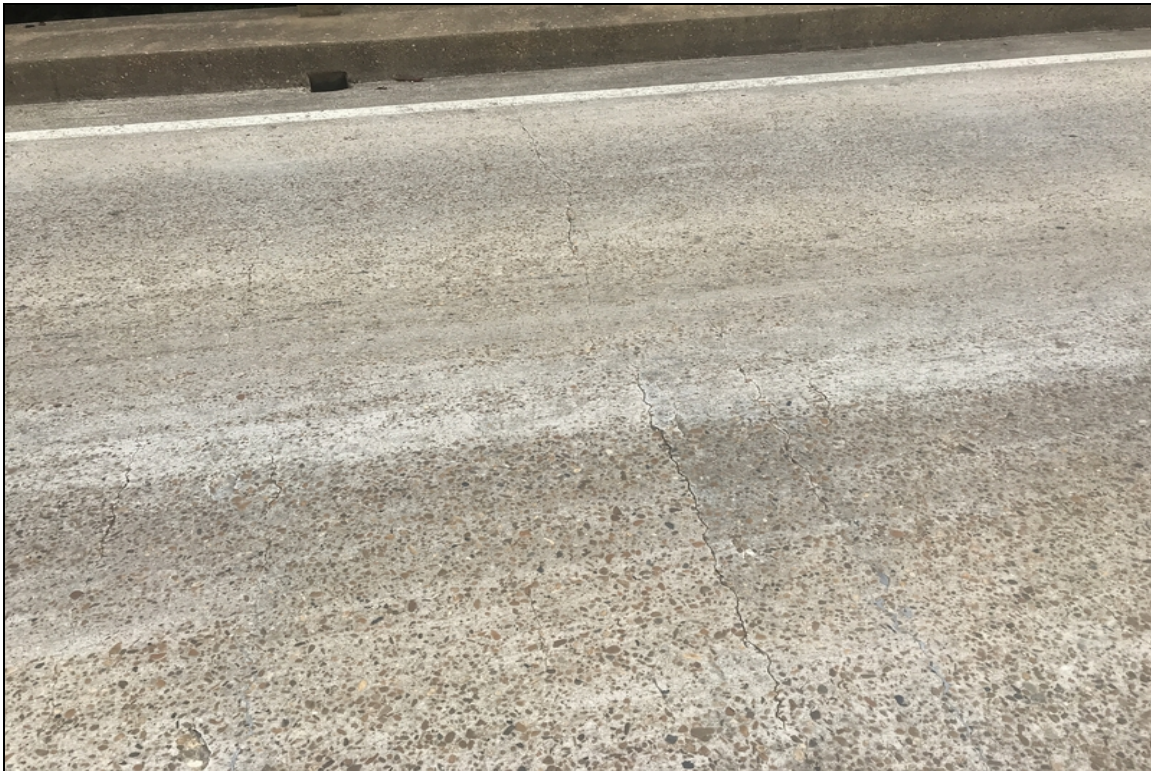
Span 8, moderate transverse cracks, max 0.040.

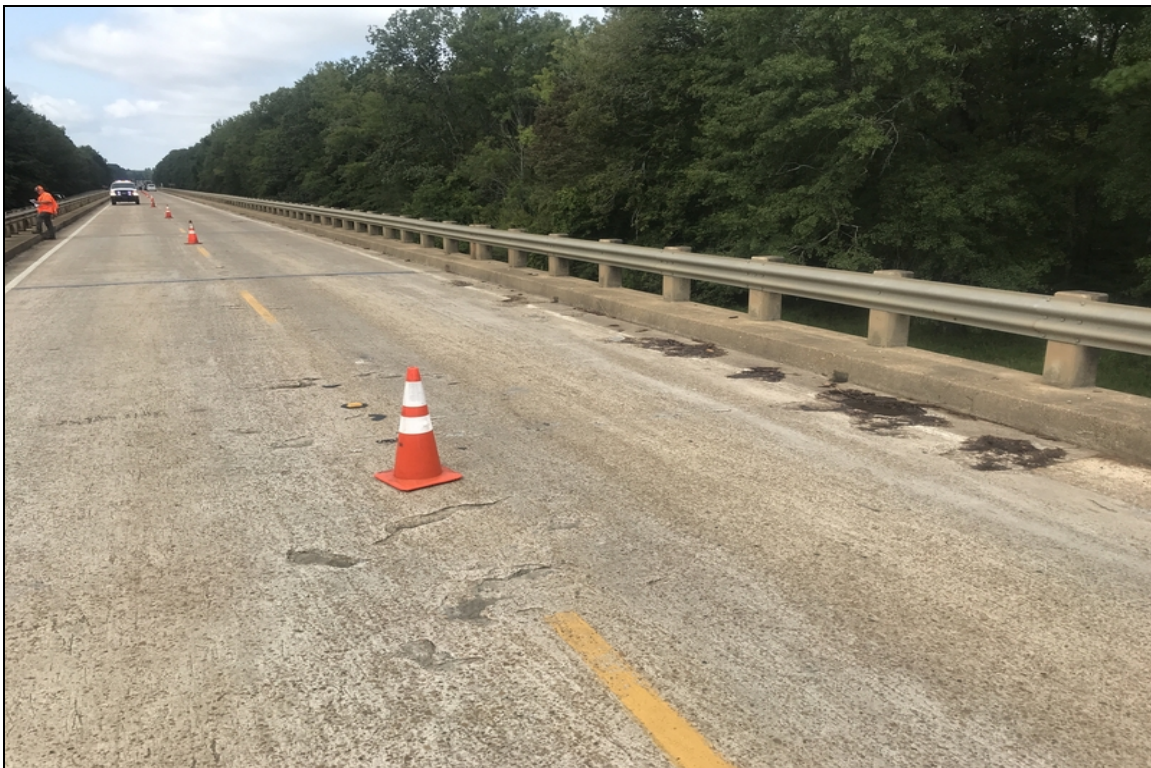
Deck overview span 23, spalls exposed rebar.
