**Bridge #03011(Routine)**  
**US79 S-7 LM 7.70 over SALINE RIVER**

**Location: 4.89 MI S JCT SH 35**

**Team Lead: Jimmy Reynolds Inspection Date: August 31, 2021**

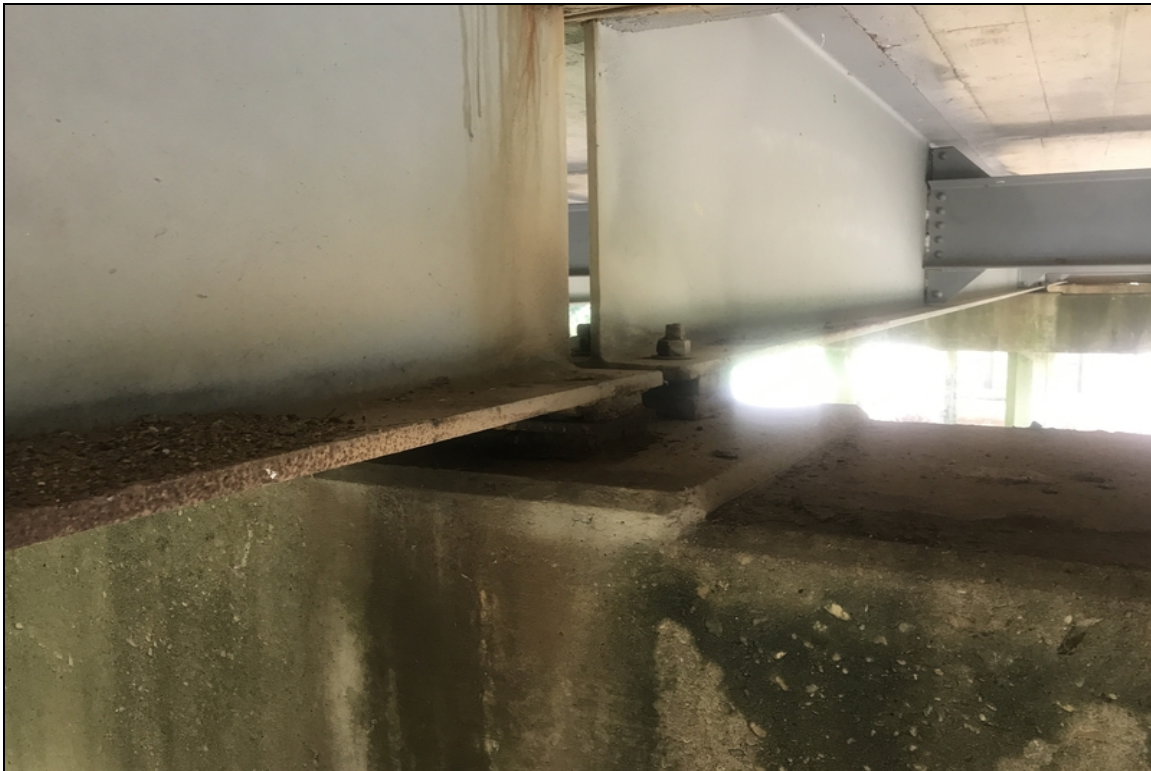
Bent 20 beam 3 bolt missing in bearing.

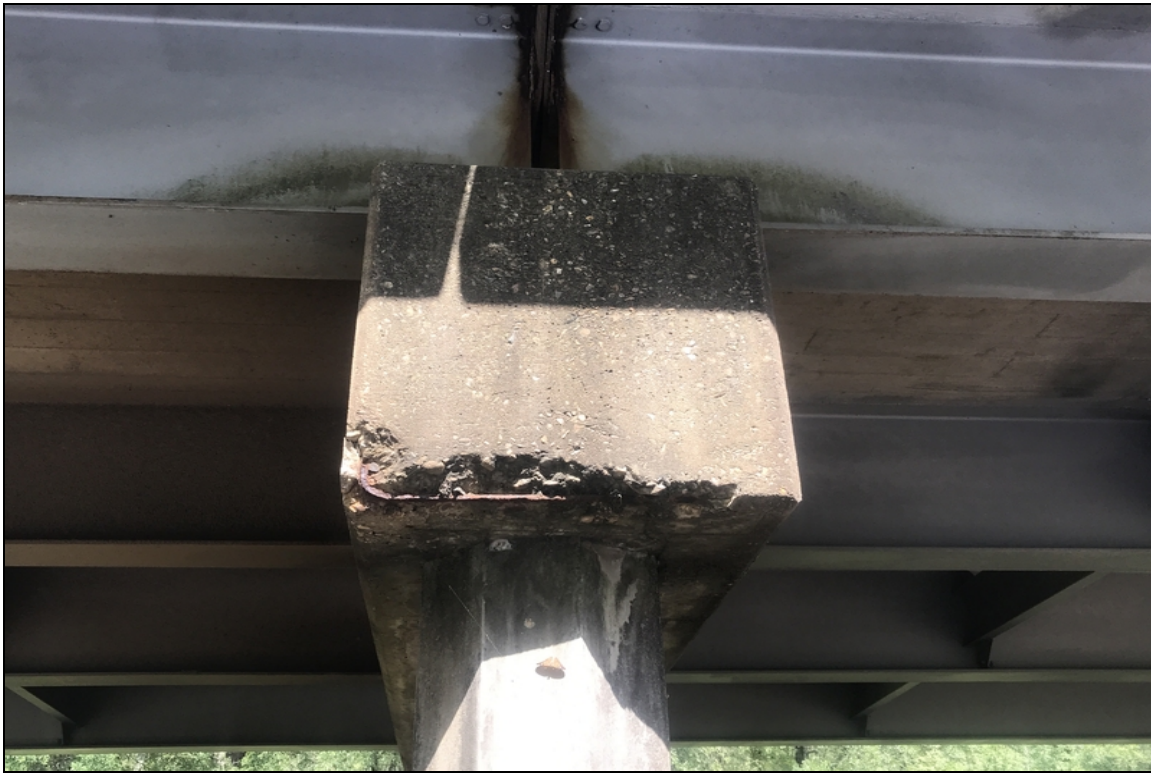
Bent 9, right end of cap spall with exposed rebar.

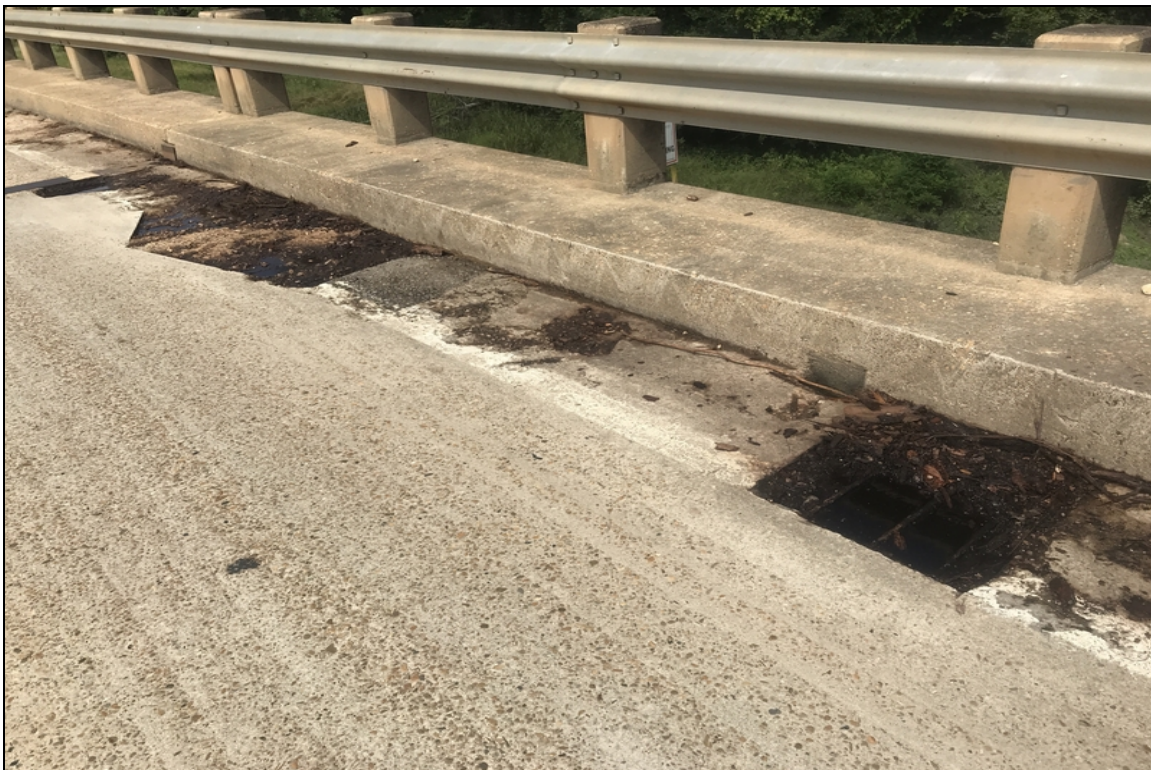
Span 25 spalls with exposed rebar in gutter line.

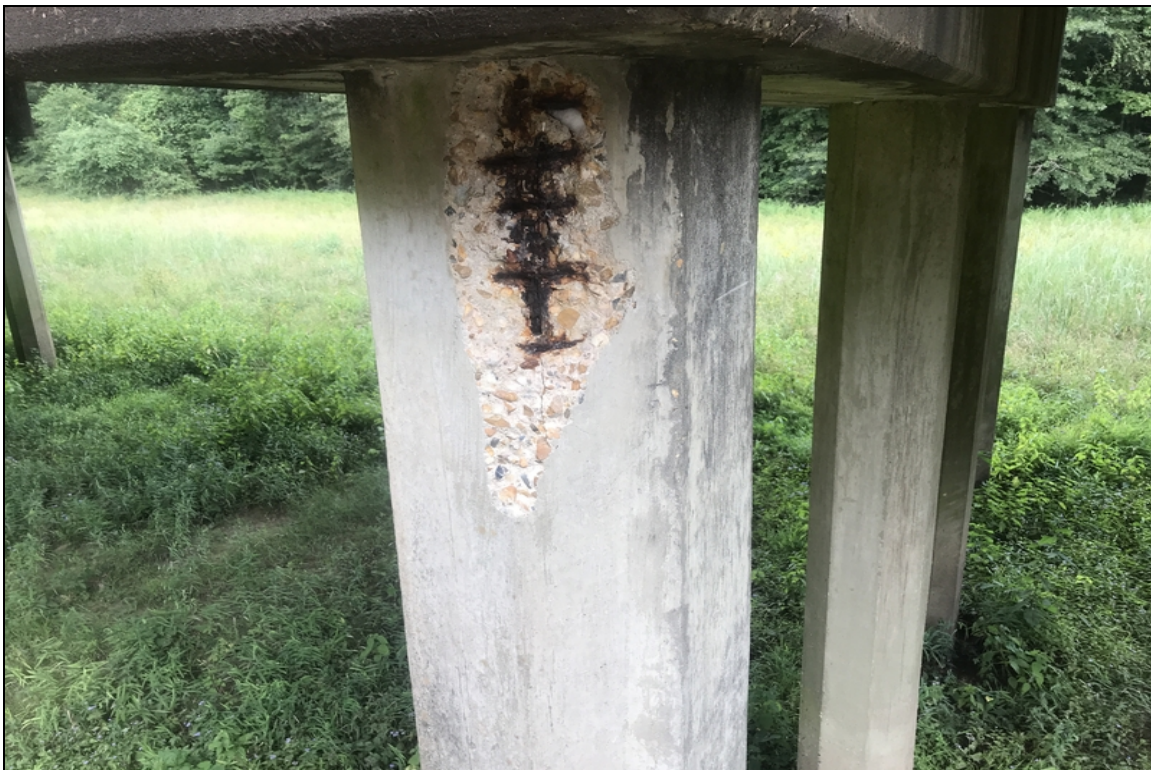
Bent41 pile 4 spall with exposed rebar

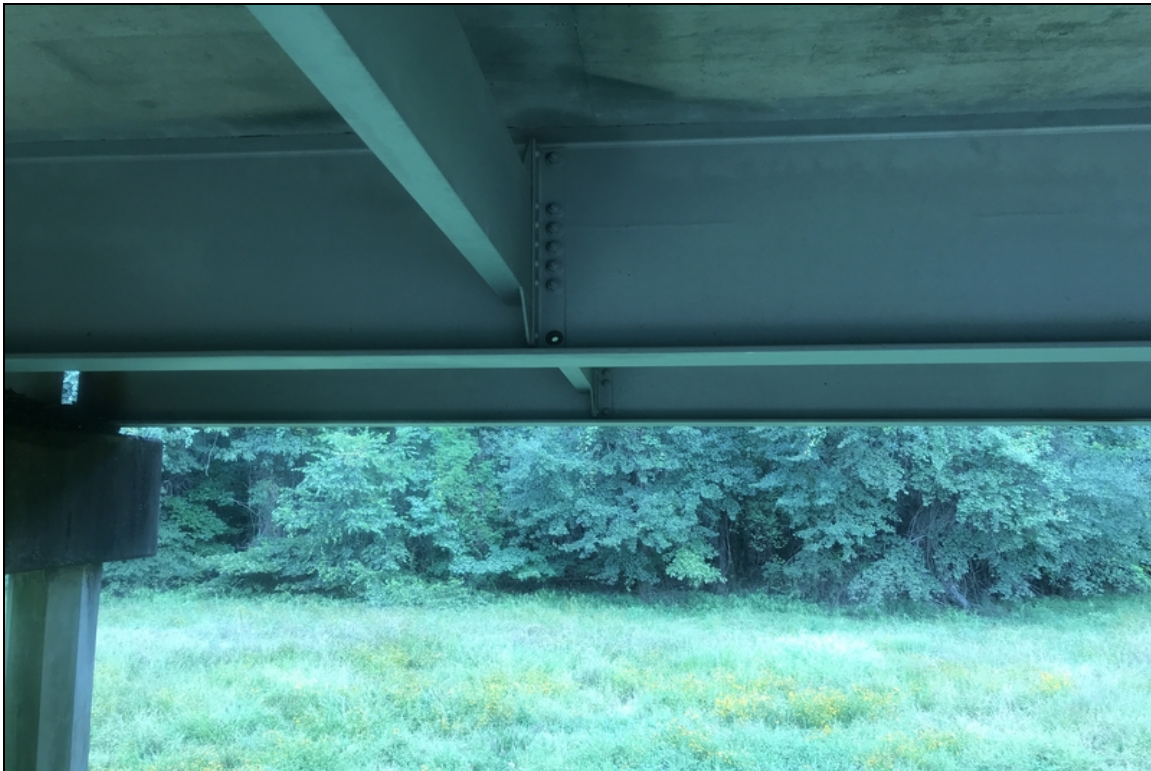
Span 33 beam2 missing bolt

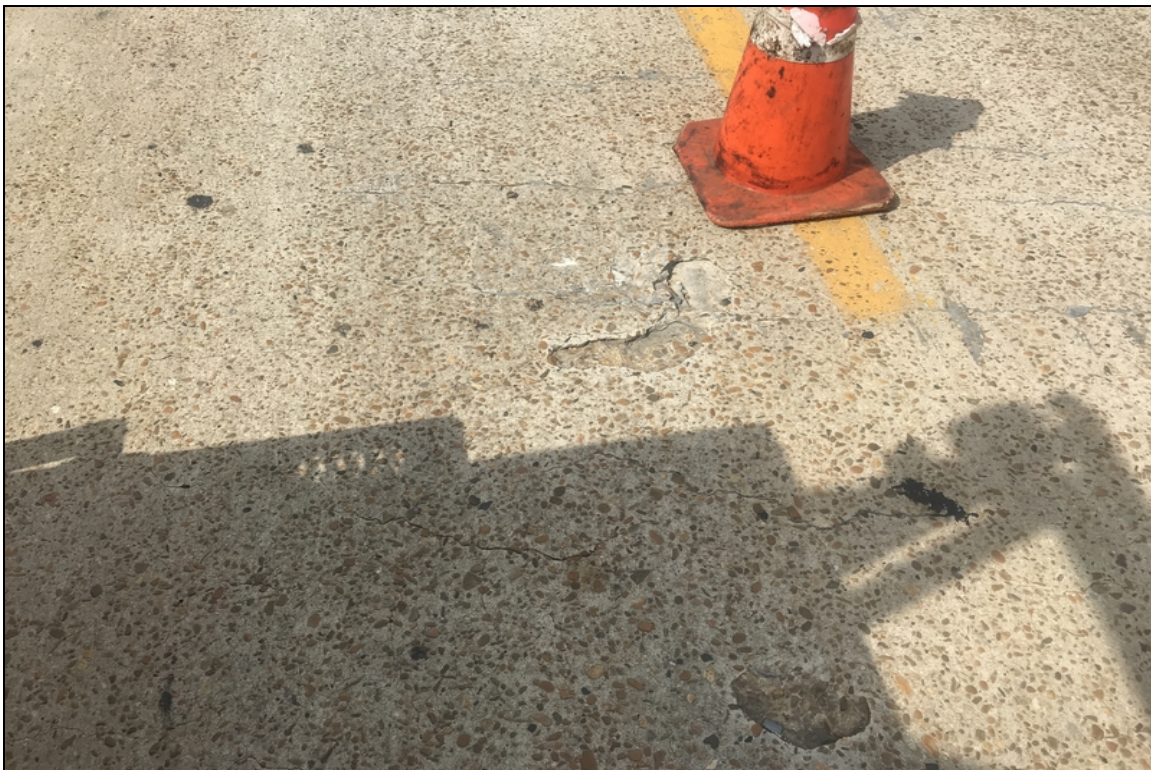
Span 48, spalls with transverse cracks.

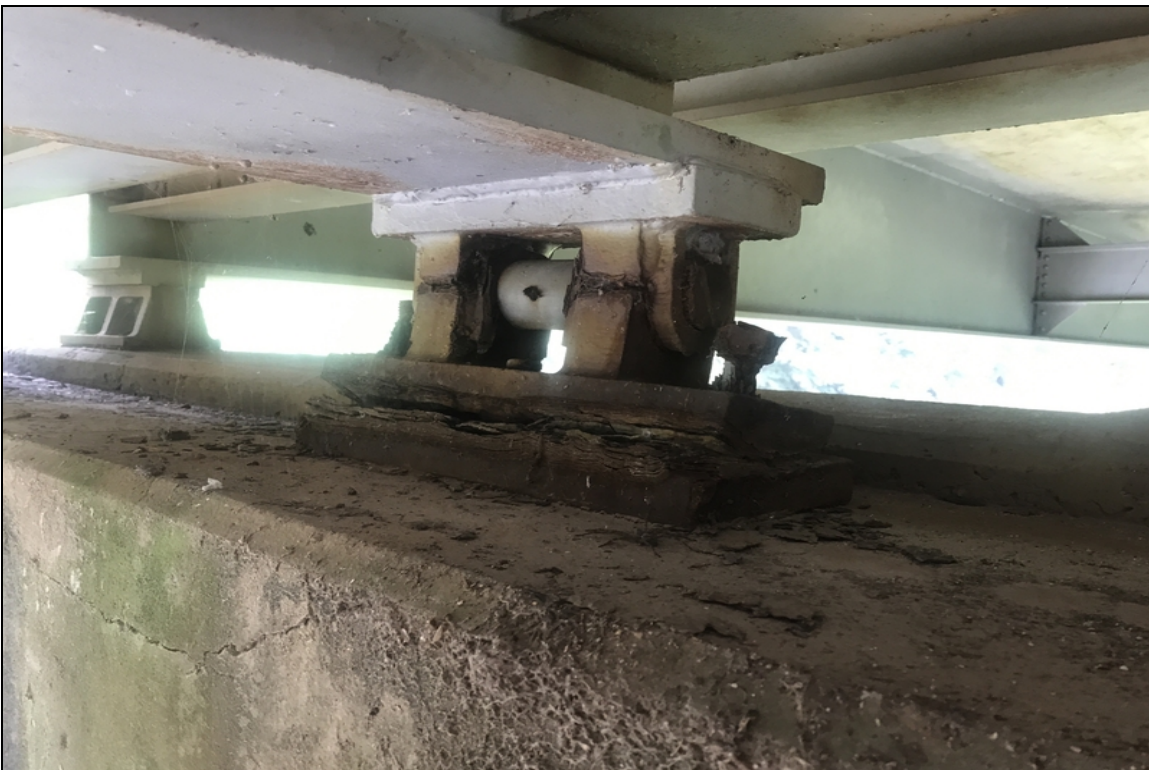
Beam2 bent27 bearing pack rust

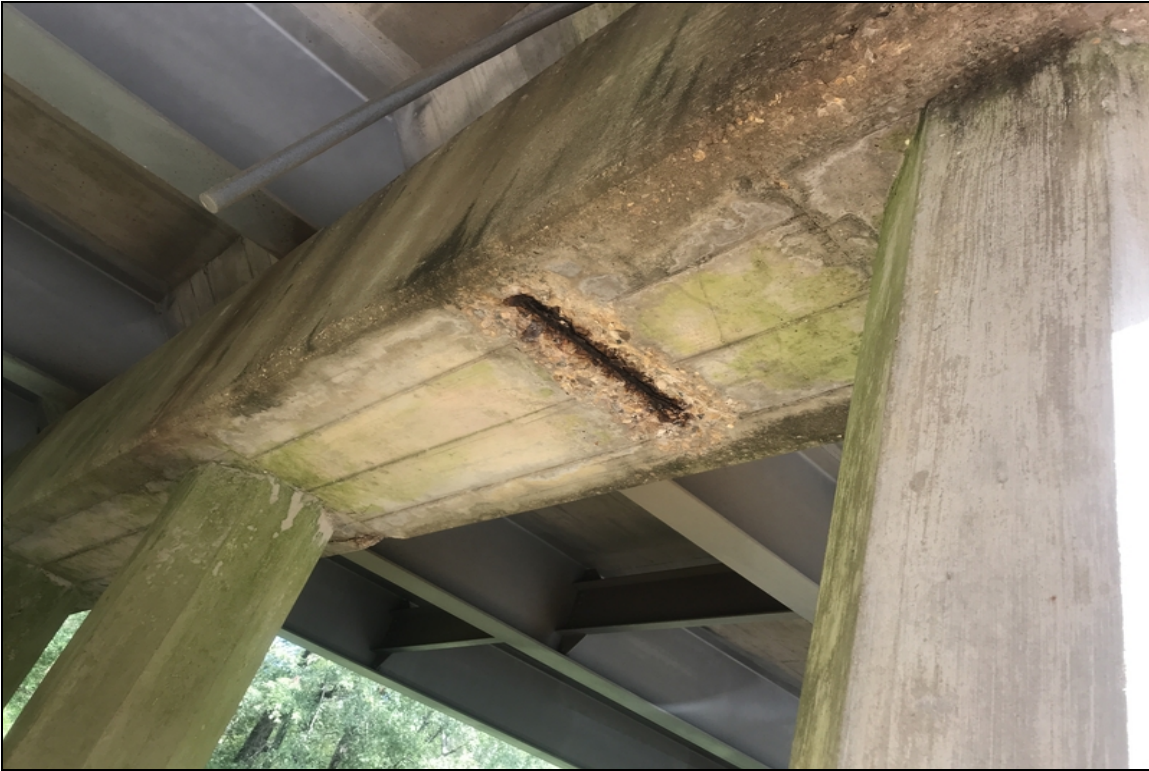
Bent 8 spall with exposed rebar, between piles 3-4.

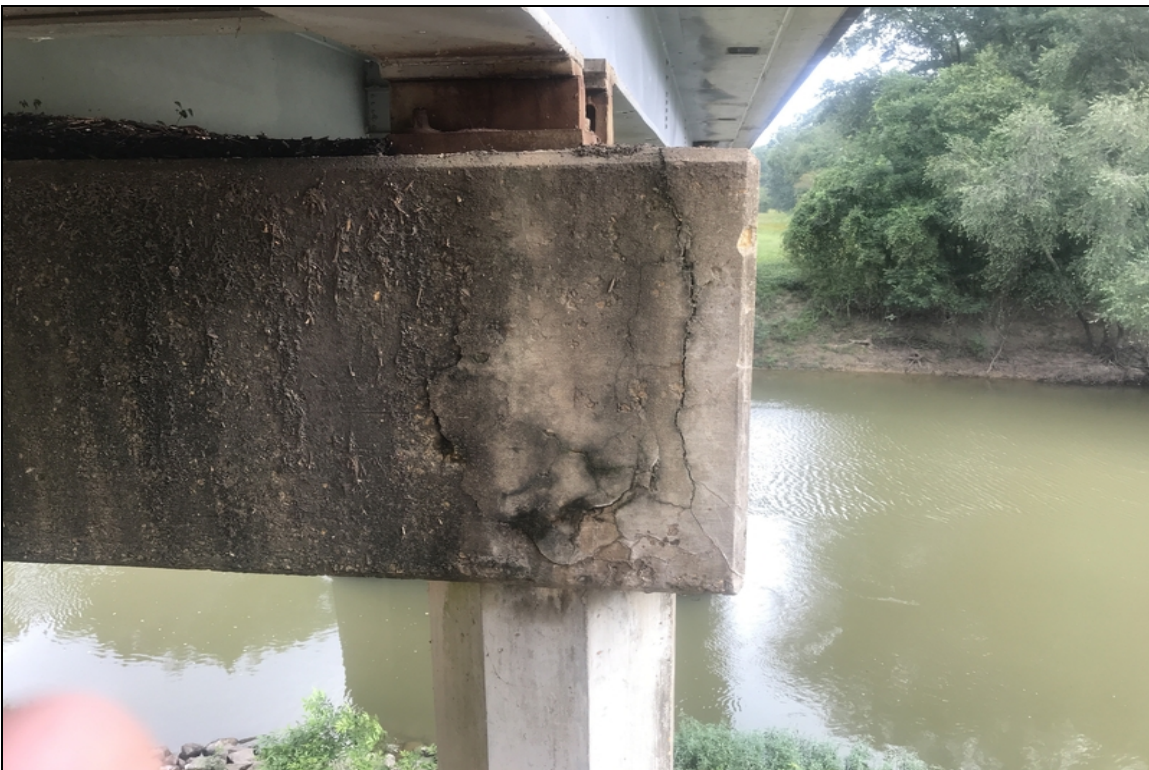
Bent 25 cap right side delam

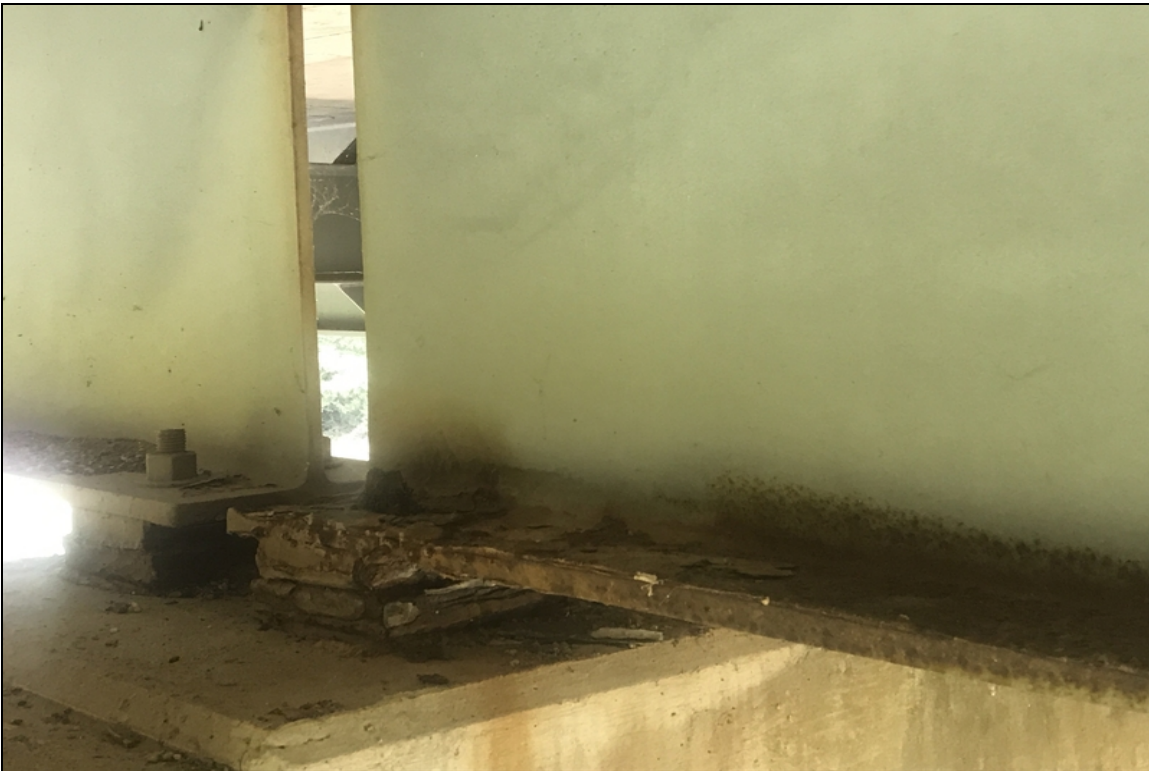
Bent 19, beam 2, typical of minor rust , with pack rust to bearing.

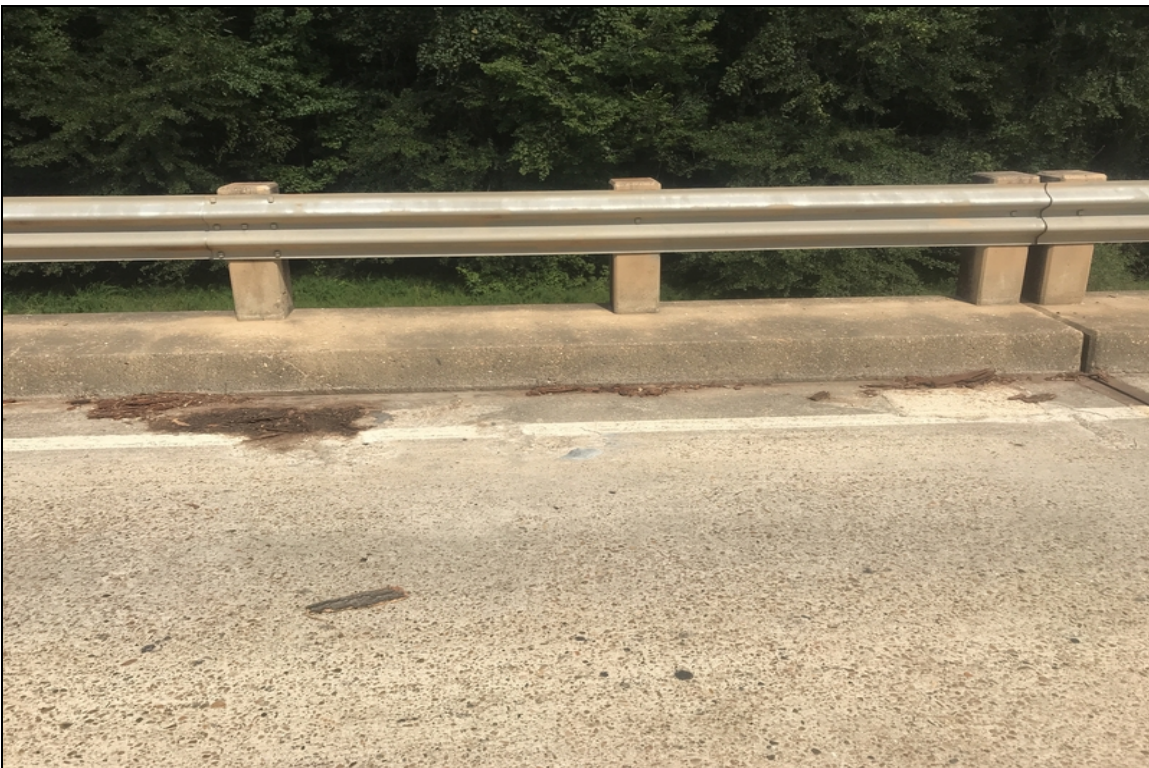
Span 41, deck spalls and patch.

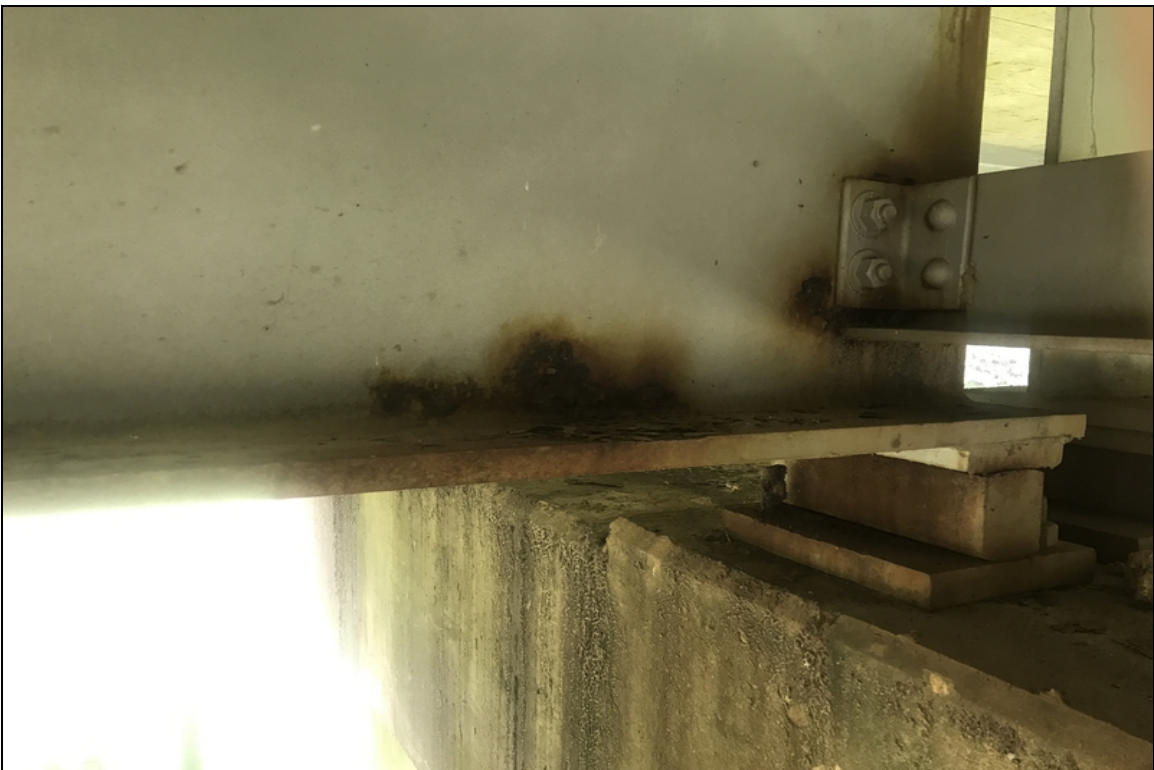
Span 27 beam 2 bent 28 flaking rust

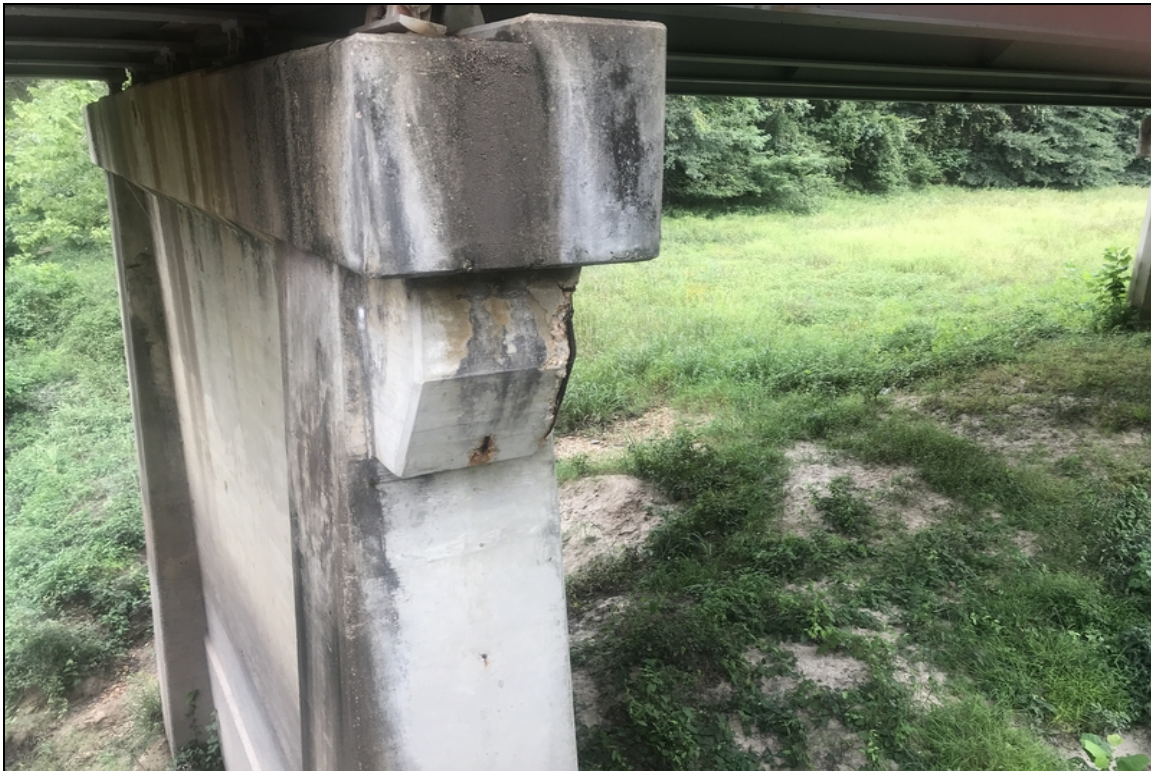
Pier 2 spall with exposed rebar right side end

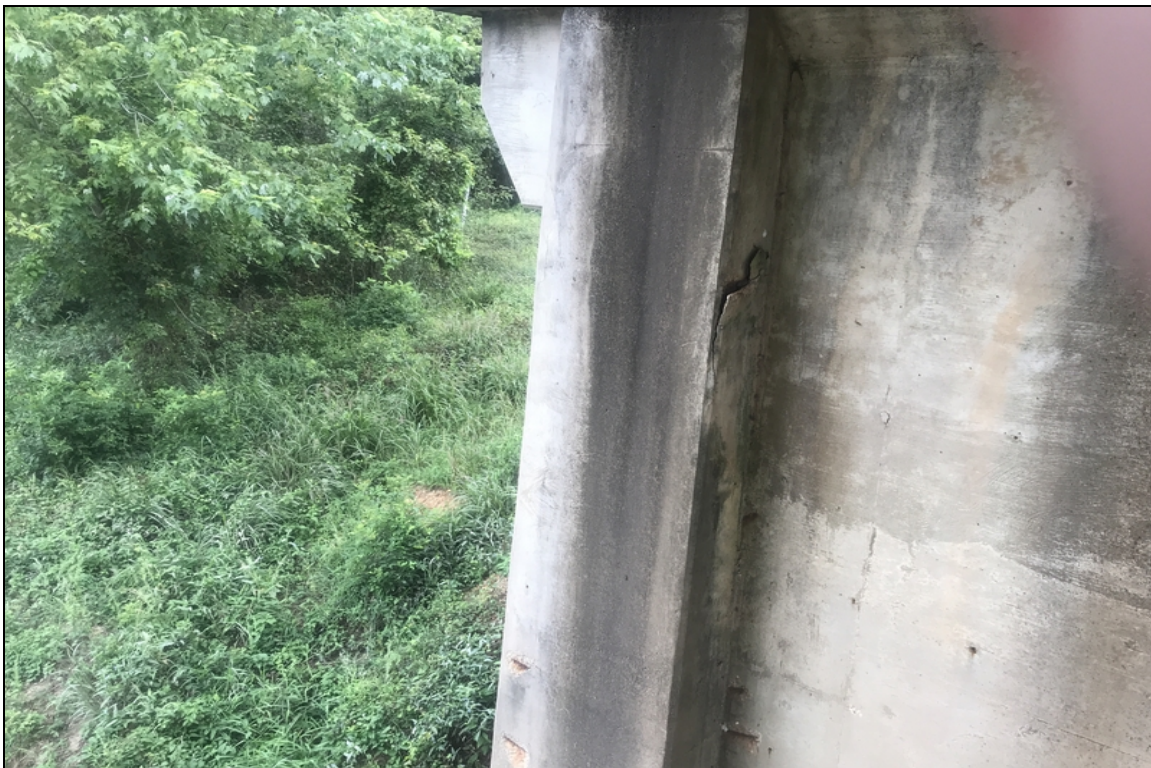
Pier 2 crack and delam with spall with exposed rebar

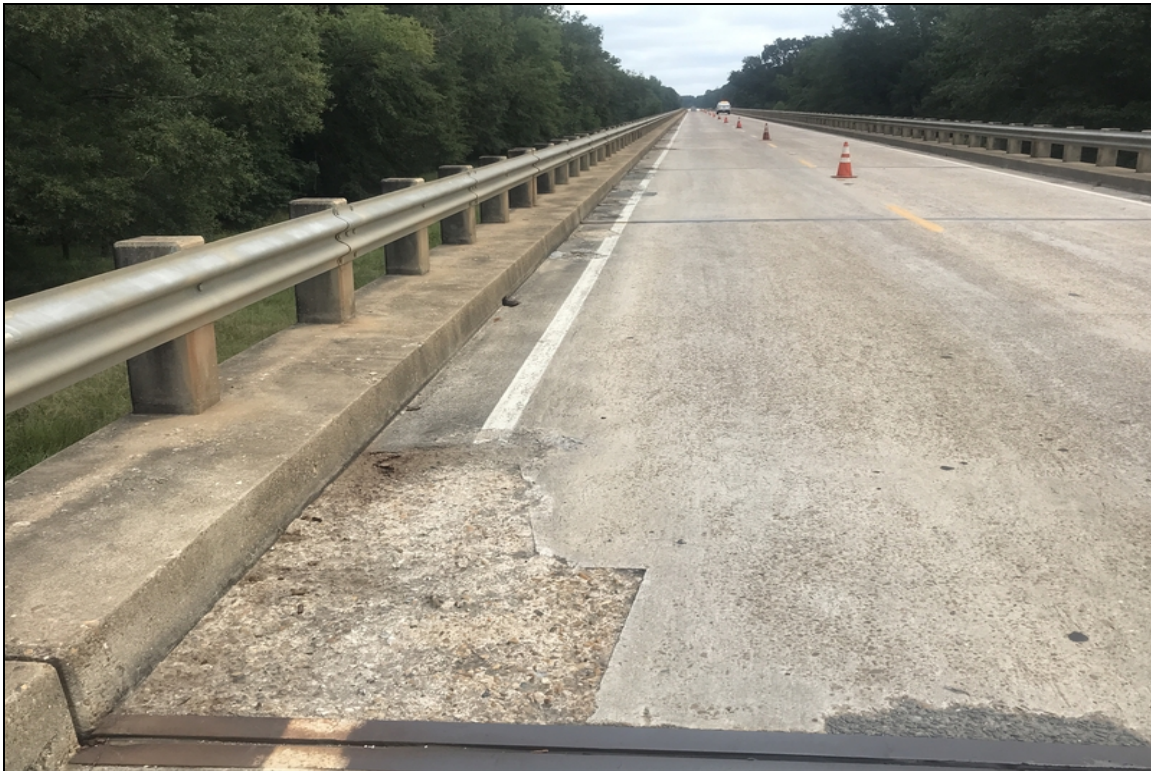
Spans 1-5, sb lane gutters have patches.

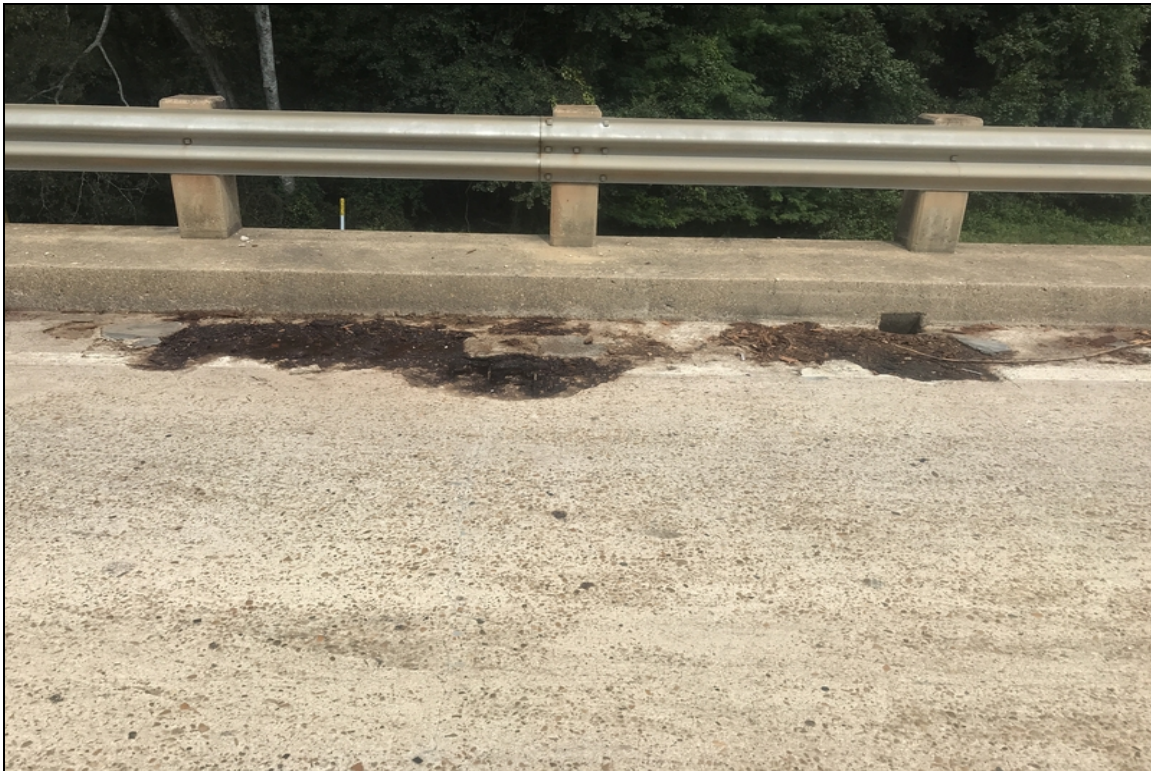
Span 28, sb lane spalled in gutter line.

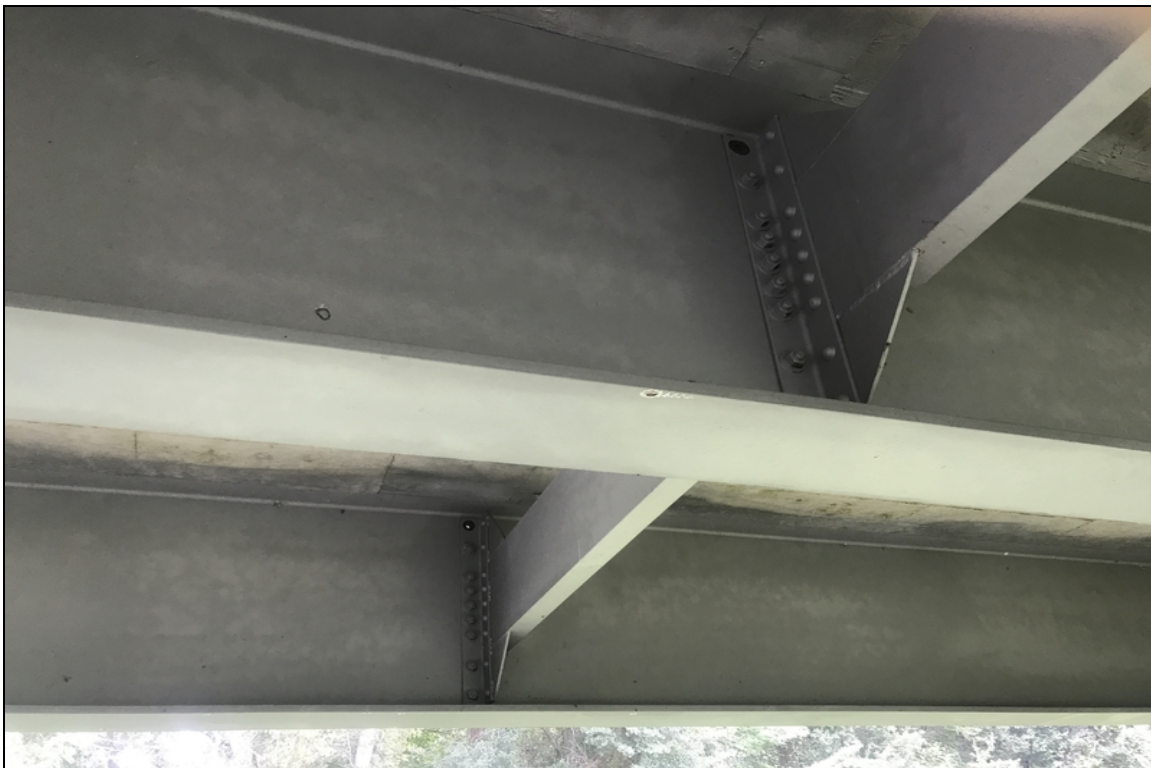
Span 27 missing bolts

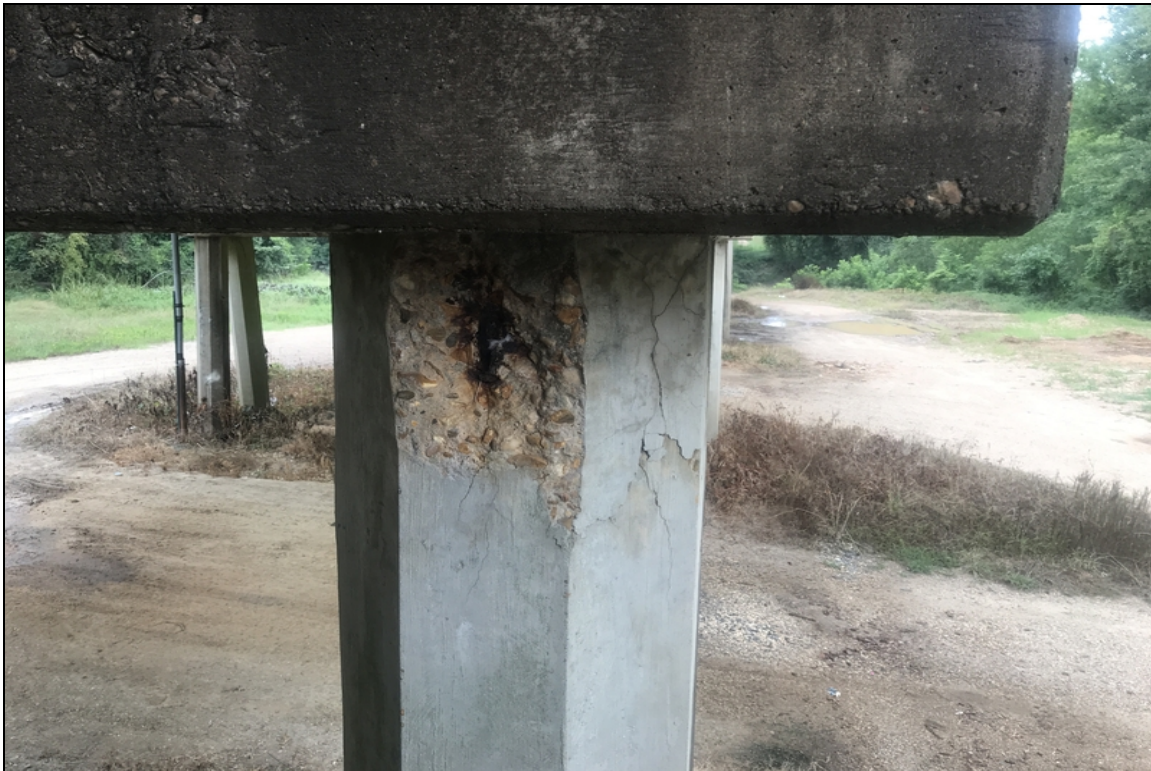
Bent 21 pile 4 spall with exposed rebar

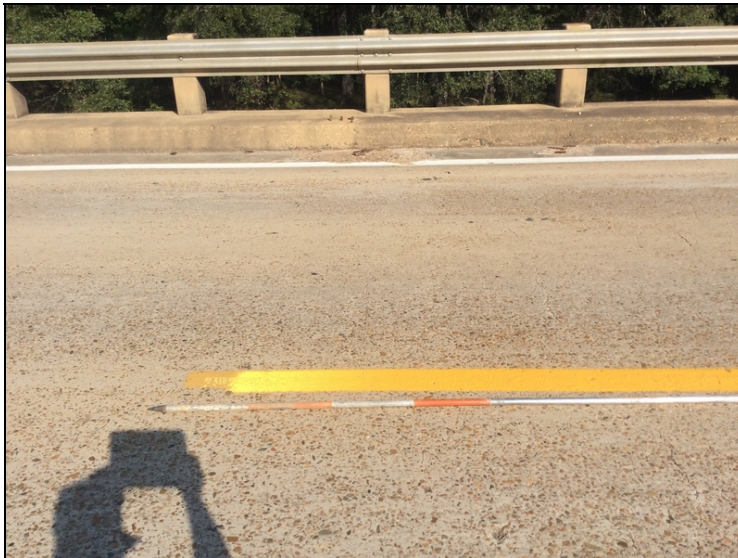
Deck spall, Span 1 Lt. lane 4' long x 2' wide x 1" deep about midspan.

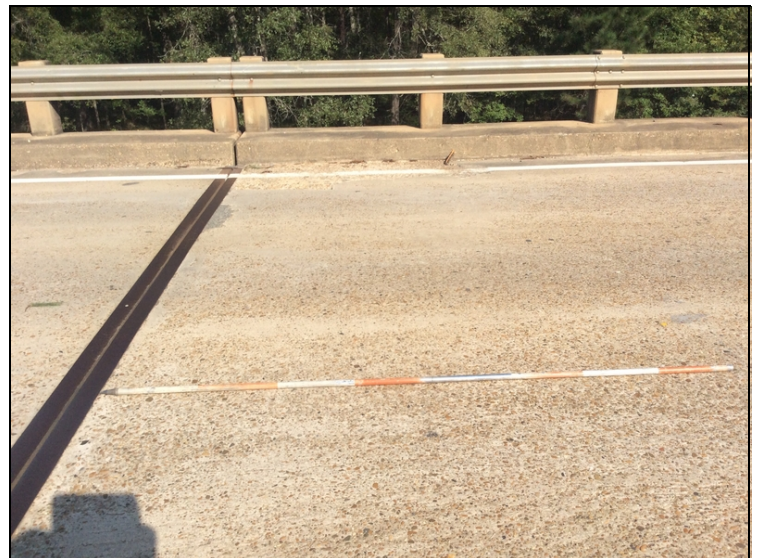
Span 2 spall 7' long

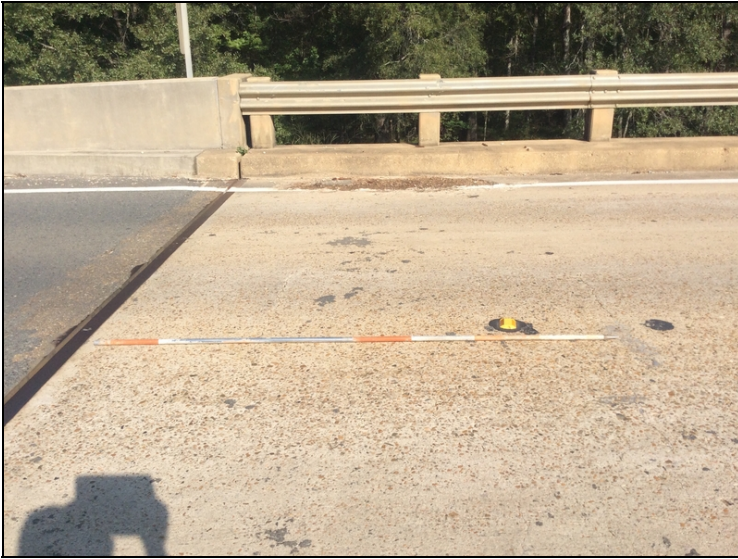
Deck spall, Span 1 2' ahead of BR begin, Lt. lane just outside the white line, is 7' long & 2' wide & about 2" deep at the deepest point.

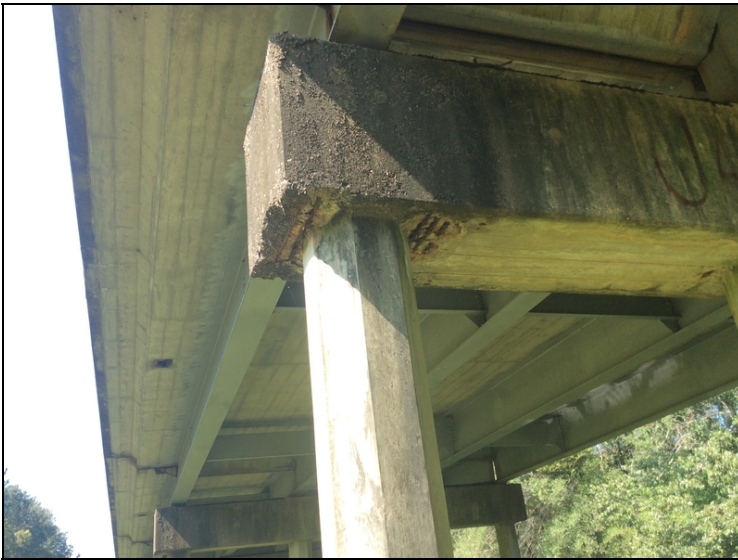
Bent 15, pier cap @ pile 4 has spalls both sides of the pile with significant section loss to exposed steel.

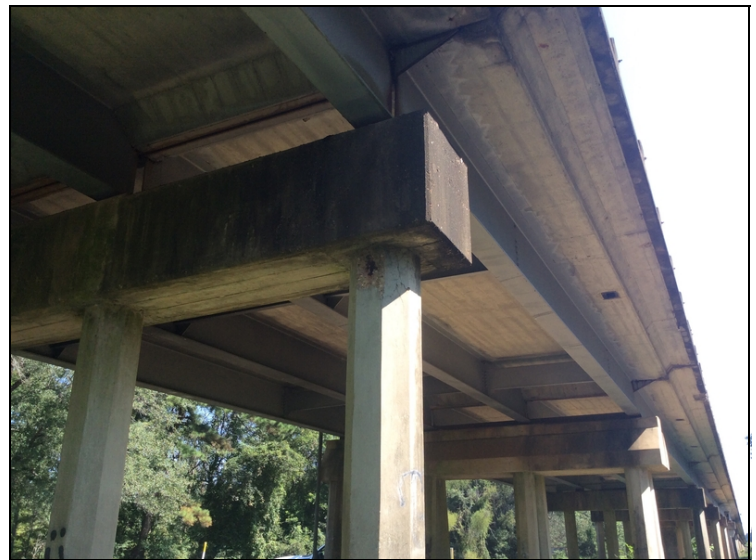
Bent 21, Pile 4 back has spall with exposed steel.

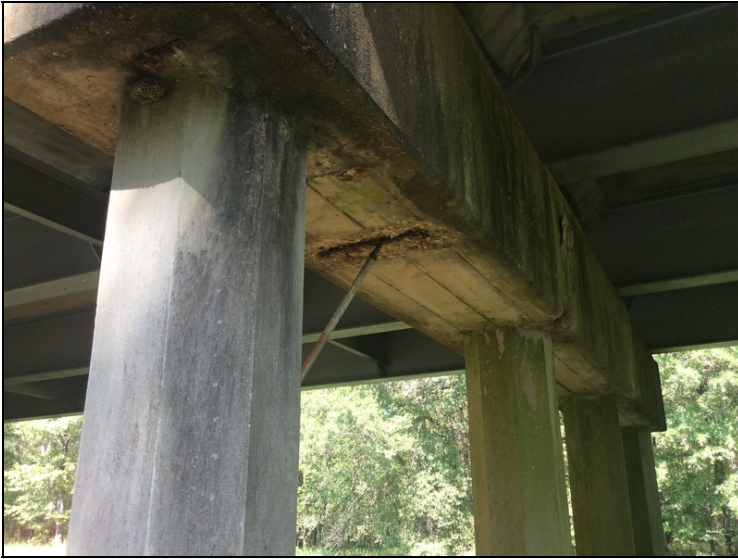
Bent 8 cap spalled with exposed rebar

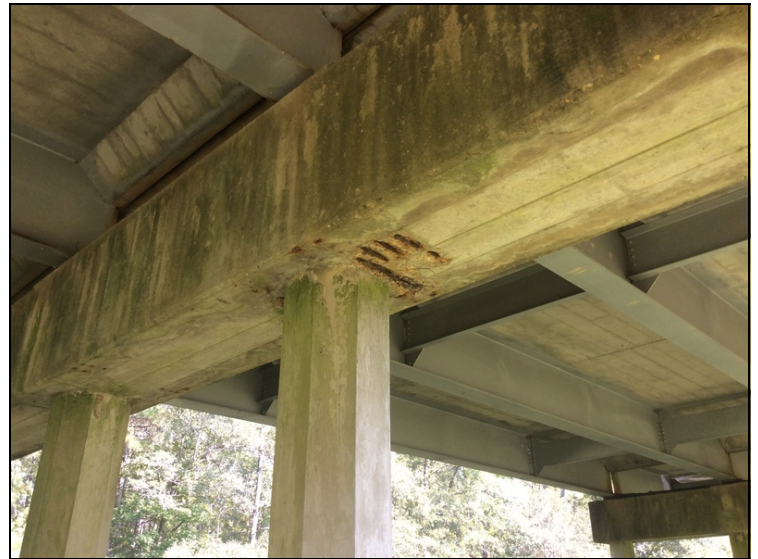
Bent 13 between piles 3 & 4, spall on the bottom of the pier cap with exposed steel with section loss.

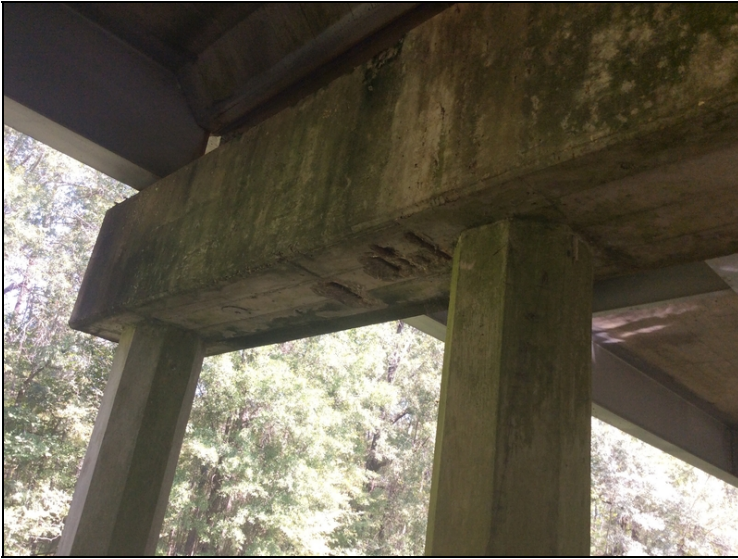
Bent 7 cap spall.
