District 10, Greene County

Bridge #03083(Routine)
US 49-02- LM 9.21 over HENDERSON CREEK

Team Lead: James Adams Inspection Date: November 19, 2020

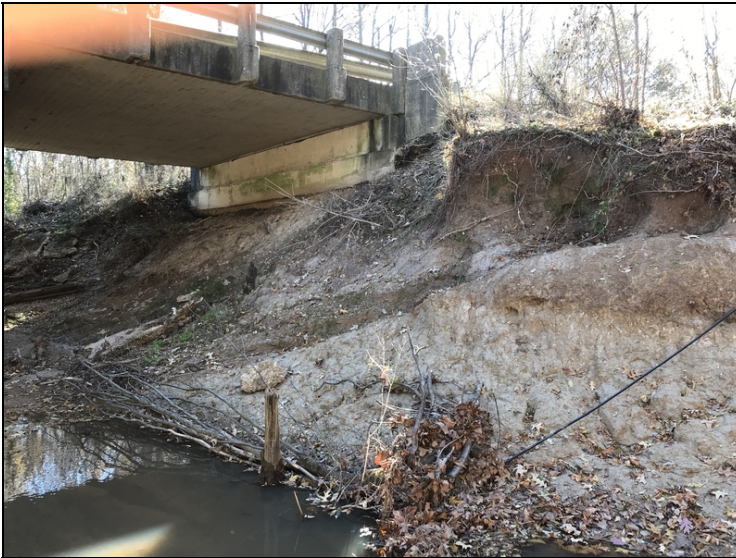
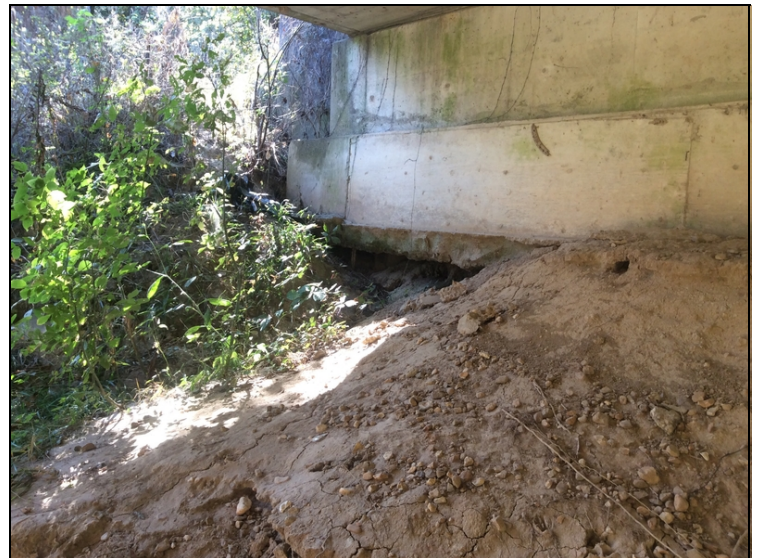
Bent 4 scour repair is beginning to undermine on left end, 1 ft. below & 1 ft. back under near centerline.
Embankment is eroded under and adjacent to bridge near bent 4 upstream side.
Very little berm remaining at bent 4.

Bent 4 embankment

Scour repaired at bent 1 some time in the past. Caps have a few minor cracks, spalls, and delaminated areas. Bent 4 scour repair is beginning to undermine on Lt end. Embankment is eroded under and adjacent to bridge near bent 4.

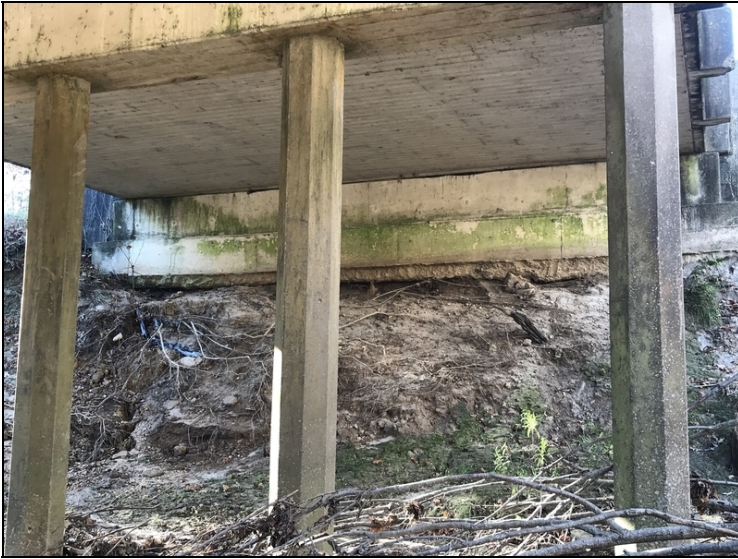
Bent 4 erosion 2020

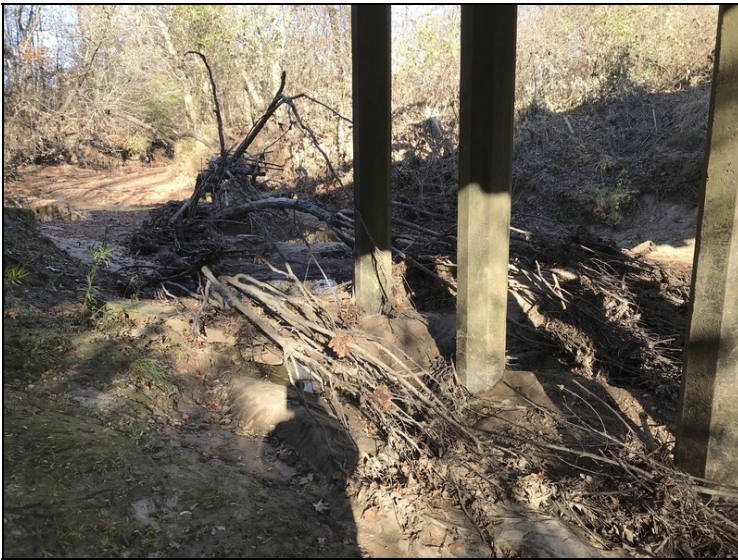
Large tree under span 2 & 3.

Drift span 2&3
