Bridge #03086(Routine)
US 49-02- LM 6.18 over SLAVENS CREEK
Location: .50 MI SO OF MARMADUKE

Team Lead: James Adams Inspection Date: November 03, 2020

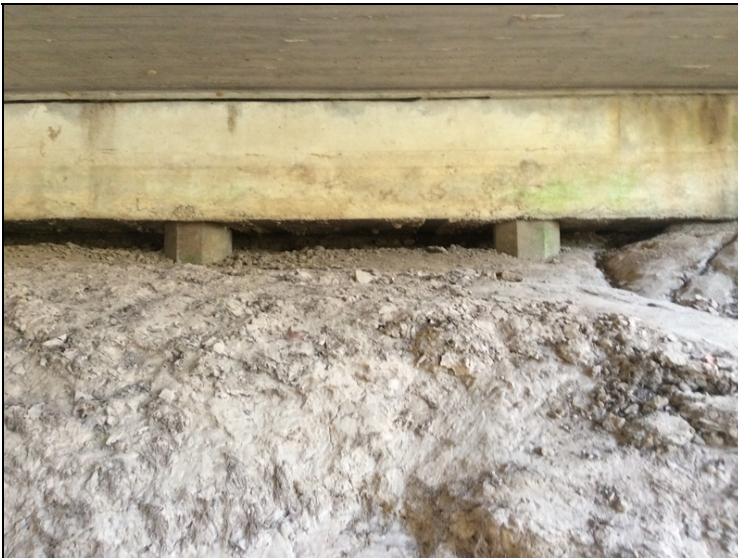
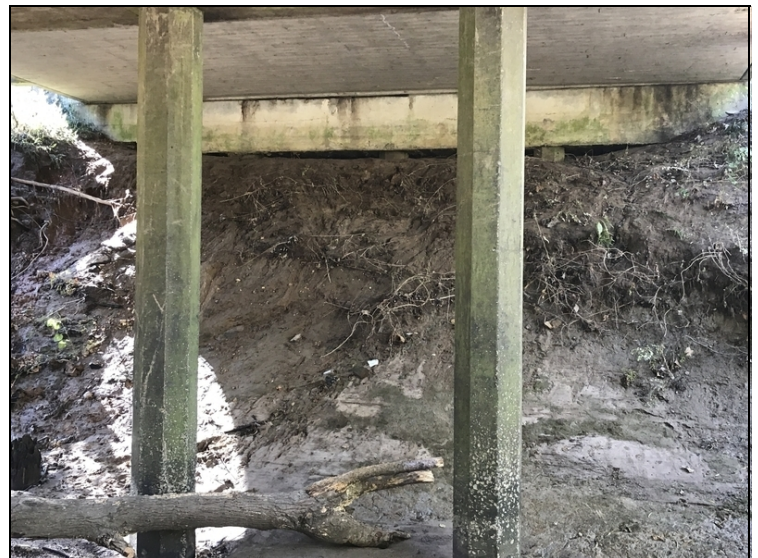
Bent 4 erosion

Bent 4 is undermined up to 1' below and 3' back under abutment with 3 piles exposed.

Bent 1 abutment has a minor vertical crack.
Bent 1 abutment has delaminated areas and spalls on old scour repair portion.
Caps have a few small spalls with exposed rebar.
Right end of bent 3 cap has some minor abrasion.
Piles at bent 3 have minor abrasion near water level.
Bent 4 is undermined up to 1 ft. below and 3 ft. back under abutment with 3 piles exposed.
Large tree & utility pole lodged under bridge.
Moderate embankment erosion under spans 1 & 3.

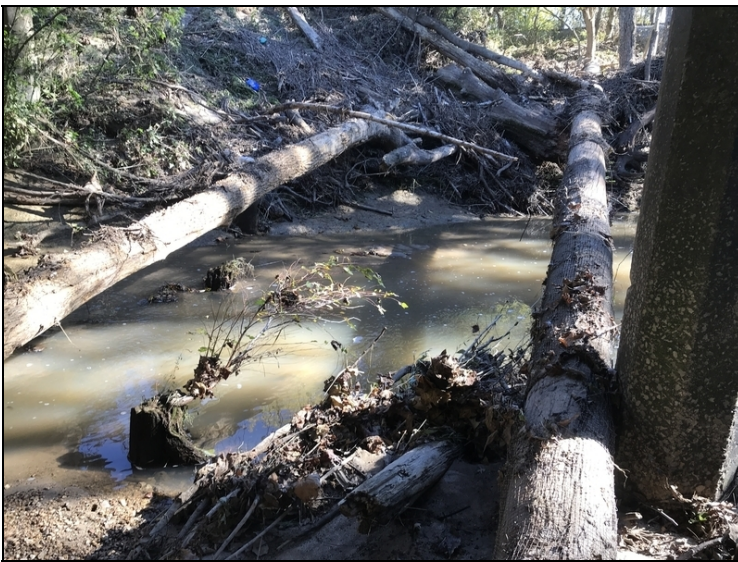
Span 2 drift

Large tree & utility pole lodged under bridge.
