Bridge #03253(Routine)
SH 115-02-LM 16.14 over STRAWBERRY RIVER
Location: 4.0 MI S OF SMITHVILLE
Team Lead: Tim Myrick Inspection Date: July 06, 2021

Bridge #03253(Routine)

SH 115-02-LM 16.14 over STRAWBERRY RIVER

Team Lead: Tim Myrick, Inspection Date: July 06, 2021

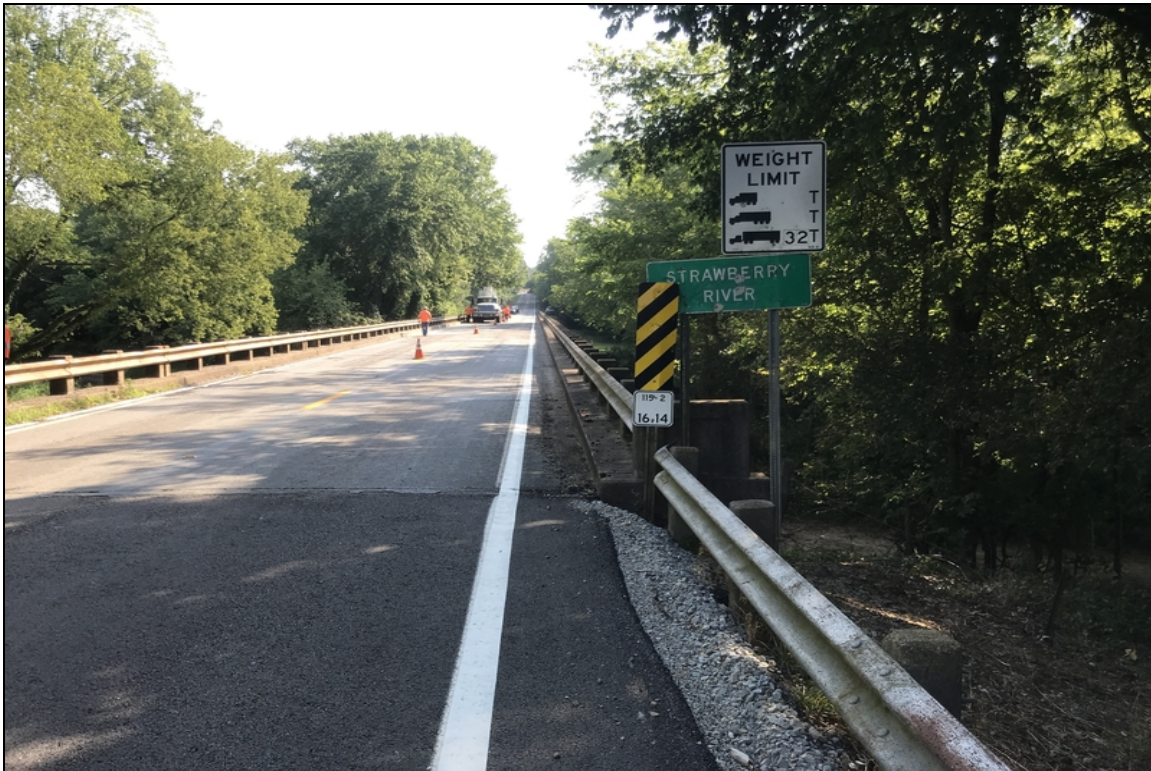
Beginning end

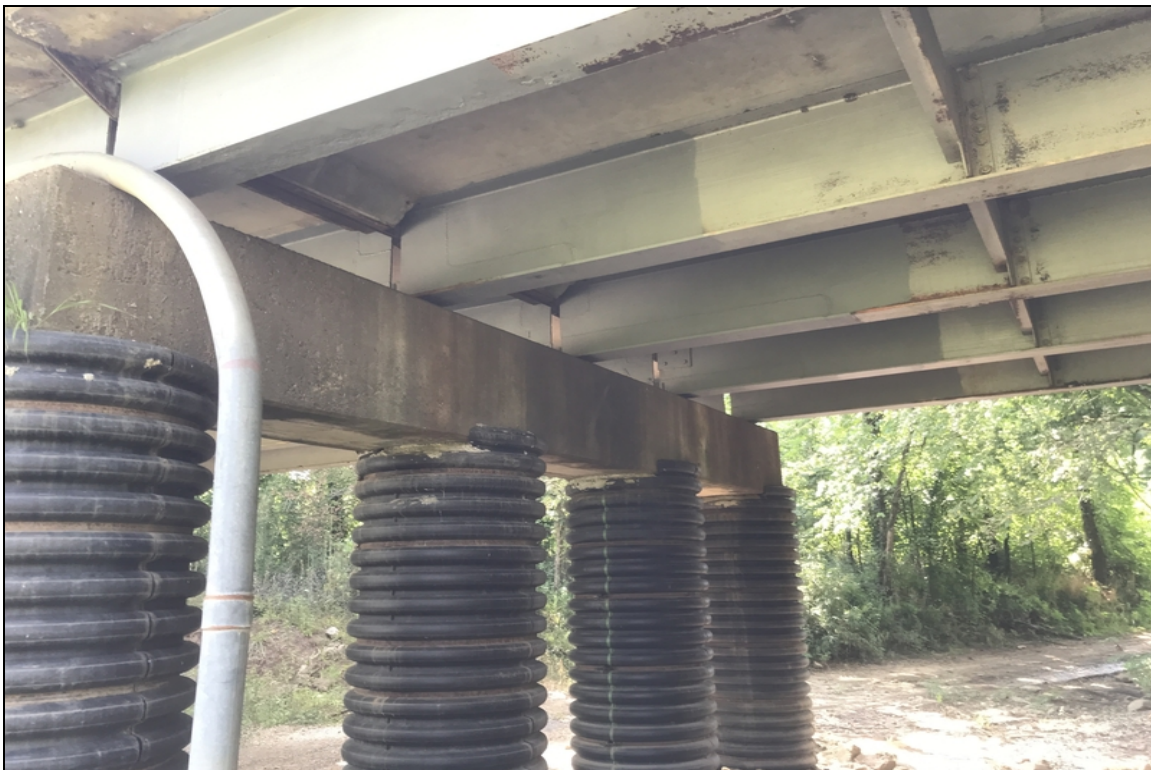
Ending end

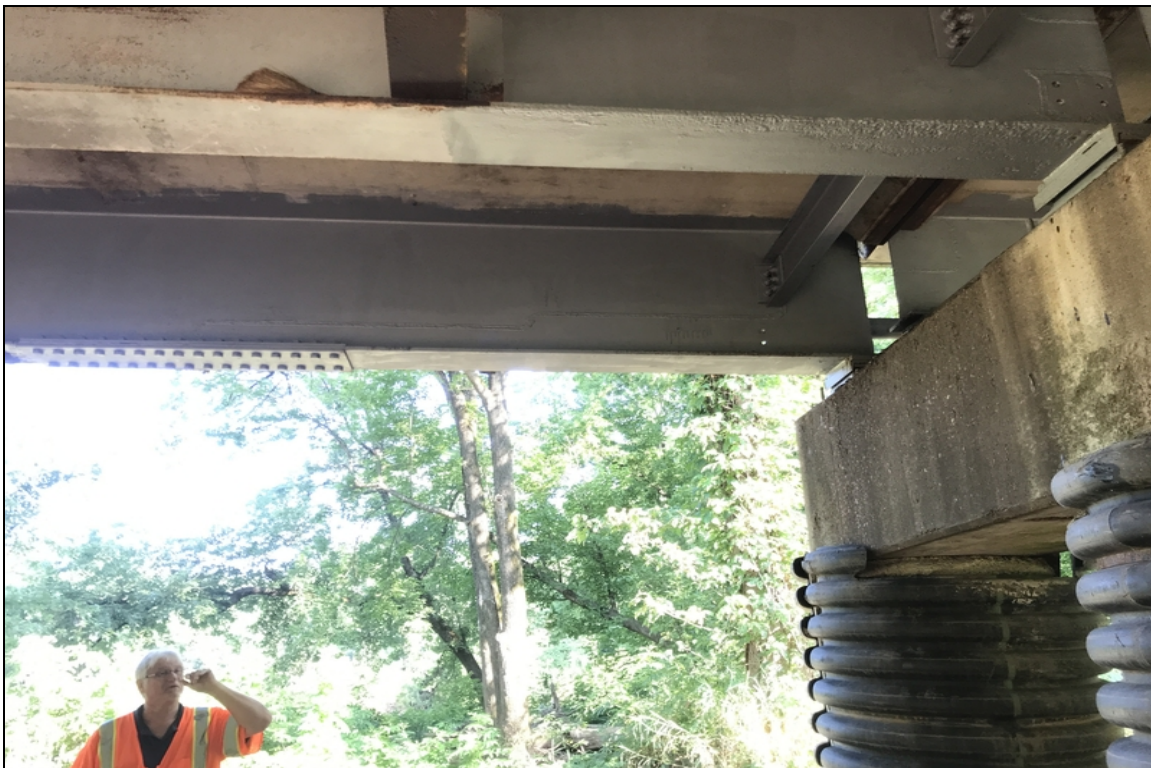
S12 b12 new bearings

Span 12 bent 12 bearings have advanced section loss and are frozen from corrosion. Rocker pins have some lateral movement. Bearings are bouncing under traffic. Span 12 is a 1/2" lower at the road iron than Span 11.

District 10 Bridge crew have cleaned and repaired Bent 12 bearing , See photo 2021

Bent 12 cap has heavy buildup of dirt on span 12 side at bearing seat. Clean and replaced bearings , see photo 2021.

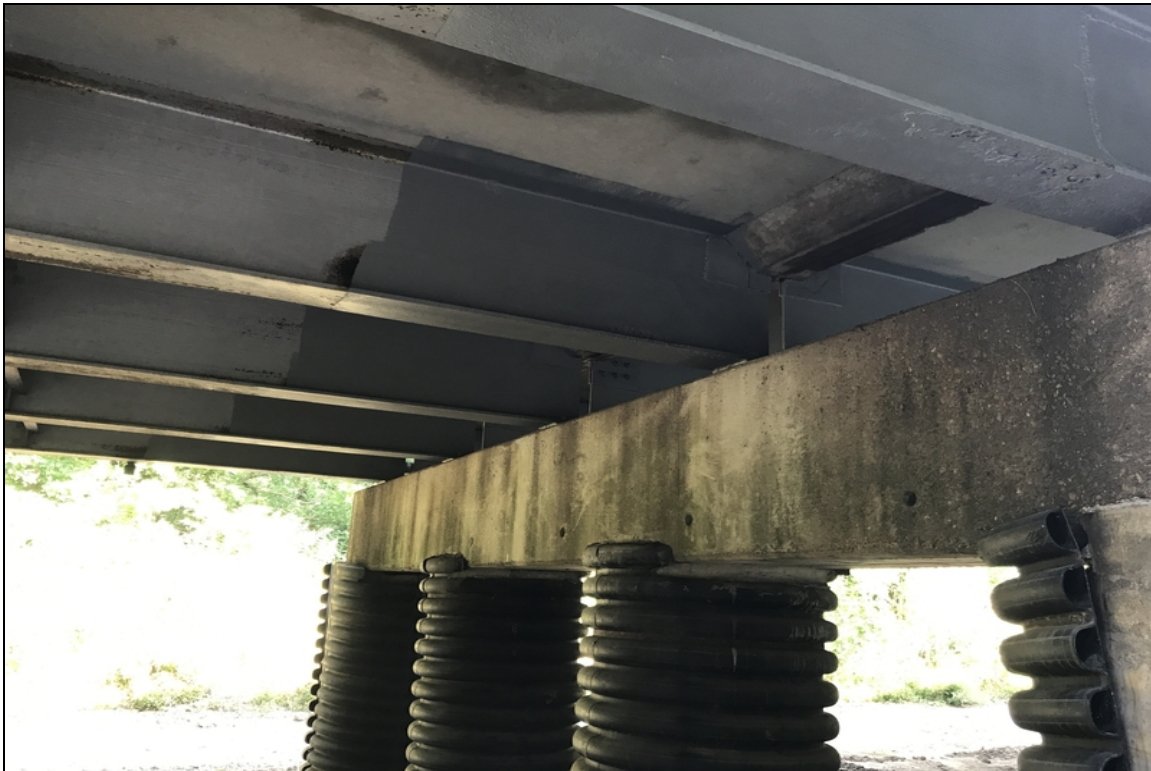
S9 b10 g1-5 haunch plate
G1 web plate, g2, 4 tsplice

Span 9 bent 10 girder 2 has heavy section loss along bottom of web with a 5" crack 4" from the end of girder.

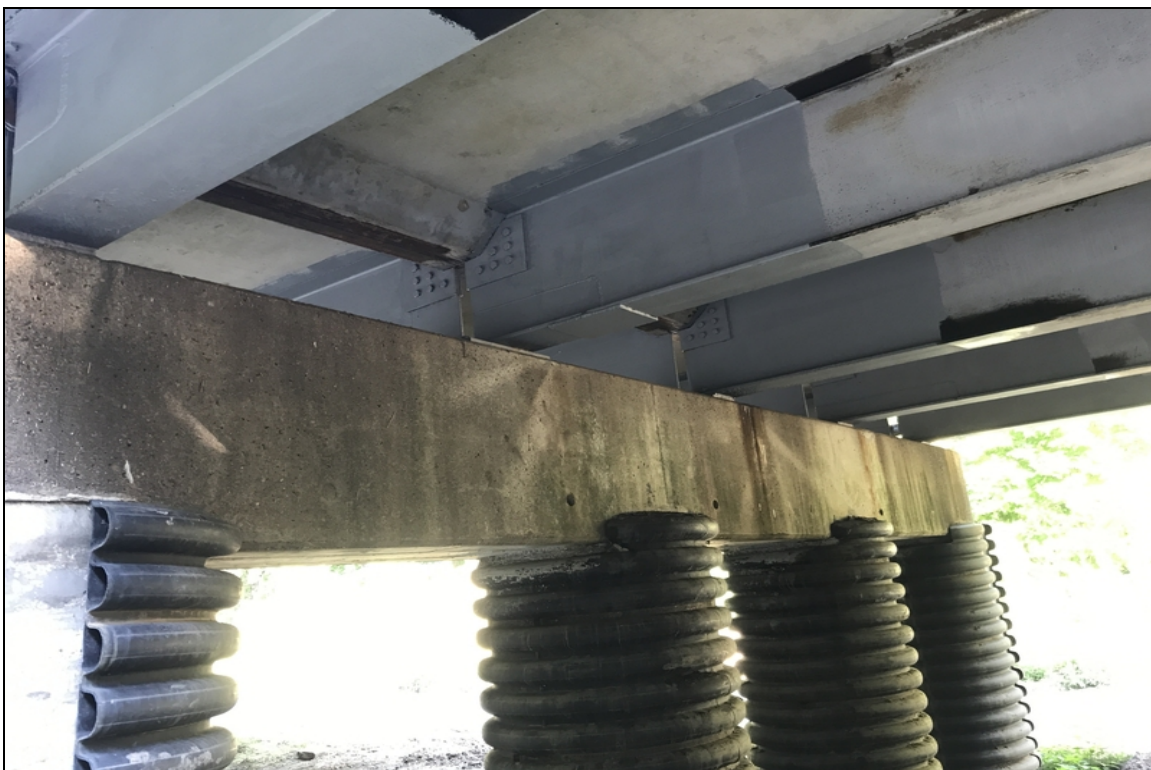
S8 b8 g1,2, & 5 haunch plate

Span 7 bent 8 girder 2 was repaired with a T splice in 2014. Bearing is floating with $1/8"$ gap at bearing.

Span 7 bent 8 bearing 2 has 1 anchor bolt missing.

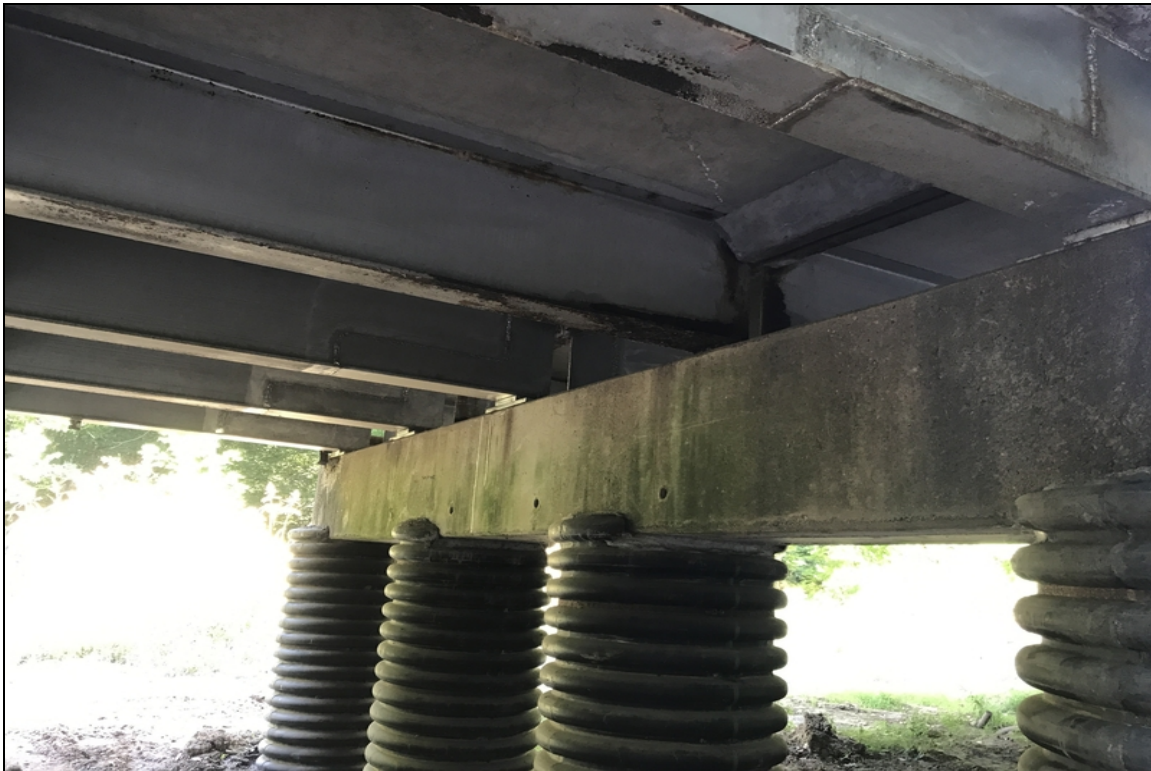
S3 b4 g1, 2, 3, & 5 haunch plate
G2 tsplce

Span 3 bent 4 girder 1 has a 2" x 1" hole in web below haunch.

Span 3 bent 4 girder 2 has a 5" x 1" hole in web below haunch.

Span 3 bent 4 girder 2 is floating, $1/8"$ gap between bearing plates.

Span 3 bent 4 bearings 2 and 4 are each missing 1 anchor bolt.

Span 3 bent 4 girder 3 has a 1.5" x $1/2"$ hole in web below haunch.

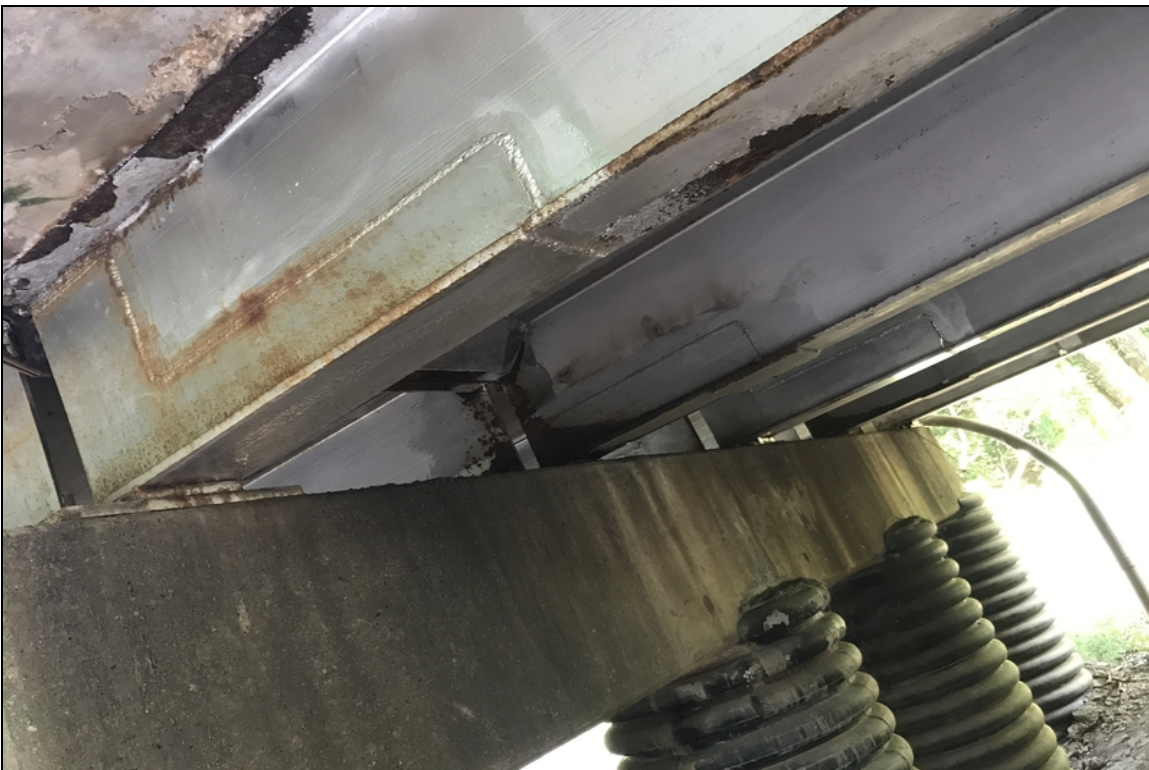
S2 b2 g1, 3- 5 tspliced

Span 2 bent 2 girder 1 has a 1" diameter hole 6" from end near haunch.*

Span 2 bent 2 girder 3 has a 2' x up to 3" area of moderate section loss to bottom of web. Bottom flange beginning to knife edge.*

Span 2 bent 2 girder 4 has a 5.5" x 1" hole in web below haunch.*

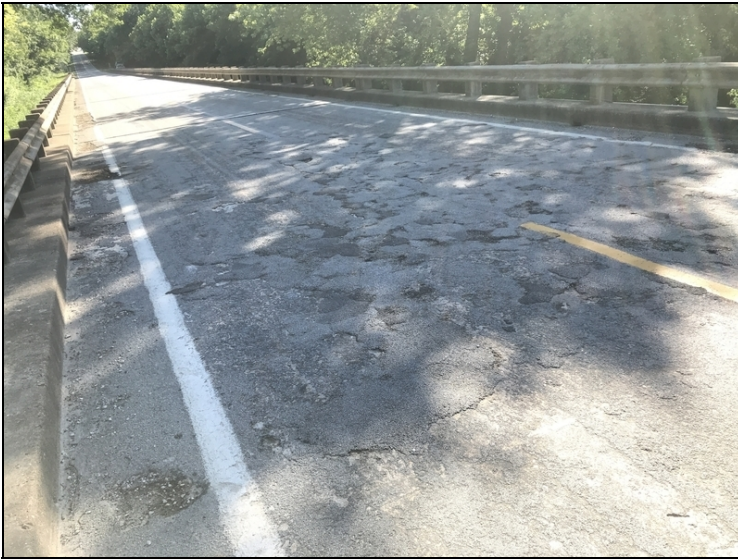
Span 13

Deck at Spans 12 – 14 have several spalled areas with some exposed rebar. Wearing surface has several spalls and asphalt patches.
