**Bridge #03384**(Routine, Underwater type 2)

**SH 1-04 LM 1.57 over Prices Branch**

**Location: 1.57 Mi NE US 165-DeWitt**

**Team Lead: Greg Loomis Inspection Date: July 21, 2021**

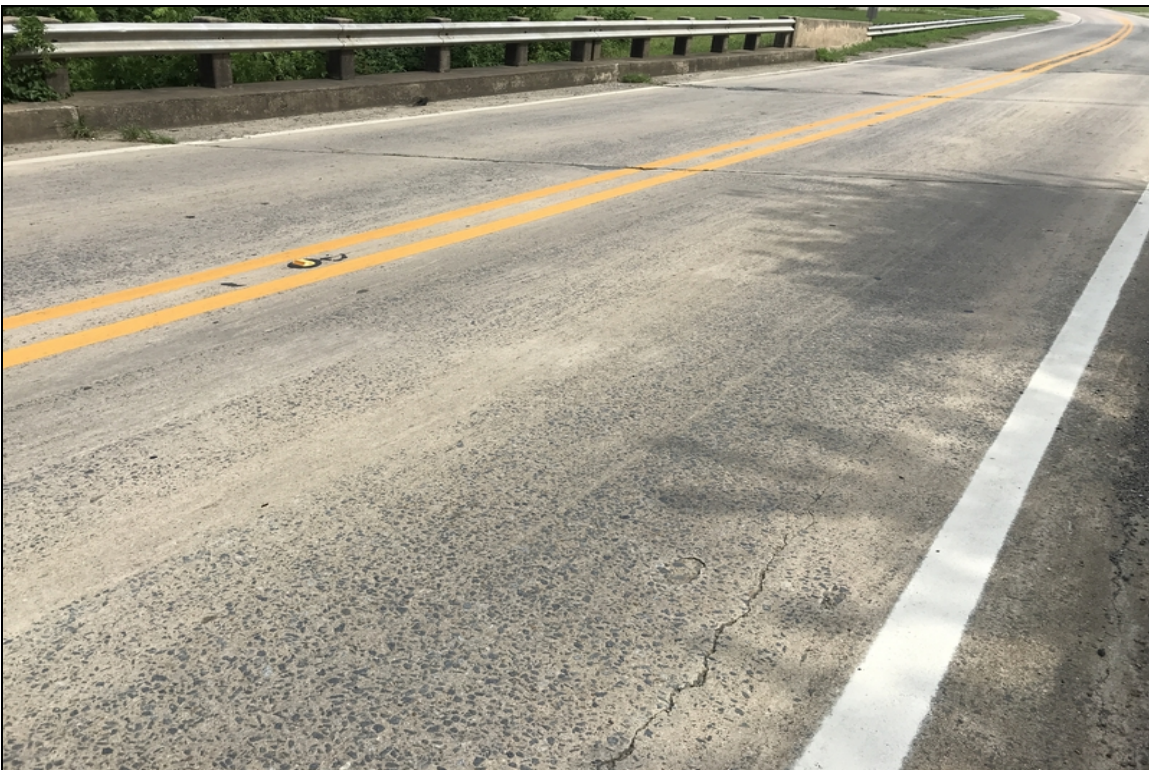
Deck - Spans 1-3: Typical

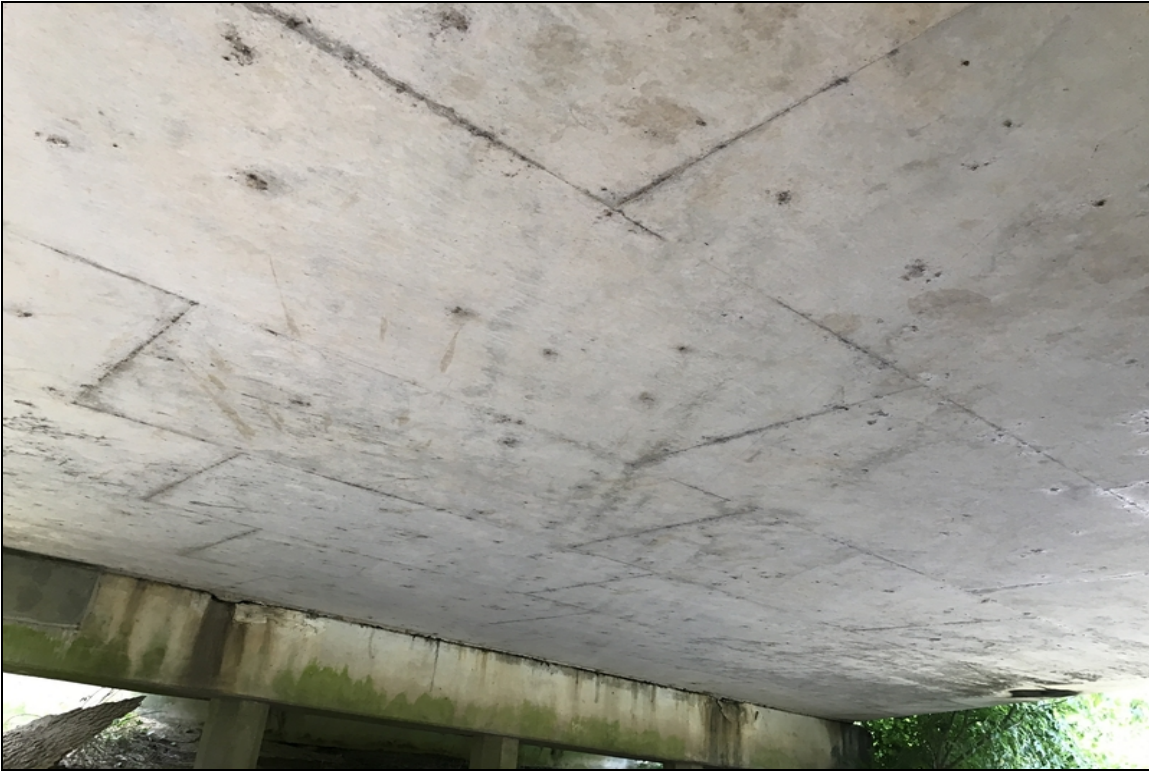
Soffit - Span 2: Typical

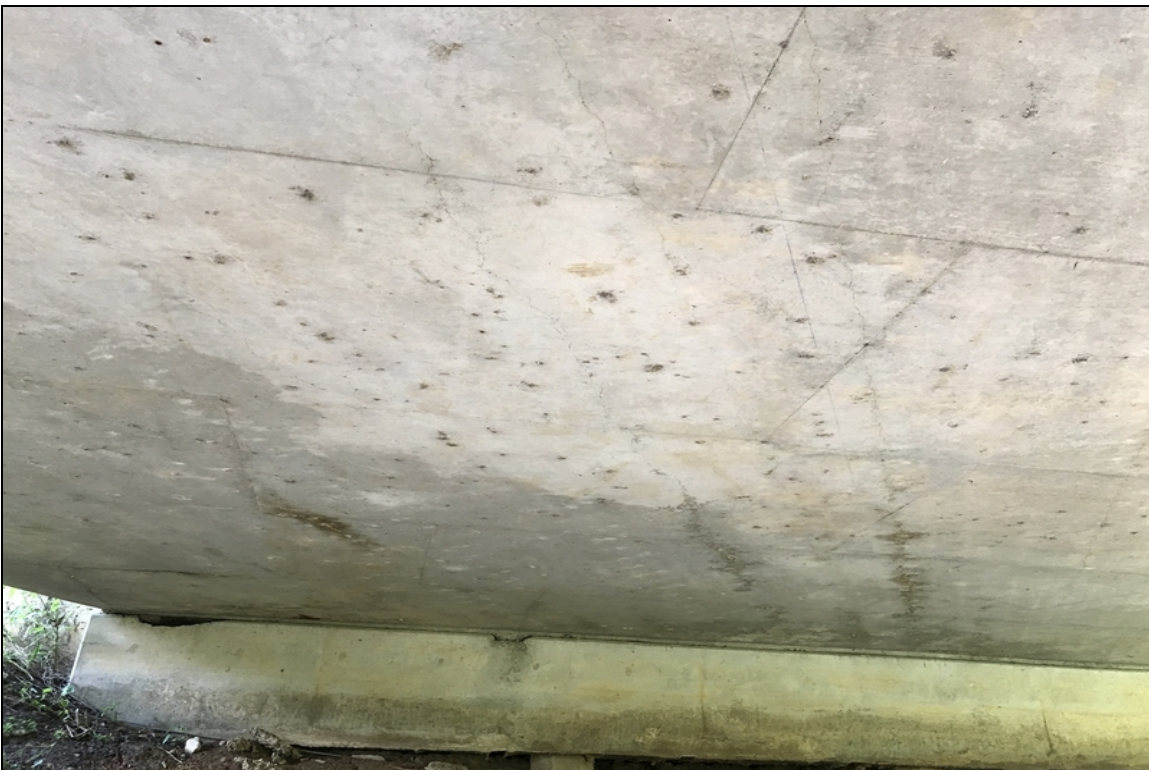
Soffit - Span 3: Cracking/rust-staining

Span 3 left: Several moderate-sized longitudinal cracks with rust staining.  
Some cracking around drains on left side.

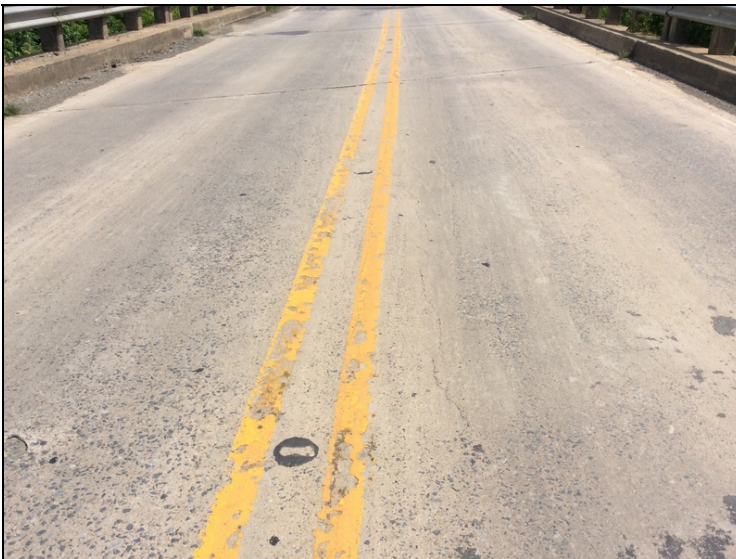
Deck - Span 1

Deck - all spans: Unsealed, minor- to large-sized longitudinal and diagonal cracks in various locations throughout deck.

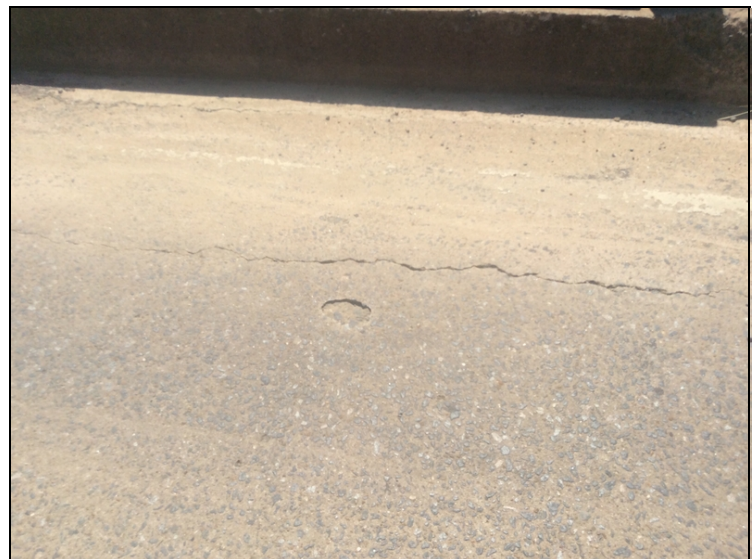
Span 1 near bent 1 right side has large unsealed longitudinal crack.

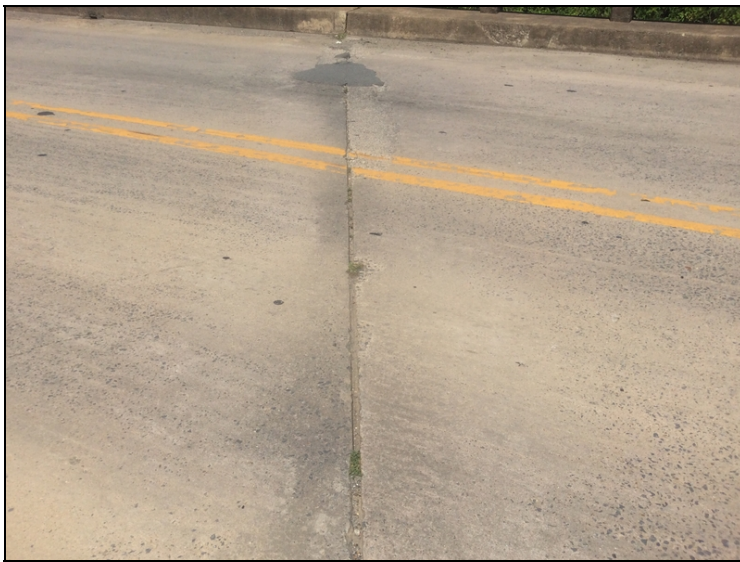
Joints – Bents 2 & 3: Poured joint material missing from joints. Joints filled with dirt and debris.

Bent 3 joint seal filled with dirt and debris. Common all bents.

Clean joints out, and re-pour material into joints

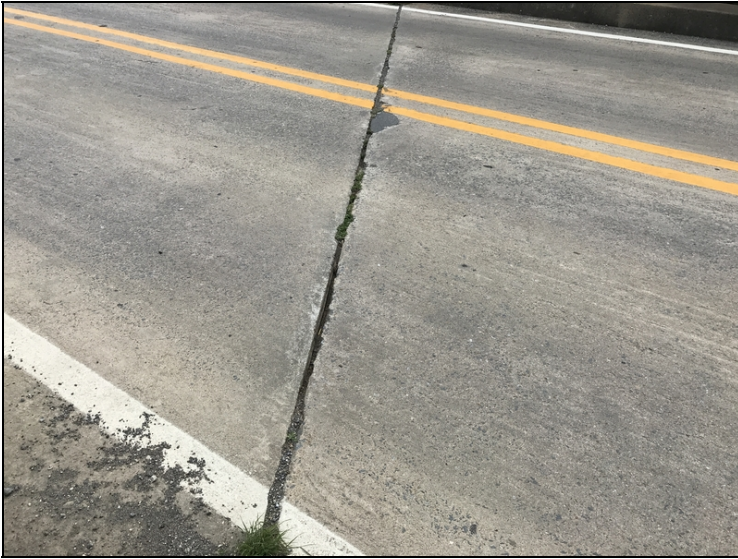
Joint - Bent 2: Material missing/debris filled

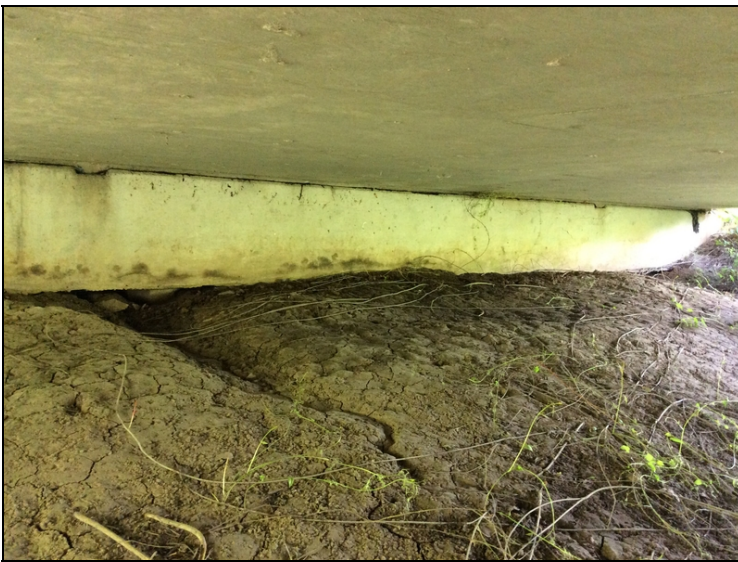
End slope -Bent 1

End slope – Bent 1: Small areas of erosion beginning near keyways, especially on right side.

No action at this time. Continue to monitor and advise if erosion worsens.

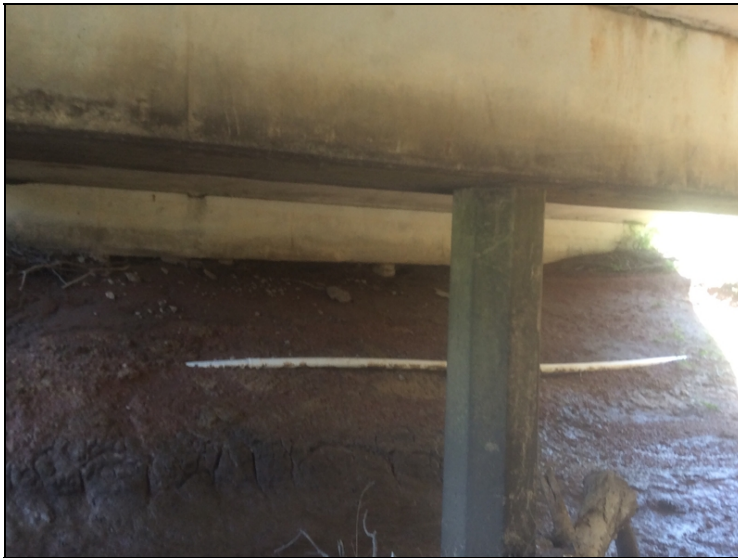
End-slope - Span 3: Moderate erosion exposing bottom of cap with some undermining and exposing utilities line(water).

End Slope erosion area under bottom of cap on bent 4 .

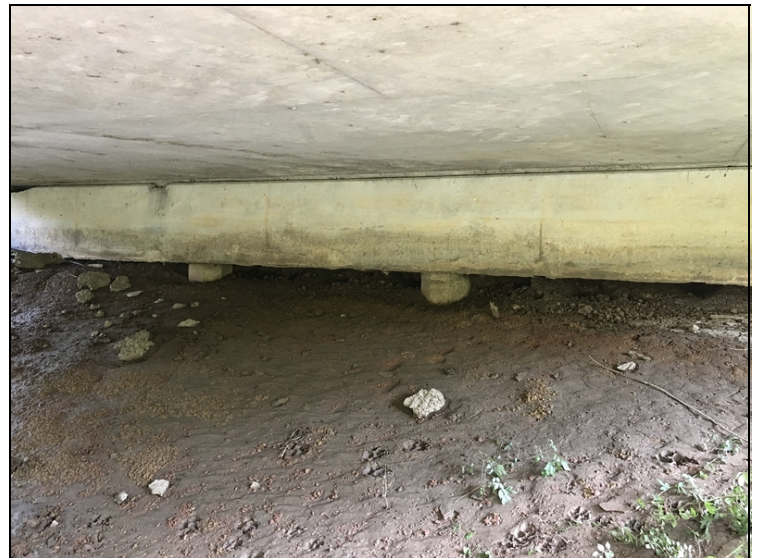
End-slope - Bent 4: Settlement/piling exposed

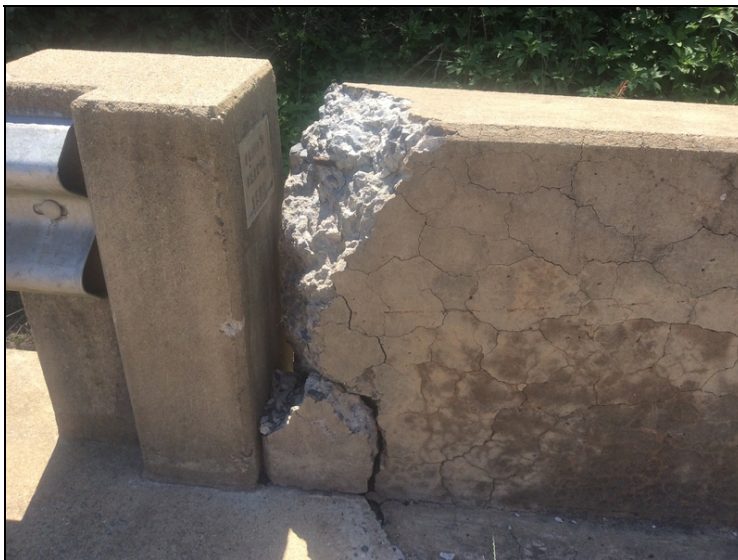
Railing - Bents 1 & 4 left & right (all 4 corners): Concrete transition post/railing is deteriorating with spalling/scaling of the surface of the post.

Southeast corner of bridge , guard rail end post has spalls with chloride contamination.

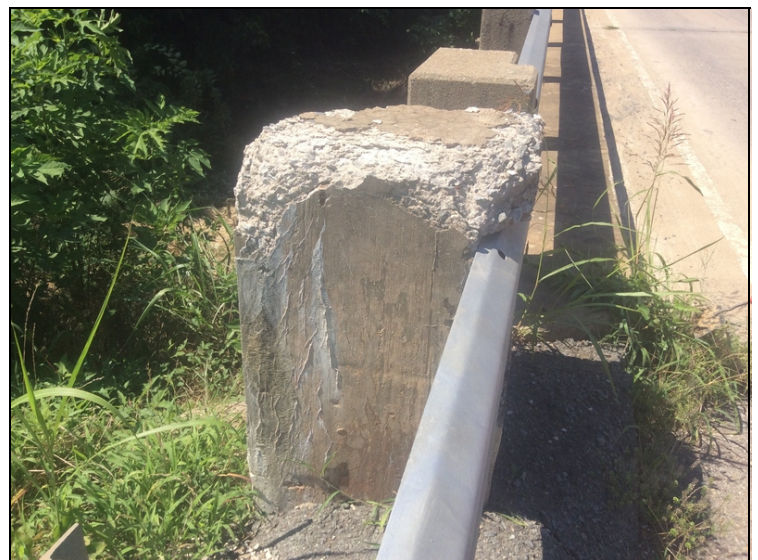
Southeast corner of bridge, guard rail end post has spalling with heavy chloride contamination..

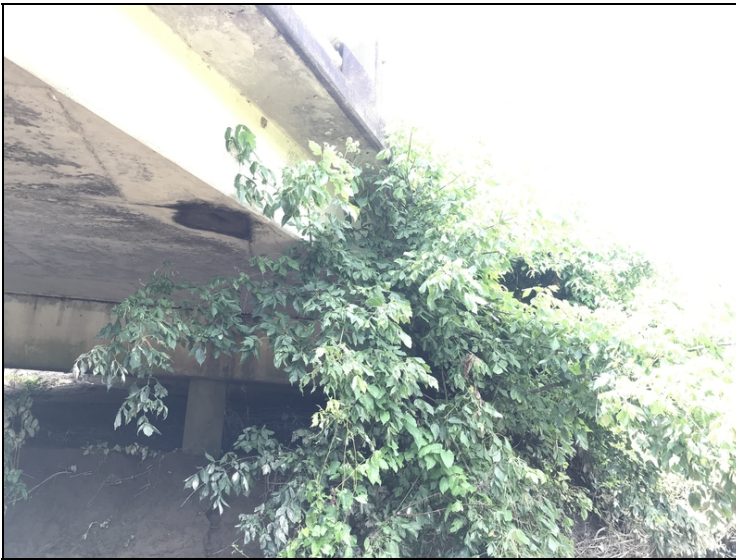
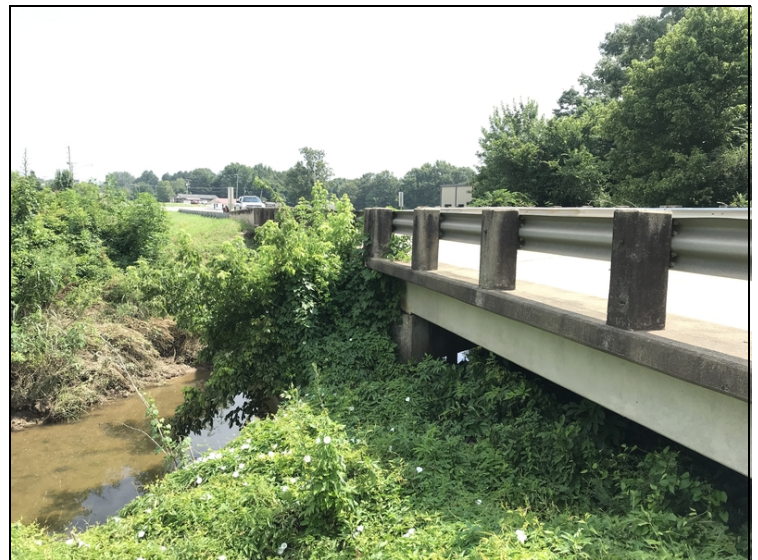
Channel - Bent 2: Small tree/bush and other vegetation growing up along side and under bridge.

Channel - Bent 2 left: Vegetation

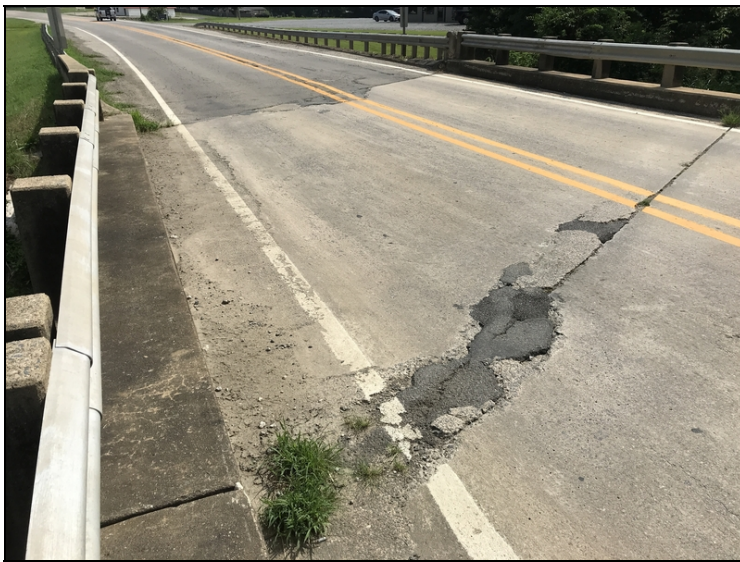
Deck - Bents 3 & 4 left sides: Some significant spalling along joints (most of spalls have been filled/patched with asphalt material).

Deck @ Bents 3-4: Spalling/patches
