# Bridge Inspection Report

**03592**  
**SH 4-17 LM 6.41**  
**over**  
**Canal No. 43**

Structure Number: 03592

Facility Carried: SH 4-17 LM 6.41

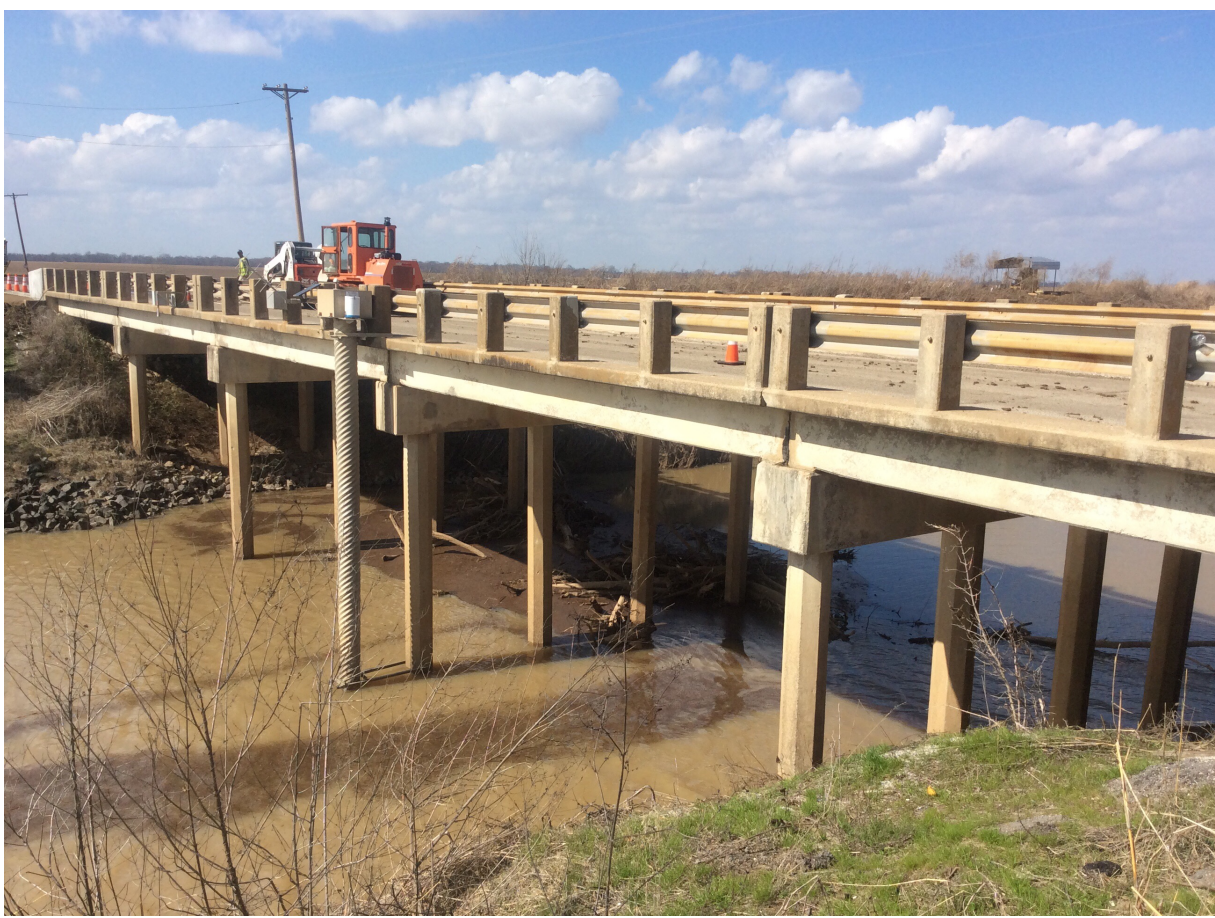
1/2 inch asphalt  
overlay

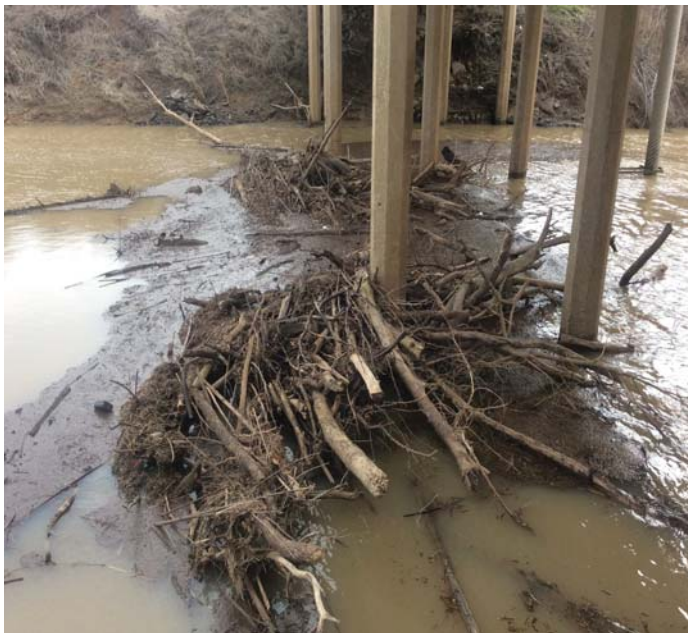
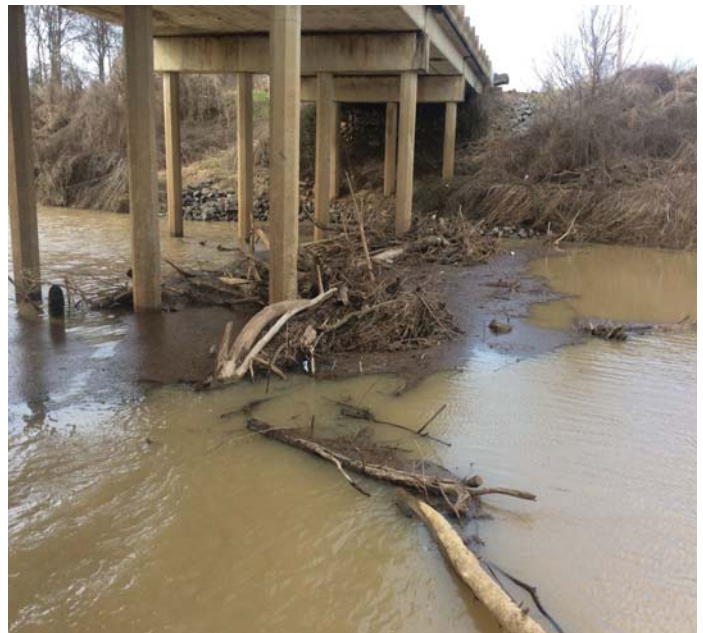
Channel - Bents 3-4 left : Minor build-up of small logs, limbs, and other debris against piling.

PHOTO 1      Description      Channel - Bents 3-4 left (debris build-up)

PHOTO 2      Description      Channel - Bents 3-4 left (debris build-up)

Desha: remove debris

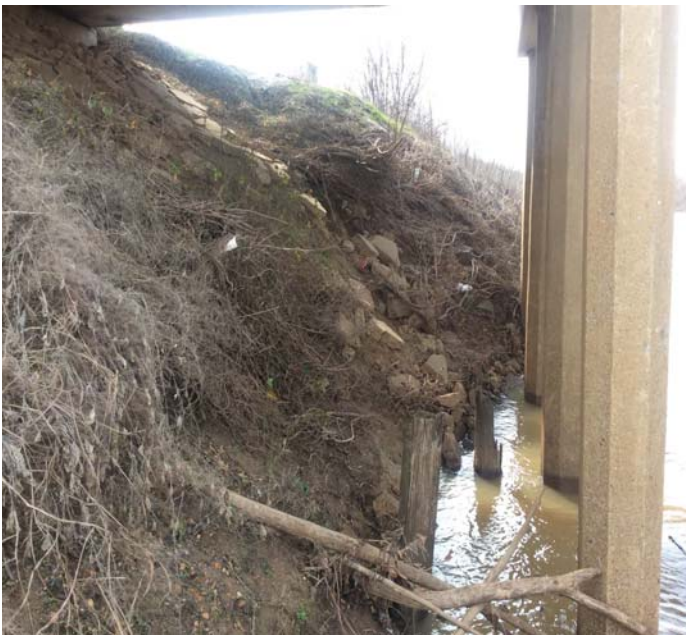
Endslope - Span 5: Some minor erosion under bridge just ahead of Bent 5.

PHOTO 1    Description    Endslope - Span 5 (erosion)

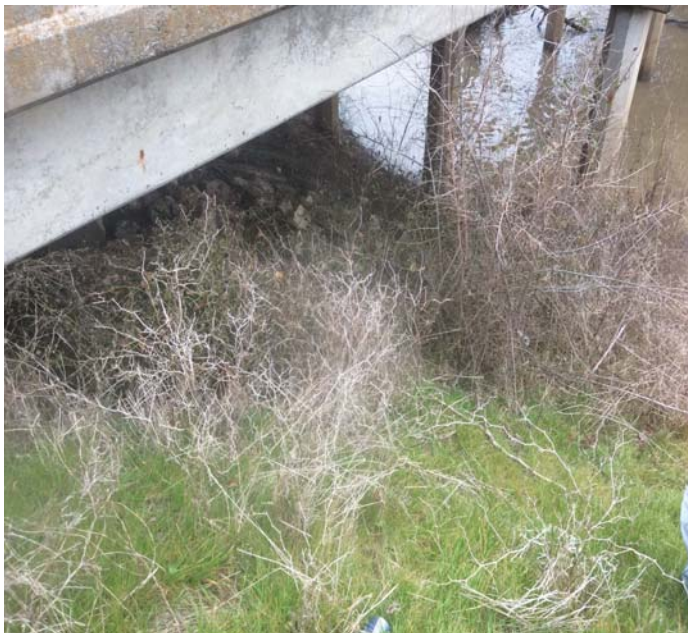
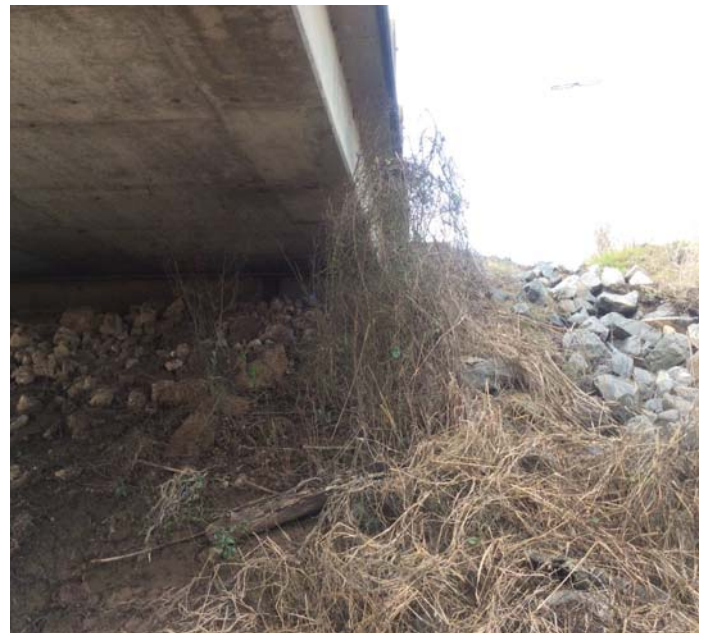
Endslope - Span 1: Some small trees, bushes, and vines growing up right beside bridge.

PHOTO 1      Description      Span 1 small trees and vines along side of bridge.

PHOTO 2      Description      Endslope - Span 1 left (vegetation)

Desha: Remove and advise when complete

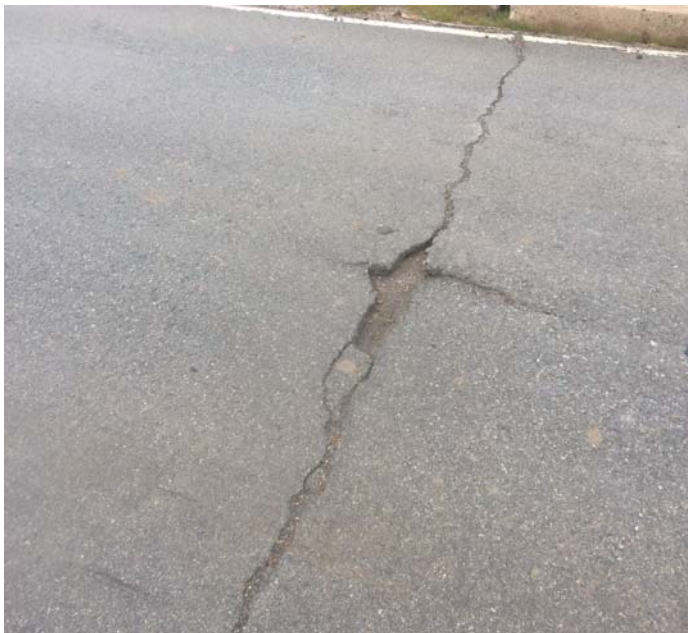
CORRECTED - Beginning of bridge small pothole in approach roadway.

PHOTO 1      Description      Beginning of bridge small pothole in roadway approach near center line.

GGL-KLR: Location currently under contract for repairs.

"Desha: repair and advise when complete"
