Bridge Inspection Report

03593

SH 4-17 LM 7.44

Boggy Bayou

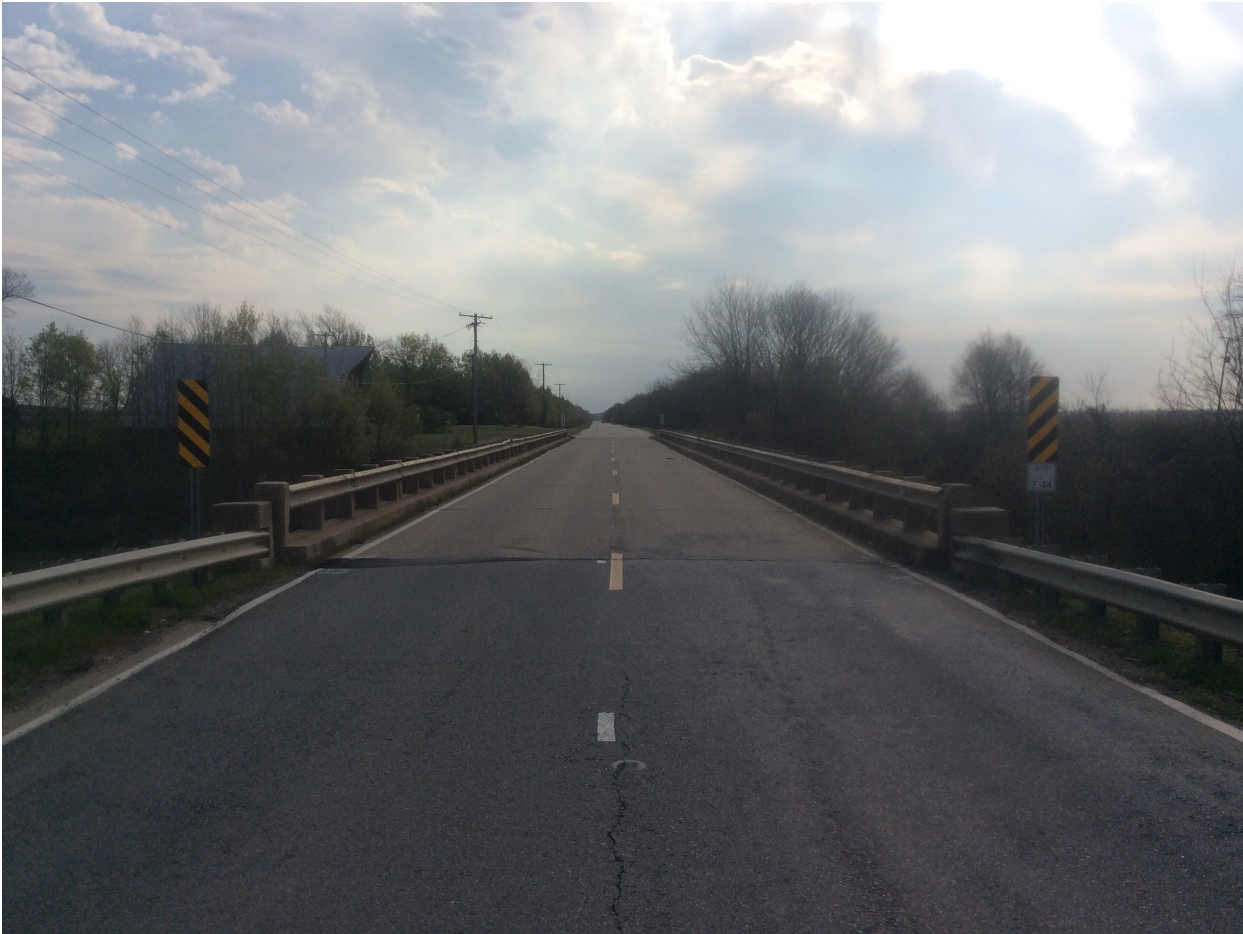
Deck has 5 inches
of asphalt overlay

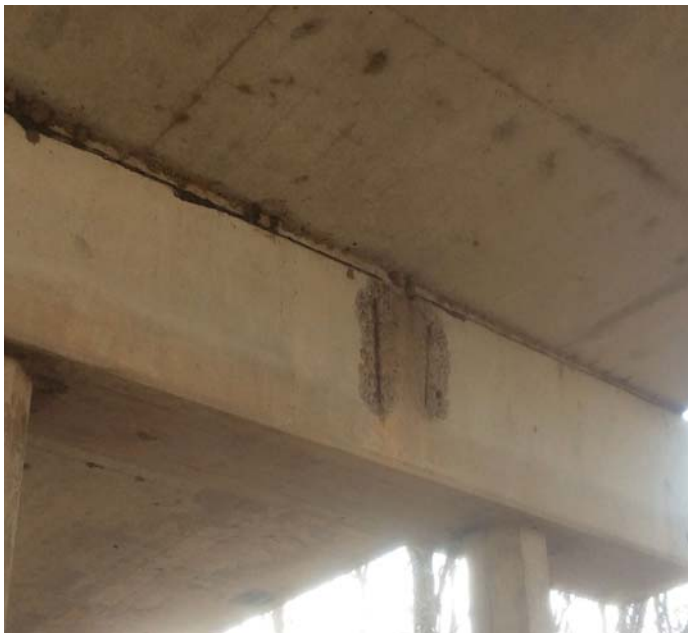
Caps - Bents 2, 3, 5, 8, 9, & 11: Scattered small, shallow delaminations and spalls with exposed rebar.

PHOTO 1 Description Caps - Bent 10 back: Rebar exposed

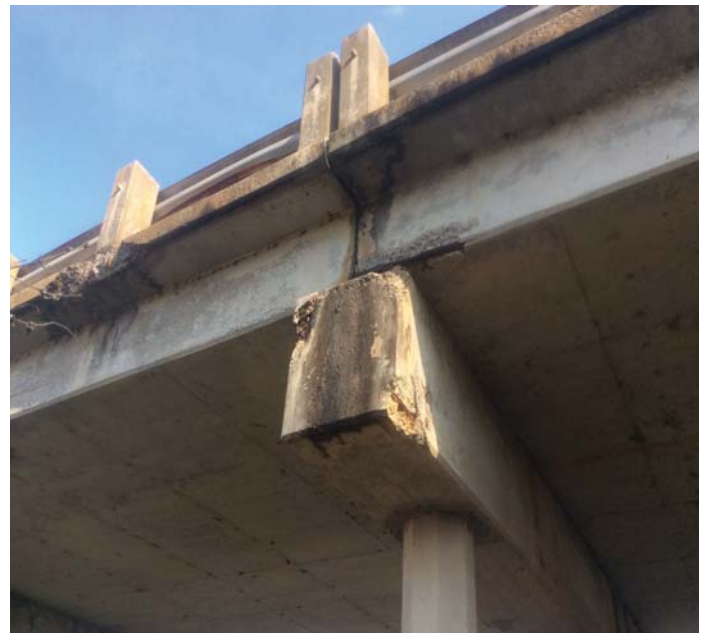
PHOTO 2 Description Cap - Bent 9 right end: Rebar exposed

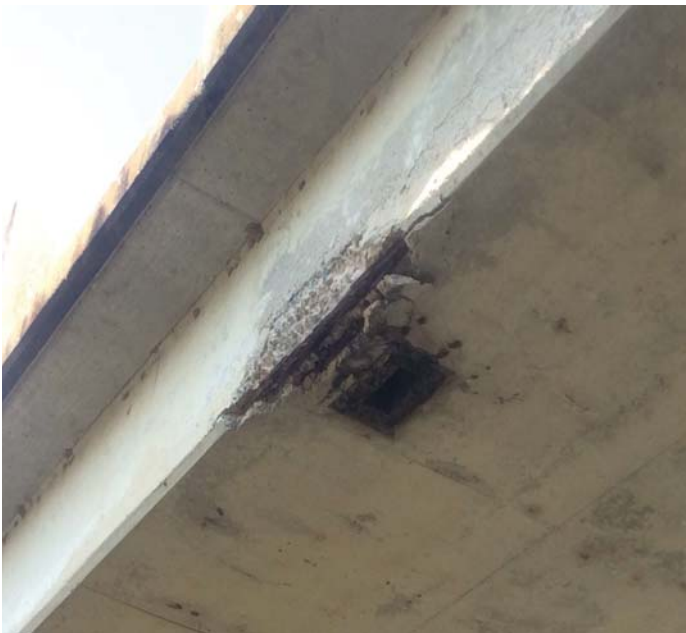
Soffit - Spans 7 & 8: Spalling with some rebar exposed on bottom corners of deck, mainly at drains and caps.

PHOTO 1 Description Soffit - Span 8 right: Rebar exposed

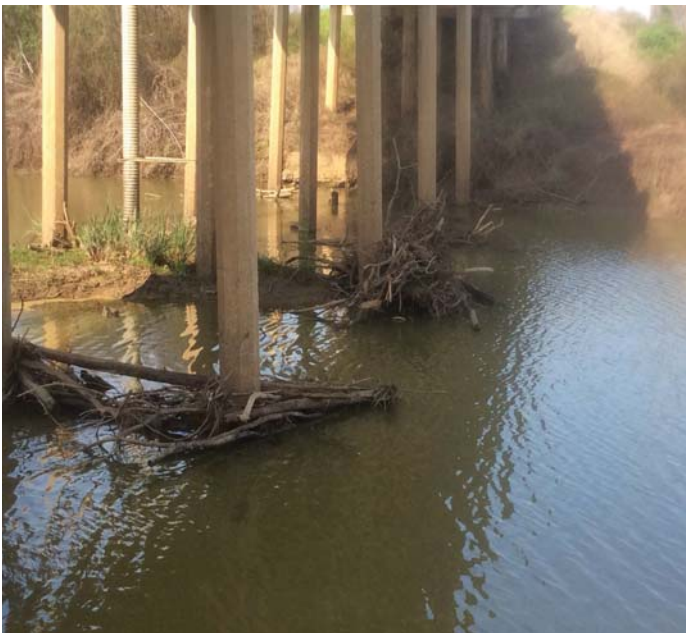
Channel - Bents 5, 6, & 7: Minor build-up of drift and debris against pile.

PHOTO 1 Description Channel - Bents 5-7: Debris build-up
