Bridge #05018(Routine, Other Special Recurring)

SH 278-16 LM 4.38 over Union Pacific R/R

Team Lead: Greg Loomis Inspection Date: April 13, 2021

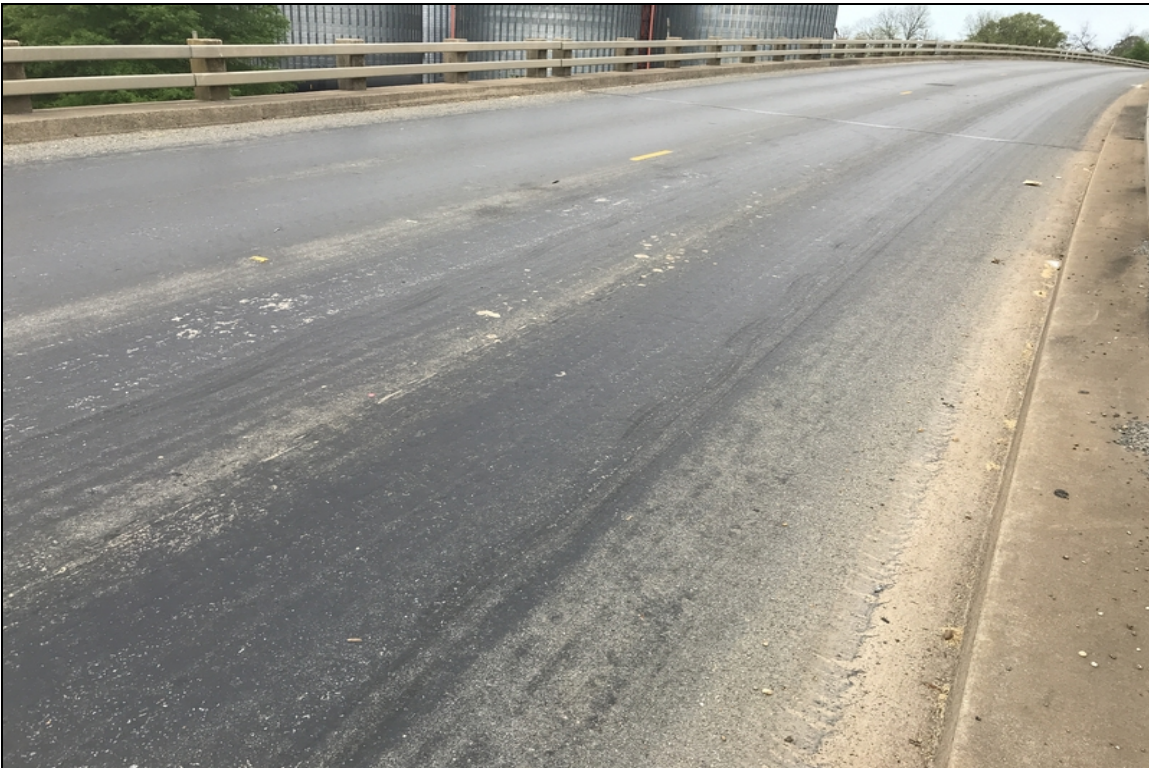
Deck - Spans 15-16: Typical

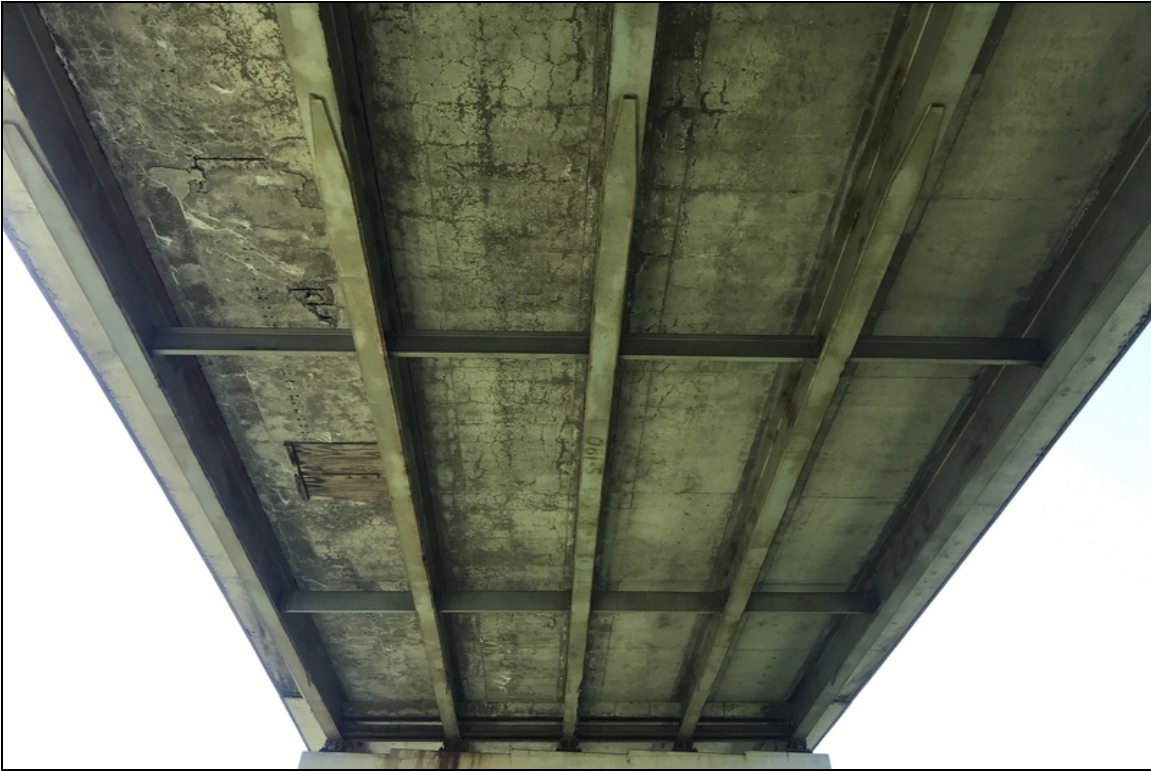
Soffit - Span 3: Typical

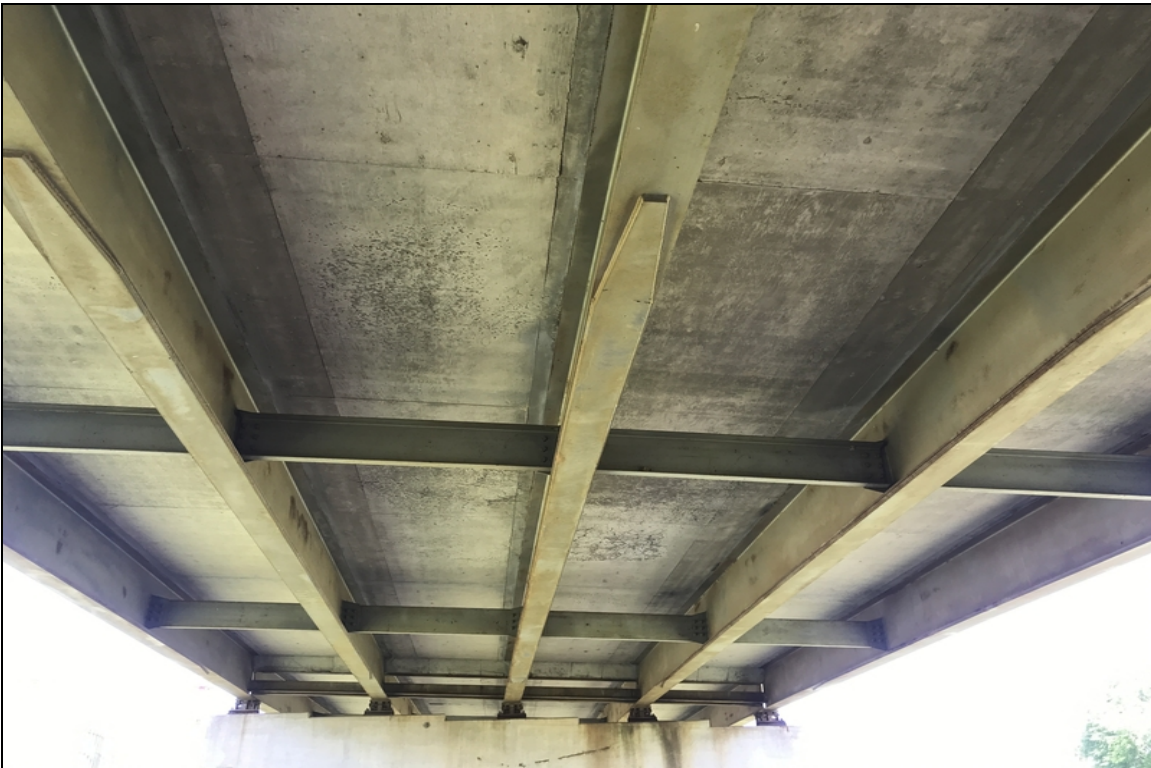
Soffit - Span 17: Typical

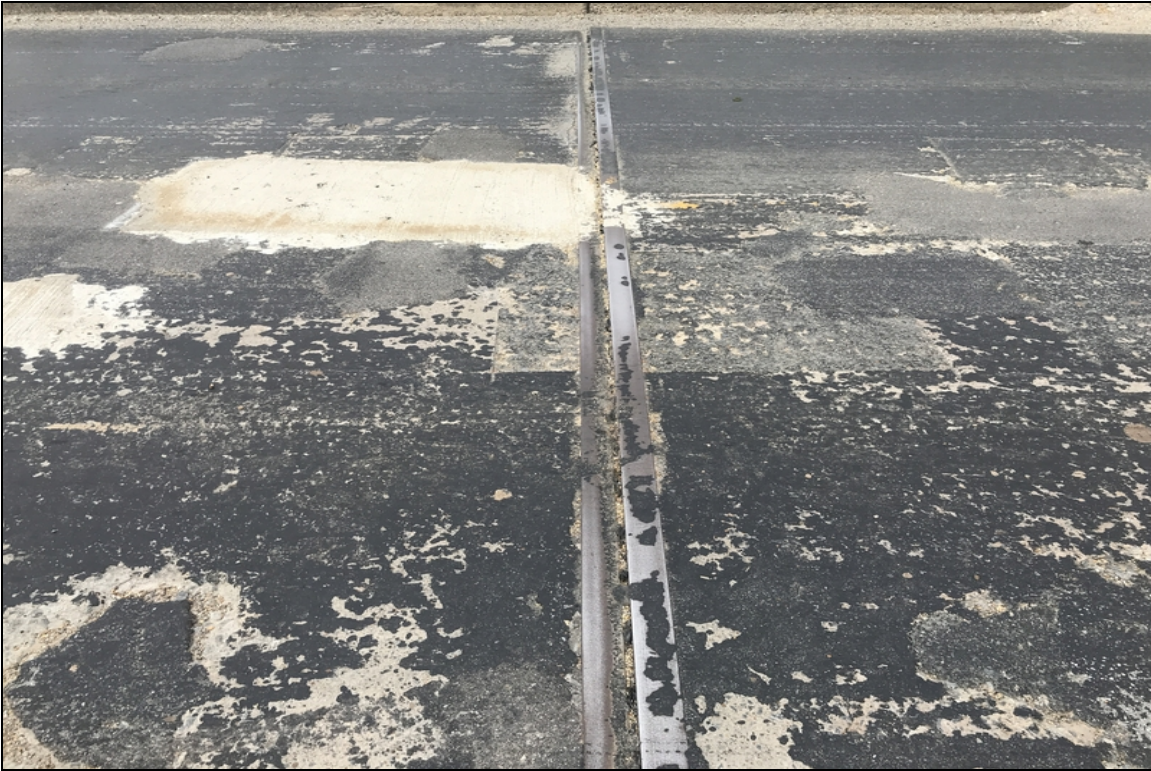
Joint - Bent 4: Loss of adhesion

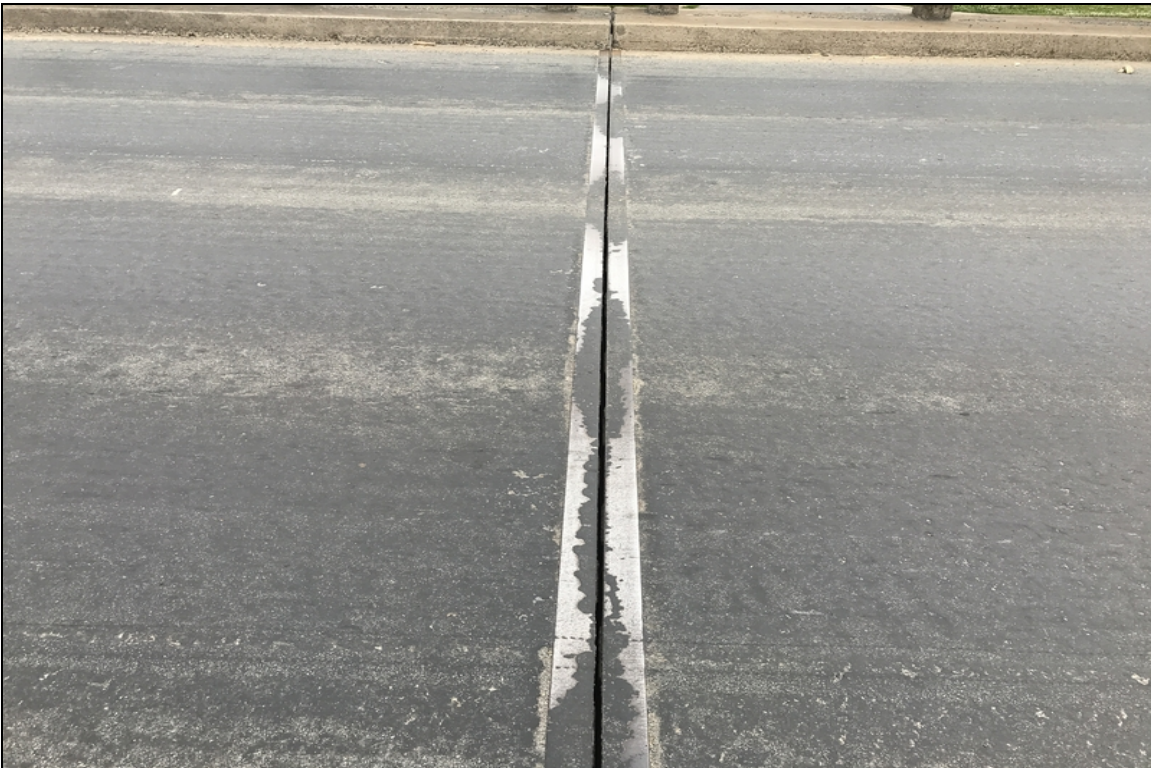
Joint - Bent 16: Material missing

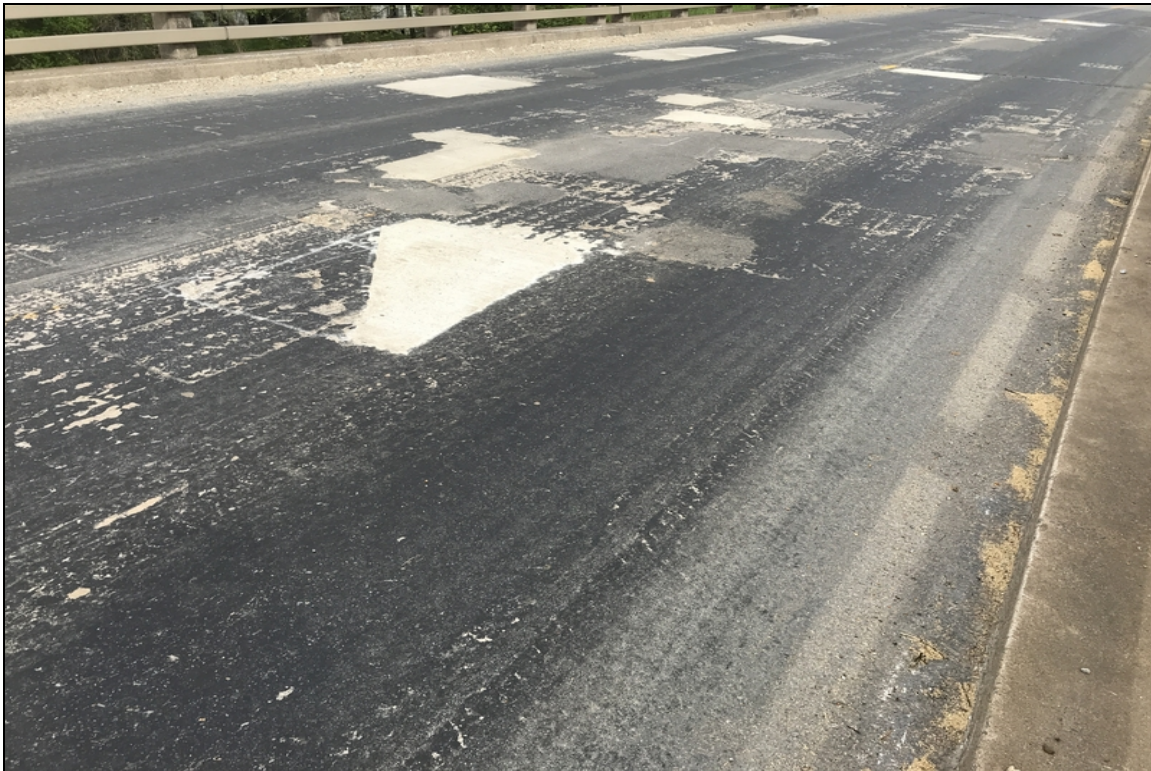
Deck - Spans 1-2: Spalling/patches

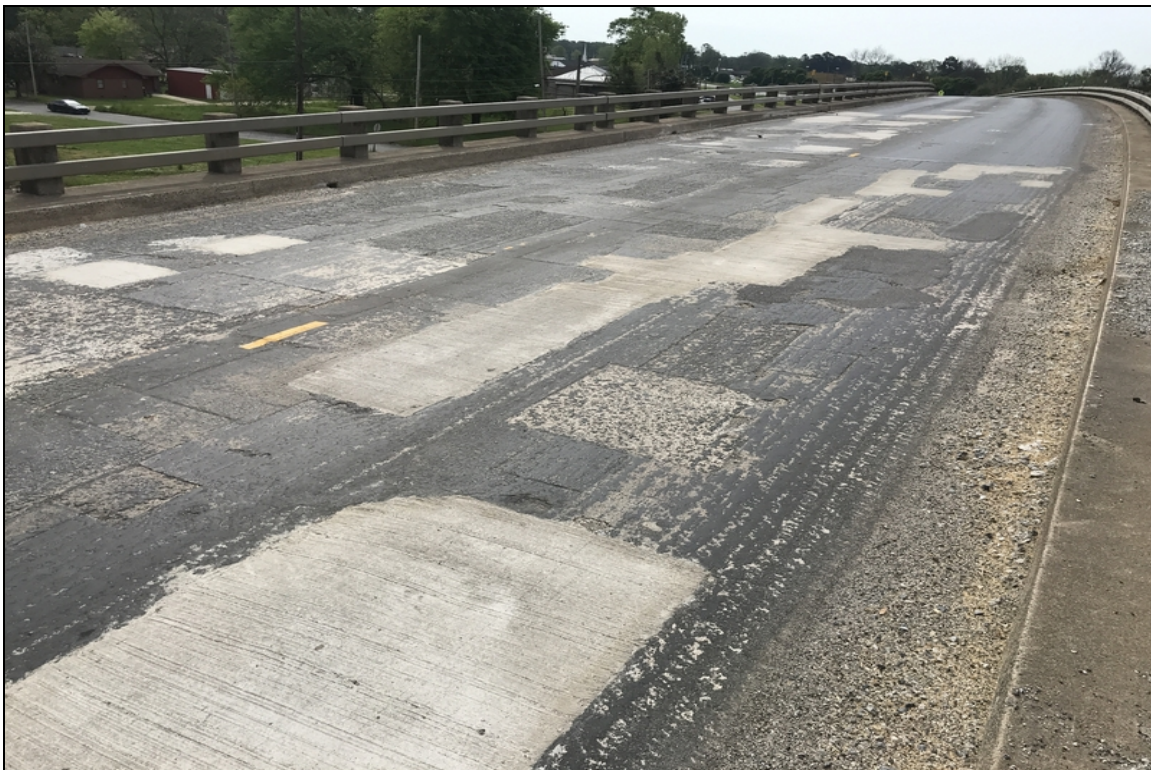
Deck - Spans 5-6: Spalling/patches

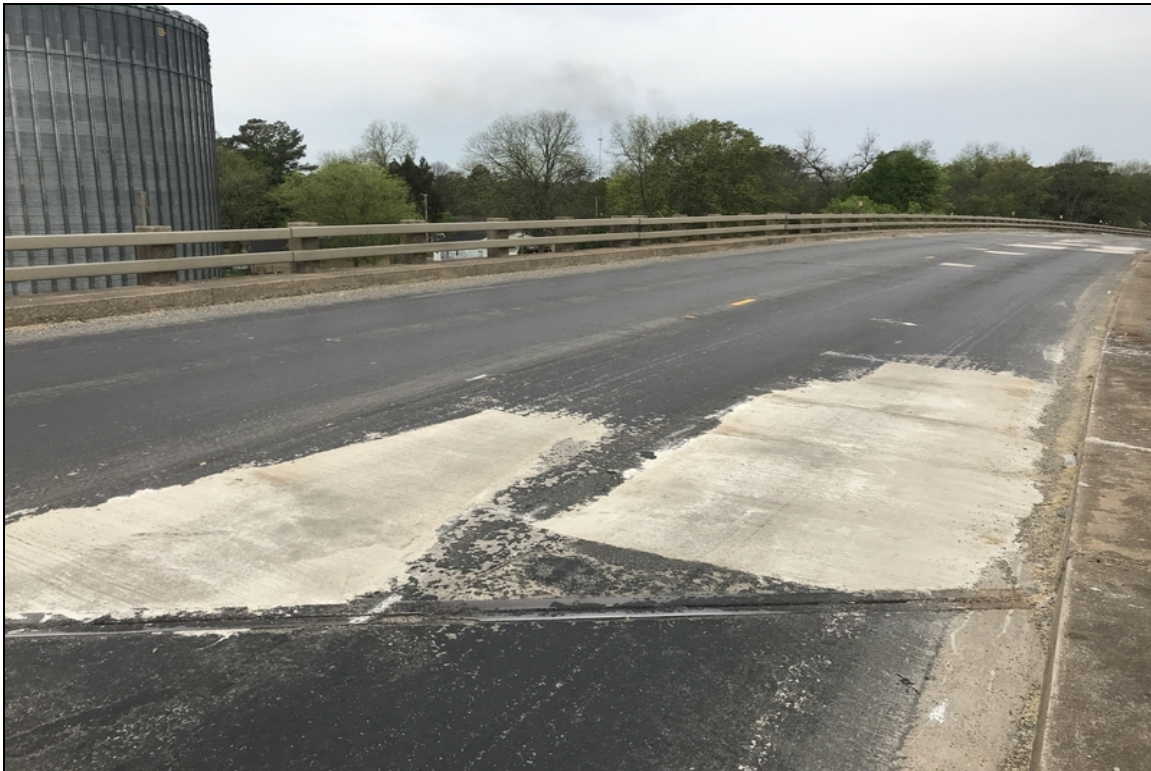
Deck - Span 10: Patches

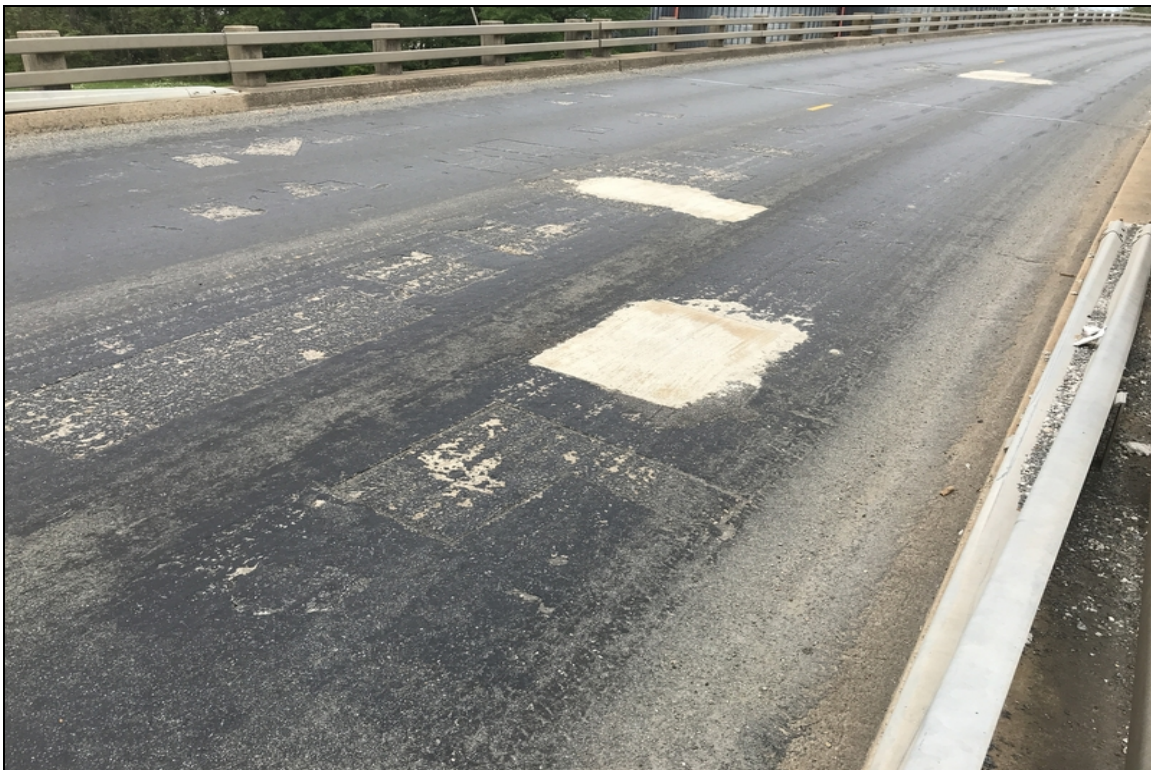
Deck - Spans 17-18: Spalling/patches

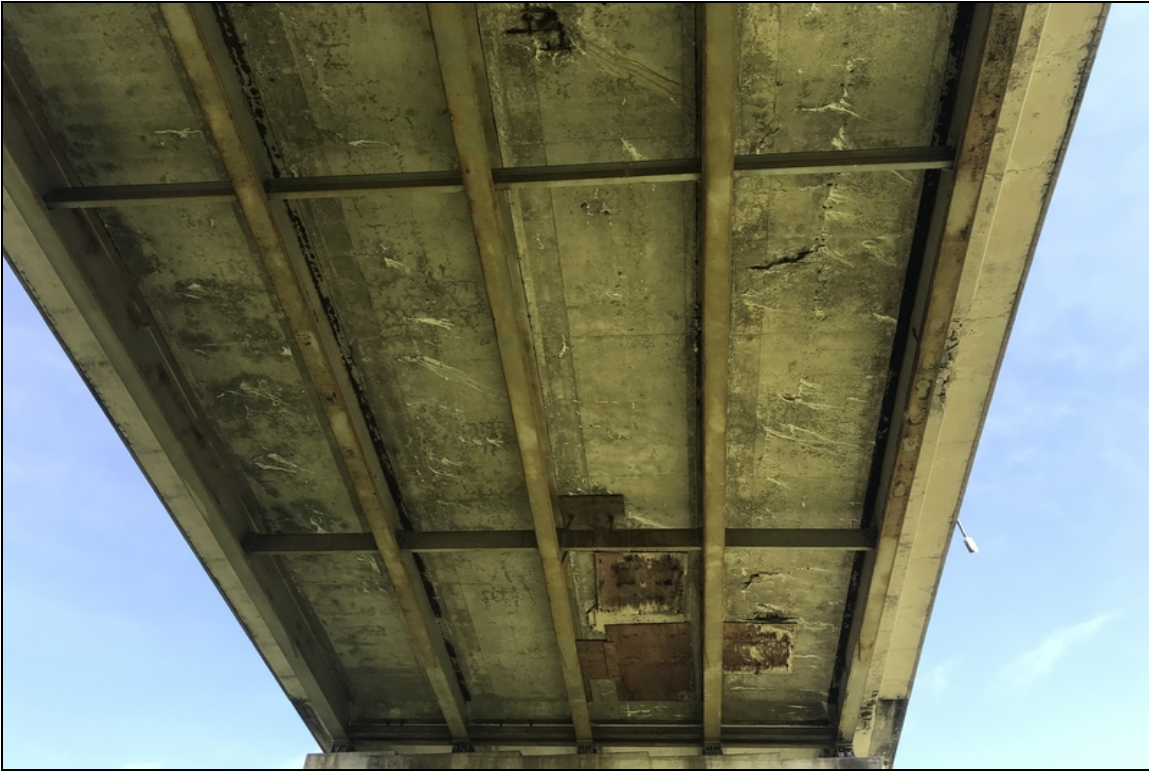
Soffit - Span 5: Efflorescence/patches

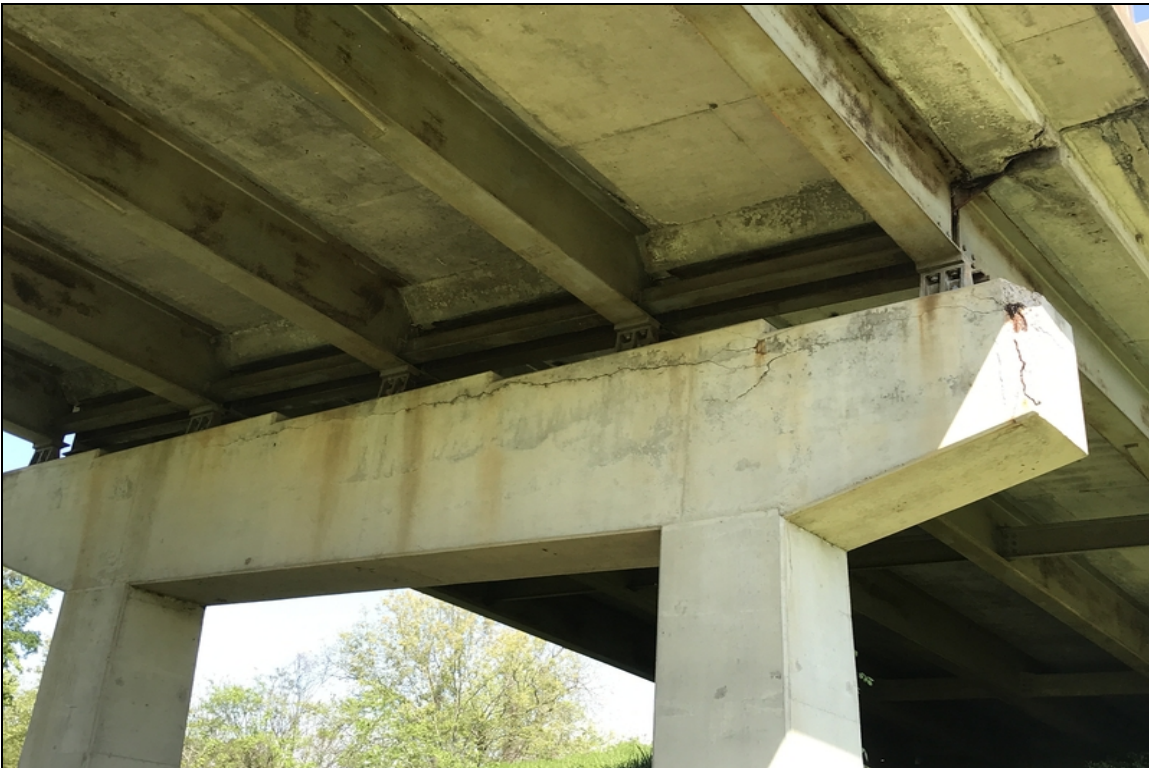
Cap - Bent 2 back: Cracking/spalling

Cap - Bent 2: Cap has a horizontal crack and delam across the ahead and back faces and a spall with exposed rebar - left end on the ahead face.

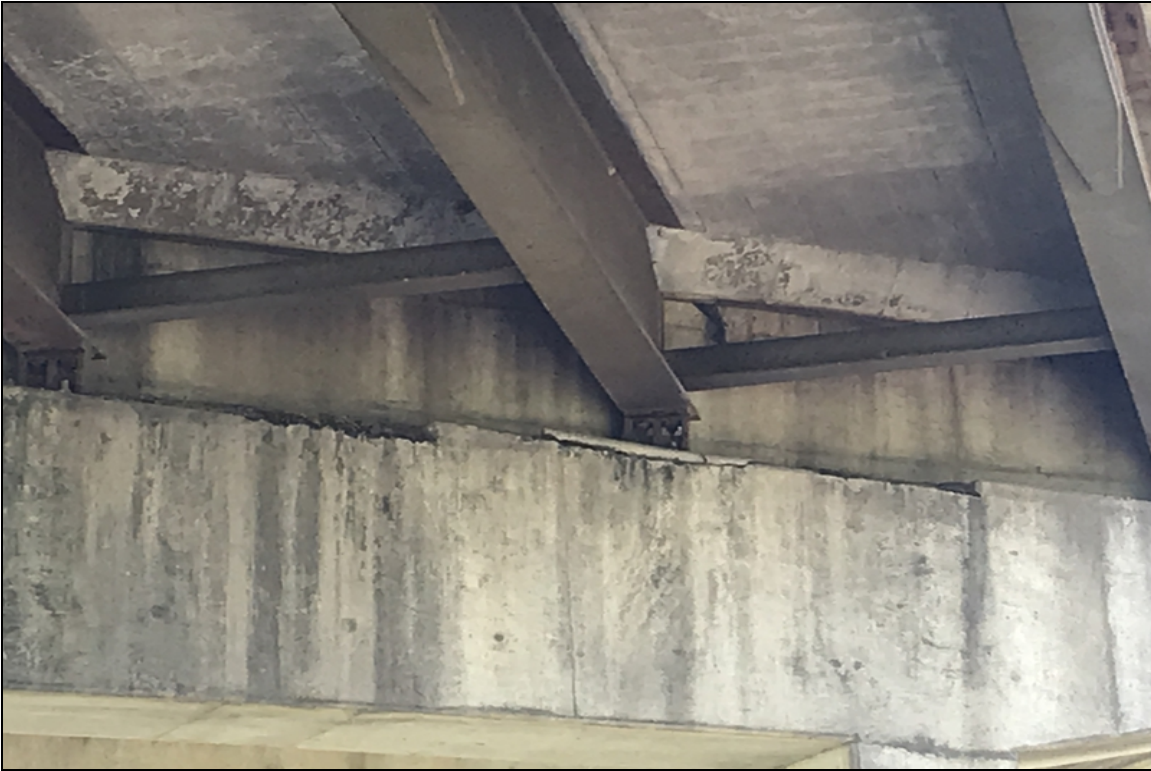
Cap - Bent 10 @ Bearing 4: Spall

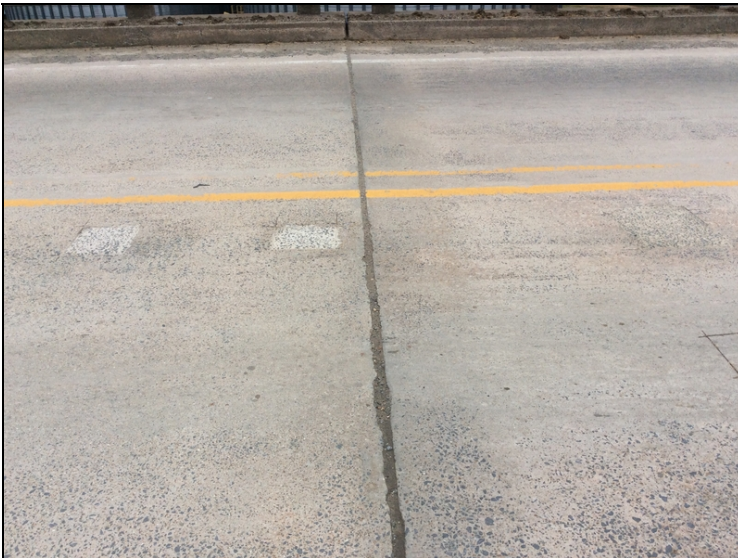
Joint - Bent 8

Joints - Bents 8 & 11: Pourable joint material is missing from joints, allowing stormwater to leak through joint and onto end of slab and cap - joint is filled with dirt and other debris, limiting expansion of spans on both sides.

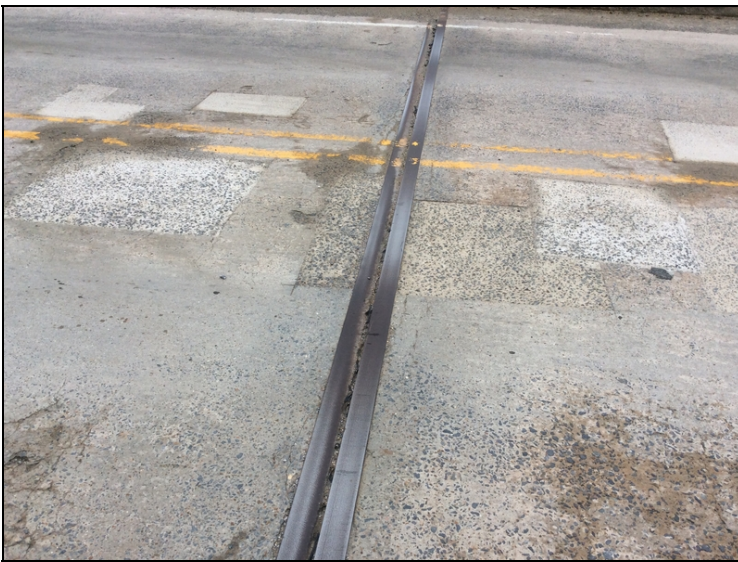
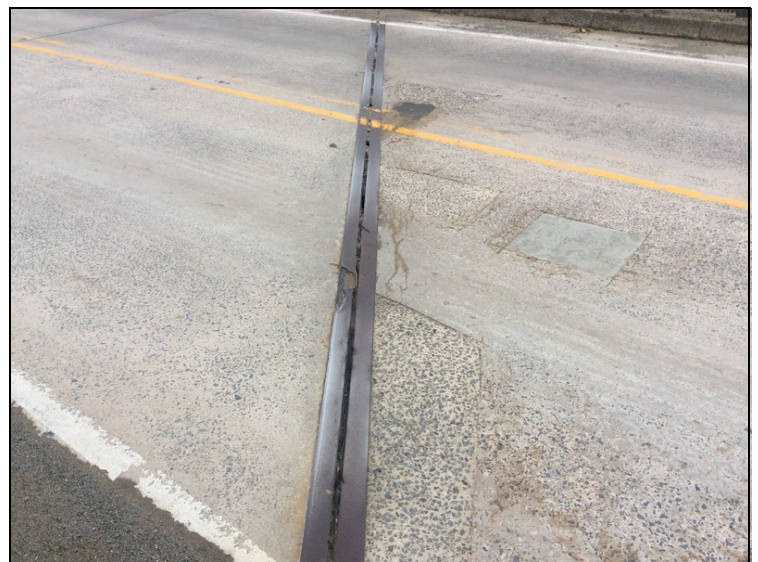
Joints - Bents 1-5, 7, 10, 15, & 17-19: Preformed joint material is tattered, torn and missing allowing stormwater to leak through and dirt and other debris to build-up on end of girders, bearings, and caps.

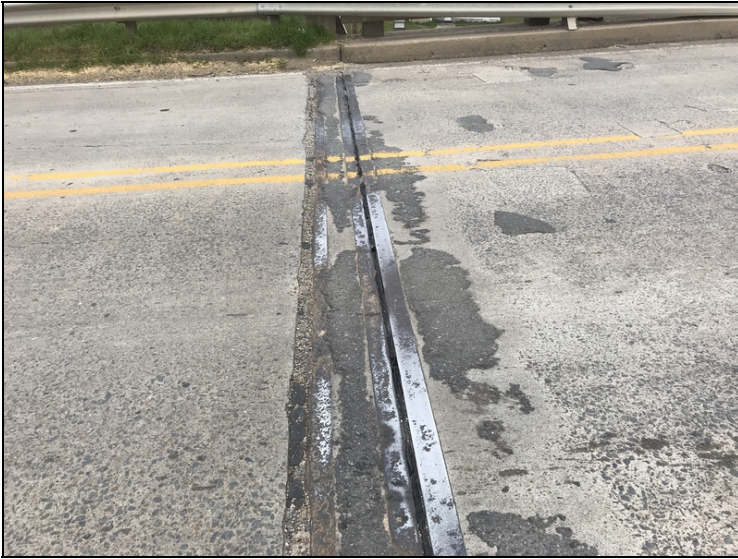
Bent 1 expansion joint damaged. This is Common at all joint.

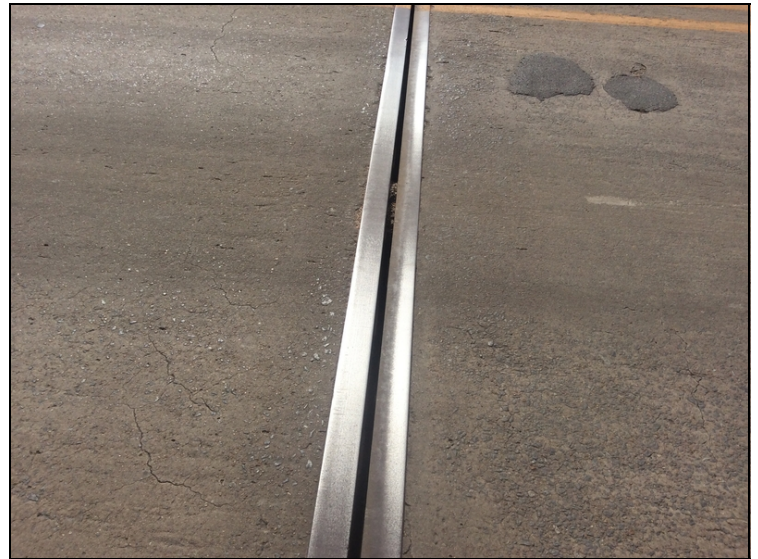
Bent 13 joint seal missing .

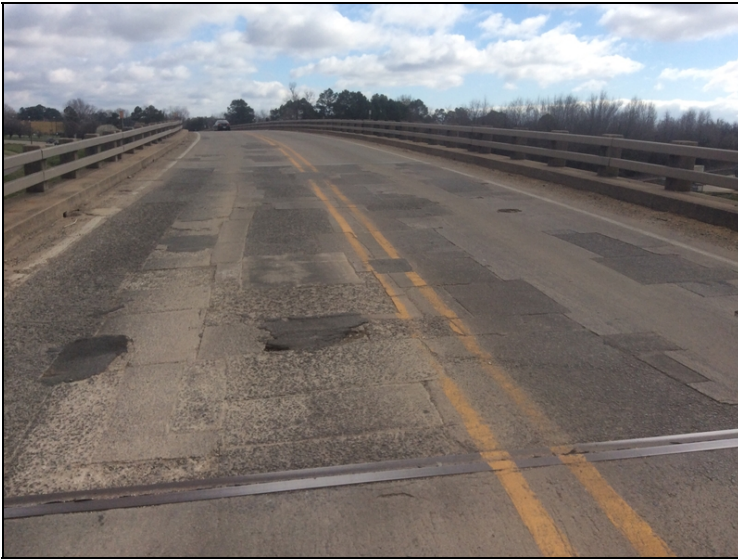
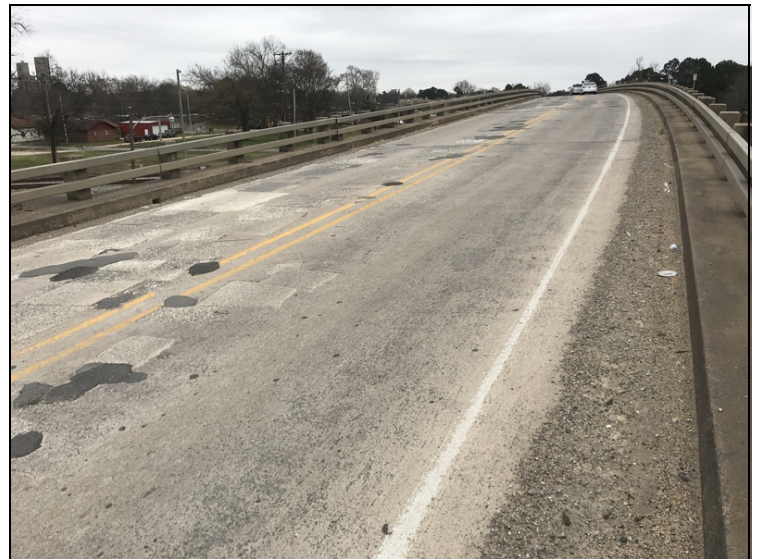
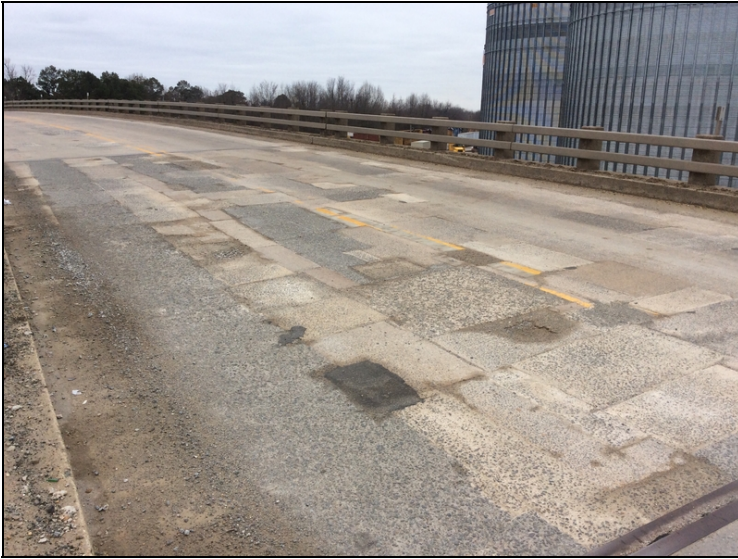
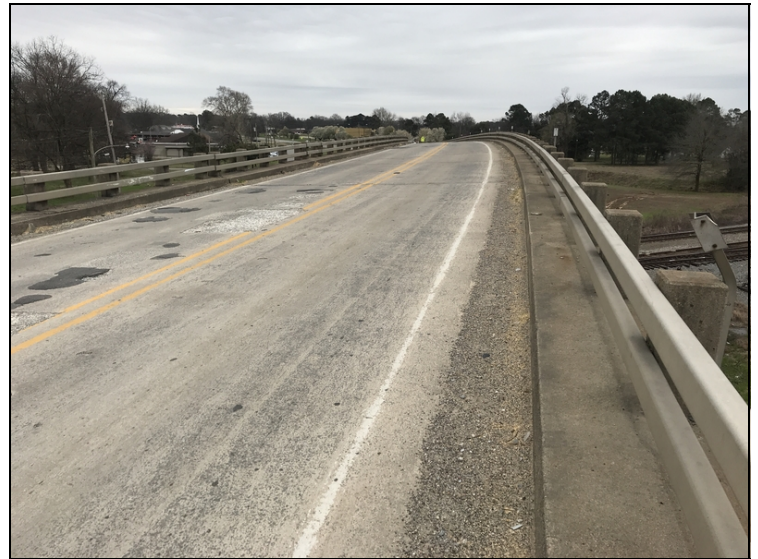
Deck - Span 1-18 Several repair patches are beginning to deteriorate and spall -out - forming potholes in deck surface. Heavy scaling and very large cracks in many spans.

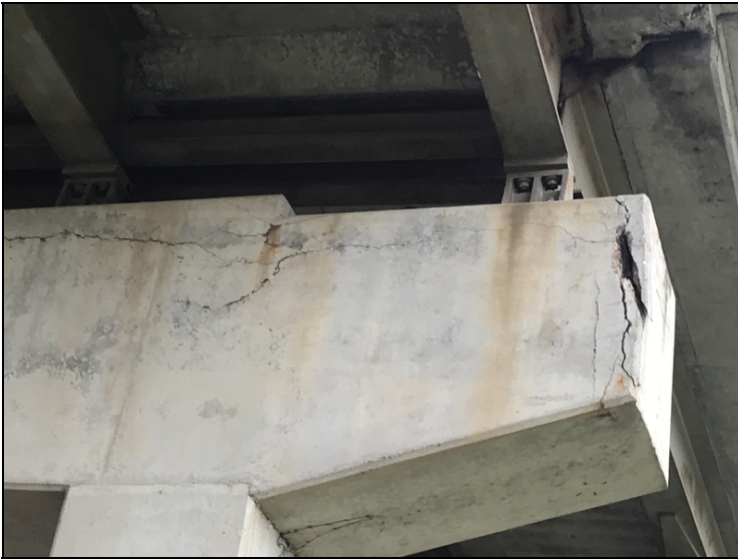
this is one we may need to look at quickly, this may fall?

Bent 2 cap ahead face left has spall with exposed rebar and delamination with cracking.

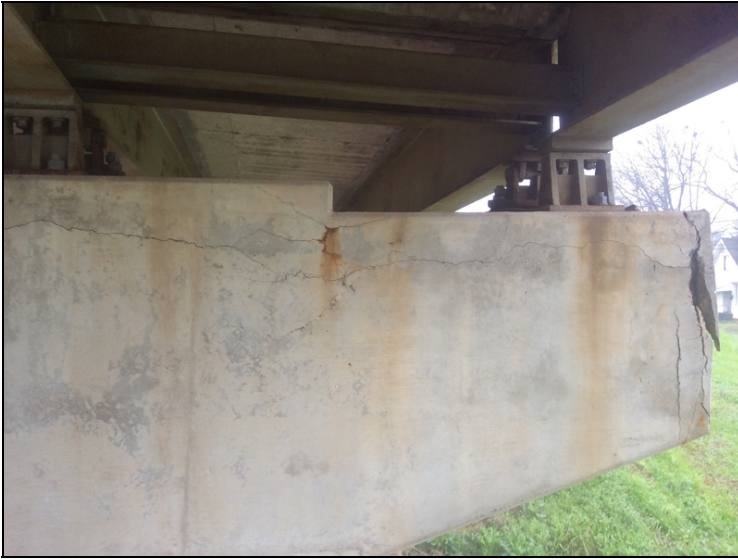
Bent 2 cap ahead has large horizontal cracks with some rust staining. Cap ahead left end has spall with exposed rebar.

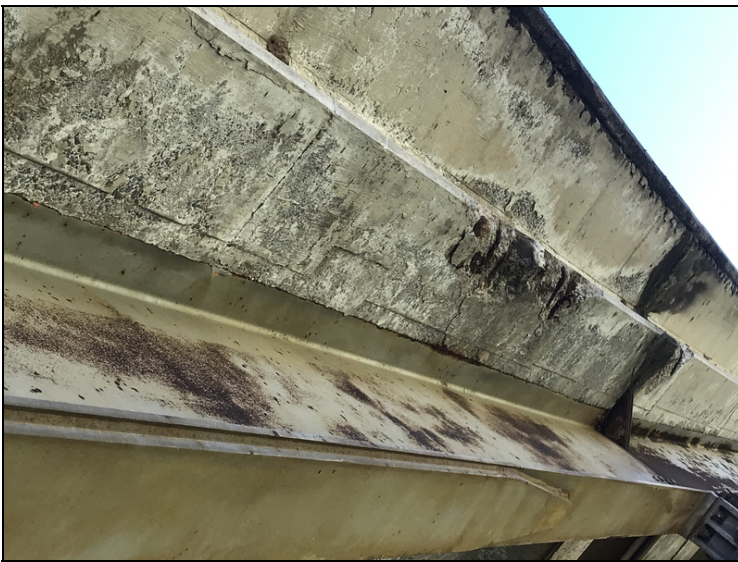
Span 6 left soffit at overhang drain opening spalling with exposed steel to bottom of deck.

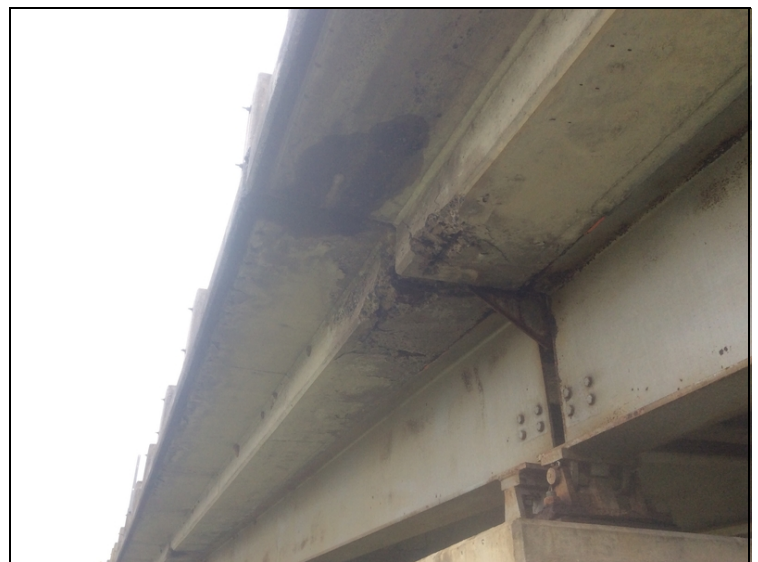
Deck soffit at bent 3 left spalls with exposed rebar near joint armor.

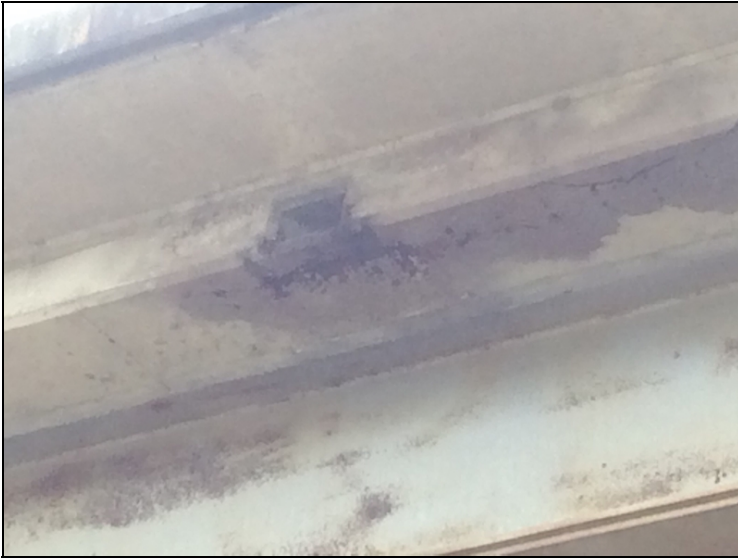
Soffit - Span 2 left side @ drain

Soffit (bottom of deck) - Spans 2-6 left side around drains: Some spalling along bottom corner of deck with rebar exposed (minor section loss).

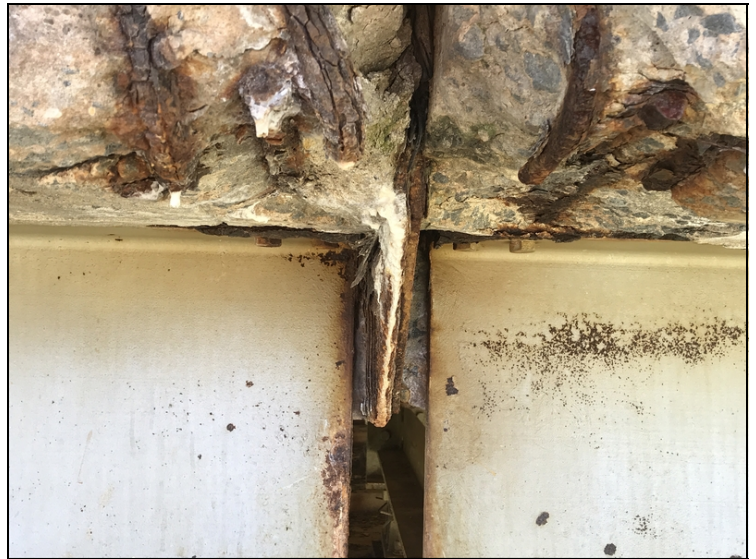
Bent 4 joint armor left side is completely closed due to pack rust.

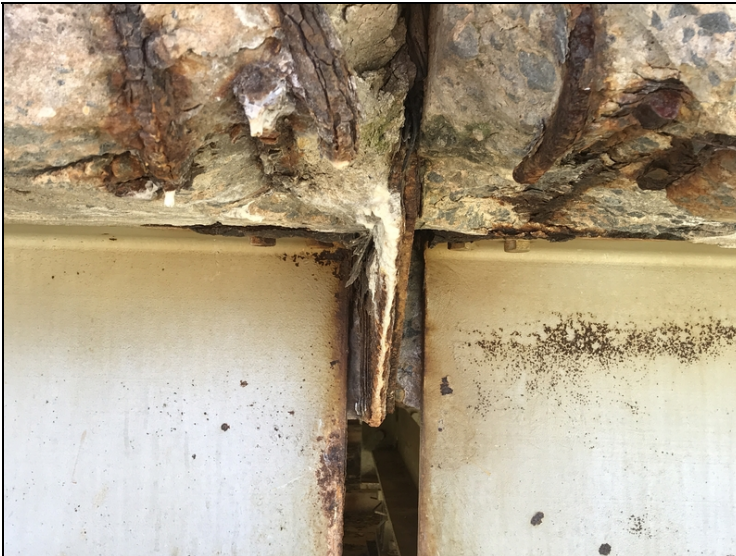
Bent 4 joint armor left side is completely closed due to pack rust.

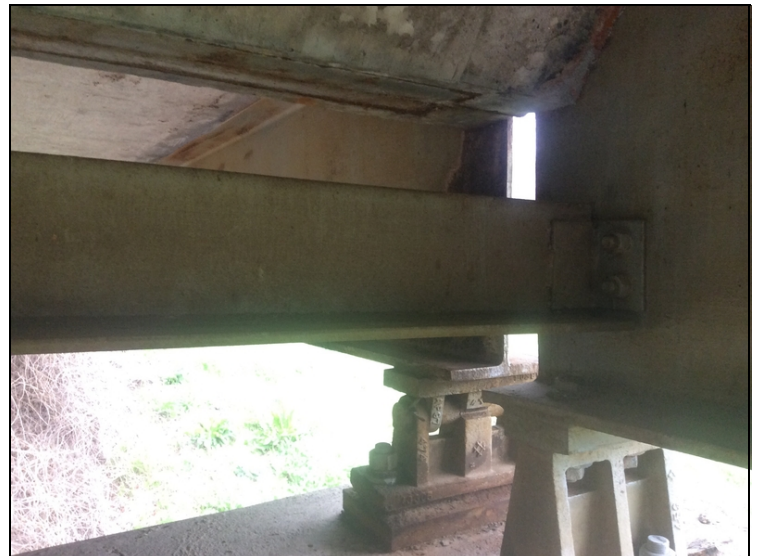
Span 1 bent 2 girder 1 has some light flaking rust to end 1'

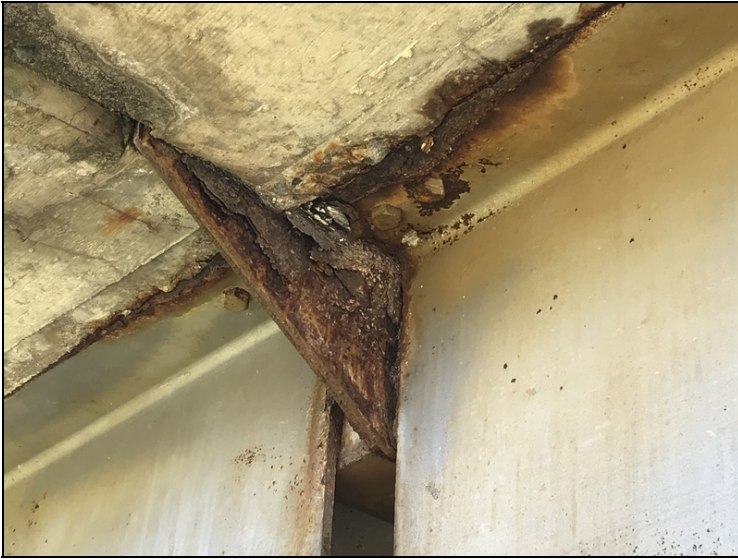
Bent 18 left has heavy flaking rust to joint armor and girder ends.

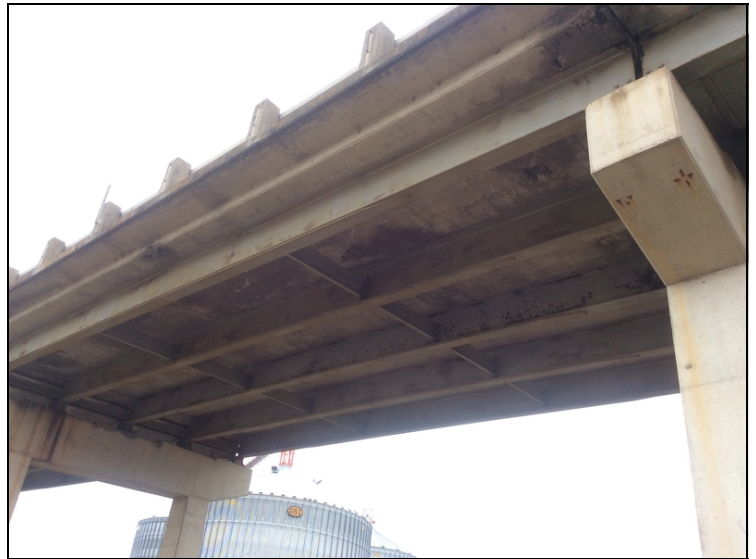
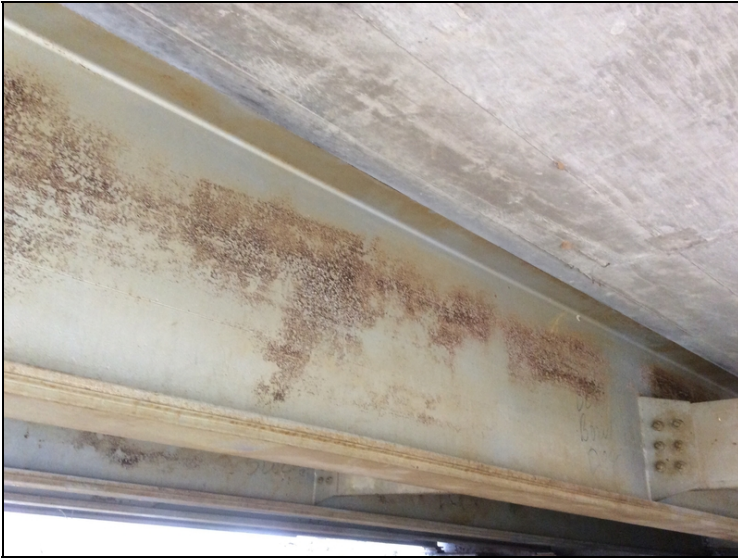
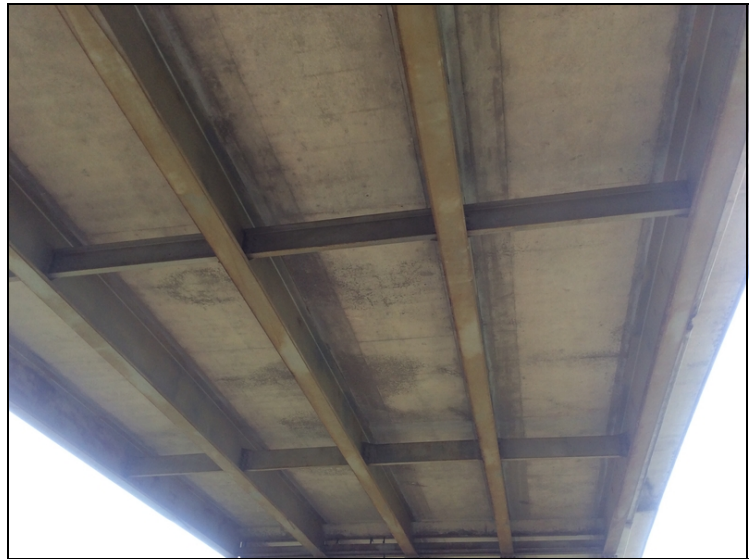
Some light scattered flaking rust beginning on web and flanges of girders - with some heavier concentration of rust at ends of girders near joints

Spans 1-6: Approximately 60% of protective system with surface rust.

Spans 12-18: Approximately 35% of protective system with surface rust - 35% substantially effective.

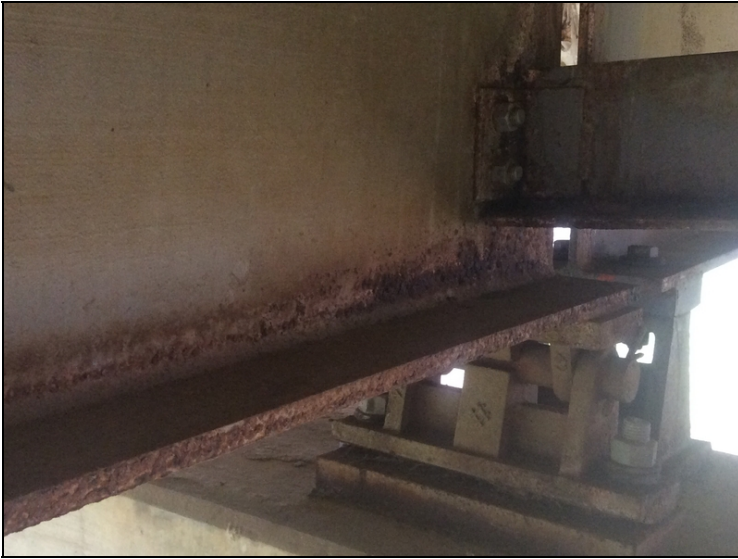
Span 2 bent 3 girder 2 has some light flaking rust to lower web and flange.

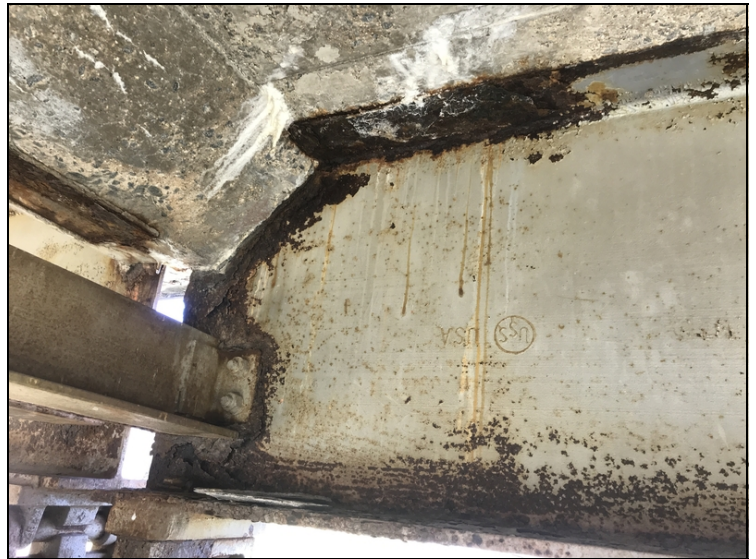
Bent 5 span 5 girder 1 has heavy flaking rust with section loss to top flange and lower web and flange.

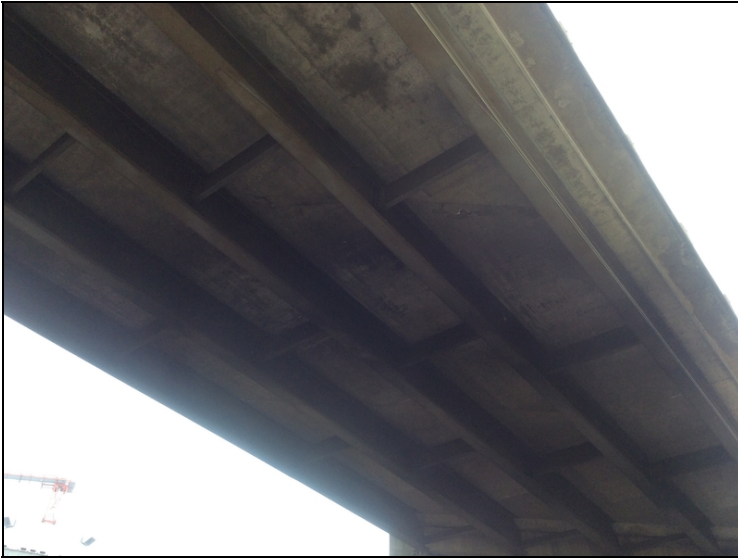
Soffit - Span 9

Span 9: Approximately 50% of protective system - 25% substantially effective. (NOTE: Girder (and soffit) are covered with a coating from diesel exhaust from passing railroad engines.)

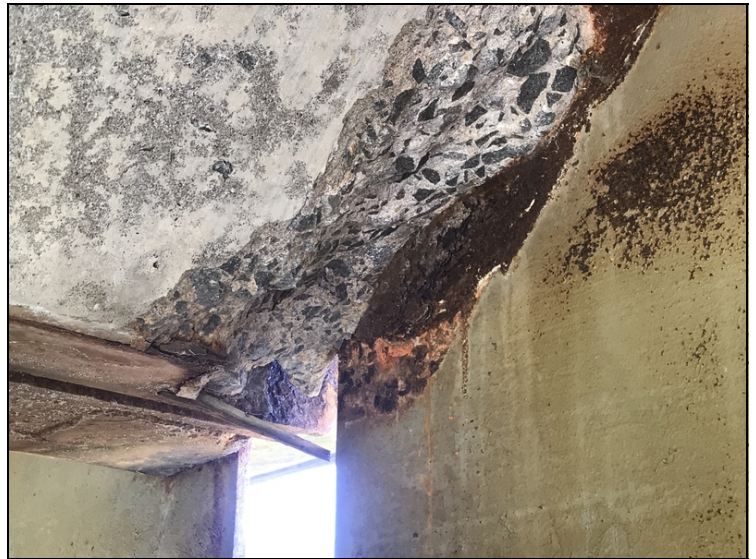
Bent 16 back left side of girder 5 has flaking rust in hunch area. Common in many locations.

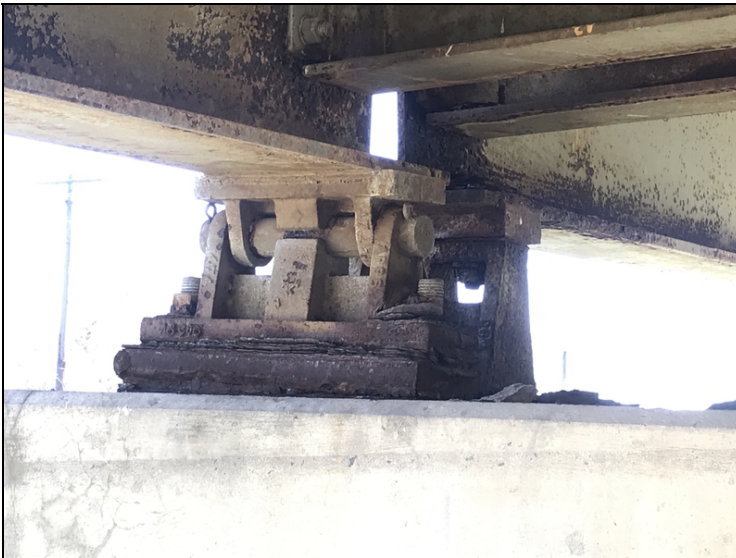
Bent 5 bearing 1 back has heavy flaking rust.

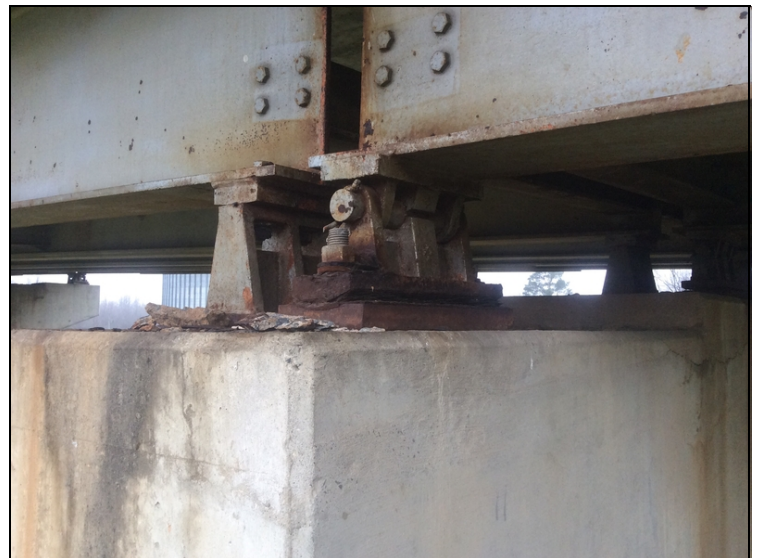
Bent 4 bearing 1 heavy flaking rust.

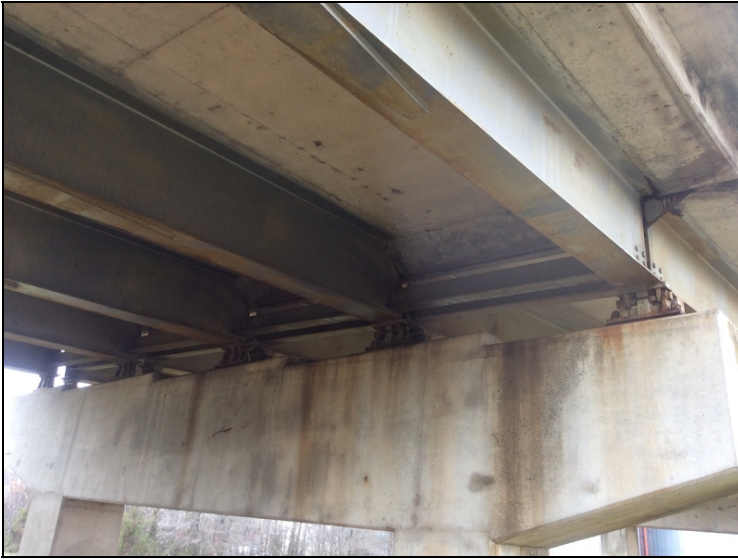
Bent 18 Bearings 1-5 ahead

Remaining bearings: Some scattered light surface rust, heaviest on masonry plates and on left side bearings (Bearings 1-3 @ Bents 1-7 and Bearings 1 & 2 @ Bents 12-19).
