Bridge #05018(Routine, Other Special Recurring)

SH 278-16 LM 4.38 over Union Pacific R/R

Team Lead: Greg Loomis Inspection Date: April 13, 2021

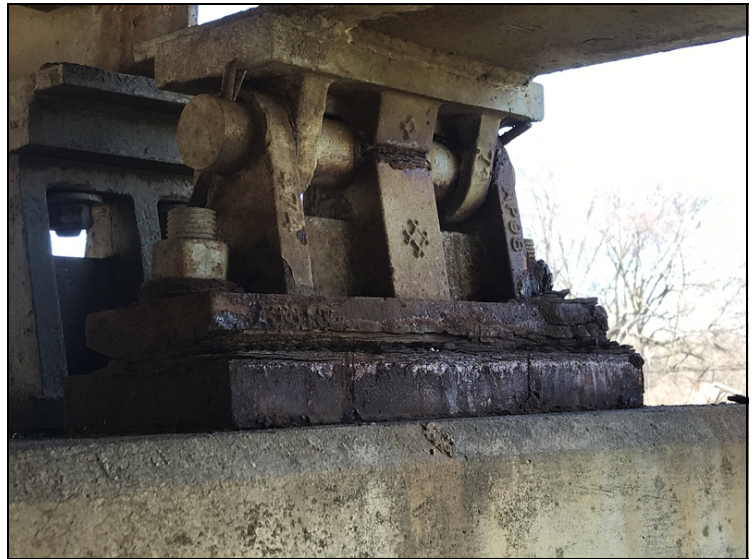
Bent 15 ahead bearing 1 has heavy flaking rust and pack rust..

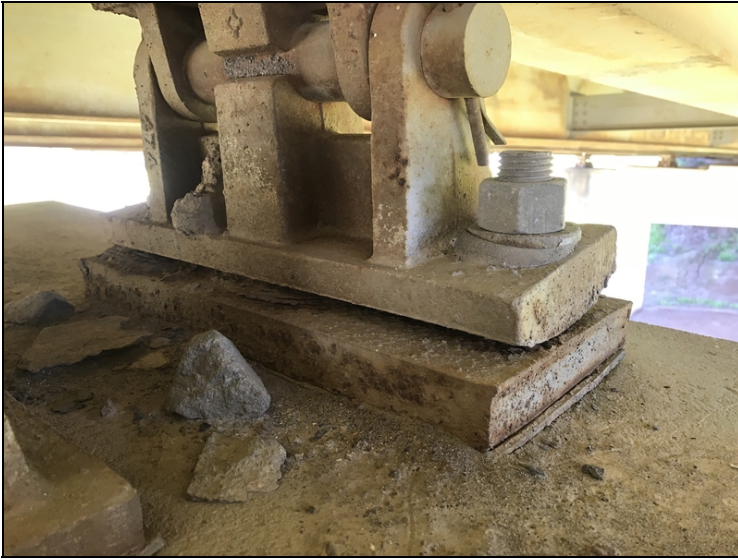
Bent 17 ahead bearing 4 has some pack rust between plate and bearing.

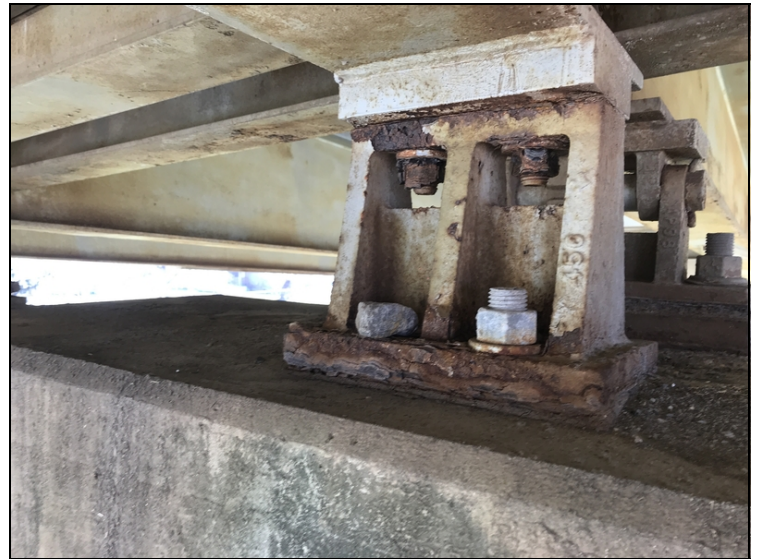
Bent 15 bearing 3 back has heavy flaking rust.

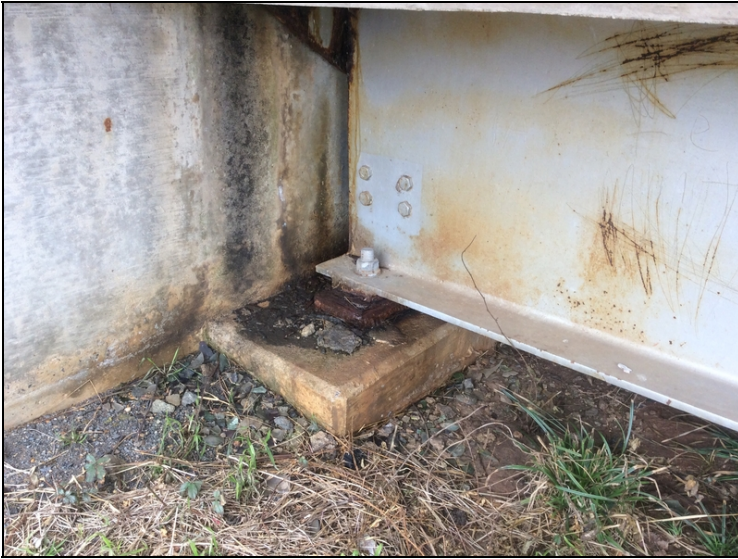
Bent 19 Bearing 1

Remaining bearings: Some scattered light surface rust, heaviest on masonry plates and on left side bearings (Bearings 1-3 @ Bents 1-7 and Bearings 1 & 2 @ Bents 12-19).

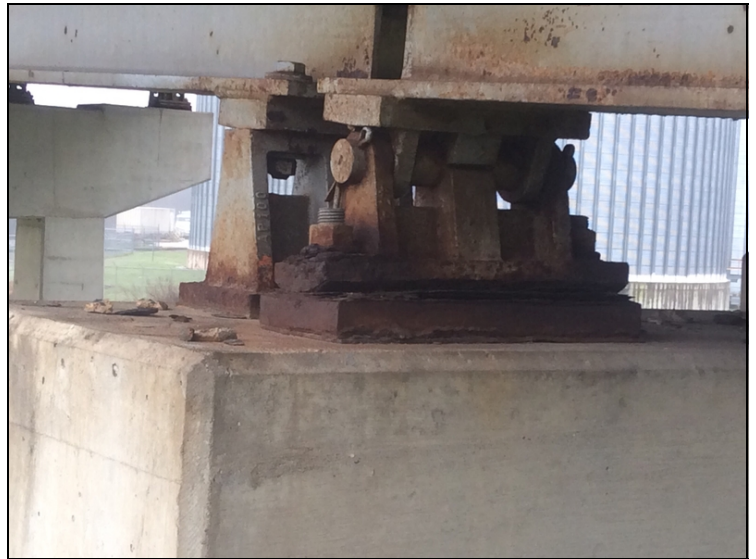
Span 2 bent 3 bearing 1 heavy flaking rust to bearing and masonry plate. Common on all bearings this bent to a lesser extent.

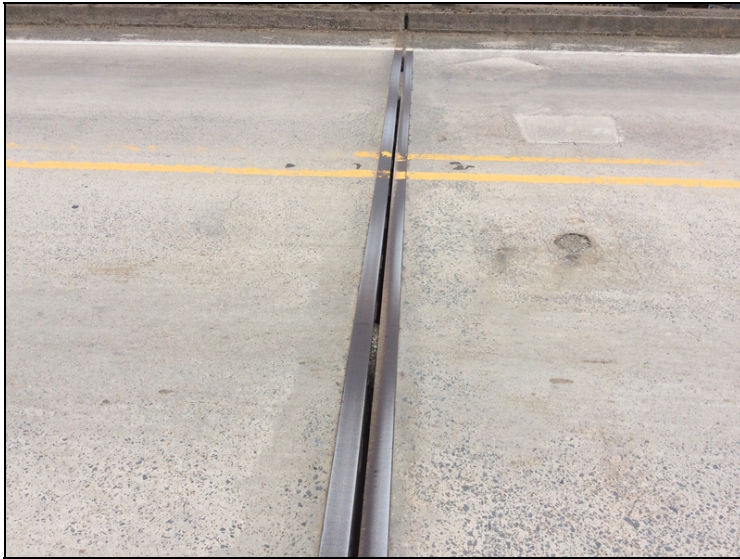
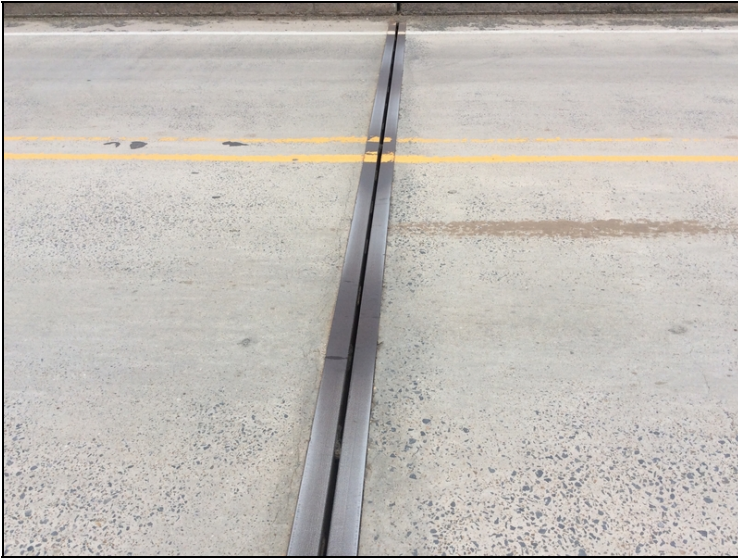
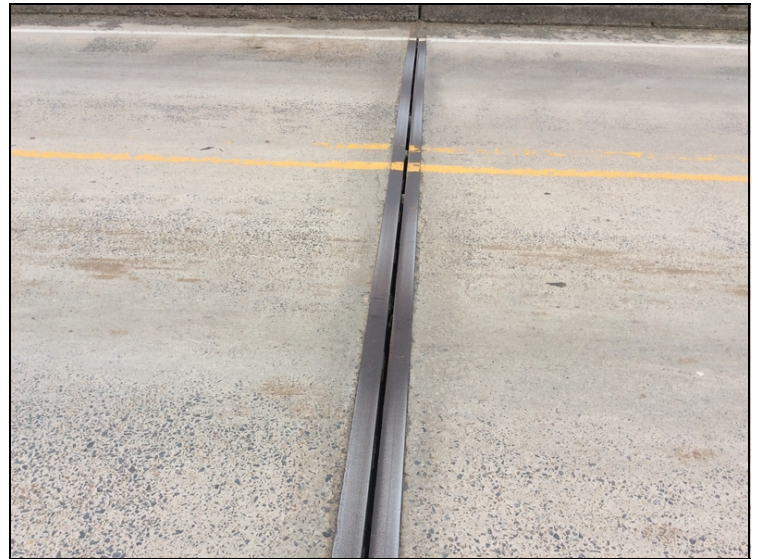
Joints - Bents 6, 9, 12, 13, 14, & 16: Preformed joint material is missing from joint, allowing stormwater to leak through and dirt and other debris to build-up on end of girders, bearings, and caps.

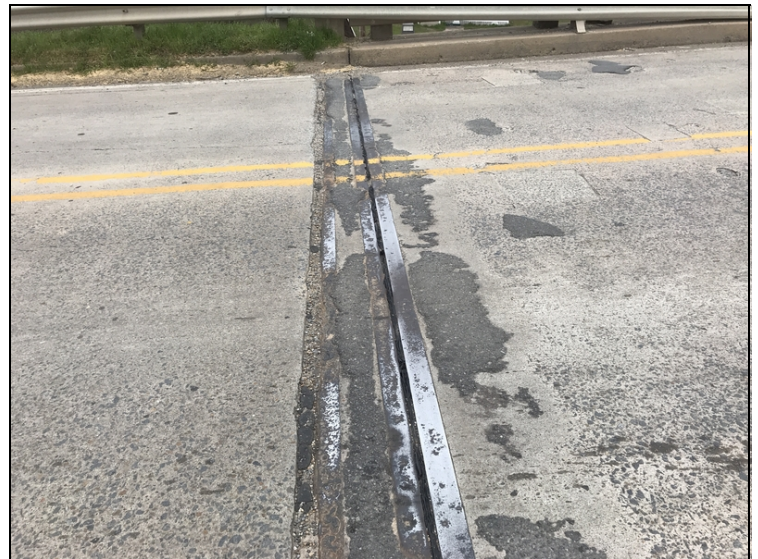
Bent 1 expansion joint damaged. This is Common at all joint.
