# Bridge Inspection Report

**04183**  
**SH 4-18 LM 9.42**  
**over**  
**Lake Isaacs**

Structure Number: 04183

Facility Carried: SH 4-18 LM 9.42

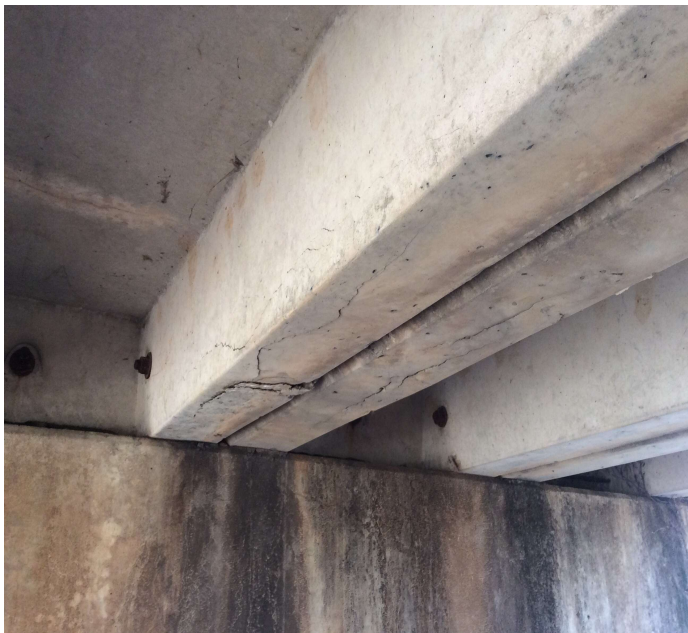
Girder - various locations: Cracking and delaminating on bottom of legs of precast channel beams units.

PHOTO 1      Description      Span 13 Units 3-4 @ Bent 13  
(cracking/delaminating)

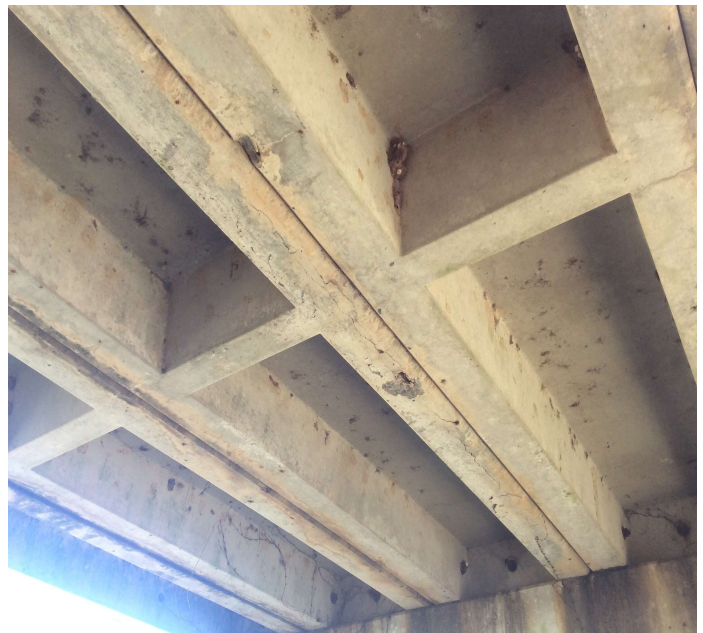
PHOTO 2      Description      Span 2 Unit 3 (cracking/delaminating)

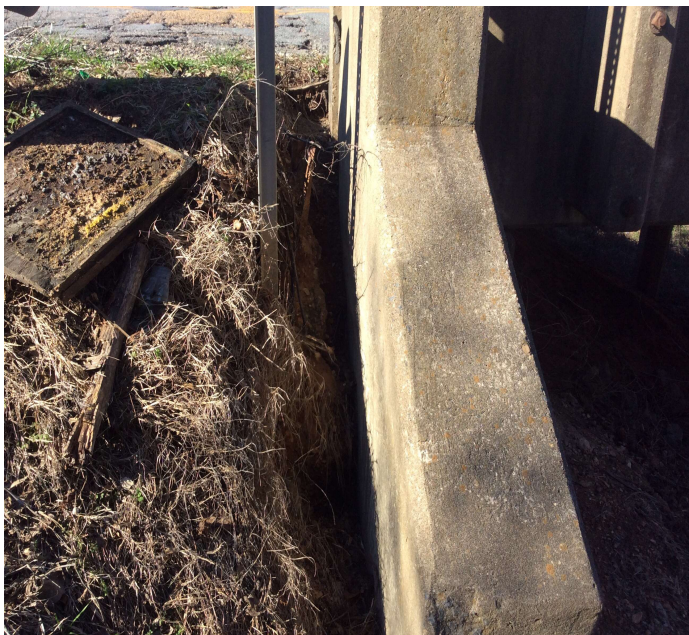
Roadway slope - Bent 1 right: Small, narrow area of erosion on the roadway side of winglette - eroded up inside of the curb of the bridge and close to the edge line.

PHOTO 1      Description      Abutment - Bent 1 right (erosion)

Desha: pack area with soil cement

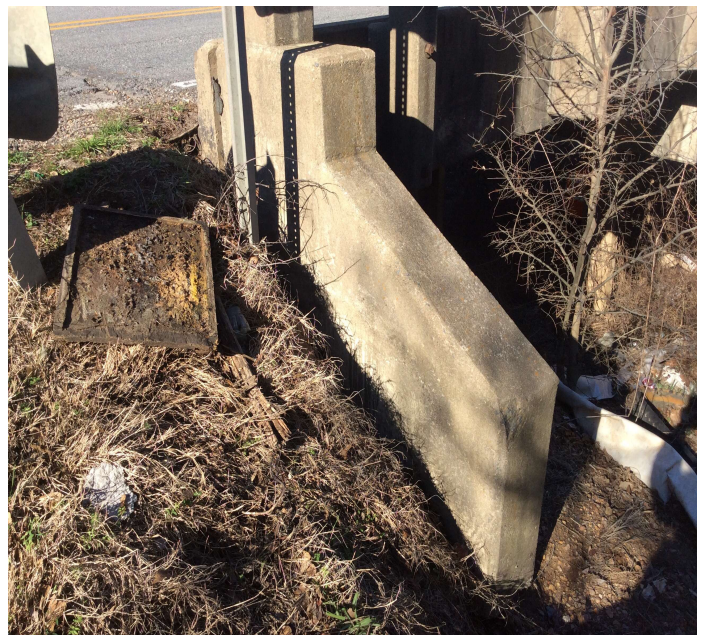
PHOTO 2      Description      Abutment - Bent 1 right (erosion)

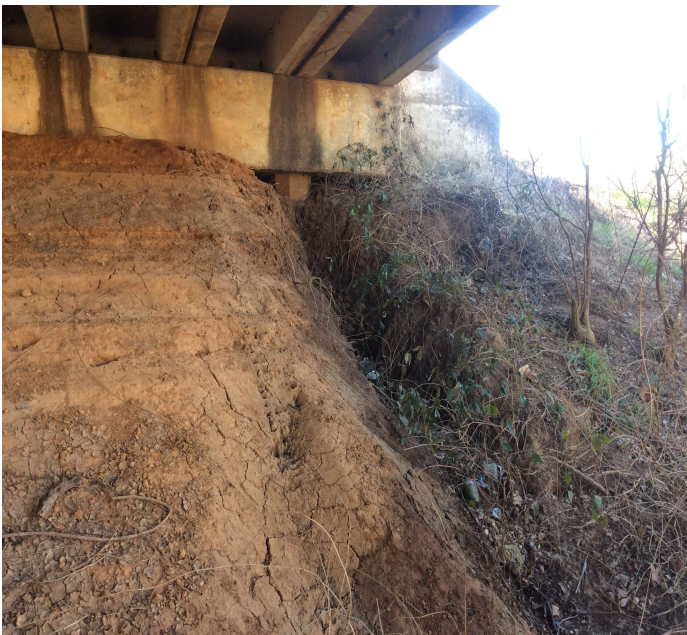
Endslope - Bent 1 left: Some erosion beginning at abutment and down slope - bottom of cap and pile exposed.

PHOTO 1    Description    Endslope - Bent 1 left (erosion)

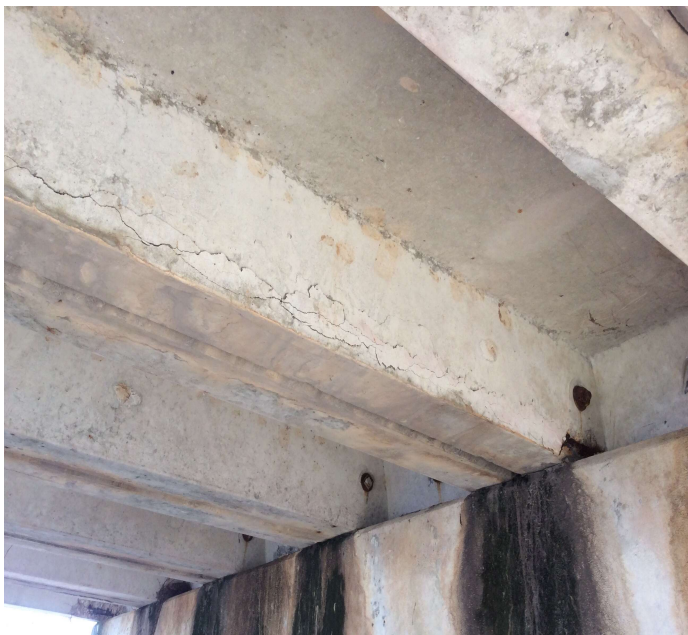
Girder - various locations: Spalling with steel exposed (some section loss) on bottom of legs of precast channel beams units.

PHOTO 1      Description      Span 12 Unit 5 @ Bent 13 (rebar exposed/cracking/delaminating)

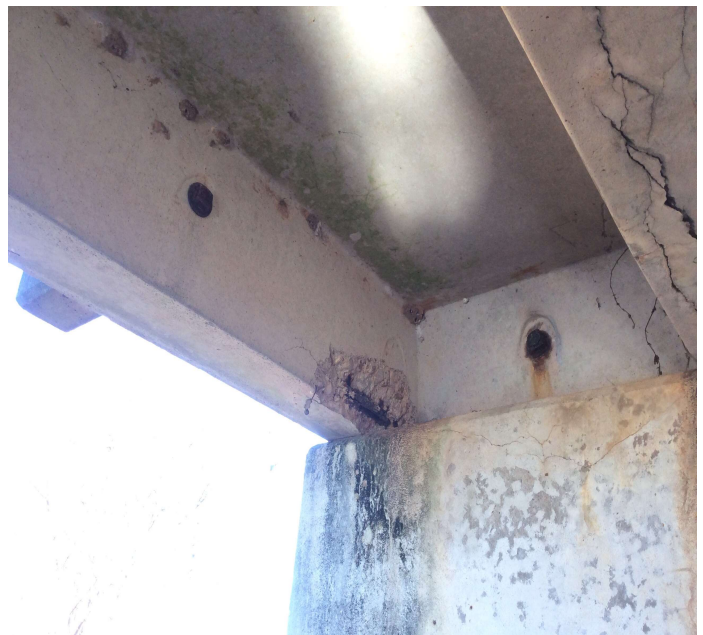
PHOTO 2      Description      Span 12 Unit 1 @ Bent 13 (rebar exposed)

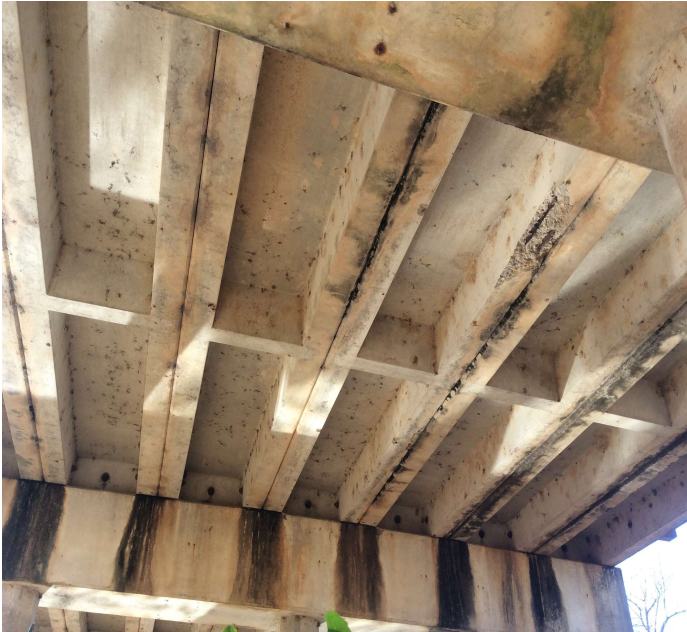
PHOTO 3 Description Span 10 Unit 4 (rebar exposed)

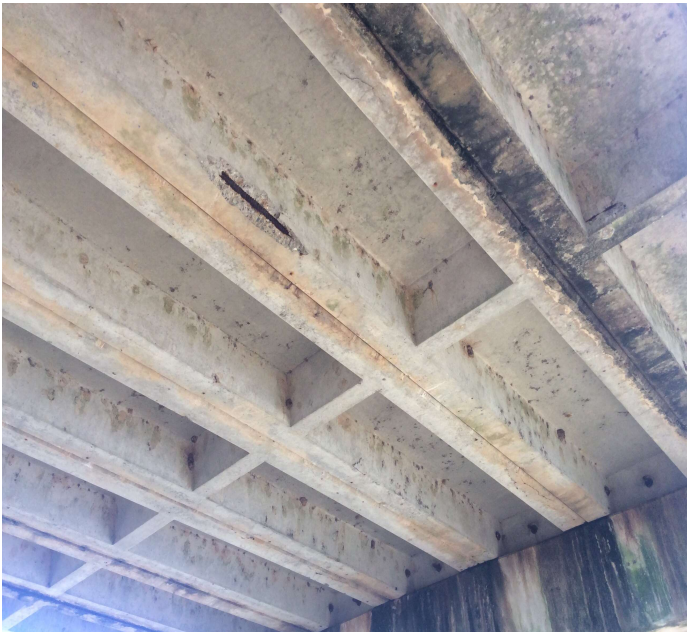
PHOTO 4 Description Span 4 Unit 6 (rebar exposed)

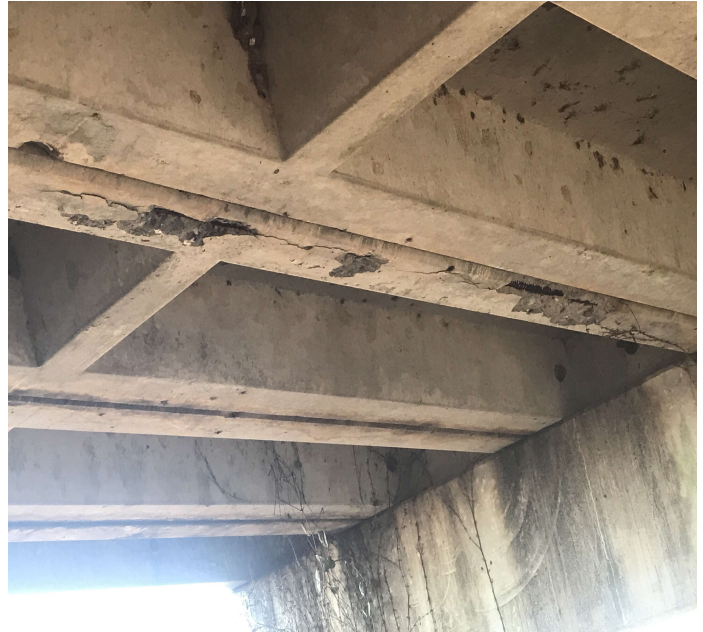
PHOTO 5 Description Span 2 girder 3 spalling to channel legs.

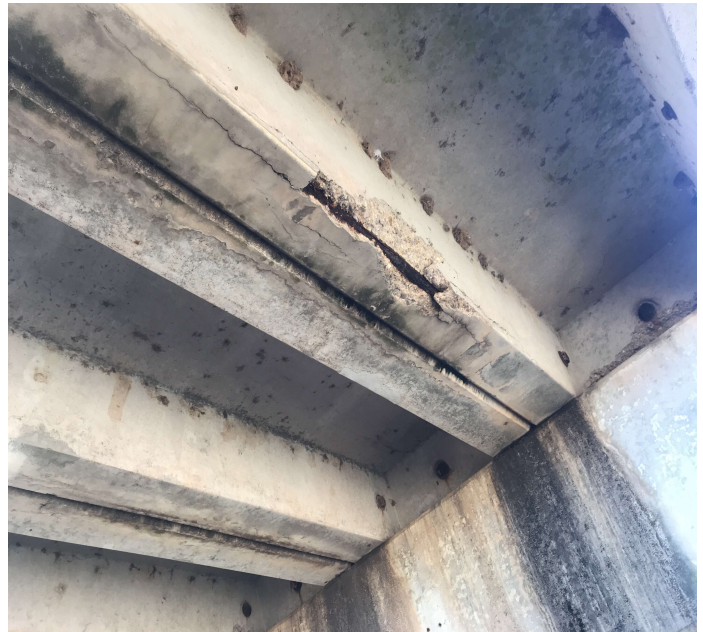
PHOTO 6 Description Span 12 unit 1 girder legs have spalls with exposed rebar. Common unit 5 this span.

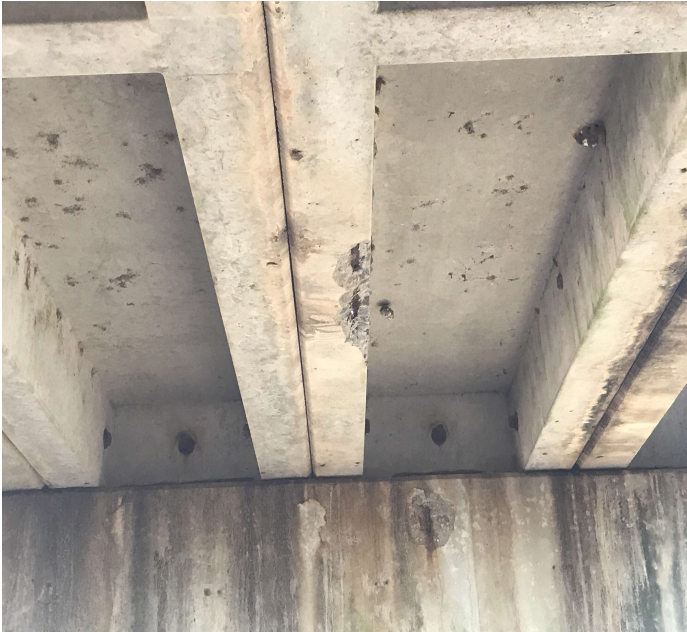
PHOTO 7      Description      Span 2 girder 6 has spalling to channel legs.

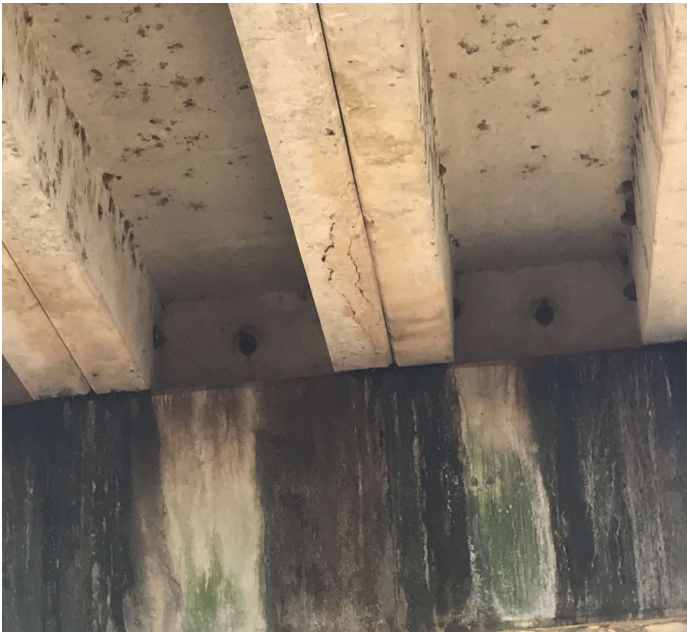
PHOTO 8      Description      Span 4 girder 5 has cracks and delam in channel legs. Common girder 3 this span.

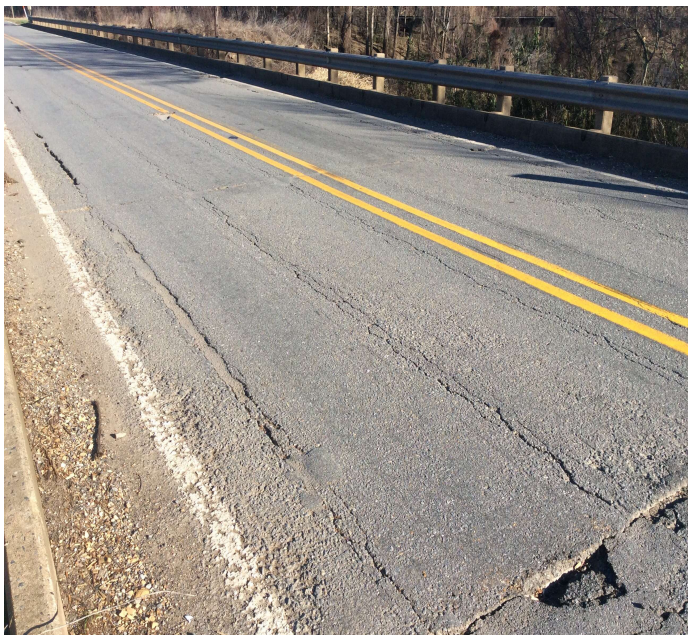
Asphalt wearing surface - all spans: Significant deterioration with large cracks along joints of units - few scattered small spalls. Moderate to large transverse cracks at bents and bridge ends.

PHOTO 1      Description      Asphalt wearing surface - Spans 1-2 (deterioration)

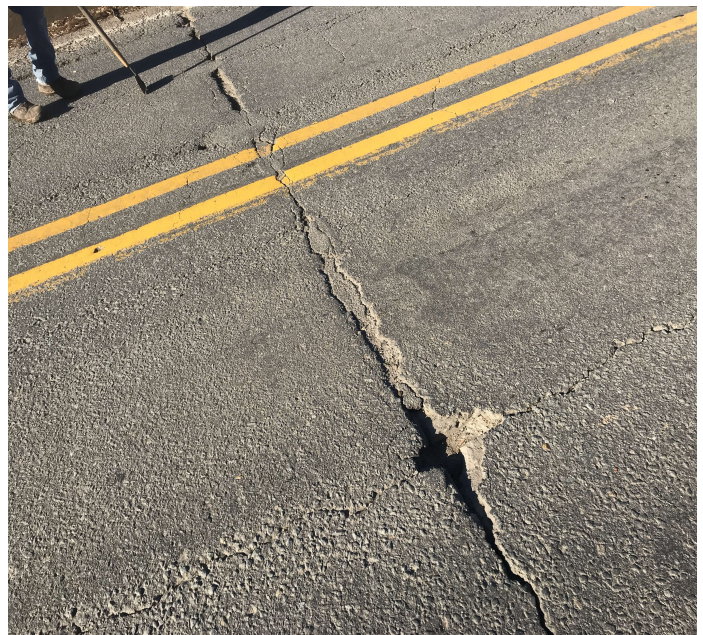
PHOTO 1      Description      Deck all spans have small spalls in asphalt wear surface at unit ends and key ways.

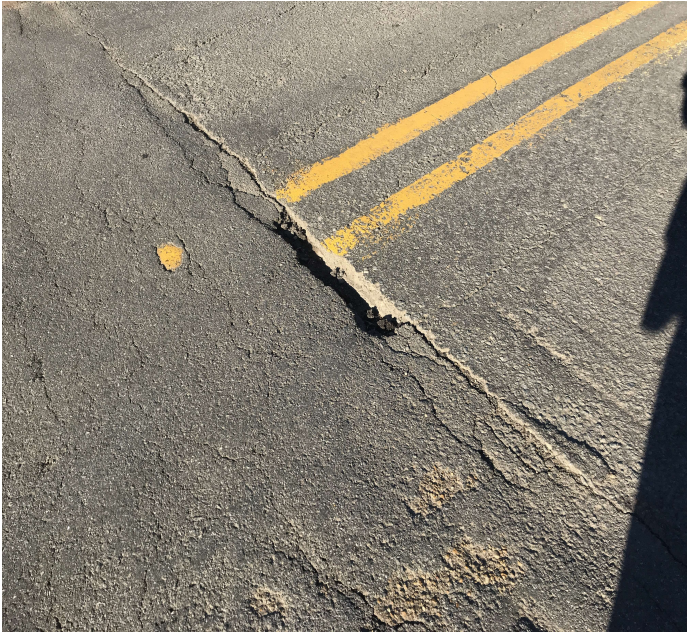
PHOTO 2 Description Bent 1 approach roadway has small pothole near centerline.

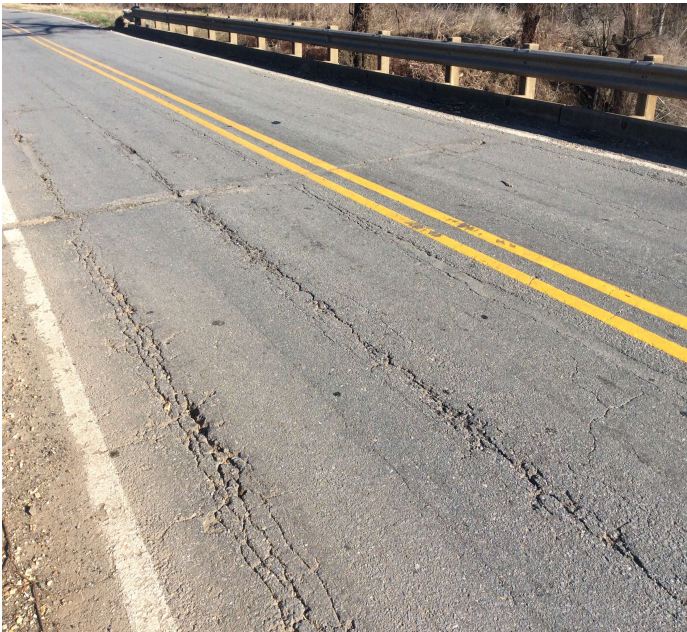
PHOTO 2 Description Asphalt wearing surface - Spans 9-10 (deterioration)

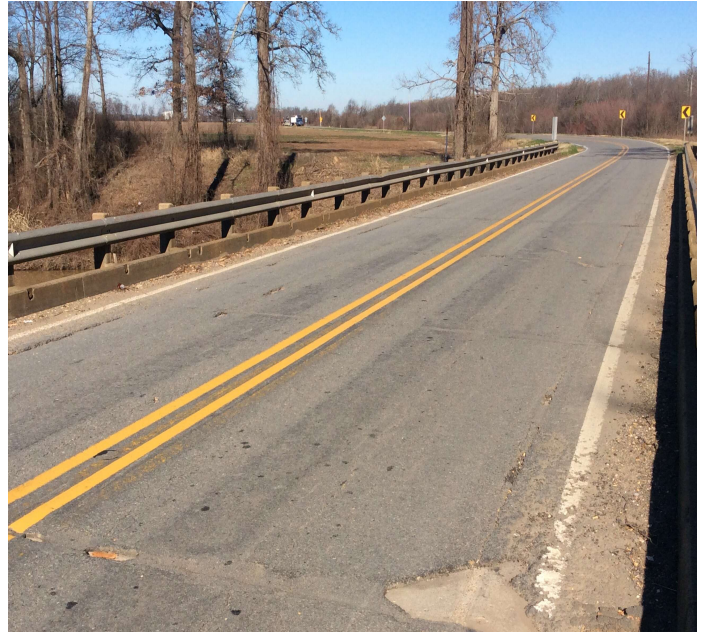
PHOTO 3 Description Asphalt wearing surface - Spans 4-5 (deterioration)

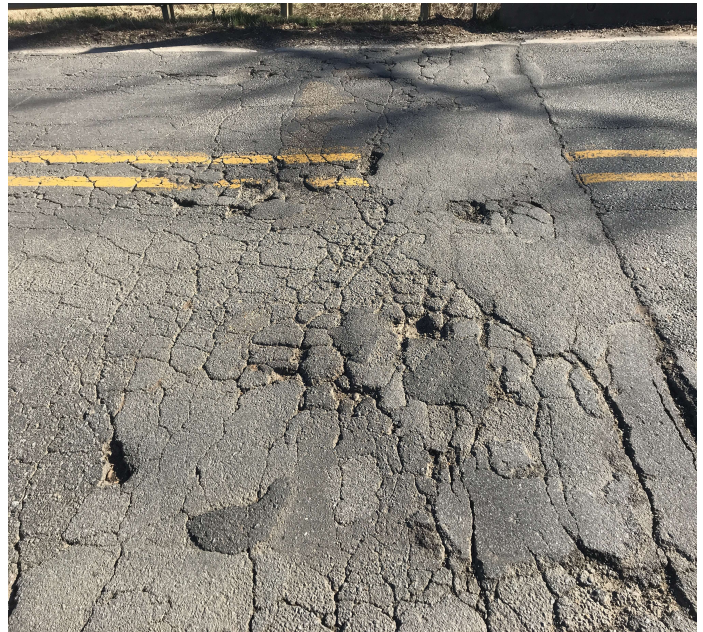
PHOTO 3 Description Bent 14 approach roadway has small pothole in asphalt.

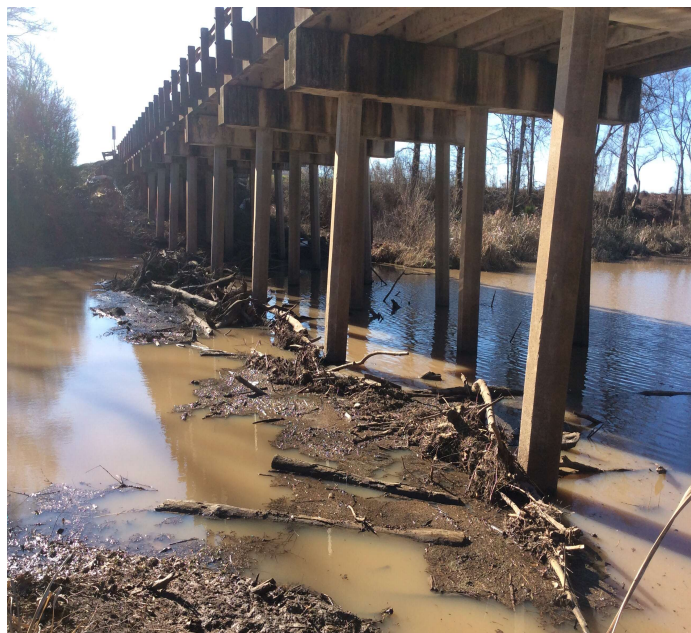
Channel - right side: Build-up of large trees, limbs, and other debris against pile at Bents 6-8.

PHOTO 1      Description      Channel - right side (debris build-up)

Remove trees and debris - work with Charlie -Ronnie if you need help

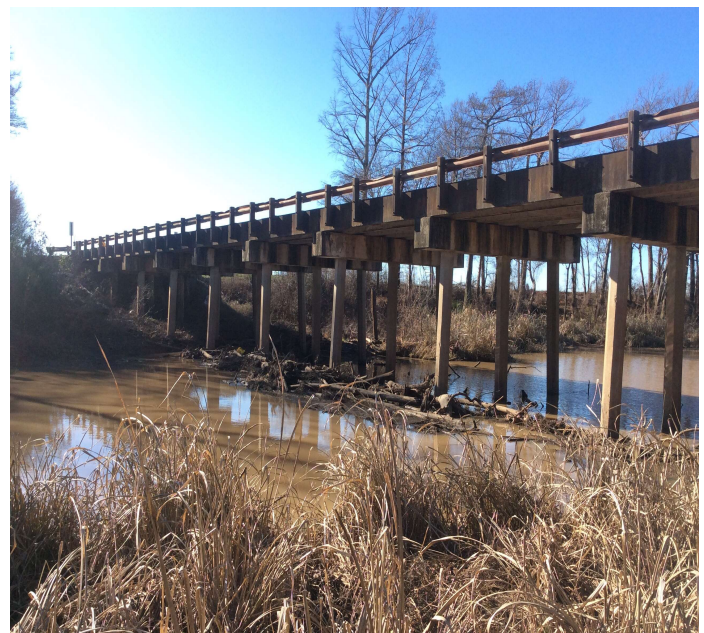
PHOTO 2      Description      Channel - right side (debris build-up)

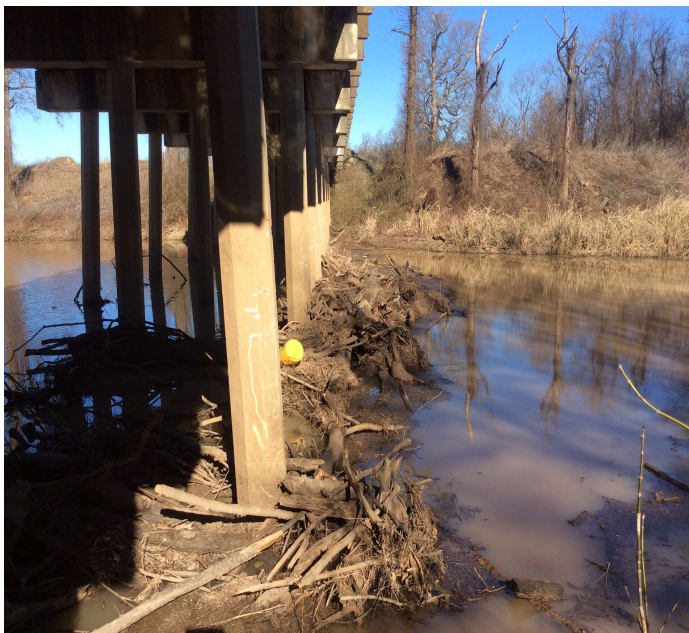
PHOTO 3      Description      Channel - right side (debris build-up)

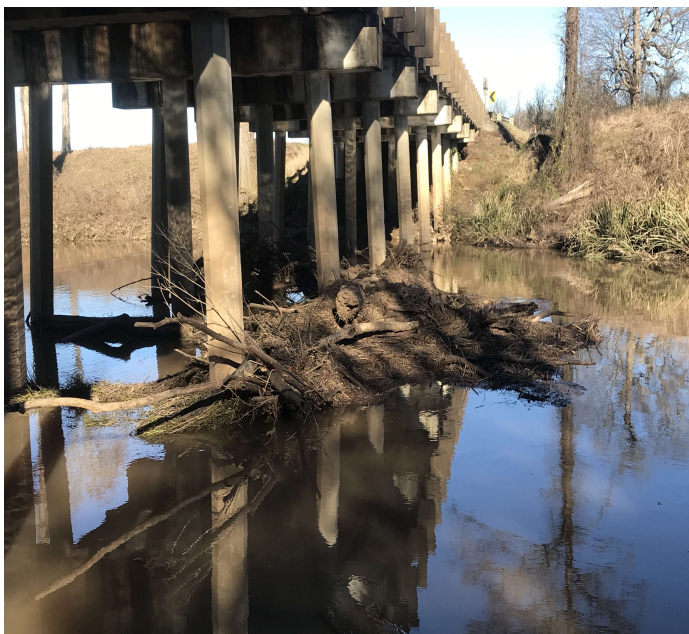
PHOTO 4      Description      Debris field at piles bents 6-8.

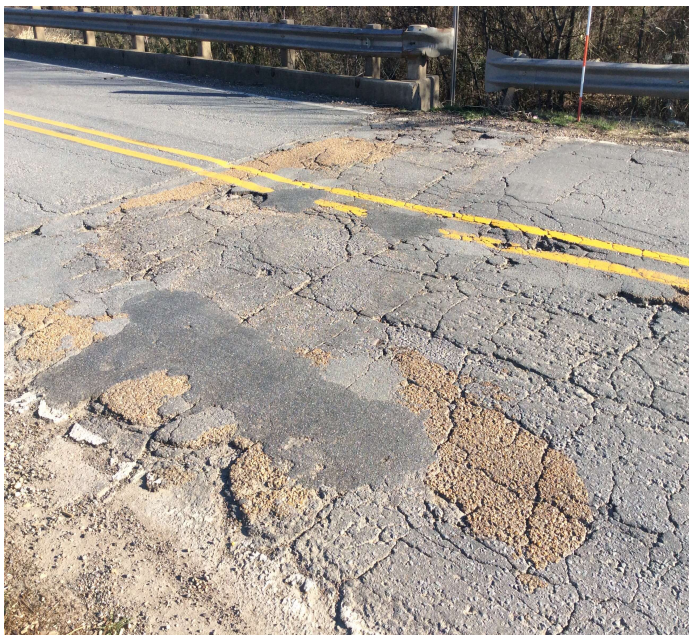
Approach roadway - both ends: Significant deterioration of asphalt wearing surface - numerous large cracks and potholes.

PHOTO 1 Description Approach roadway - Bent 1 (deterioration)

Desha: get a bobcat- mill out his approach and replace with hot mix

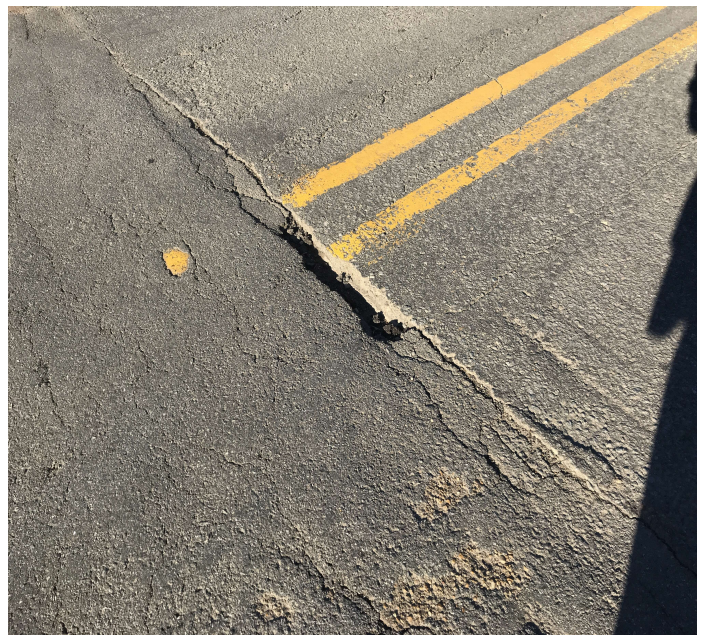
PHOTO 1 Description Bent 1 approach roadway has small pothole near centerline.

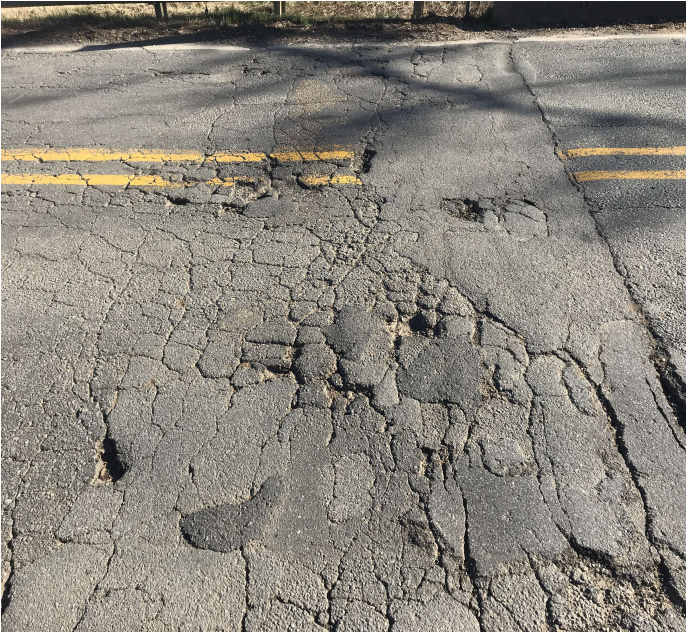
PHOTO 2      Description      Bent 14 approach roadway has small pothole in asphalt.

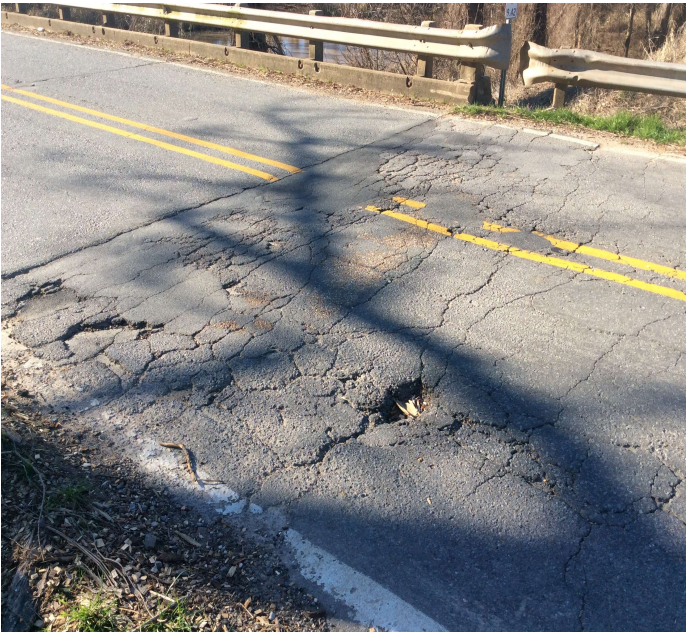
PHOTO 2      Description      Approach roadway - Bent 14 (deterioration)
