# Bridge Inspection Report

**02953**

**US 278-16 LM 0.38**

**Bayou Bartholomew**

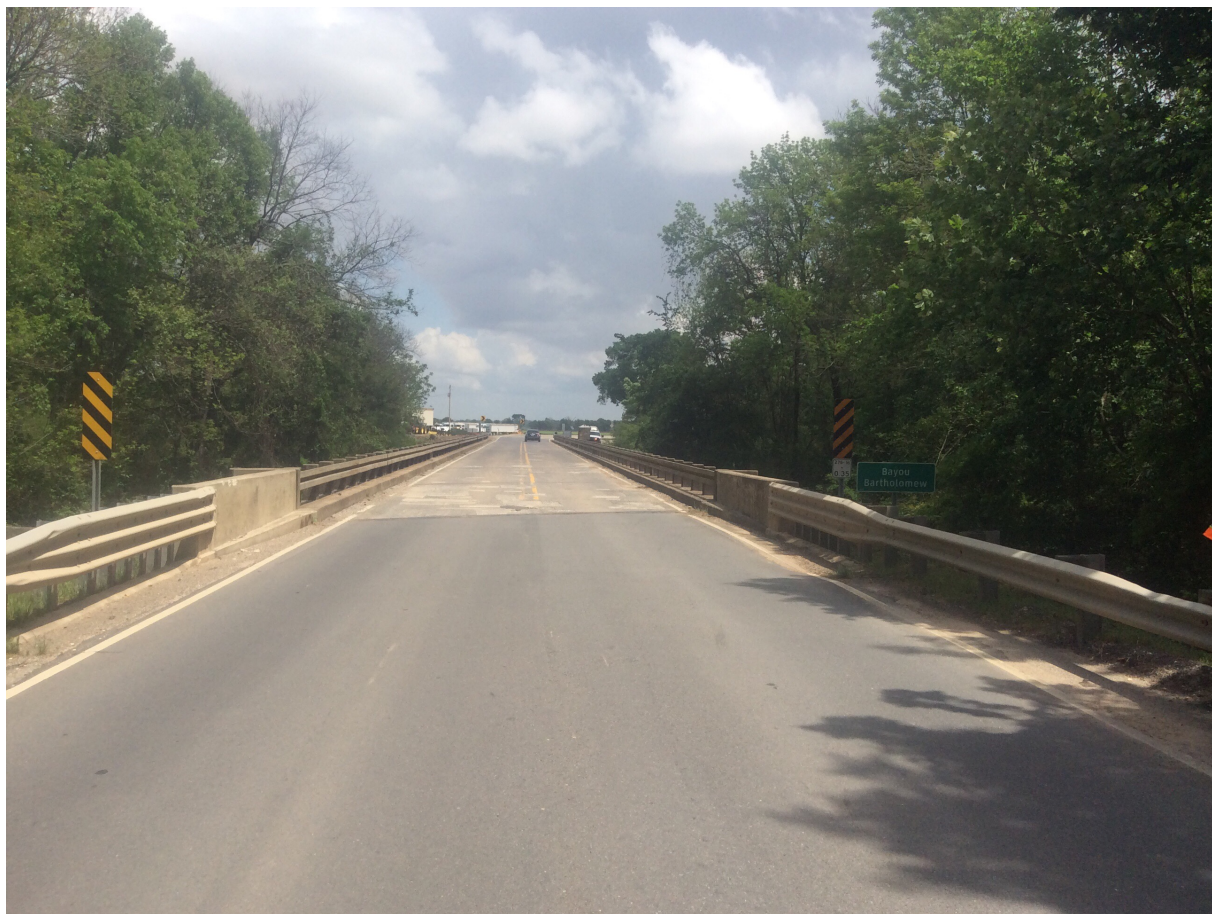
No overlay on the bridge deck.

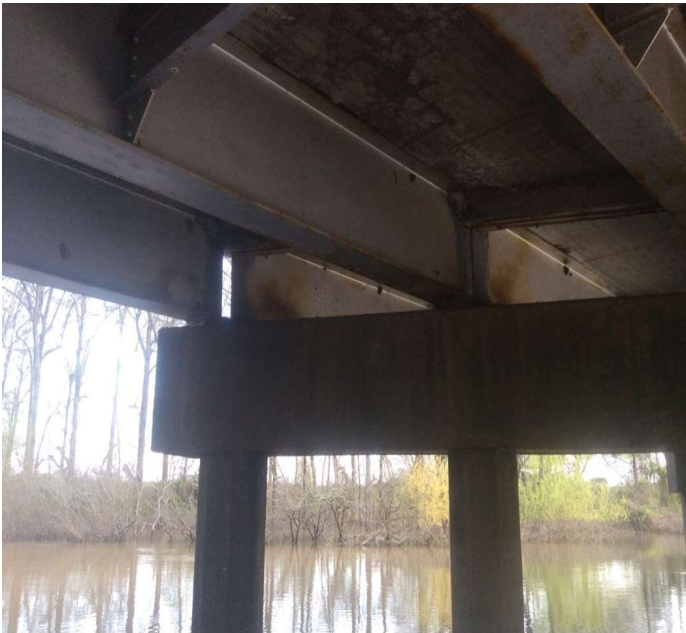
PHOTO 1 Description

All spans girder are rusty with some pitting most common at ends and drain openings.

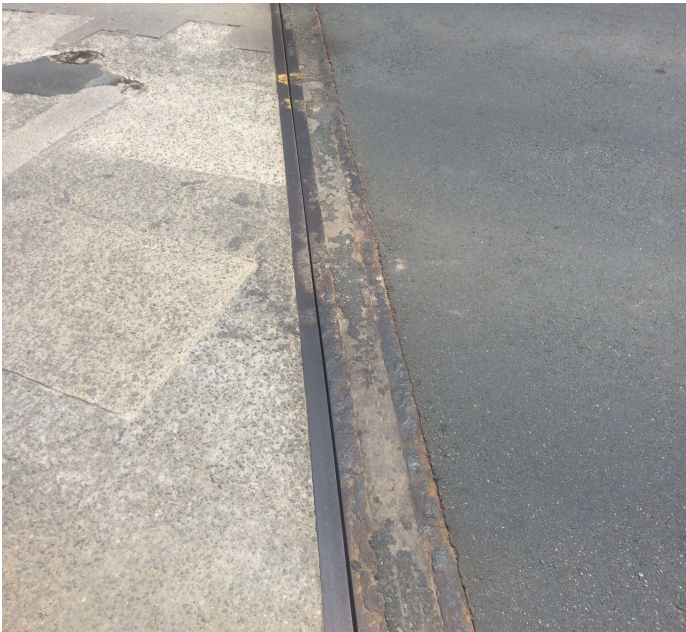
Joint armor all spans has rust with some pitting and are open allowing water on to girder ends causing section loss to girders.

PHOTO 1      Description      Open joint seals at span1 bent 1

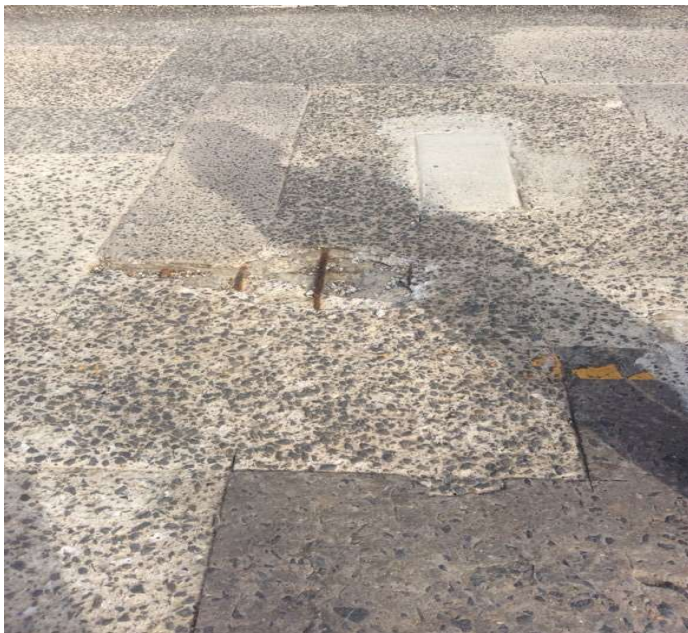
PHOTO 1 Description

Deck all spans have spalls with exposed rebar. Deck all spans have small spalls and spalls filled with asphalt.

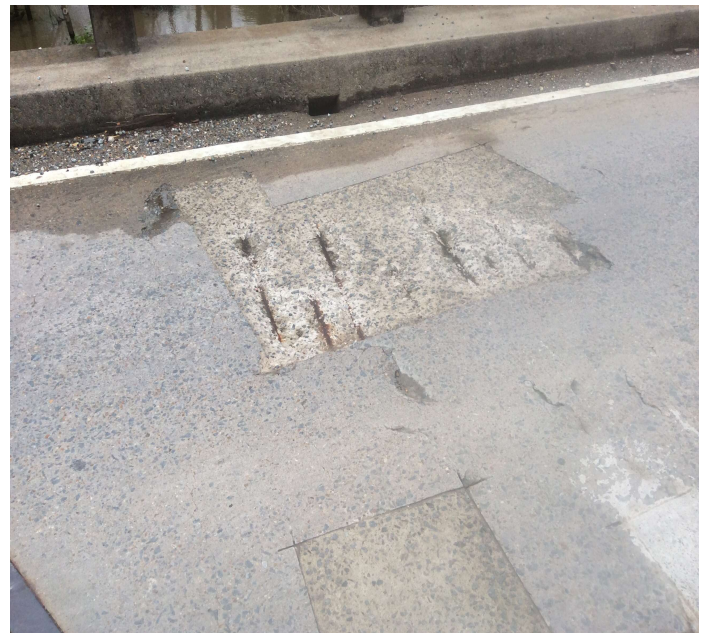
PHOTO 2 Description Span 3 left lane near bent 3 spall with exposed rebar in previously patched area.

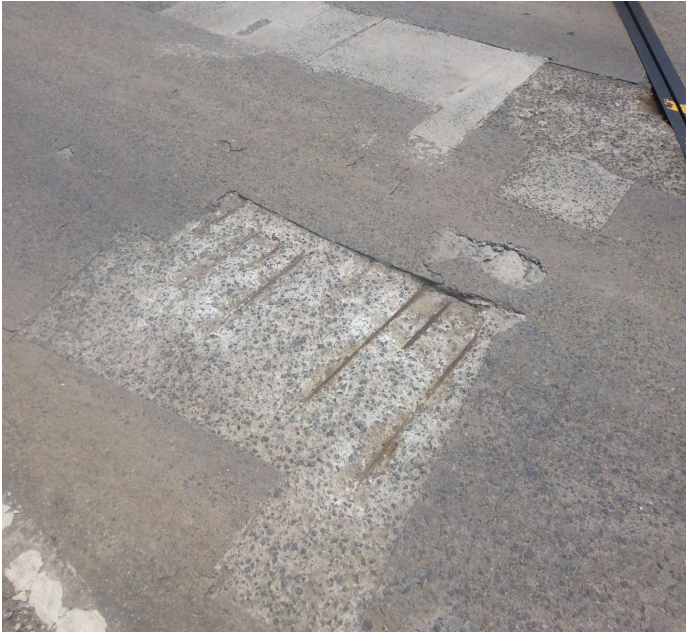
PHOTO 3      Description      Spall with exposed rebar span 3 near bent 3

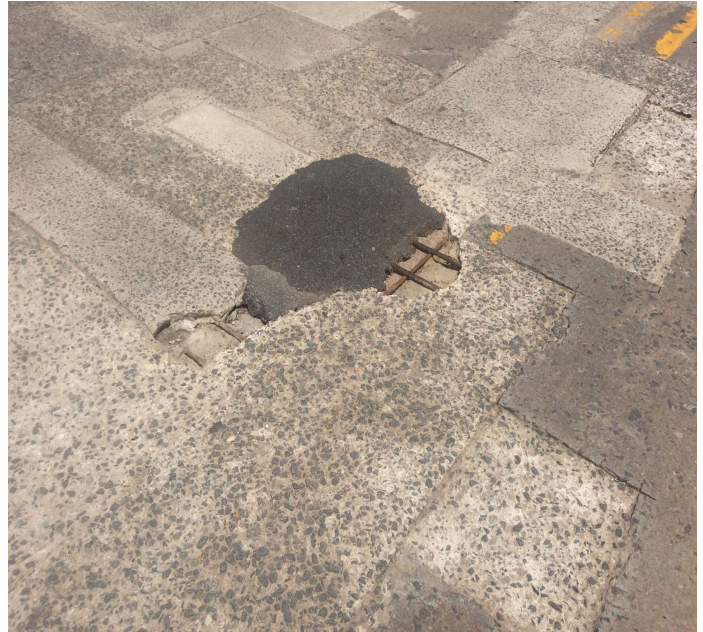
PHOTO 5      Description      Span 1 near bent 1 spall with exposed rebar

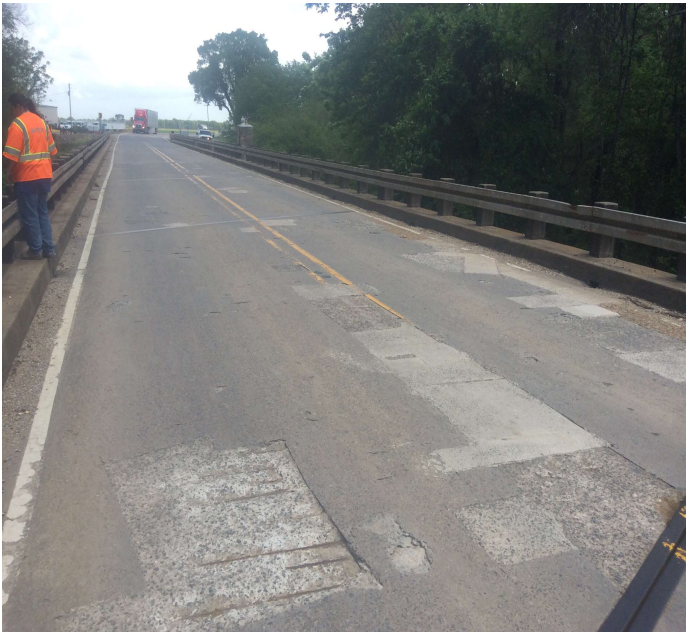
PHOTO 4      Description      Deck over view of span 3
