Bridge Inspection Report

02954
US 278-16 LM 1.27
over
Big Bayou Canal

Structure Number: 02954

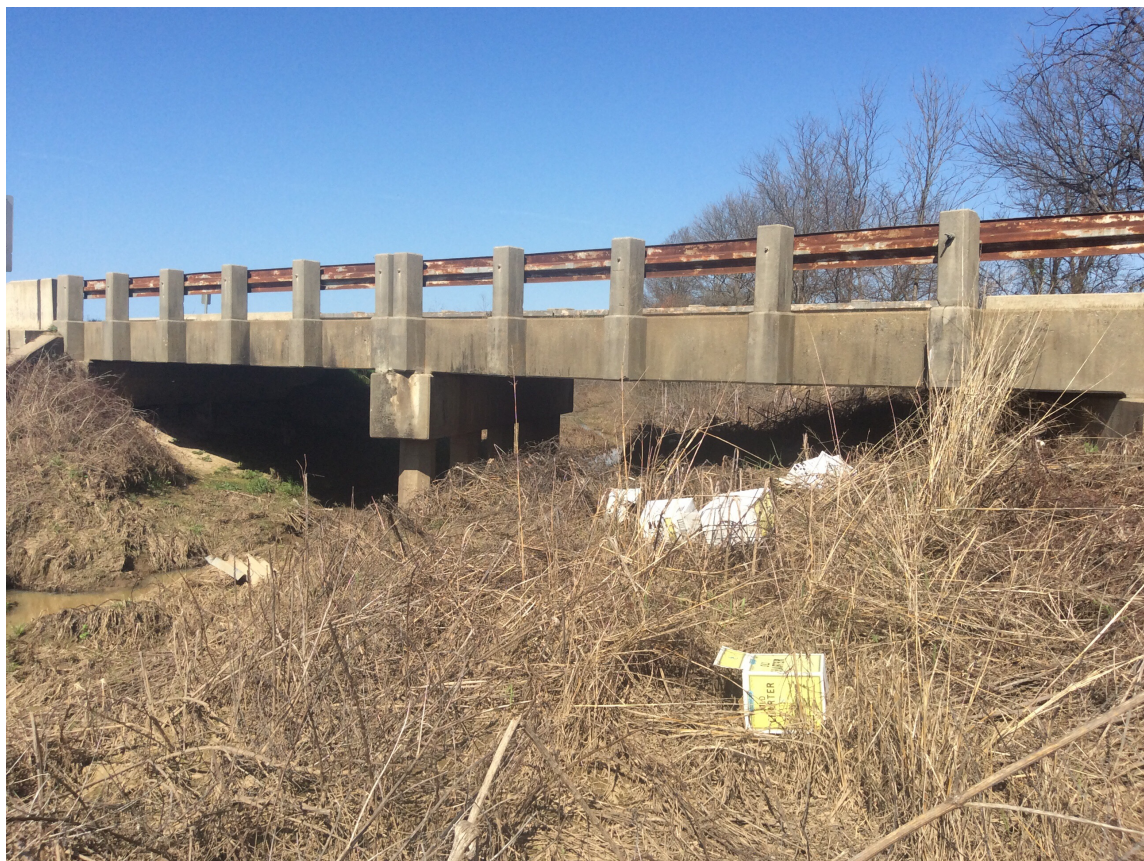
There is a 3-inch thick asphalt overlay on the bridge deck.
