# Bridge Inspection Report

**06160**  
**US 278-15 LM 13.75**  
**over**  
**Cut-Off Creek**

Structure Number: 06160

Facility Carried: US 278-15 LM  
13.75

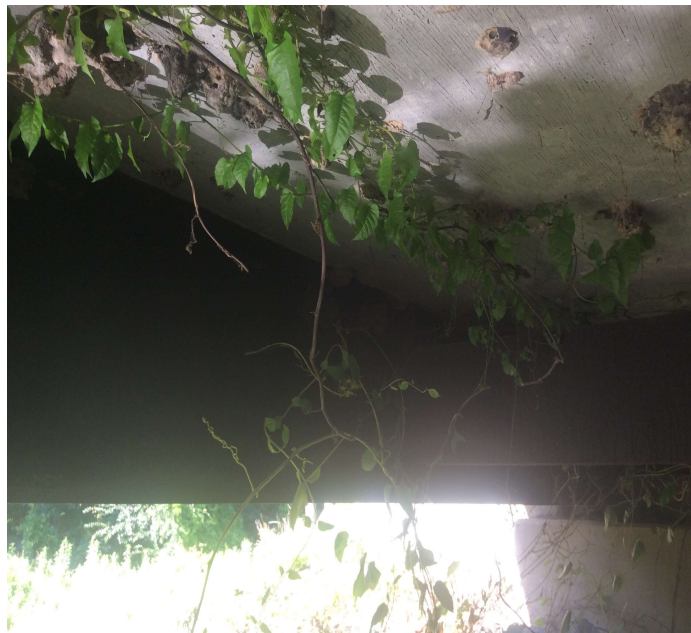
Spans 1 & 3 vines and vegetation growing under bridge.

PHOTO 1      Description      Span 1 vines growing on the underside of bridge.

Gerald: remove vegetation and advise when complete

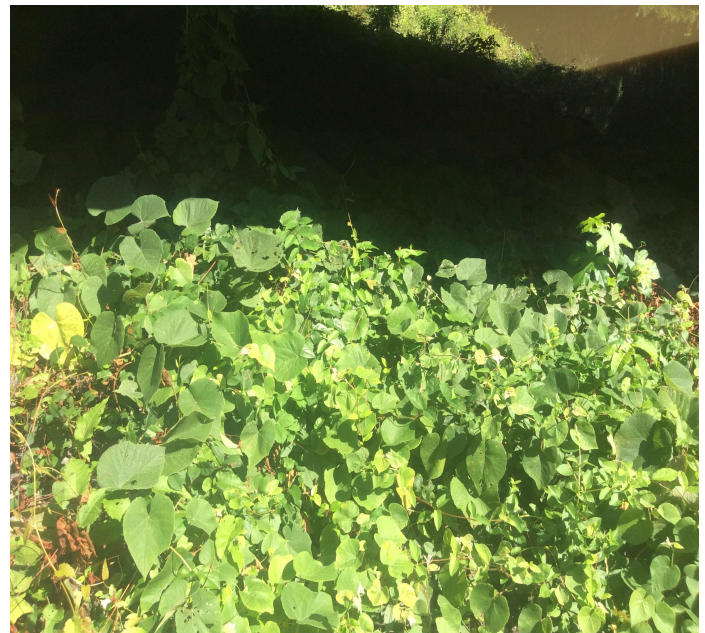
PHOTO 2      Description      Span 1 & 3 Vines and vegetation growing under bridge.
