Bridge Inspection Report

06161

US 278-15 LM 13.83

Cut-Off Creek Relief

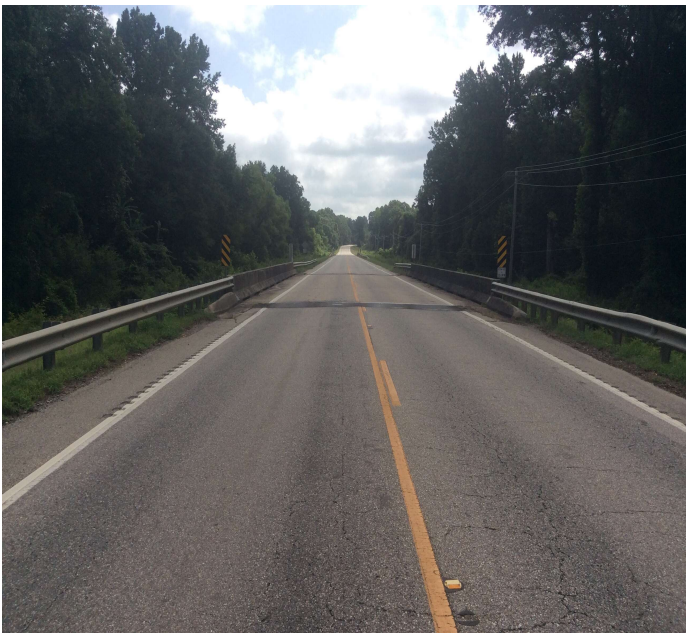
PHOTO 1 Description

Both ends of bridge route section markers read Log Mile 13.99 should read 13.83

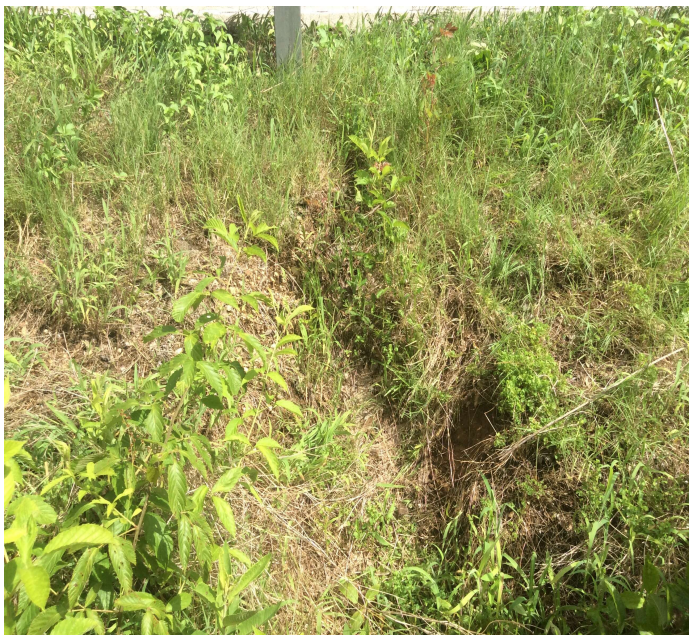
Roadbed front slopes behind approach guard rails sections erosion gullies. Approach roadway at end bents erosion at guardrail and back wall.

PHOTO 1 Description Erosion by guard railing west end south side of the slope. Common southeast slope.

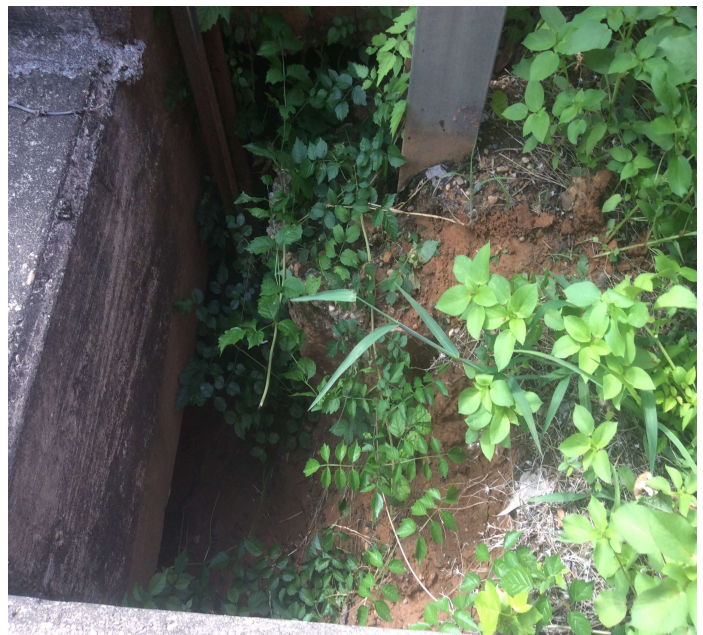
PHOTO 2 Description Erosion on northwest corner of roadway by outside of end bent. Common all four corners.
