Bridge Inspection Report

06162

US 278-15 LM 13.95

Cut-Off Creek Relief

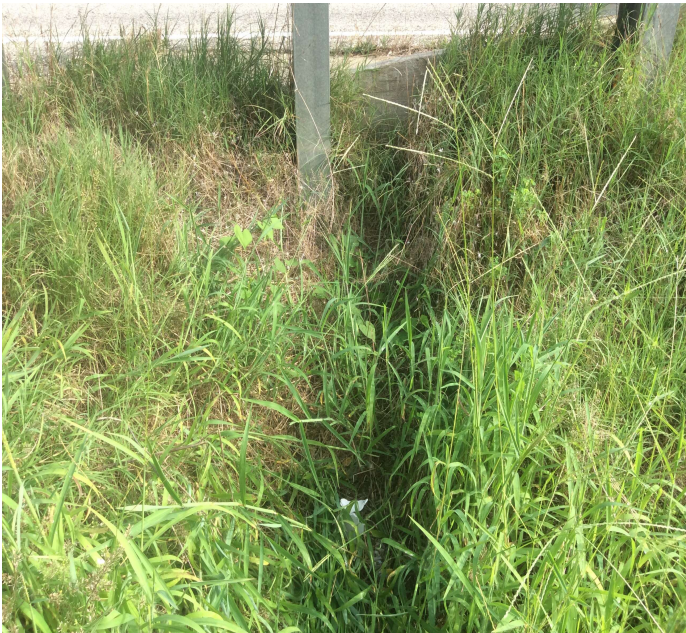
Roadbed front slopes behind approach guard rails sections erosion gulleys.

PHOTO 1 Description Approach roadway west end , south
erosion to end slope.
