# Bridge Inspection Report

**02840**  
**SH 1-01 LM 15.45**  
**over**  
**Amos Bayou**

Structure Number: 02840

Facility Carried: SH 1-01 LM 15.45

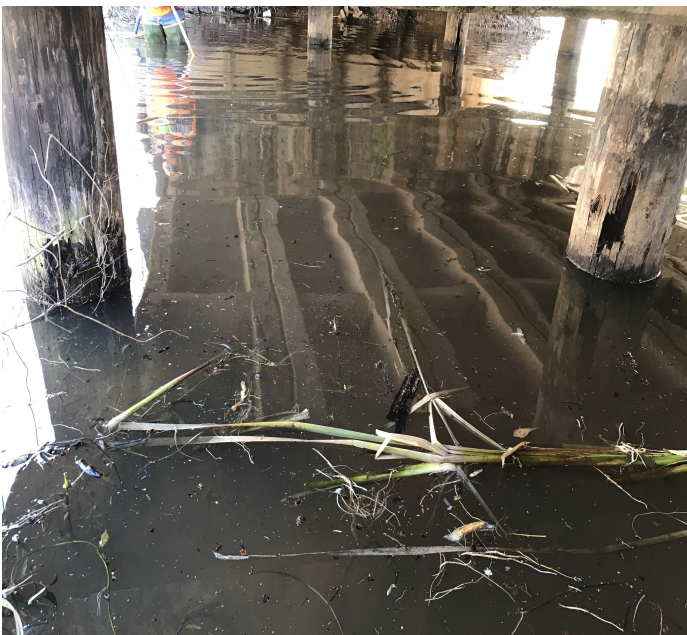
Bent 2 Pile 1: Moderate-sized checking with some moderate surface decay along waterline.

Bent 2 Pile 2: Moderate-sized checking with moderate decay (hole rotten on back side near waterline).

PHOTO 1      Description      Bent 2 - Pile 1 & 2: Decay
